Characterization Schematic
 Corral Canyon 20-32 FED State Com 306H

Client Name: ExxonMobil Production Company
 Site Name: Corral Canyon 20-32 FED State Com 306H
 NMOCD Tracking #: nAPP2601529351
 Project #: 26A-00691
 Lab Reports: H261454 and H261875

Table 3. Initial Characterization Laboratory Results

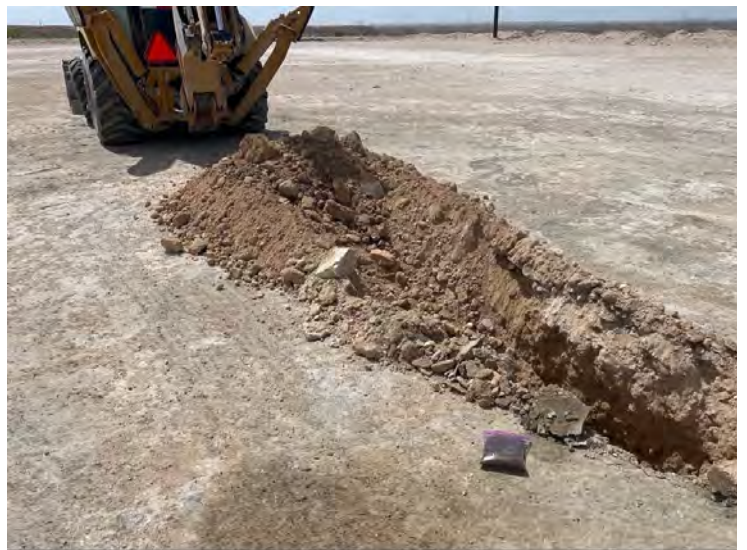
Date: 3/31/2026
 Time: 12:14
 Notes: BH26-13 @ 3'
 Latitude: 32.119530555555556
 Longitude: -103.99949722222222
 Direction: N

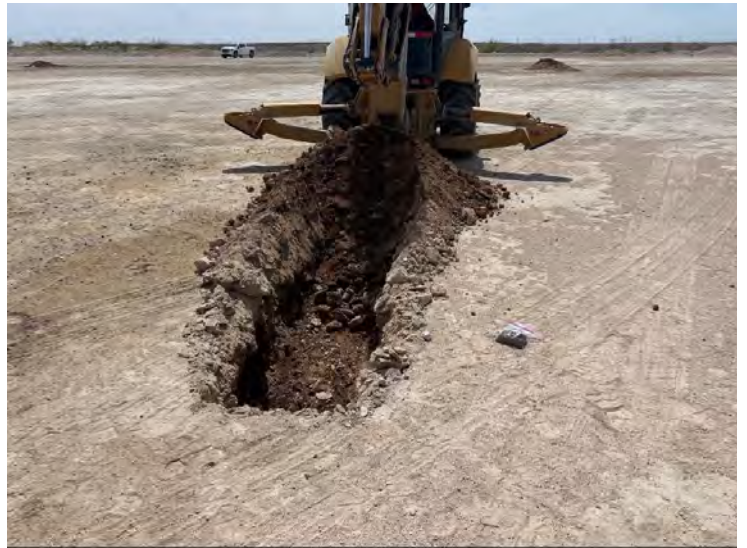
Date: 3/31/2026
 Time: 12:17
 Notes: BH26-14 @ 3' Refusal
 Latitude: 32.11951388888889
 Longitude: -103.99955
 Direction: E

Default Site Location | Lat: 32.11951, Lon: -103.99955 | Azimuth: 99.2 E , Tue, Mar 31, 2026 12

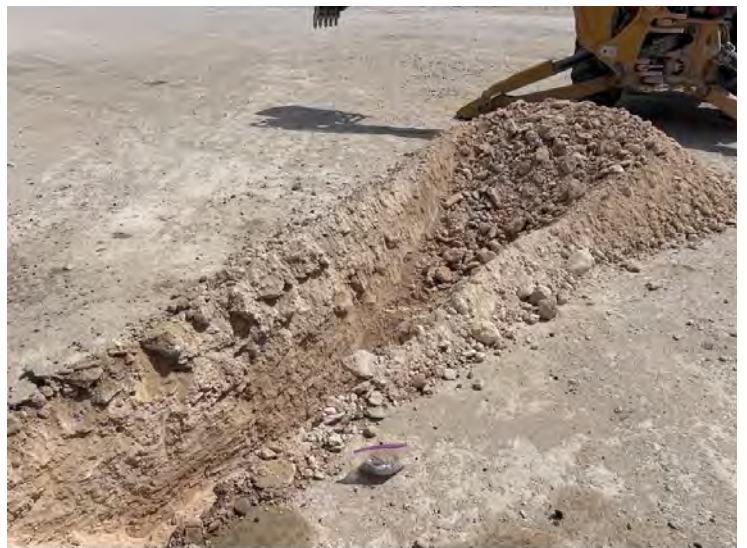
Date: 3/31/2026
 Time: 12:23
 Notes: BH26-17 @ 3'
 Latitude: 32.119391666666665
 Longitude: -103.99820555555556
 Direction: SE

Default Site Location | Lat: 32.11939, Lon: -103.99821 | Azimuth: 129.8 SE , Tue, Mar 31, 2026 12
