**Re: Closure Request  
PLU BS 03-25-31 USA Battery  
Incident Number nAPP2603041012  
Eddy County, New Mexico**

XTO Energy, Inc.  
Closure Request  
PLU BS 03-25-31 USA Battery

XTO Energy, Inc  
 PLU BS 03-25-31 USA Battery  
 nAPP2603041012

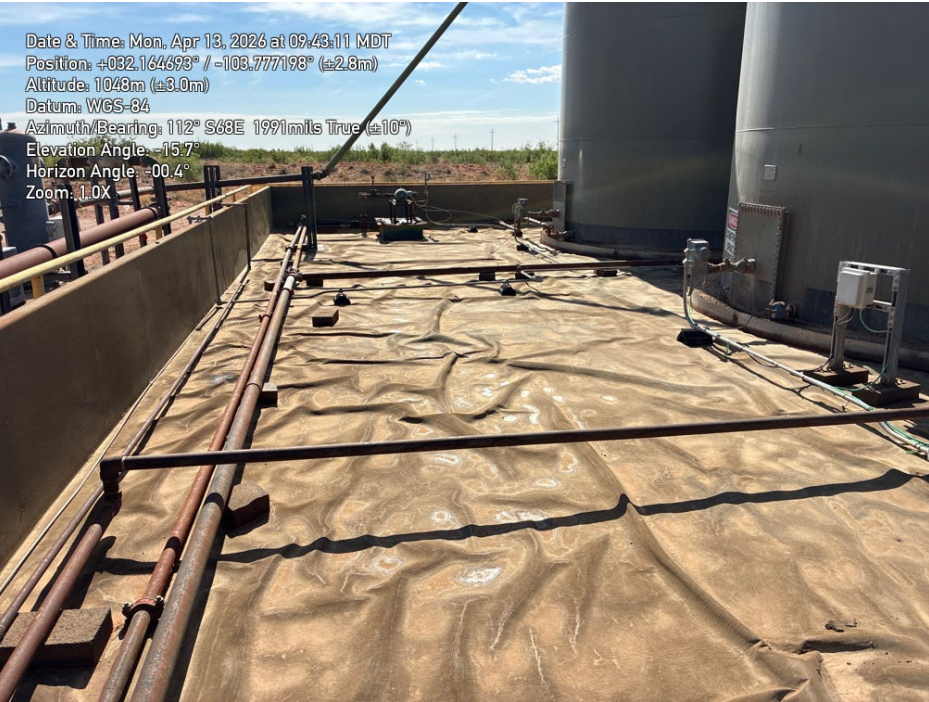
<p><b>Description</b> View of east corner inside lined containment</p>		
<p><b>View</b> Southeast</p>

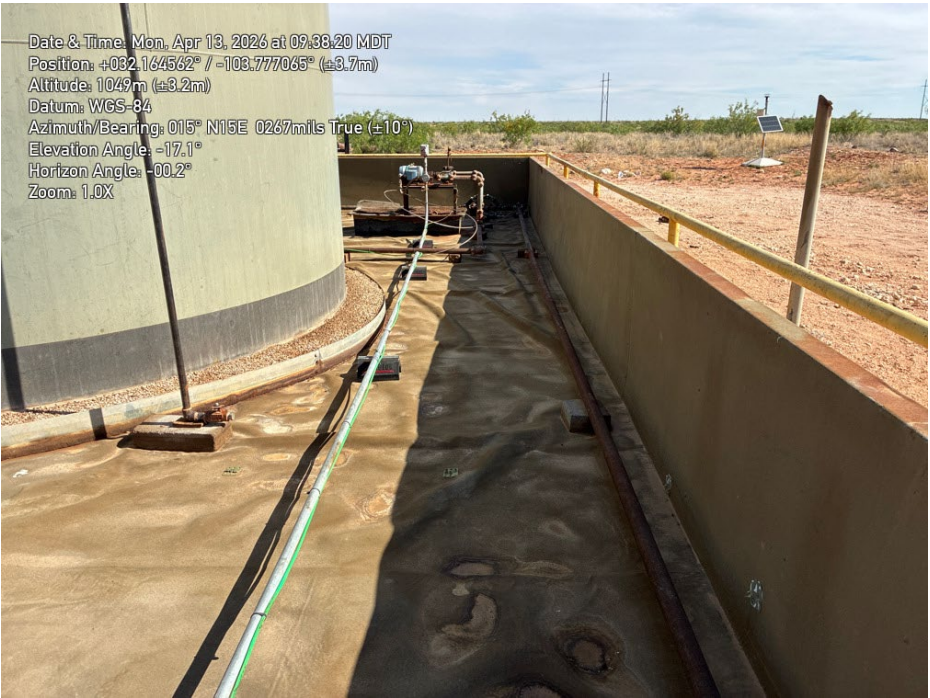
<p><b>Description</b> View of east corner inside lined containment</p>		
<p><b>View</b> Northeast</p>		
<p><b>Photograph</b> 10</p>	<p><b>Date</b> 4/13/2026</p>	<p>Date &amp; Time: Mon, Apr 13, 2026 at 09:40:47 MDT                  Position: +032.164570° / -108.777141° (±4.6m)                  Altitude: 1050m (±4.2m)                  Datum: WGS-84                  Azimuth/Bearing: 037° N37E 0658mils True (±10°)                  Elevation Angle: -19.3°                  Horizon Angle: -00.8°                  Zoom: 1.0X</p>

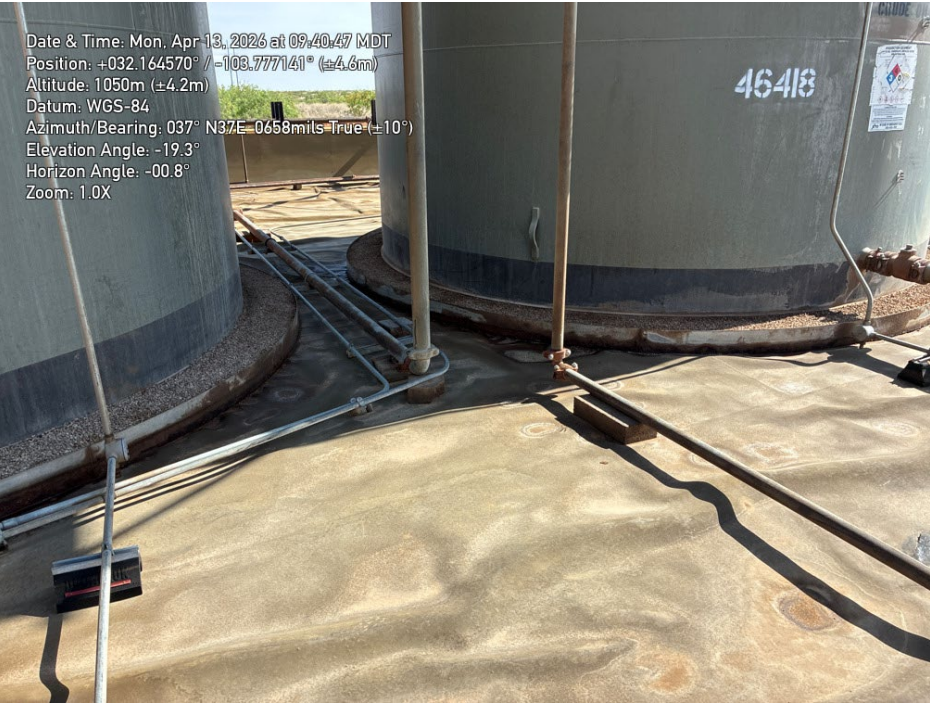
<p><b>Description</b> View of area between tanks inside lined containment</p>		
<p><b>View</b> Northeast</p>
