FINAL REMEDIATION REPORT

McCroden Line — 4-Inch Flowline Release

Township 25N, Range 3W, Section 9

OCD Incident Number: NAPP2603834243

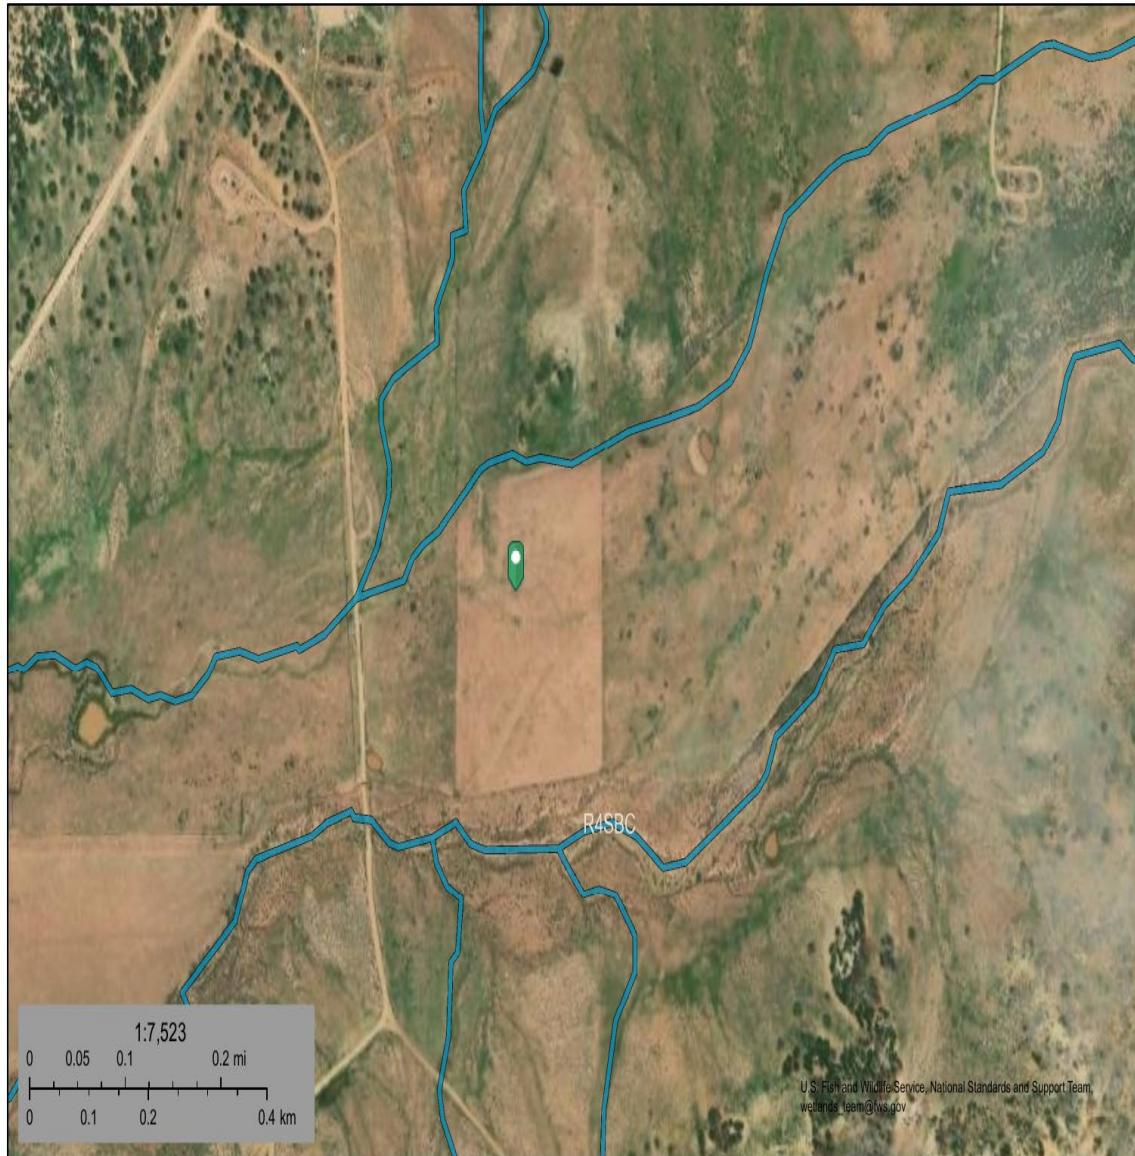
The U.S. Fish and Wildlife Service National Wetlands Inventory map for the McCroden Line release area is provided below. No wetland features are mapped on the impacted area. The nearest mapped wetland feature is an off-site Riverine, Lower Perennial, Streambed, Seasonally Flooded (R4SBC) reach south of the release point and is not hydrologically connected to the impacted area.

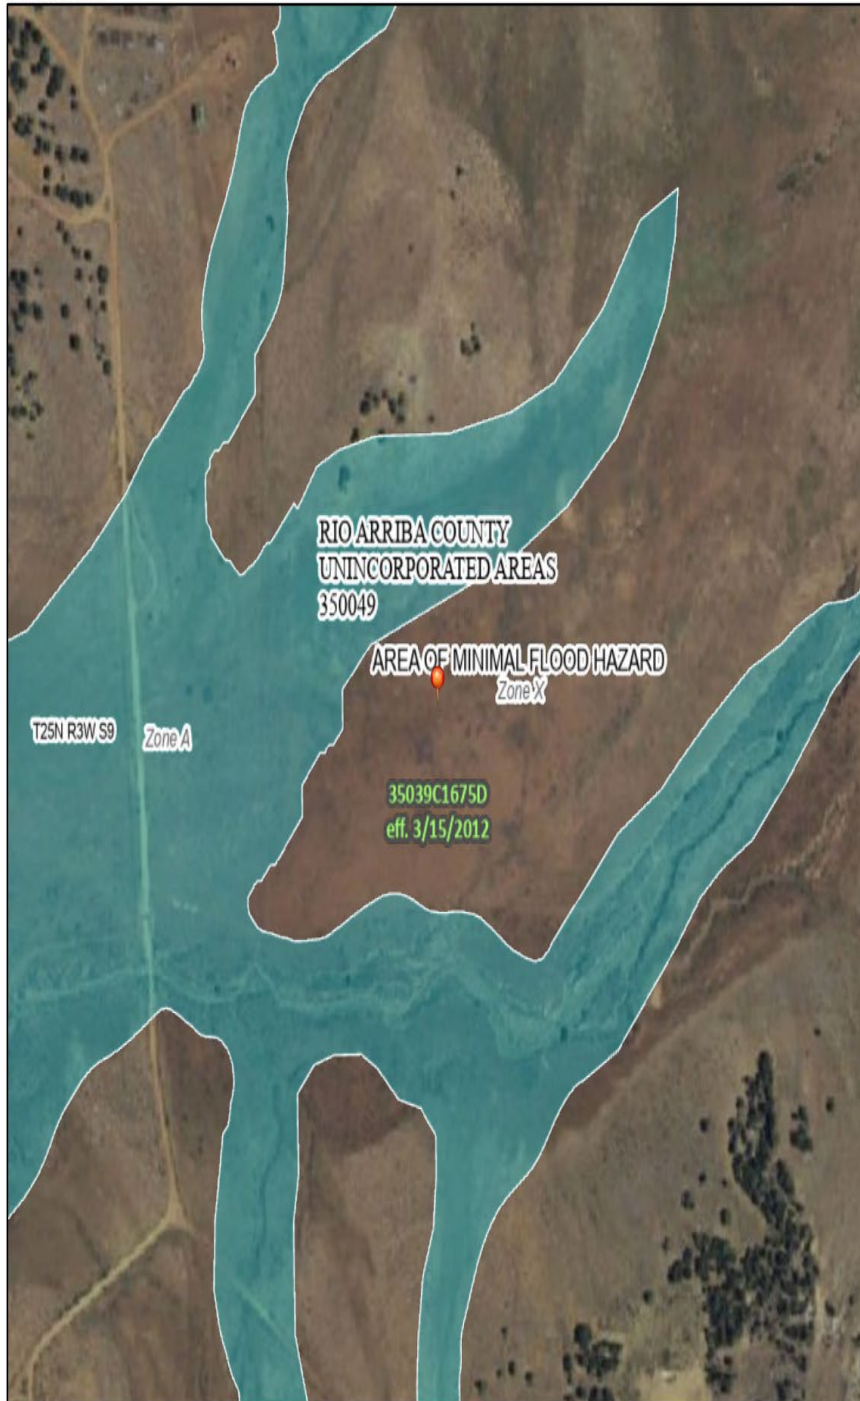
The Federal Emergency Management Agency National Flood Hazard Layer FIRMette for the McCroden Line release point is provided below. The release point falls within FIRM Panel 35039C1675D, effective March 15, 2012, and is mapped as Zone X — Area of Minimal Flood Hazard. The release point is not within the 100-year (1% annual chance) floodplain or any associated regulatory floodway.

The Federal Emergency Management Agency (FEMA) National Flood Hazard Layer was reviewed for the release point. The site falls within FEMA Flood Insurance Rate Map (FIRM) Panel 35039C1675D, effective March 15, 2012, and is mapped as Zone X — Area of Minimal Flood Hazard. The release point is not within the 100-year (1% annual chance) floodplain or any associated regulatory floodway. The FIRMette is included as Appendix E.

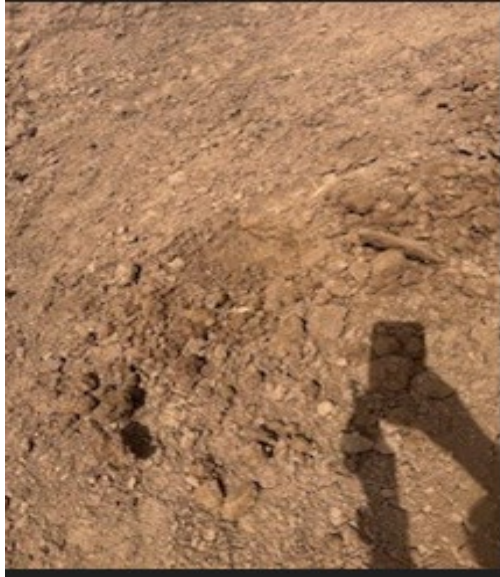
Photograph 1 — Sampling location SB1. Hand-augered borehole in the disturbed surficial soil zone of the McCroden Line release area. Foot/shadow visible at lower right provides scale. Soil exhibits typical upland-mesa loamy texture with no visible hydrocarbon staining or free product at the boring location.

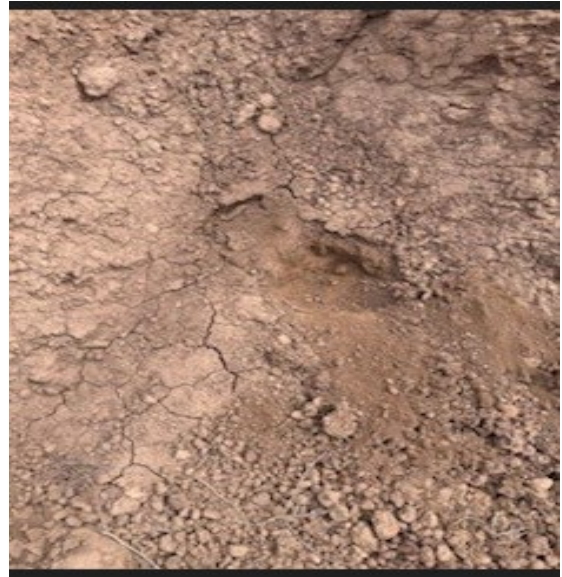
Photograph 2 — Sampling location SB2. Close-up view of hand-augered borehole in dry, cracked clay-rich surface soil. Surface fissuring is consistent with desiccation of native fine-grained soils typical of the local mesa setting. No visible petroleum staining or free product observed at the sampling location.

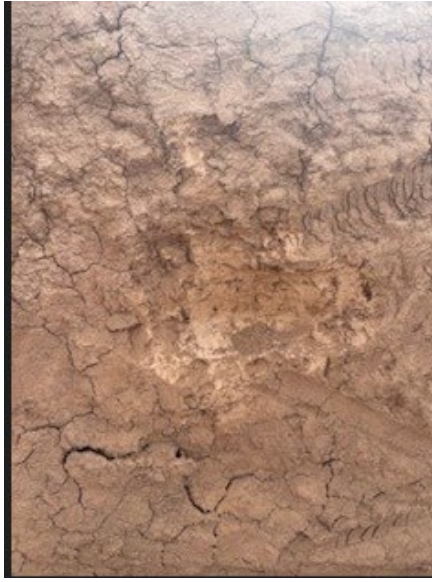
Photograph 3 — Sampling location SB3. Surface conditions at the third boring, showing cracked dry clay soil with vehicle/equipment access tracks visible across the impacted area. Tracks reflect the operator's response and characterization activities. No visible hydrocarbon staining at the sample point.

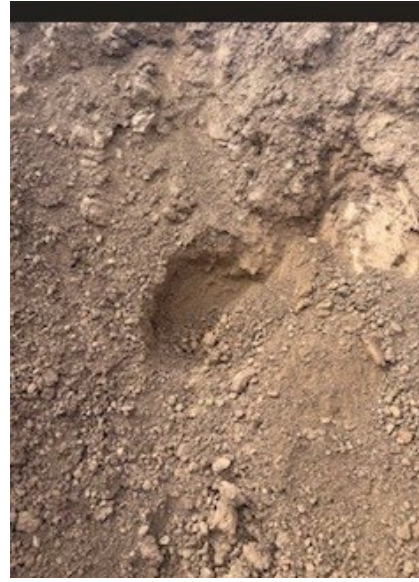
Photograph 4 — Sampling location SB4. Hand-augered borehole at the location that returned the only above-threshold result in the initial characterization round (DRO of 104 mg/kg, marginally above the 100 mg/kg most-stringent TPH closure standard). Soil shown is loose and friable; no obvious free product was observed at the surface during sampling, consistent with low-concentration residual impact later confirmed by the laboratory result.

Based on the initial characterization results, soil at the SB4 location was identified as the only sample point with petroleum hydrocarbon concentrations above the most stringent OCD soil closure standard of 100 mg/kg TPH. Targeted excavation was performed at the SB4 location to remove the impacted soil. Approximately 5 additional cubic yards were removed via backhoe under field oversight, and the lateral and vertical limits of the excavation were extended until field-screening indicators (visual saturation, hydrocarbon staining, and field organic-vapor screening as applicable) showed no further impact.

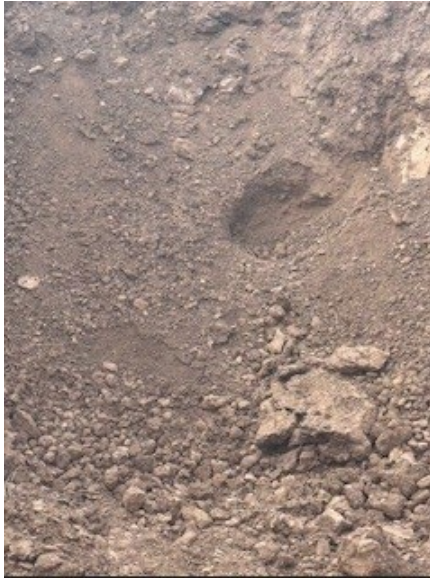
Photograph 5 — Sampling location SB5. Borehole in rocky, clumpy soil with visible chunks of partially consolidated material; consistent with weathered sandstone/shale parent material at depth. No visible hydrocarbon staining or free product at the sampling location.

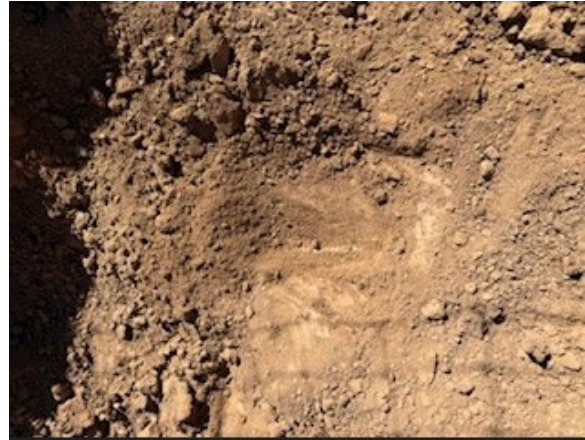
Photograph 6 — Sampling location SB6. Hand-augered borehole on lightly disturbed surface near the perimeter of the impacted area. Vehicle/equipment access tracks are visible across the surrounding surface. No visible hydrocarbon staining or free product observed at the sampling location.

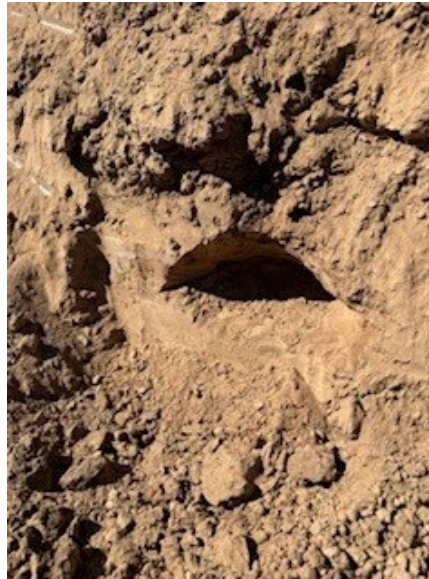
Photograph 7 — SB4 confirmation resampling at the McCroden Line release area, April 24, 2026. The photograph documents the post-excavation sampling location and surface conditions at the SB4 footprint at the time the confirmation sample (SB#4/2-1) was collected.

Soil at the SB4 location was excavated another 1' bgs and managed under Logos's standard waste-management procedures. Following excavation, a confirmation sample (SB#4/2-1) was collected on April 24, 2026 and submitted to Envirotech for the same analytical suite. The confirmation sample returned non-detect results for benzene, toluene, ethylbenzene, xylenes, gasoline range organics, diesel range organics, and oil range organics, and a chloride concentration of 41.5 mg/kg — well below the most stringent applicable threshold.

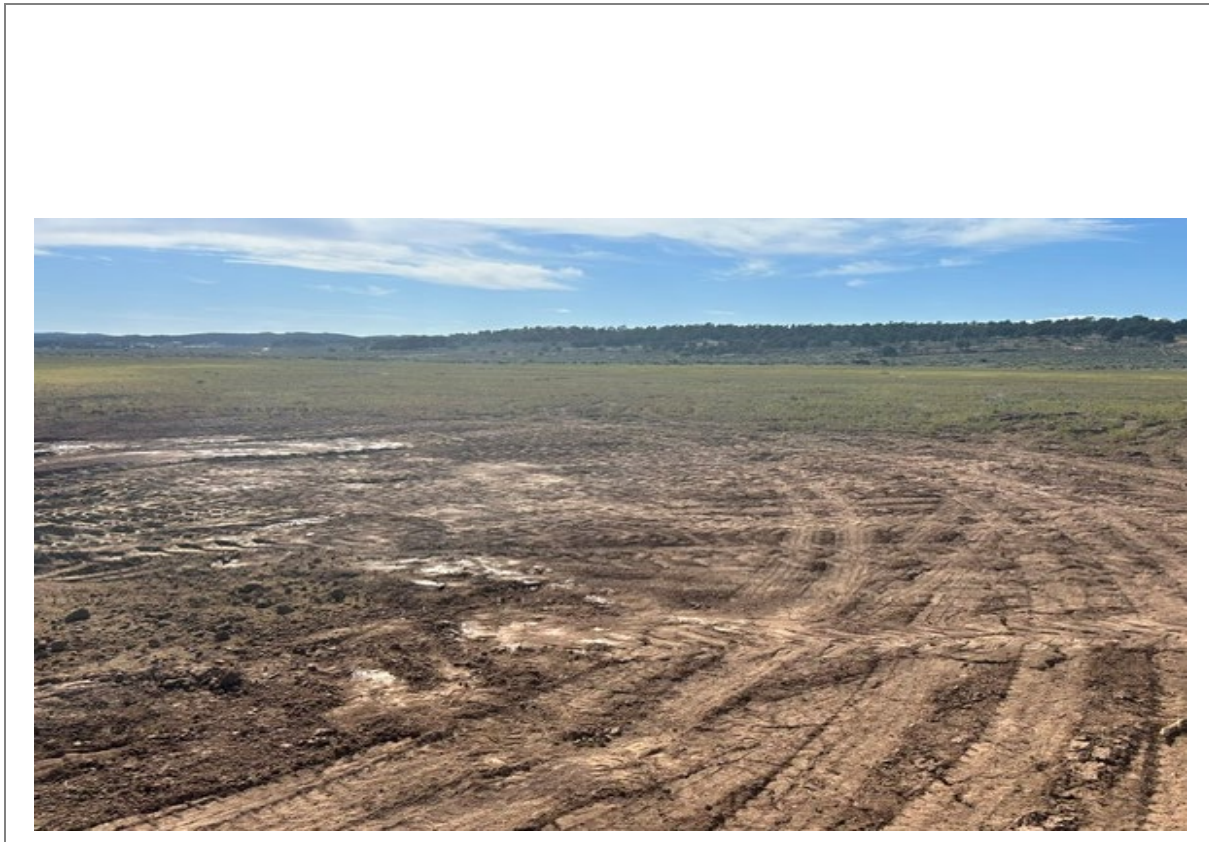
Photograph 8 — Post-excavation backfill and site restoration at the SB4 excavation footprint, McCroden Line release area. The excavation was backfilled with clean native borrow material, lightly compacted, and graded to match surrounding contours; the restored surface was prepared for revegetation consistent with the surrounding undisturbed upland-mesa rangeland.

The photograph below documents the post-excavation backfill and site restoration activities at the SB4 excavation footprint. Following completion of the targeted excavation and receipt of the confirmation analytical results demonstrating compliance with the 100 mg/kg most-stringent OCD soil closure standard, the excavation was backfilled with clean native borrow material, lightly compacted, and graded to match the surrounding contours. The surface was then prepared for revegetation in accordance with applicable surface-owner agreements and standard reclamation practices for upland-mesa rangelands.
