Closure Report
Tatanka North CTB (04.19.2026)
Incident ID: nAPP2611037443
Lea County, New Mexico
Unit N, Sec 35, T25S, R35E
32.08211°, -103.33911°

Crude Oil Release

Point of Release: Malfunction with the Vapor Recovery Tower Resulting in a Flare Fire

Re: **Closure Report**
Tatanka North CTB (04.19.2026)
Incident ID: nAPP2611037443
Coterra Energy Operating Co.
Site Location: Unit N, S35, T25S, R35E
32.08211°, -103.33911°
Lea County, New Mexico

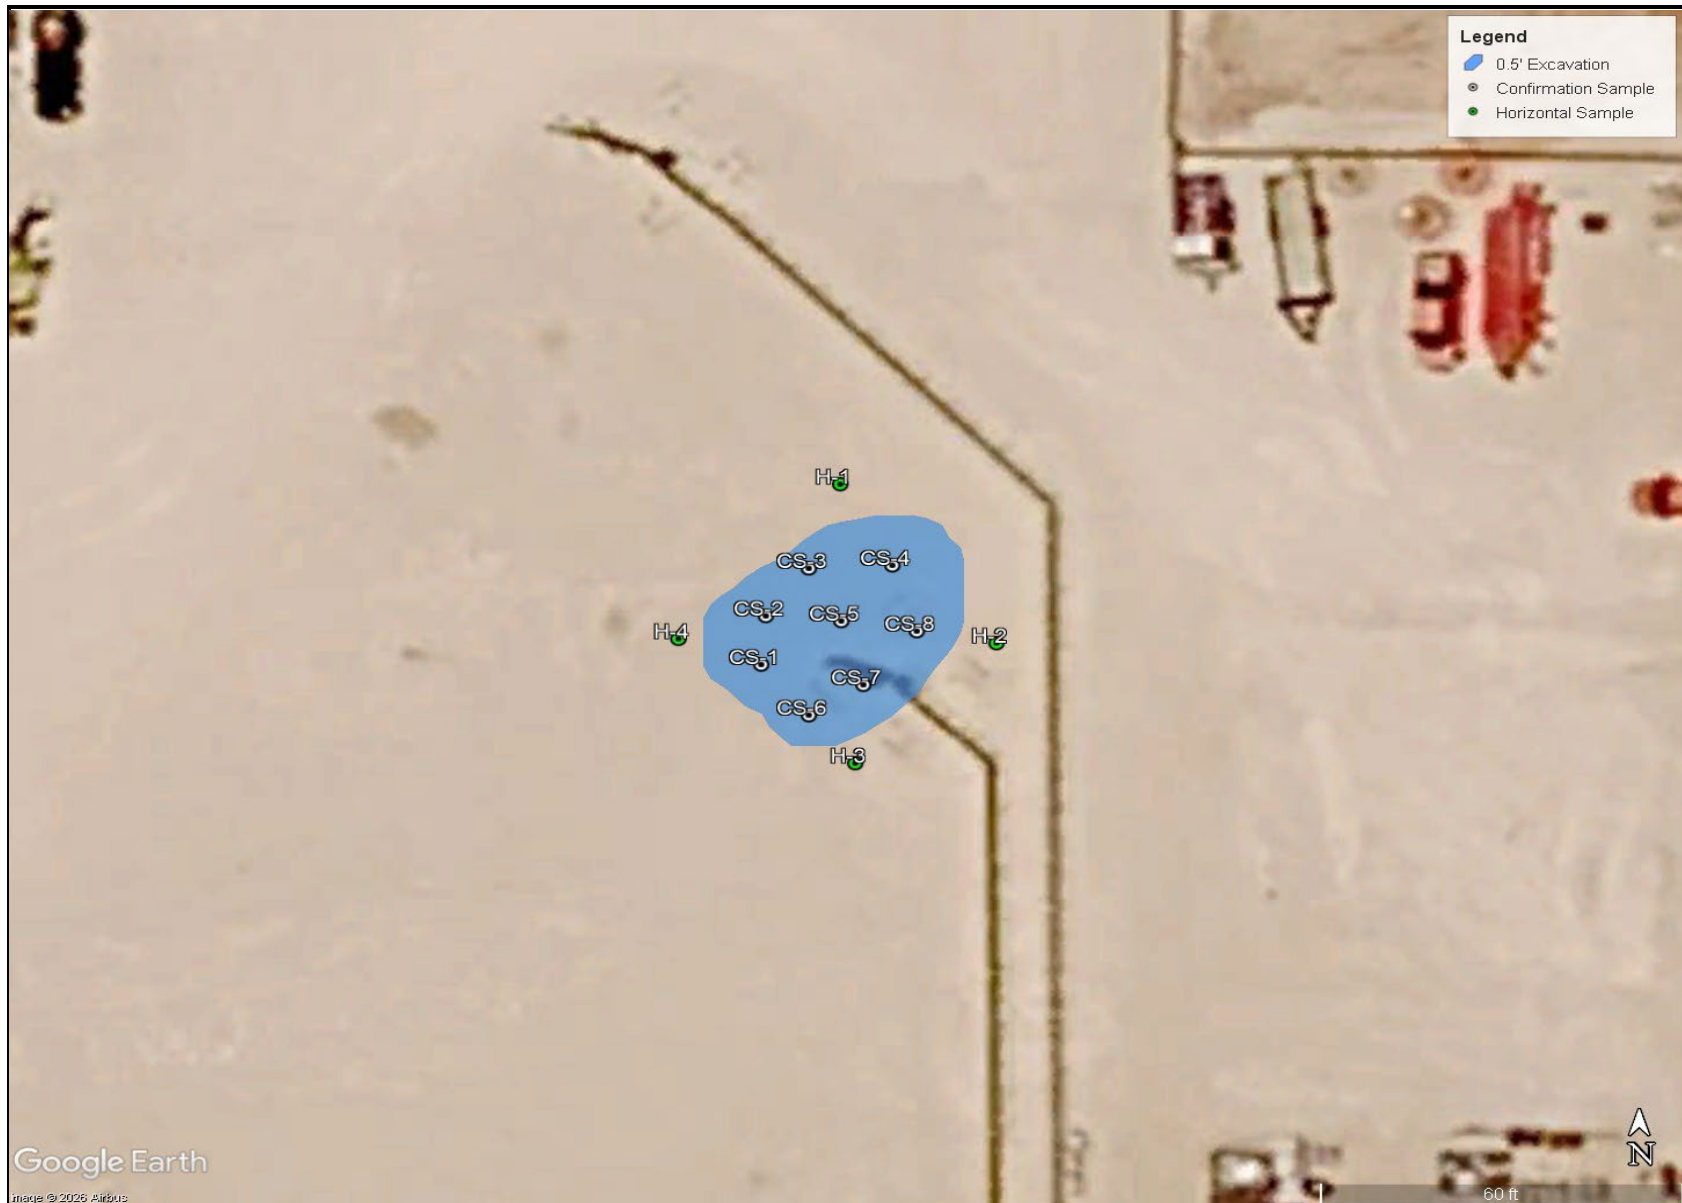
</p>	<p>FIGURE 3</p>
---	--	-----------------

All final confirmation samples were below the regulatory requirements for TPH, BTEX, and Chlorides. Refer to Table 1. The excavation depths and confirmation sample locations are shown in Figure 3.

<p>EXCAVATION DEPTH MAP COTERRA ENERGY OPERATING CO. TATANKA NORTH CTB (04.19.2026) LEA COUNTY, NEW MEXICO 32.08211°, -103.33911°</p>	<p>CARMONA RESOURCES

On April 28, 2026, Carmona Resources personnel were onsite to collect confirmation samples. Prior to arriving on site, a Coterra contractor was on site to conduct a 0.5 ft surface scrape within the affected area. Only charred caliche remained onsite from the flare fire and following the surface scrape, all affected material was removed. Before collecting composite confirmation samples, the NMOCD division office was notified via NMOCD portal on April 24, 2026, per Subsection D of 19.15.29.12 NMAC, see Appendix C. The area was excavated to a depth of 0.5 ft bgs. A total of four (4) horizontal samples (H-1 through H-4) were collected for horizontal delineation, and eight (8) confirmation floor samples (CS-1 through CS-8) were collected every 200 square feet to ensure the proper removal of contaminated soil. Composite confirmation sidewall samples were not collected due to the excavation depth not exceeding 0.5 ft bgs. For chemical analysis, the soil samples were collected and placed into laboratory-provided sample containers, stored on ice, and transported under the proper chain-of-custody protocol to Eurofins Laboratories in Midland, Texas in accordance with established chain-of-custody protocols. All collected samples were analyzed for TPH analysis by EPA method 8015 modified, BTEX by EPA method 8021B, and Chloride by EPA method 300.0. Copies of laboratory analysis and chain-of-custody documentation are included in Appendix E.

Approximately 1,400 square feet of impacted area was remediated, resulting in the removal of an estimated 20 cubic yards of soil, which was transported offsite for proper disposal at an approved facility. Due to the shallow nature of the surface scrape, the location was not backfilled with any material. Production managers onsite have determined that the caliche thickness remaining on the well pad is sufficient and does not pose any safety or stability risks for oil field operations. Once the wells on site have been plugged and abandoned, and all facility equipment has been removed, the entire well pad will be reclaimed per NMAC 19.15.29.13.

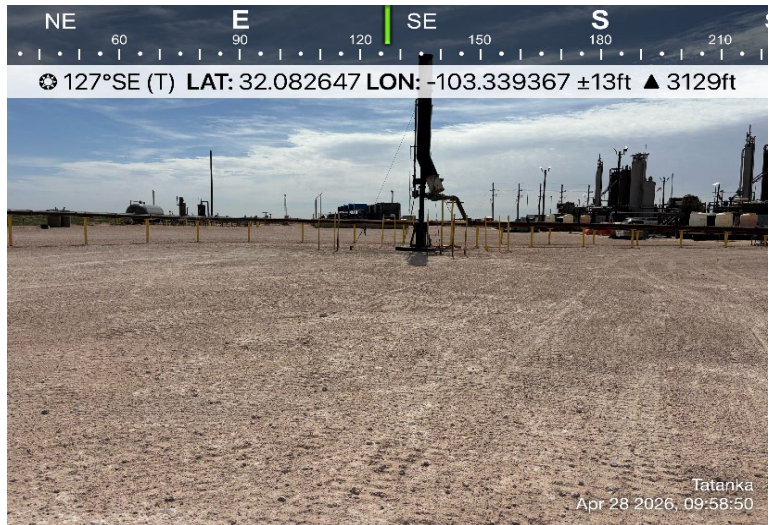
Photograph No. 1

Description:
View Southeast, area of CS-1 through CS-8.

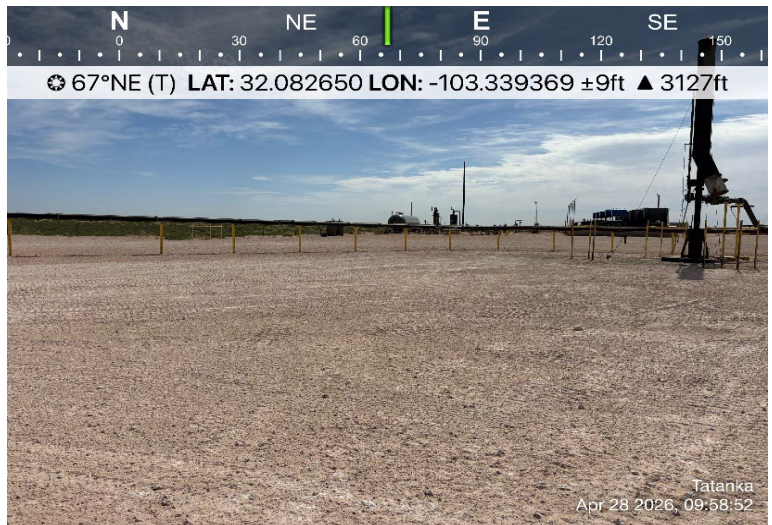
Photograph No. 2

Description:
View Northeast, area of CS-1 through CS-8.

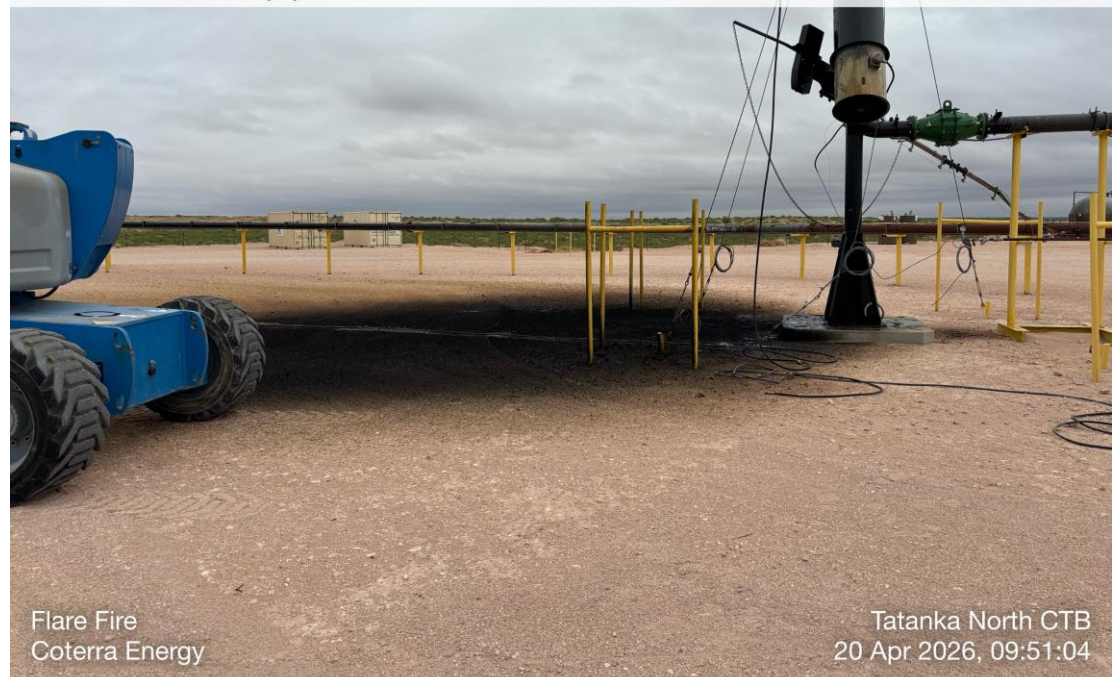
Flare Fire
Coterra Energy

Tatanka North CTB
20 Apr 2026, 09:51:04
