Characterization Plan

Rio Penasco KD Com #001

Incident ID# nMCS0124836953

Vertex Resource Services, Inc.

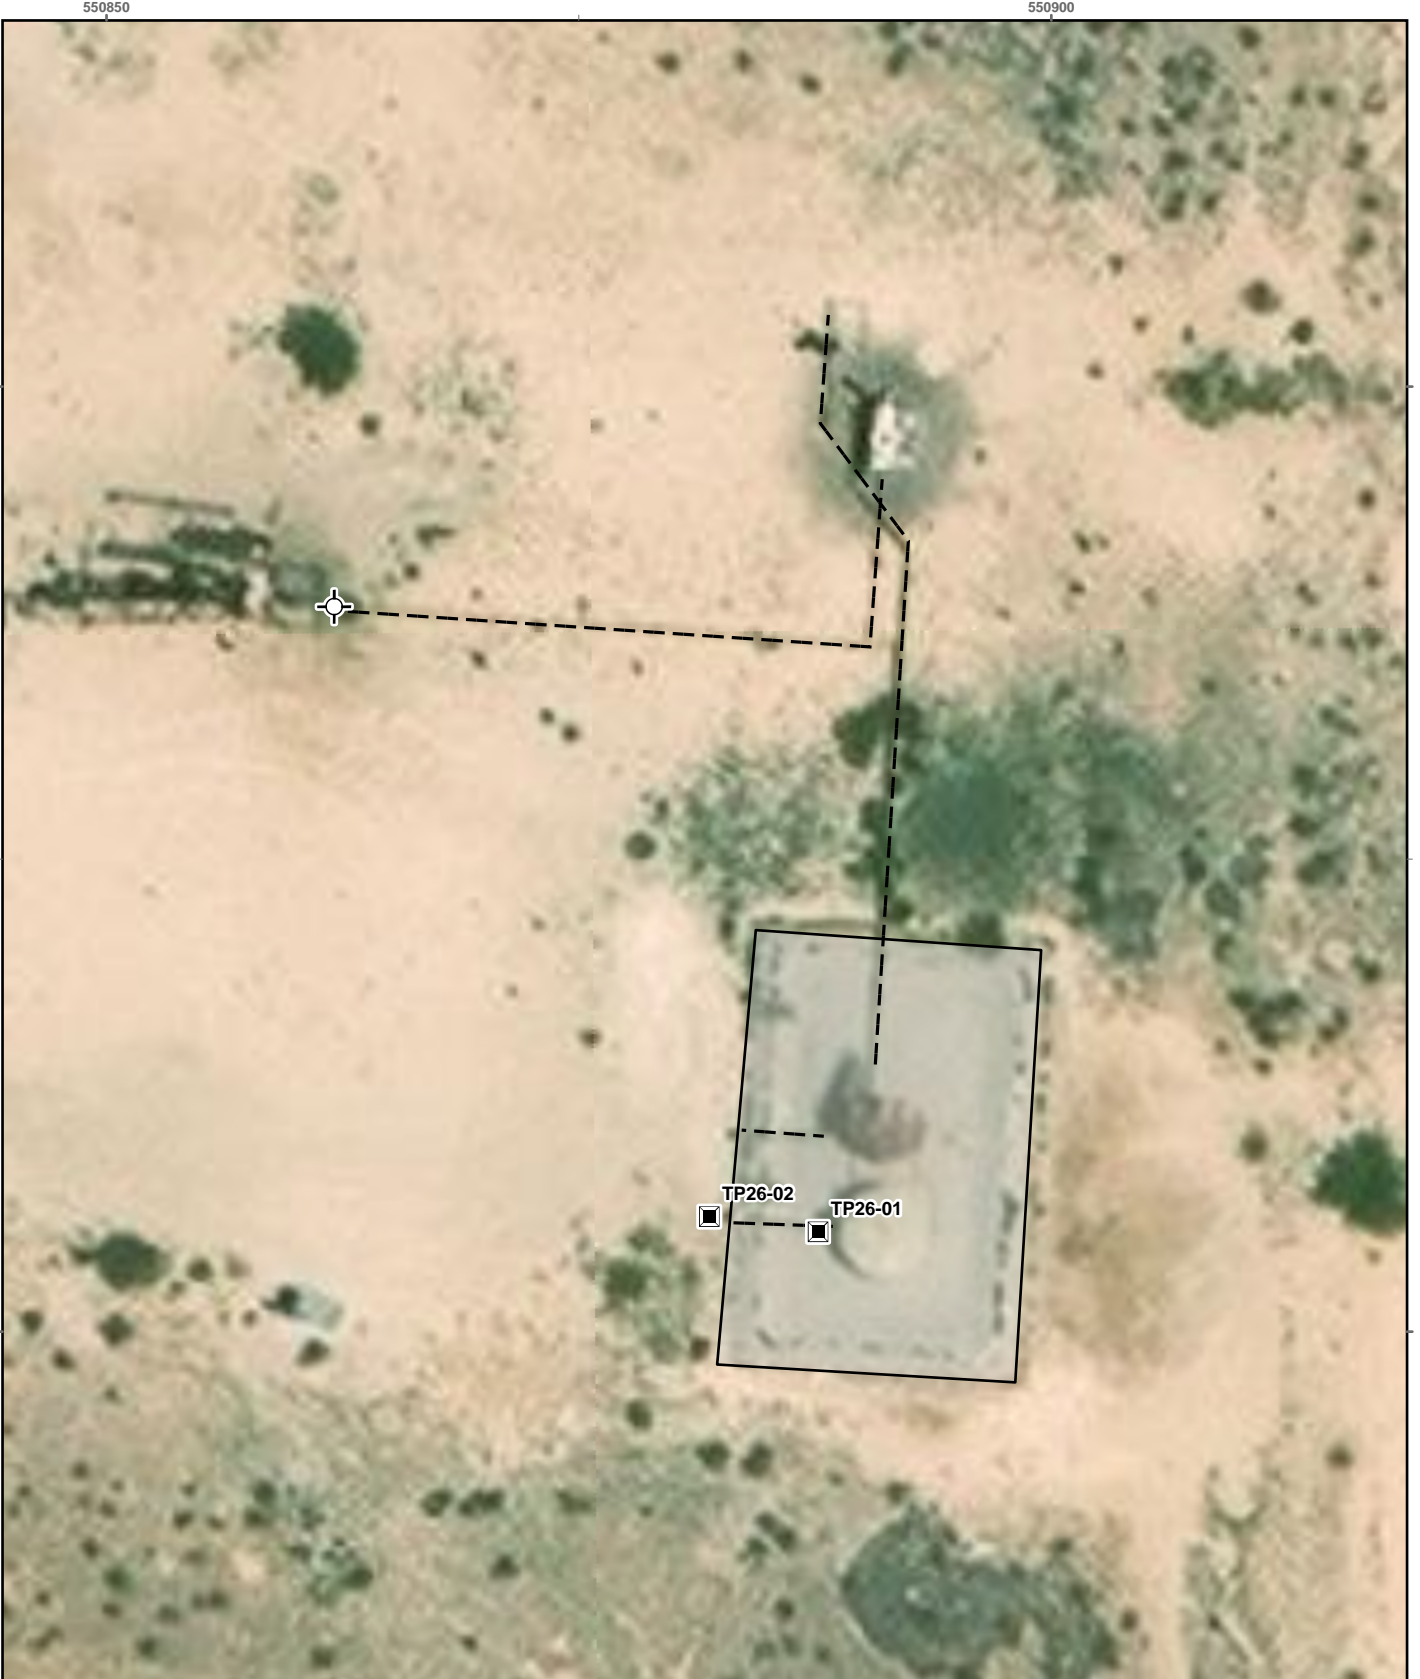
FIGURE:
 1

Vertex personnel will advance four exploratory boreholes/test pits at the locations shown on Figure 1 to a depth of four feet below ground surface, or until analytical results indicate that the vertical extent of impacts meets the closure criteria established in Table 1, in accordance with 19.15.29 NMAC requirements to define the nature and extent of contamination. Soil samples will be collected at two-foot intervals and will satisfy the delineation requirements per 19.15.29 NMAC with more than two discrete samples collected per sample point. Field screening results will be used to guide sample collection and evaluate the vertical extent of potential impacts.

Proposed Characterizat on Sampling Schemat c
 Rio Penasco KD Com #001

The site is an active production pad for oil and gas operations including the battery and containment where the incident occurred. (Figure 1). Surface and subsurface mineral ownership belongs to the Wilson Ranch. The site is situated in a mostly flat area surrounded by gravelly, sandy loam plains with grassy mesquite shrublands. Grama grasses and forbs are present on and off the pad.

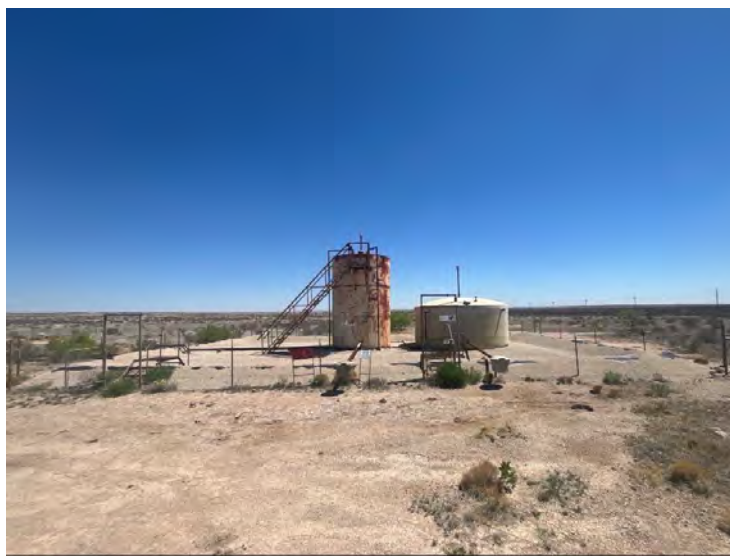
Date: 4/8/2026
Time: 12:39
Notes: Overview of the AOI and adjacent containment.
Latitude: 32.68426944444444
Longitude: -104.45755833333334
Direction: E

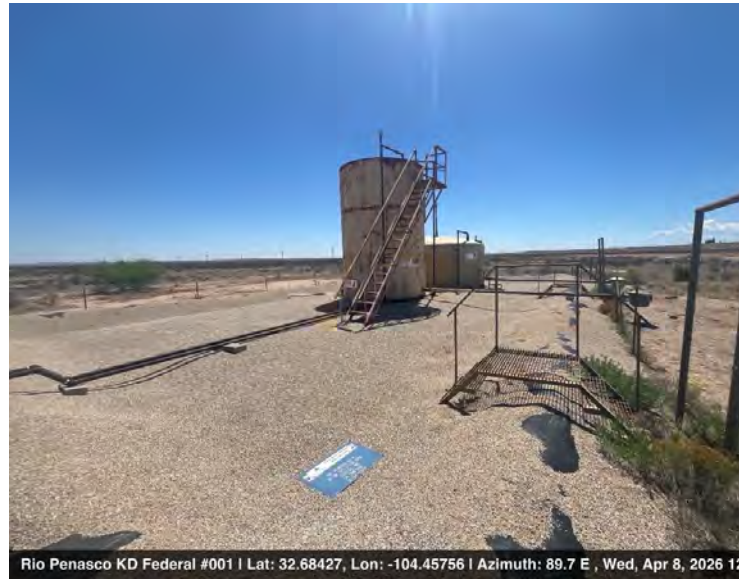
Date: 4/8/2026
 Time: 12:39
 Notes: Northwest extent of the containment.
 Latitude: 32.68426944444444
 Longitude: -104.45755833333334
 Direction: E

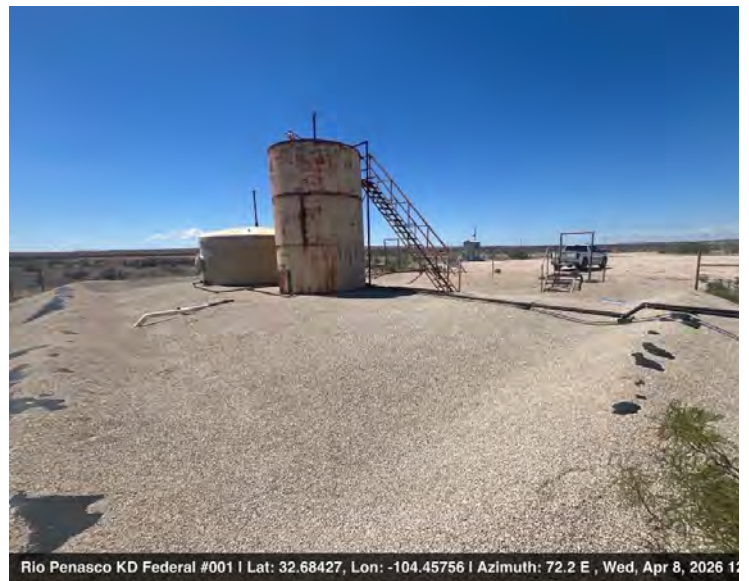
Date: 4/8/2026
 Time: 12:39
 Notes: Northeast extent of the containment.
 Latitude: 32.68426944444444
 Longitude: -104.45755833333334
 Direction: E

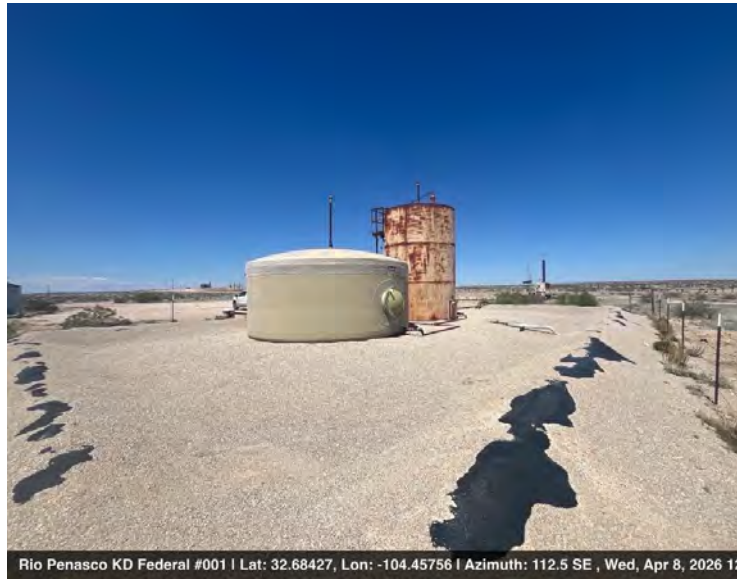
Date: 4/8/2026
 Time: 12:39
 Notes: Southeast extent of the containment.
 Latitude: 32.68426944444444
 Longitude: -104.45755833333334
 Direction: E

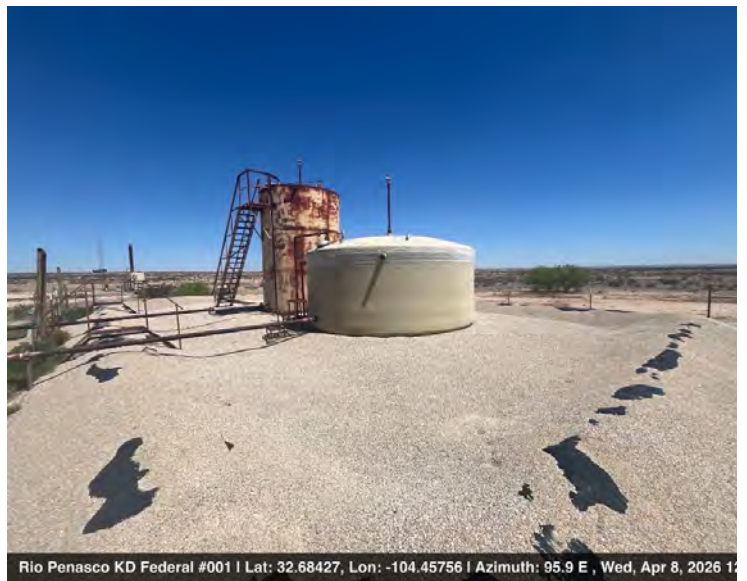
Date: 4/8/2026
 Time: 12:39
 Notes: Southwest extent of the containment.
 Latitude: 32.68426944444444
 Longitude: -104.45755833333334
 Direction: E

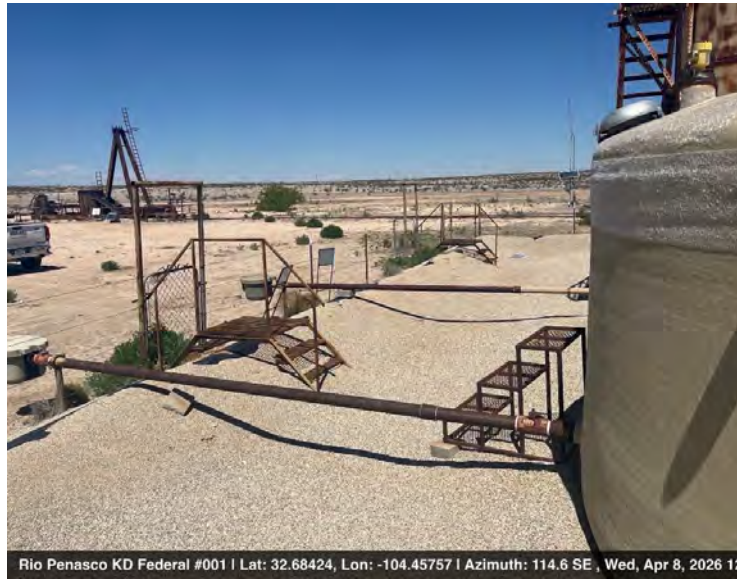
Date: 4/8/2026
 Time: 12:39
 Notes: West side of the fiberglass water tank and load line in question.
 Latitude: 32.684238888888885
 Longitude: -104.45757222222223
 Direction: E

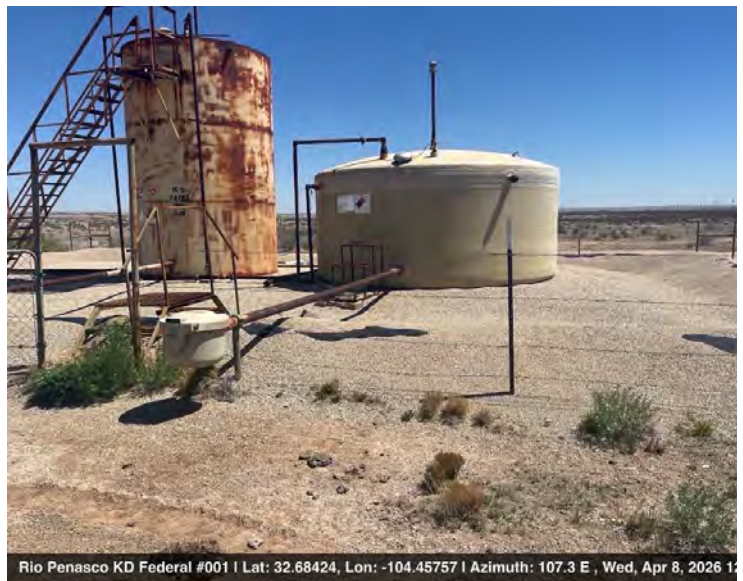
Date: 4/8/2026
 Time: 12:39
 Notes: West side of the fiberglass water tank and load tank in question. Viewed from the pad.
 Latitude: 32.684238888888885
 Longitude: -104.45757222222223
 Direction: E

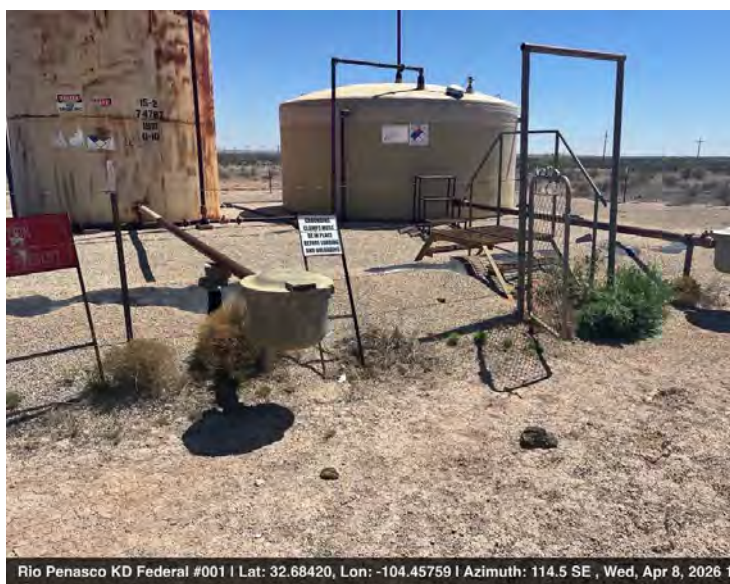
Date: 4/8/2026
 Time: 12:39
 Notes: Load line coming off a crude oil tank.
 Latitude: 32.68420277777778
 Longitude: -104.45758888888889
 Direction: E

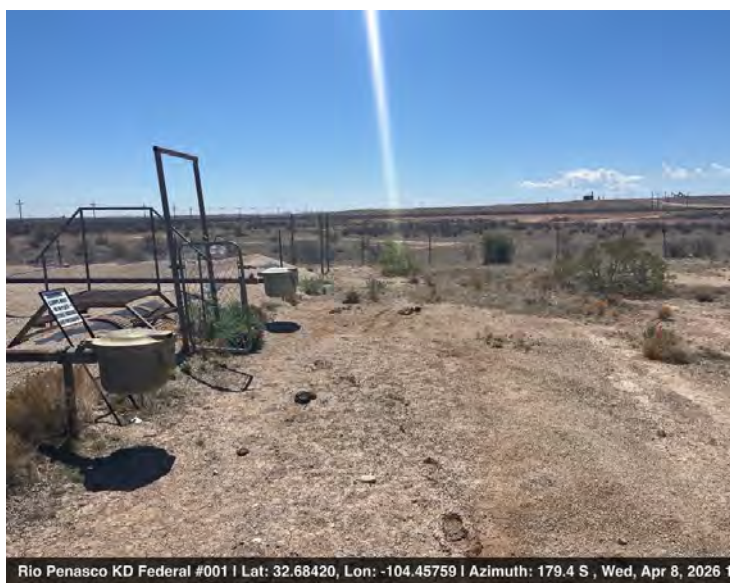
Date: 4/8/2026
 Time: 12:39
 Notes: AOI located adjacent to the west side of the containment.
 Latitude: 32.68420277777778
 Longitude: -104.45758888888889
 Direction: S

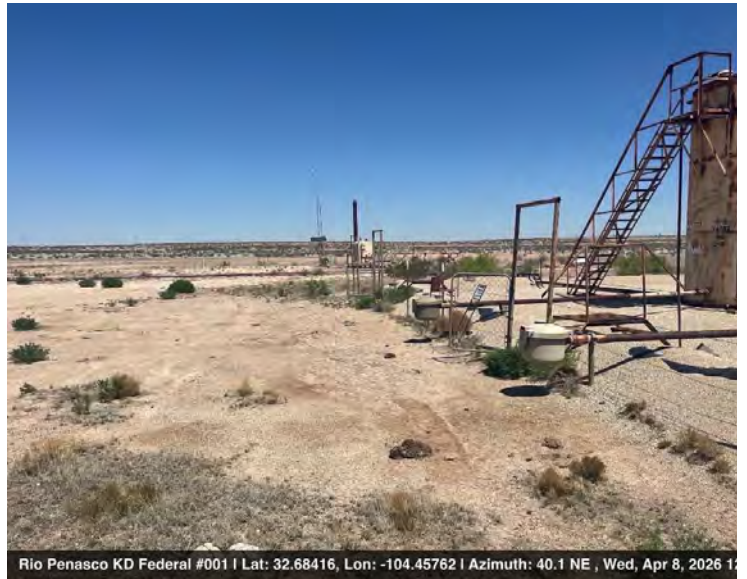
Date: 4/8/2026
 Time: 12:42
 Notes: AOI on the west side of the containment.
 Latitude: 32.68415555555555
 Longitude: -104.45761944444445
 Direction: NE

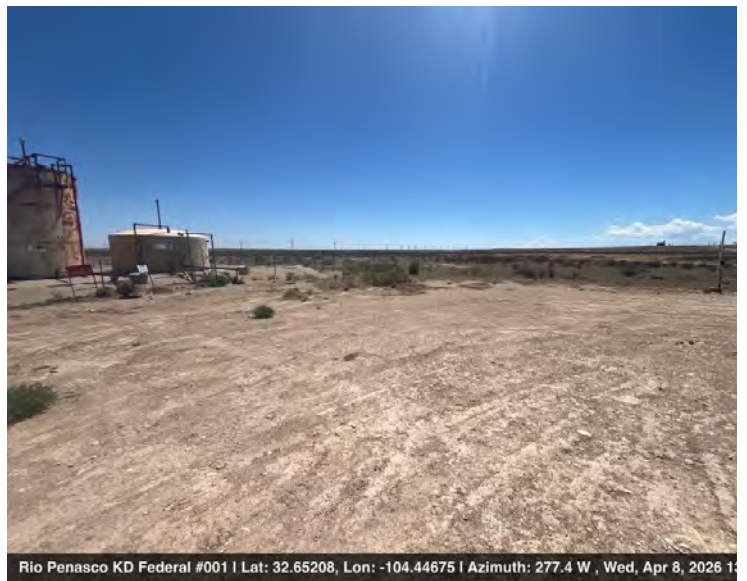
Date: 4/8/2026
 Time: 13:08
 Notes: AOI.
 Latitude: 32.65207777777778
 Longitude: -104.44674722222223
 Direction: W
