**Re: Closure Request
PLU Ross Ranch 33-25-30 USA Battery
Incident Number nAPP2527929108
Eddy County, New Mexico**

XTO Energy, Inc.
Closure Request
PLU Ross Ranch 33-25-30 USA Battery

Site Receptor Map
 XTO Energy, Inc
 PLU Ross Ranch 33-25-30 USA Battery
 Incident Number: nAPP2527929108
 Unit D, Section 33, T 25S, R 30E
 Eddy County, New Mexico

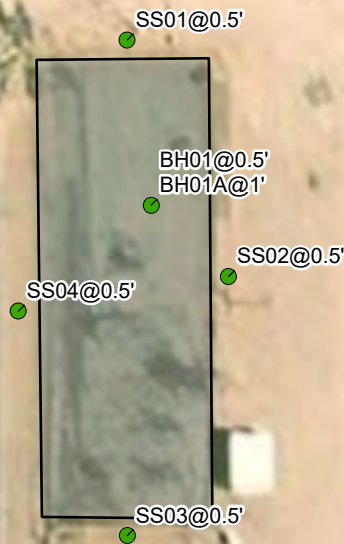
FIGURE
2

- Delineation Soil Sample in Compliance with Closure Criteria
- Electric Line
- Lined Containment

Notes:
Sample ID @ Depth Below Ground Surface.

On October 23, 2025, Ensolum personnel were at the Site to complete delineation activities. Four delineation soil samples (SS01 through SS04) were collected around the lined containment at a depth of 0.5 feet bgs (surface) to assess the lateral extent of the release. One borehole (BH01) was advanced via hand auger to a terminal depth of 1-foot bgs in a central location of the two liner holes. Discrete soil samples were collected from the borehole at depths ranging from 0.5 feet bgs to 1-foot bgs. All delineation soil samples were field screened for volatile organic compounds (VOCs) utilizing a calibrated photoionization detector (PID) and chloride utilizing Hach® chloride QuanTab® test strips. Field screening results and observations of the soil samples from the borehole were logged on a lithologic soil sampling log, which is included in Appendix C. The delineation soil sample locations were mapped utilizing a handheld Global Positioning System (GPS) unit and are depicted on Figure 2. Photographic documentation is included in Appendix B.

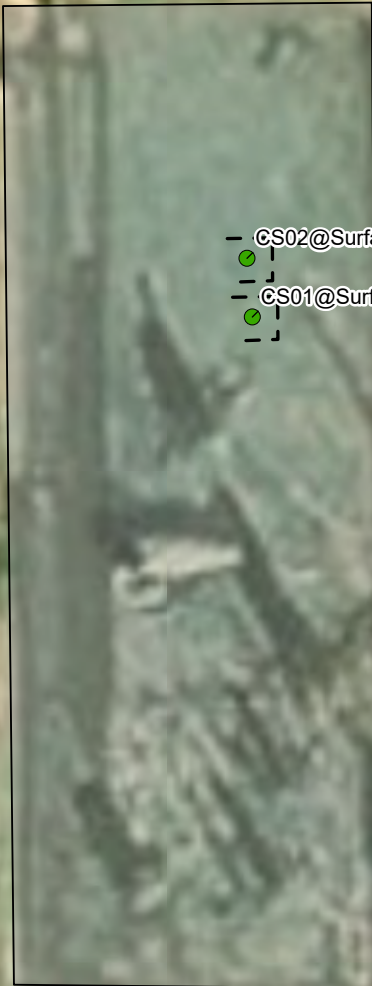
- Confirmation Soil Sample in Compliance with Closure Criteria
- Electric Utility Line
- - - 5x5 Cut Section
- Liner

CS02@Surface
 CS01@Surface

Notes:
 Sample ID @ Depth Below Ground Surface.

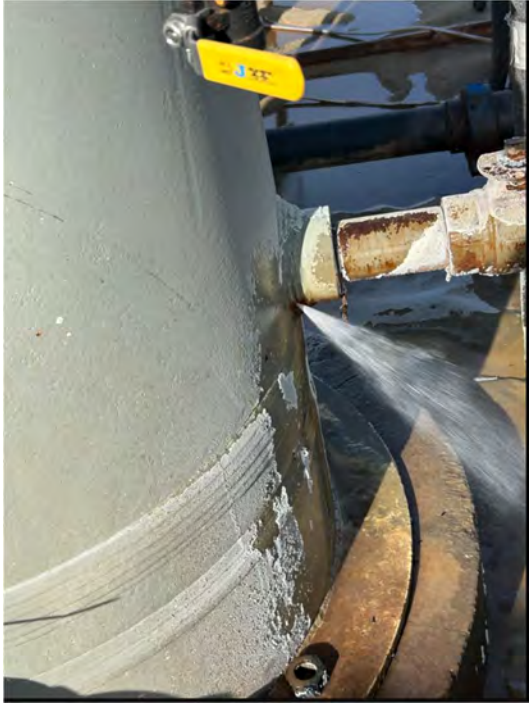
<p><u>Photograph</u> 1</p>	<p><u>Date</u> 10/3/2025</p>

<p><u>Description</u> Initial release observed for Incident Number nAPP2527929108</p>		
<p><u>View</u> POR located at approximately 32.09321°, -103.89301°</p>		
<p><u>Photograph</u> 2</p>	<p><u>Date</u> 10/3/2025</p>

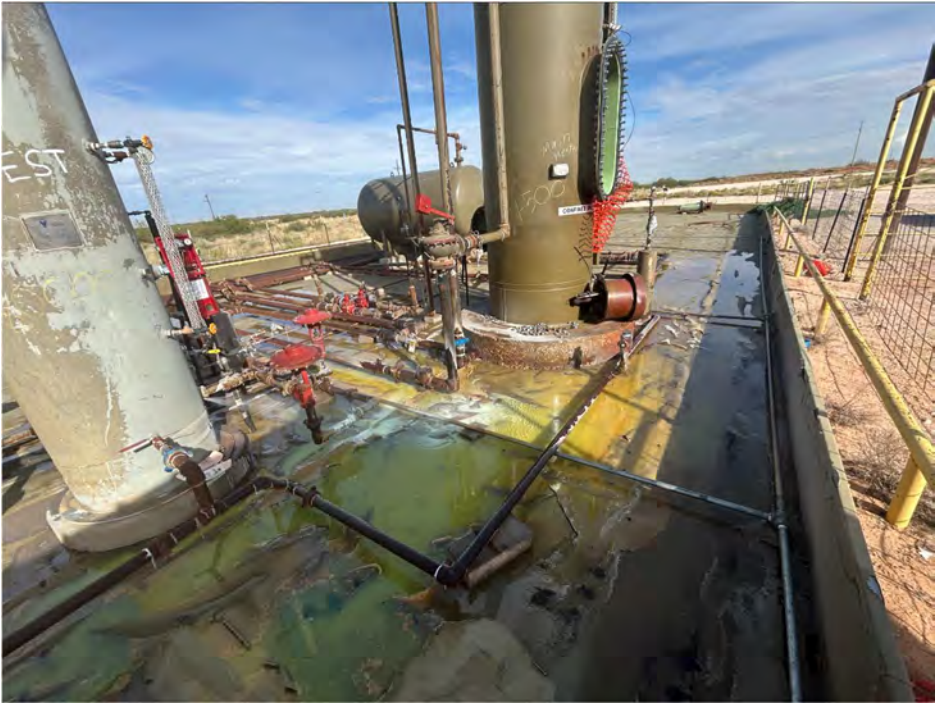
<p><u>Description</u> Initial release observed for Incident Number nAPP2527929108</p>		
<p><u>View</u> POR located at approximately 32.09321°, -103.89301°</p>

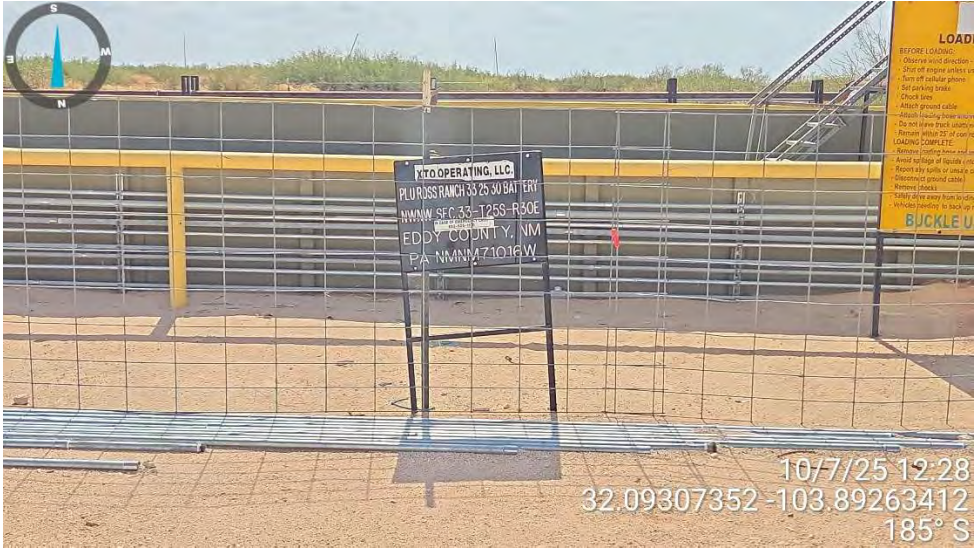
<p><u>Photograph</u> 3</p>	<p><u>Date</u> 10/7/2025</p>

<p><u>Description</u> Well sign during liner inspection activities</p>		
<p><u>View</u> South</p>		<p>10/7/25 12:28 32.09307352 -103.89263412 185° S</p>
<p><u>Photograph</u> 4</p>	<p><u>Date</u> 10/7/2025</p>

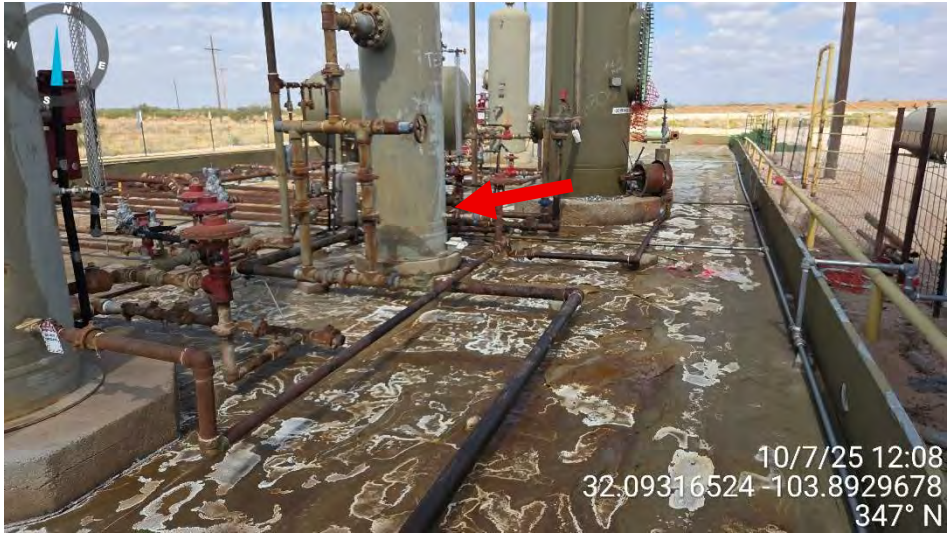
<p><u>Description</u> Near POR observed during liner inspection activities</p>		
<p><u>View</u> North</p>		<p>10/7/25 12:08 32.09316524 -103.8929678 347° N</p>

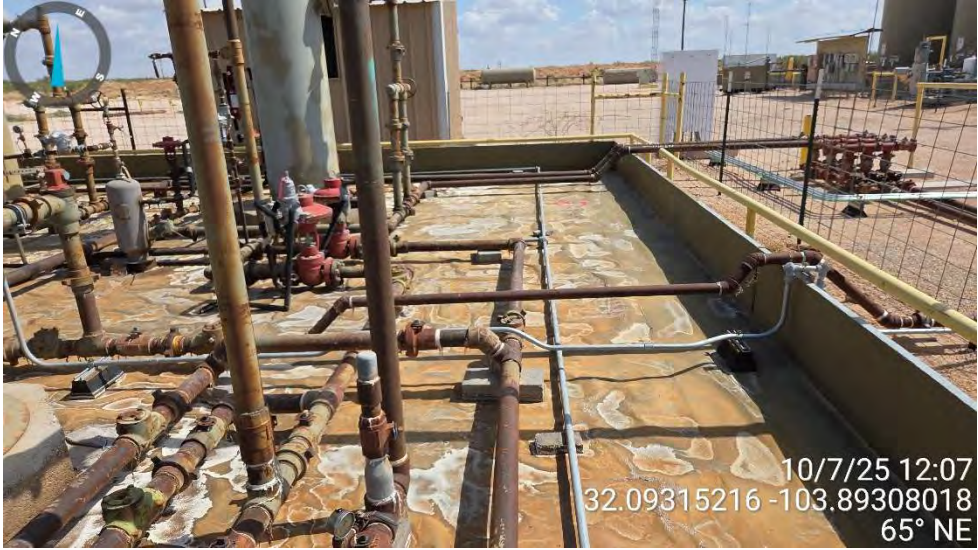
<p><u>Photograph</u> 5</p>	<p><u>Date</u> 10/7/2025</p>

<p>10/7/25 12:07 32.09315216 -103.89308018 65° NE</p>
<p><u>Description</u> Liner inspection activities</p>		
<p><u>View</u> Northeast</p>		
<p><u>Photograph</u> 6</p>	<p><u>Date</u> 10/7/2025</p>	  <p>10/7/25 12:07 32.09326582 -103.89307551 147° SE</p>
<p><u>Description</u> Liner inspection activities</p>		
<p><u>View</u> Southeast</p>

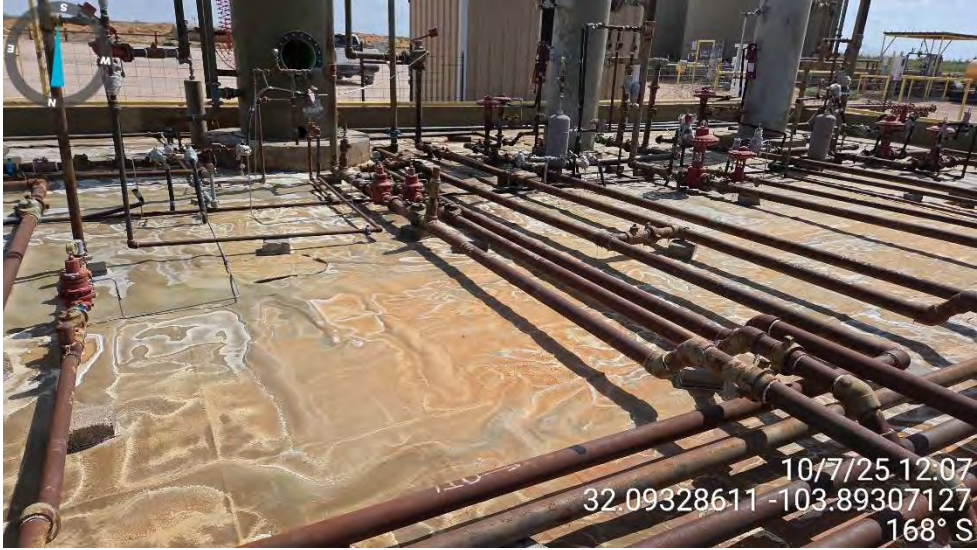
<p><u>Photograph</u> 7</p>	<p><u>Date</u> 10/7/2025</p>

<p><u>Description</u> Liner inspection activities</p>

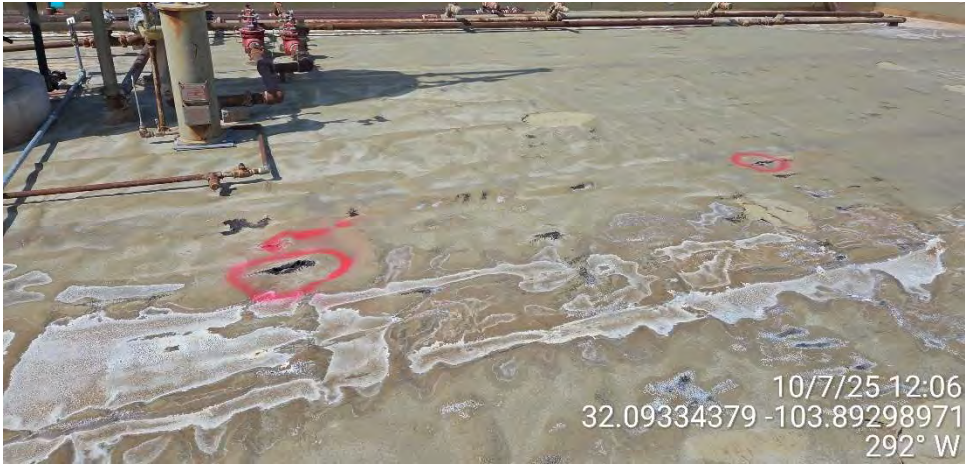
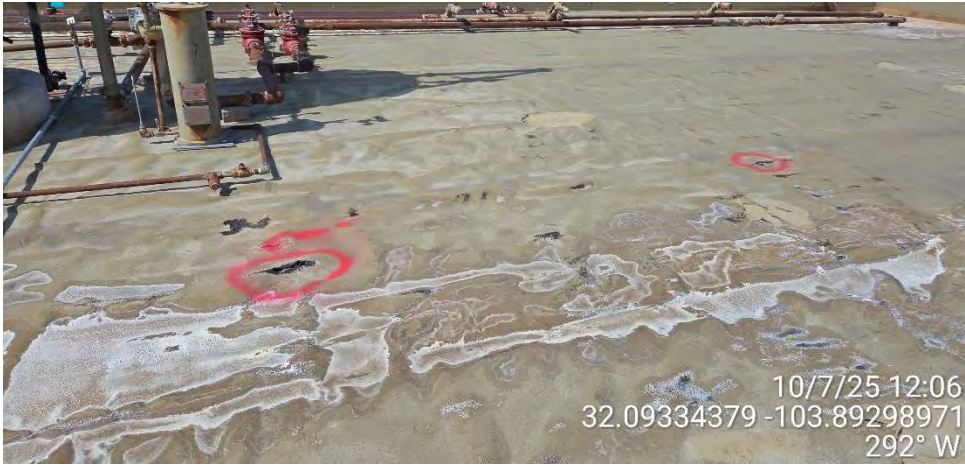
<p><u>Description</u> Observed holes in liner floor during inspection activities</p>

A 48-hour advance notice of the liner inspection and soil sampling activities was submitted to the NMOCD on February 18, 2026. On February 26, 2026, Ensolum personnel returned to the Site and the lined containment was inspected. The liner was observed to be operating as designed and no tears, damage, or debris were identified. Ensolum personnel observed the patch in the liner in the central portion of the north end of the lined containment, installed following the delineation activities completed in October 2025. As requested by the NMOCD, Ensolum personnel cut a 5 foot by 5-foot hole in the liner and conducted additional sampling of the soil in the exposed area of the lined containment. A 5-point composite soil sample was collected by placing five equivalent aliquots of soil into a 1-gallon, resealable plastic bag and homogenizing the samples by thoroughly mixing. Confirmation soil sample CS01 was collected at the surface. The soil sample was field screened for VOCs and chloride. The soil sample was collected, handled, and analyzed following the same procedures as above and submitted to Eurofins Laboratories (Eurofins) and analyzed for the same COCs as previously described above. The liner was subsequently patched and sealed.

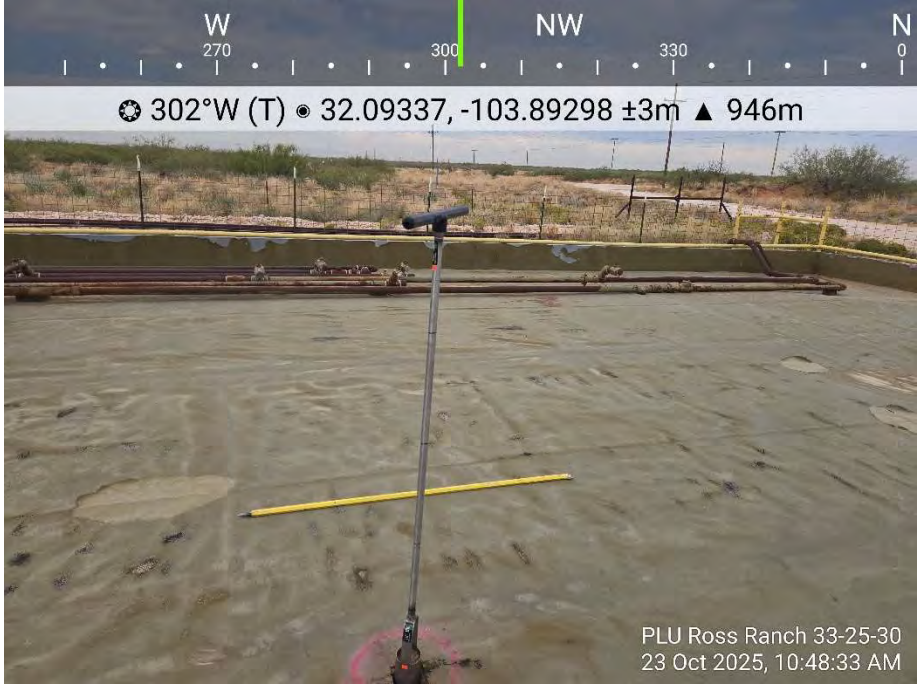
<p><u>Photograph</u> 9</p>	<p><u>Date</u> 10/23/2025</p>

<p><u>Description</u> Delineation activities near BH01</p>		
<p><u>View</u> Northwest</p>		
<p><u>Photograph</u> 10</p>	<p><u>Date</u> 10/23/2025</p>

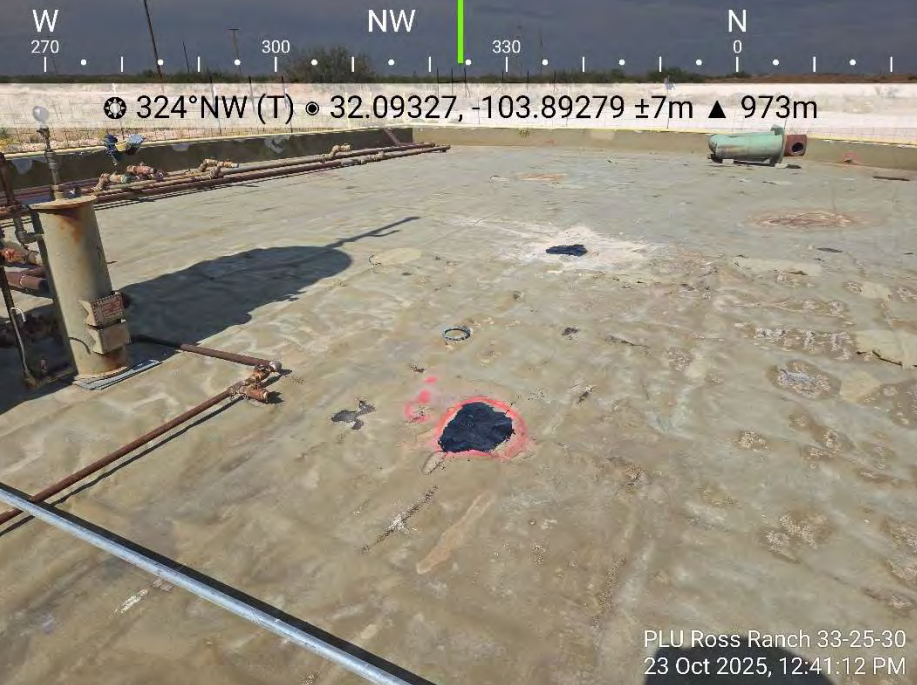
<p><u>Description</u> Patching activities</p>		
<p><u>View</u> Northwest</p>

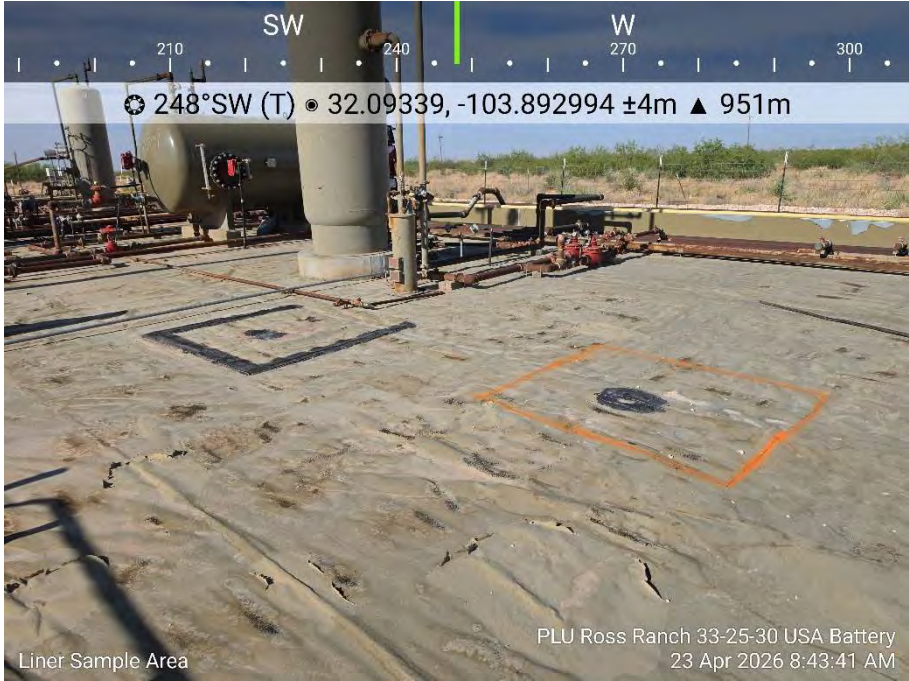
<p><u>Photograph</u> 13</p>	<p><u>Date</u> 4/23/2026</p>

<p><u>Description</u> Liner cutting and patch activities near CS01, proposed cut section near CS02</p>		
<p><u>View</u> West</p>		
<p><u>Photograph</u> 14</p>	<p><u>Date</u> 4/23/2026</p>

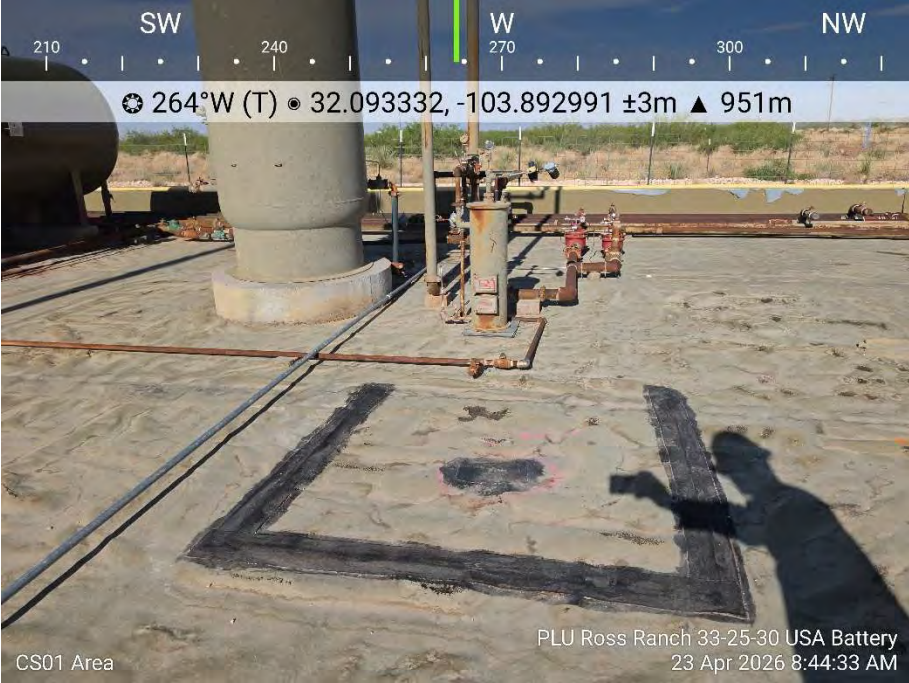
<p><u>Description</u> Liner patch over CS01</p>		
<p><u>View</u> West</p>

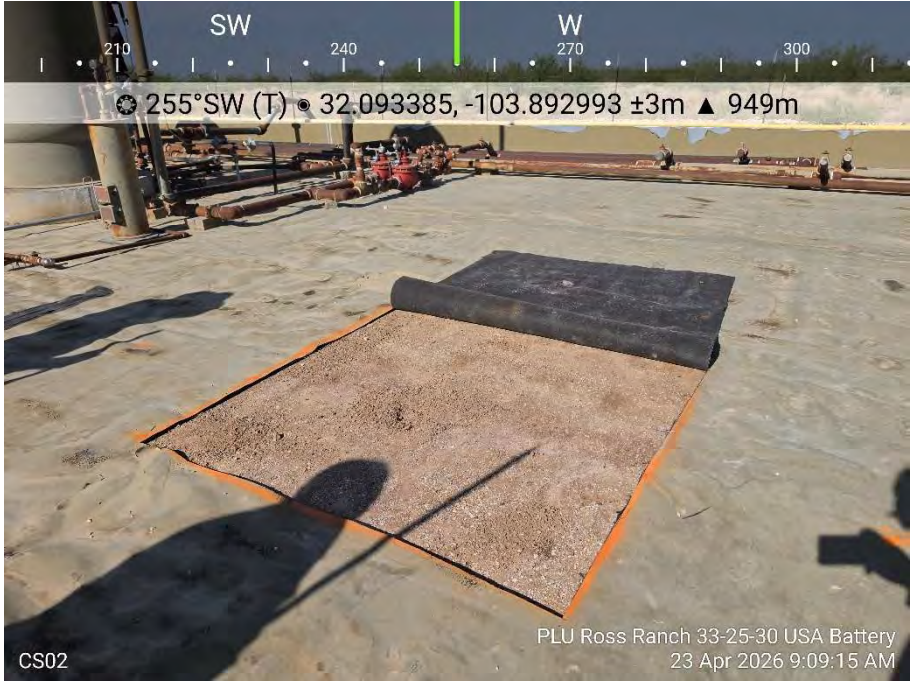
<p><u>Photograph</u> 15</p>	<p><u>Date</u> 4/23/2026</p>

<p><u>Description</u> Liner cutting and sampling activities near CS02</p>		
<p><u>View</u> West</p>		<p>CS02</p> <p>PLU Ross Ranch 33-25-30 USA Battery 23 Apr 2026 9:09:15 AM</p>
<p><u>Photograph</u> 16</p>	<p><u>Date</u> 4/23/2026</p>

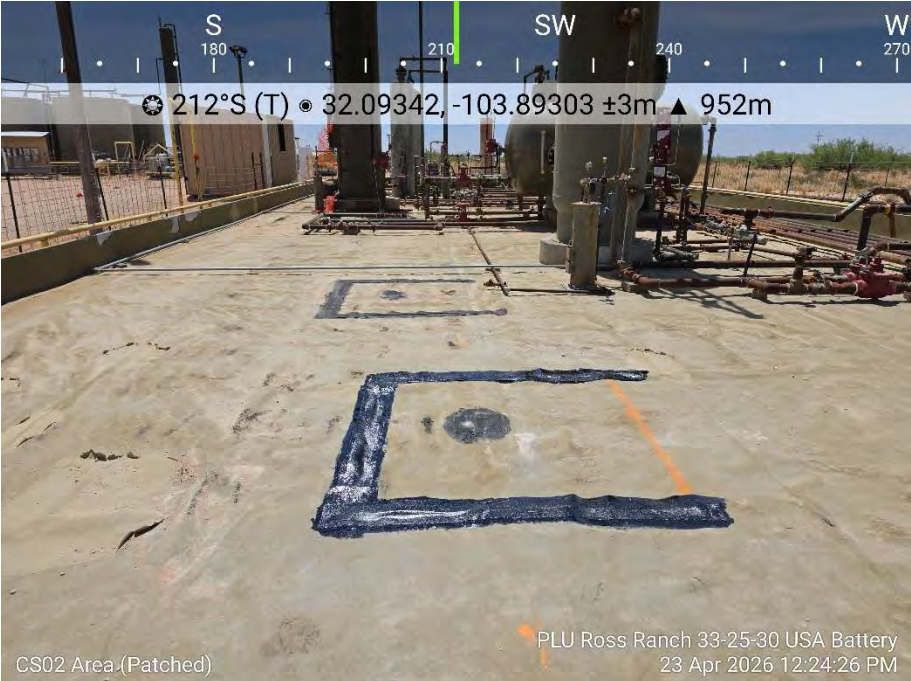
<p><u>Description</u> Patching activities near CS02 and CS01</p>		
<p><u>View</u> Southwest</p>		<p>CS02 Area.(Patched)</p> <p>PLU Ross Ranch 33-25-30 USA Battery 23 Apr 2026 12:24:26 PM</p>

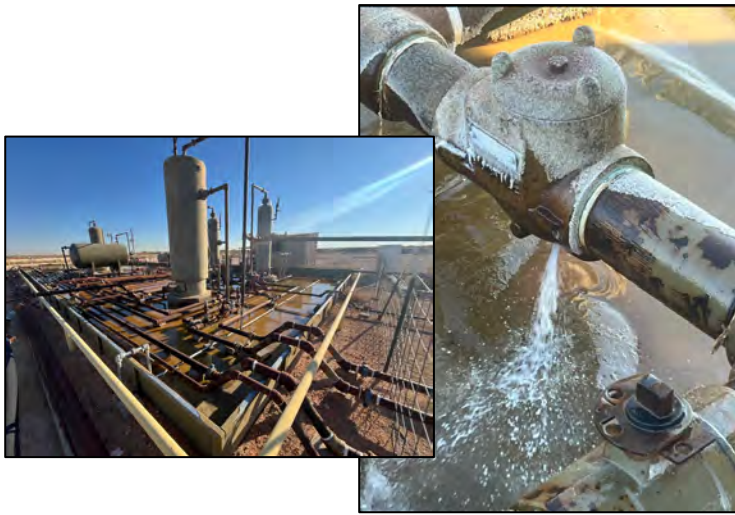
Photograph: 1 Date: 09/27/2025
Description: Initial release observed for Incident Number nAPP2527230287
POR located at approximately 32.09331°, -103.89309°

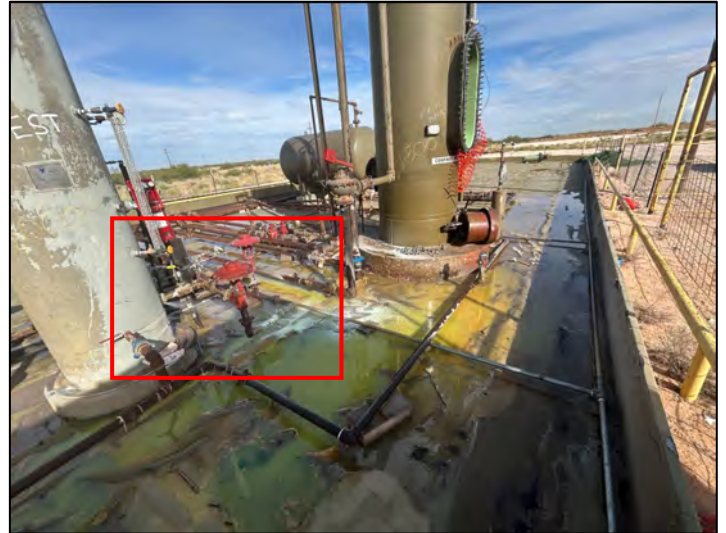
Photograph: 2 Date: 10/03/2025
Description: Initial release observed for Incident Number nAPP2527929108
POR located at approximately 32.09321°, -103.89301°

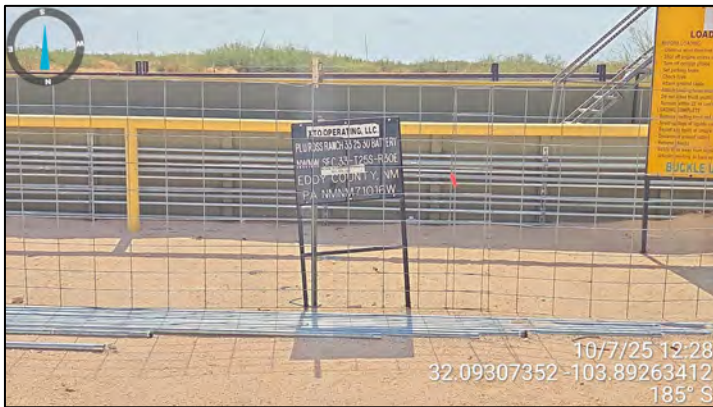
Photograph: 3 Date: 10/07/2025
Description: Well sign during liner inspection activities
View: South

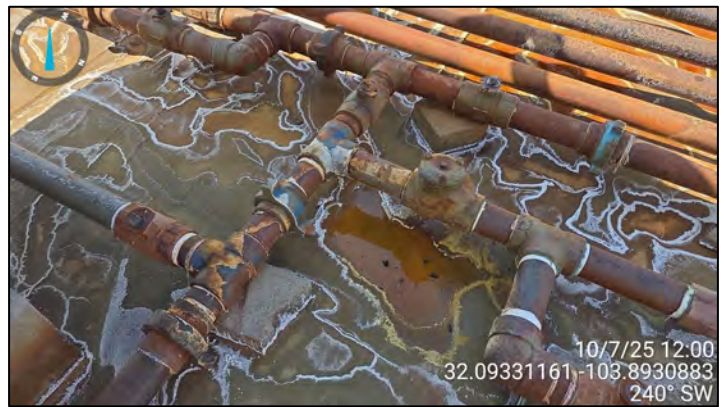
Photograph: 4 Date: 10/07/2025
Description: POR for Incident Number nAPP2527230287 observed during liner inspection activities.
View: Southwest

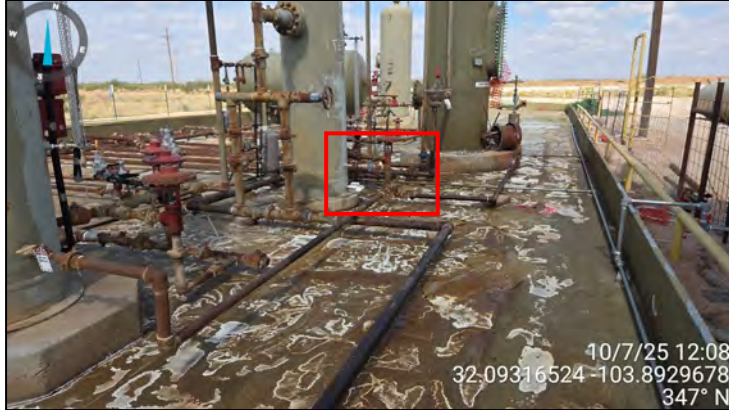
Photograph: 5 Date: 10/07/2025
Description: POR for Incident Number nAPP2527929108 observed during liner inspection activities.
View: North

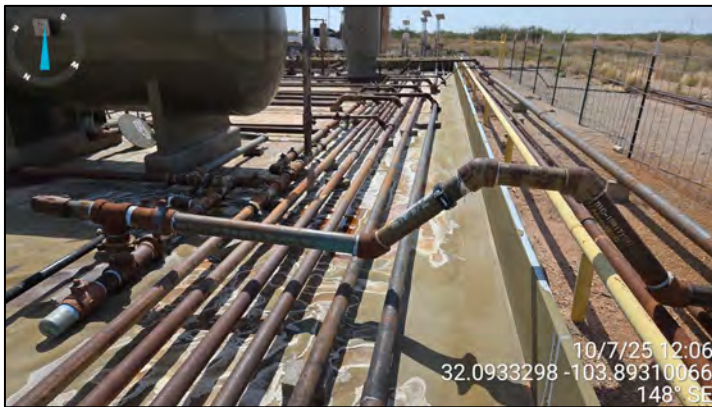
Photograph: 7 Date: 10/07/2025
Description: Liner inspection activities
View: Southeast

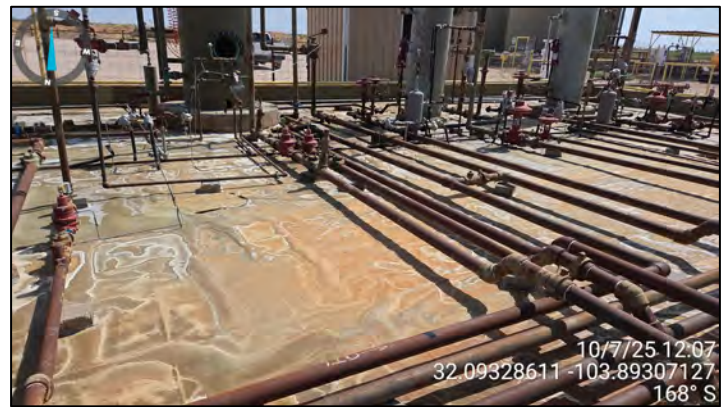
Photograph: 8 Date: 10/07/2025
Description: Liner inspection activities
View: South

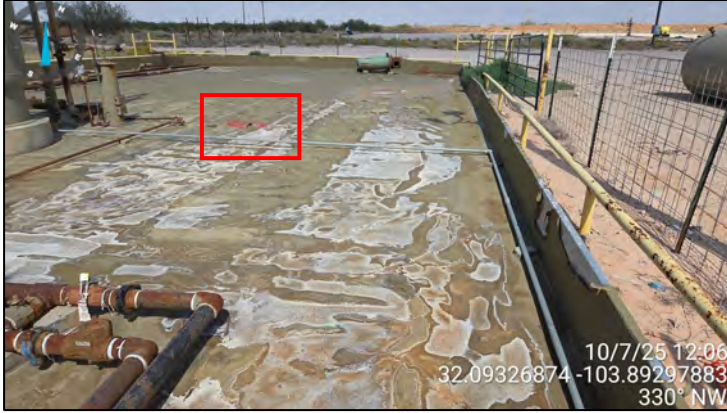
Photograph: 9 Date: 10/07/2025
Description: Damage and breach in the liner observed
View: Northwest

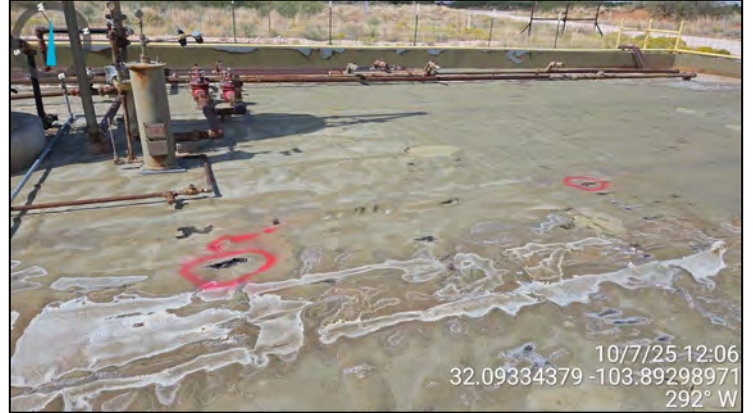
Photograph: 10 Date: 10/07/2025
Description: Damage and breach in the liner observed
View: West

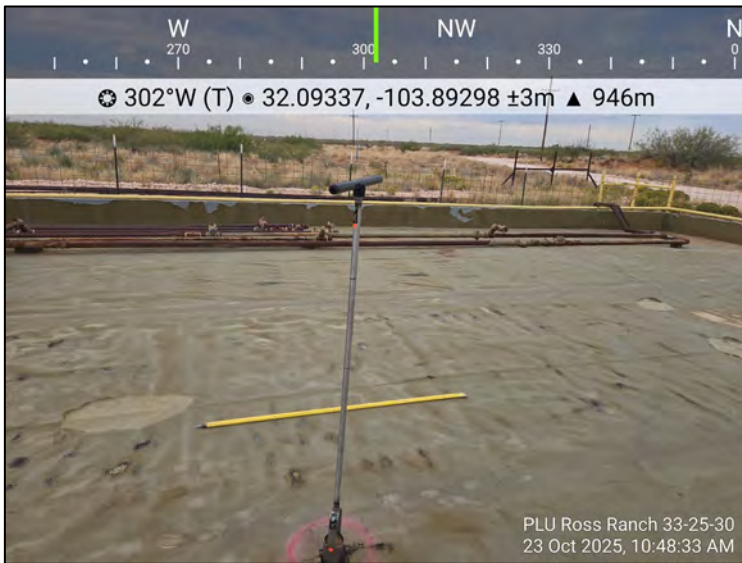
Photograph: 11 Date: 10/23/2025
Description: Delineation activities, BH01, at breach in the liner
View: Northwest

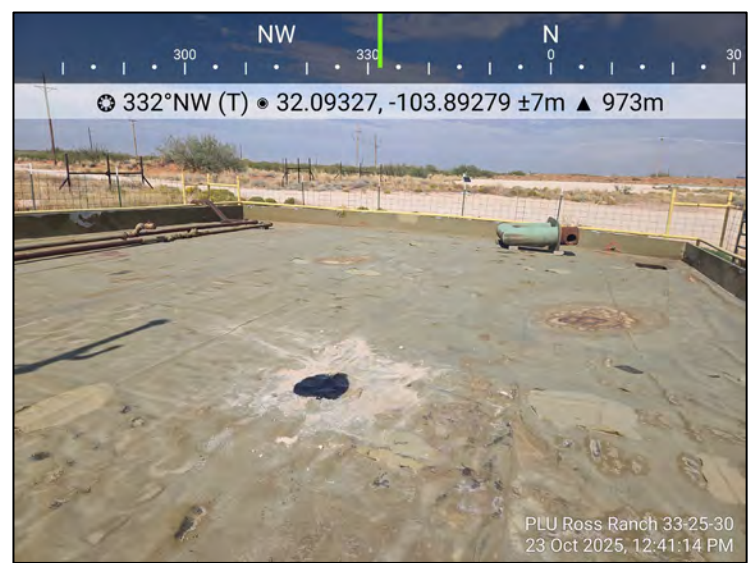
Photograph: 12 Date: 10/23/2025
Description: Liner patching activities at BH01
View: Northwest
