Incident Number: nAPP2602836374

Liner Inspection Closure Report

Vega 29 Fed 1H_2H Battery

Vertex File Number: 26A-00873

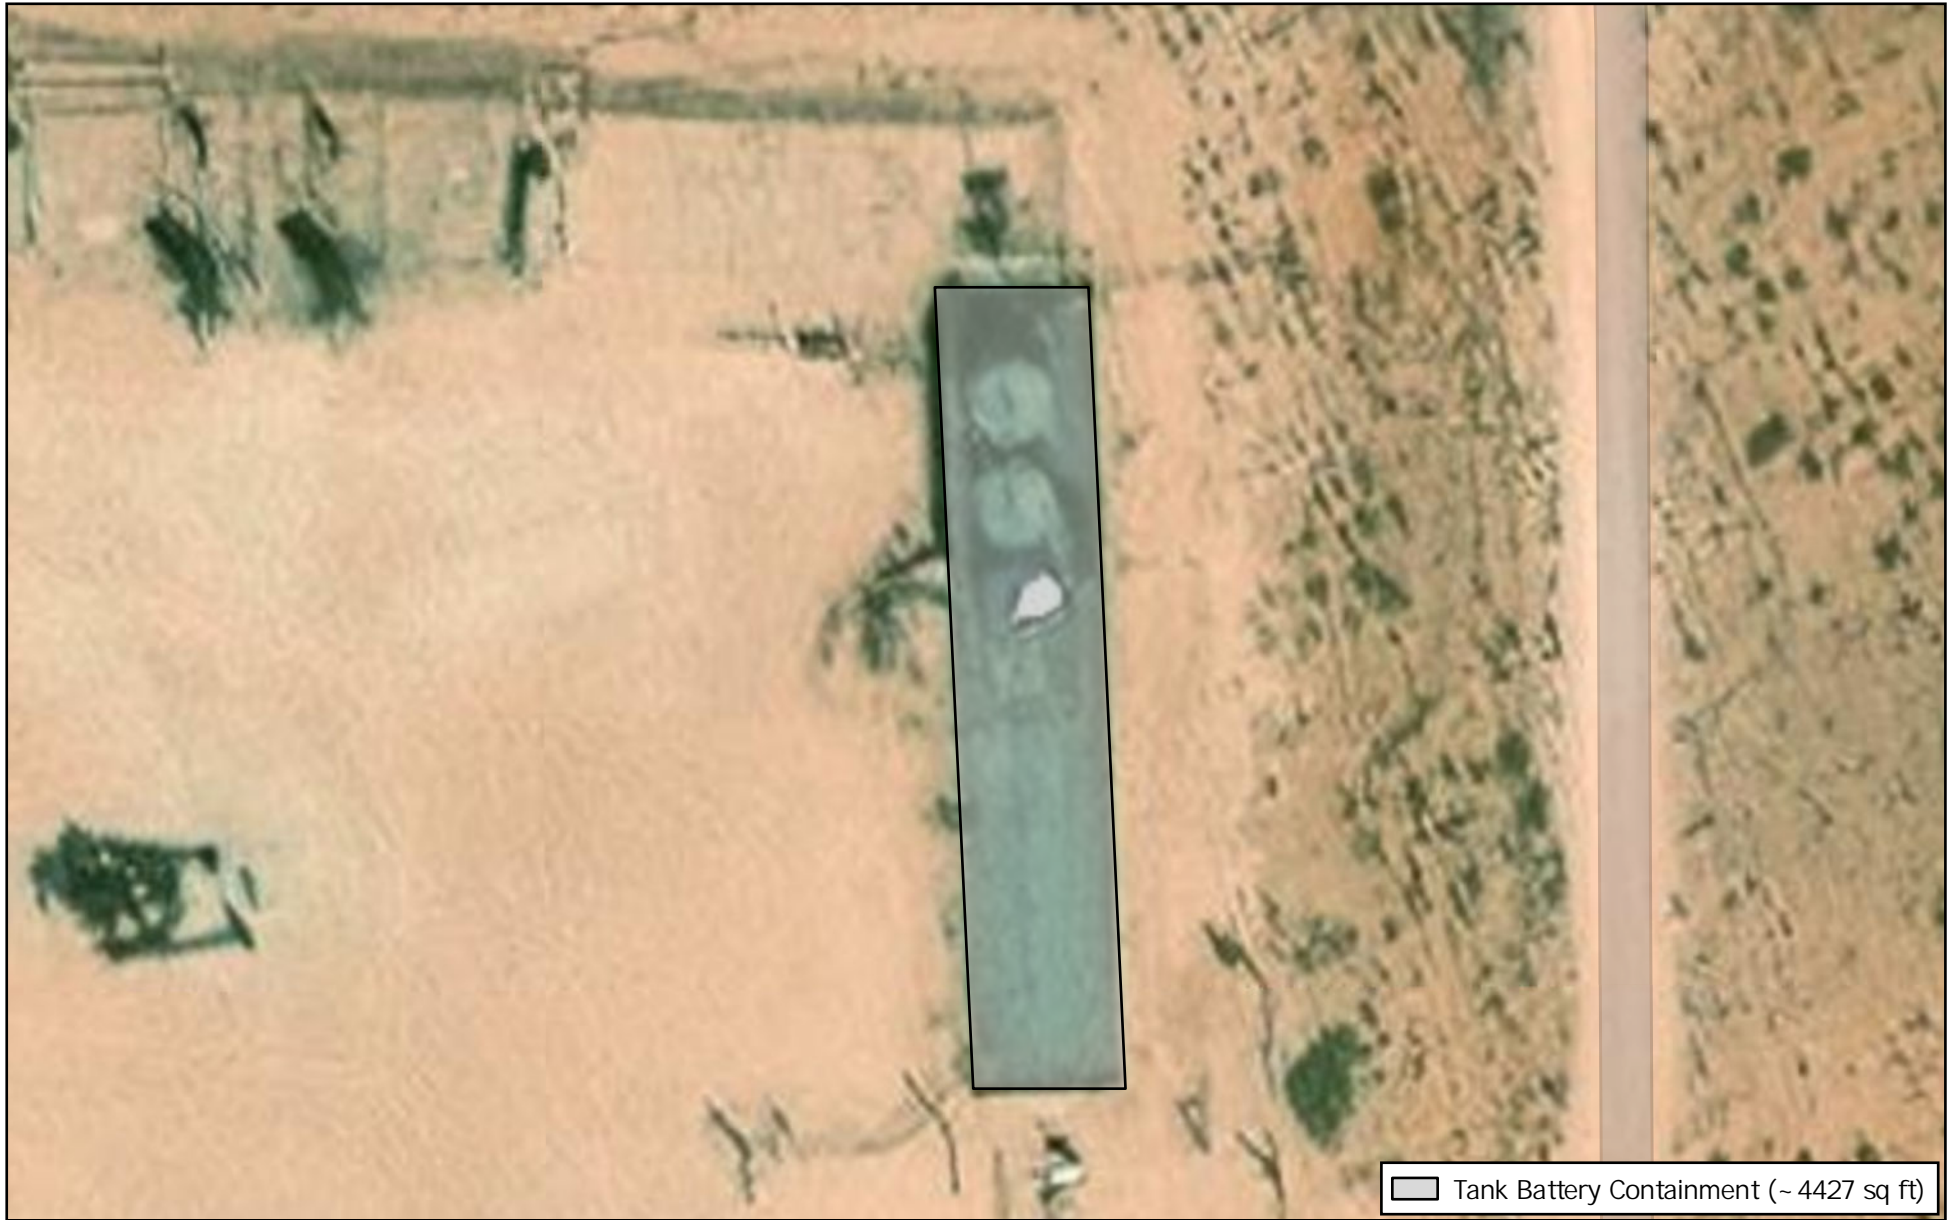
FIGURE:
 1

□ Tank Battery Containment (~ 4427 sq ft)

Liner Inspect on Site Schemat c
 Vega 29 Federal 1H_2H

The site is located approximately 21.1 south miles south of Loco Hills, New Mexico. The legal location for the site is Unit B, Section 29, Township 19 South and Range 31 East in Eddy County, New Mexico. The release area is located on Federal property. An aerial photograph and site schematic are presented on Figure 1.

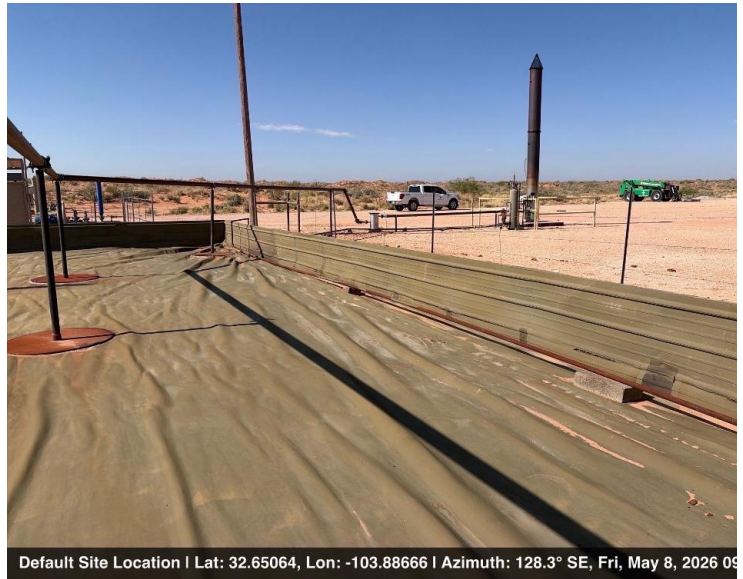
Date: 5/8/2026
 Time: 09:24
 Notes: The western side of the southern 1/2 of the liner is free of any rips, tears, or holes
 Latitude: 32.65063611111111
 Longitude: -103.88666388888889
 Direction: SE

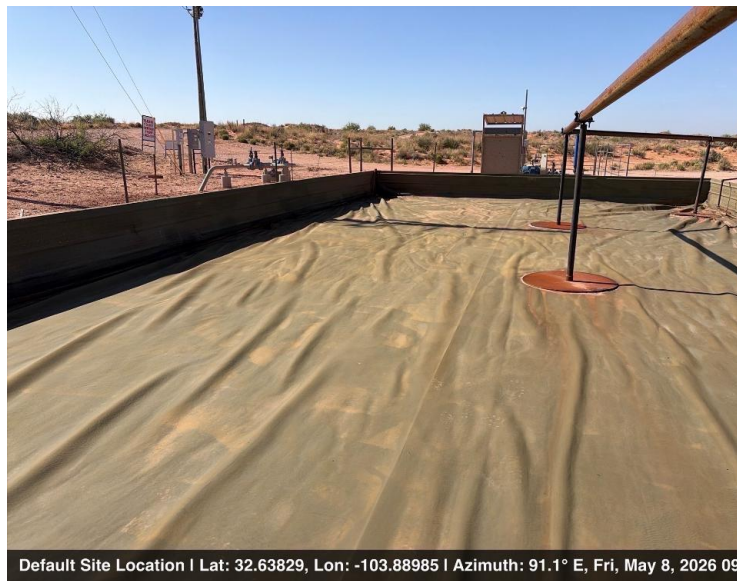
Date: 5/8/2026
 Time: 09:26
 Notes: The eastern side of the southern half of the liner is free of any rips tears or holes
 Latitude: 32.63829444444444
 Longitude: -103.88984722222223
 Direction: E

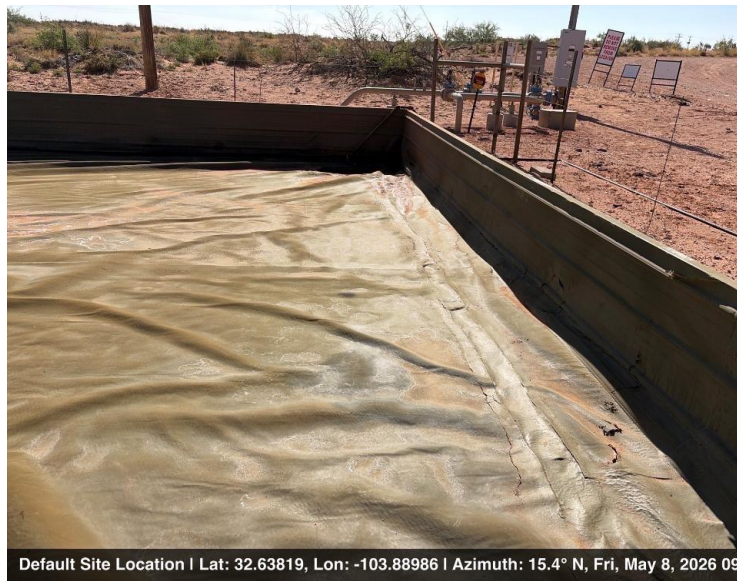
Date: 5/8/2026
 Time: 09:26
 Notes: The southern most part of the liner is free from any rips tears or holes
 Latitude: 32.638186111111111
 Longitude: -103.88986111111112
 Direction: N

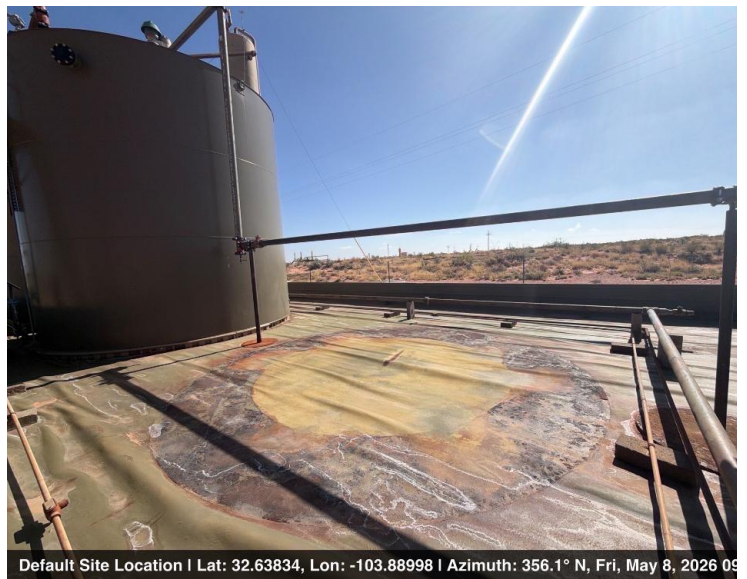
Date: 5/8/2026
 Time: 09:28
 Notes: The center of the liner where a tank appears to be removed is free of any rips tears or holes. The discoloration is not sediment or salt, but rather staining left over from removed equipment. The discolored area was carefully inspected for any weaknesses and none were present
 Latitude: 32.638344444444444
 Longitude: -103.88997777777779
 Direction: N

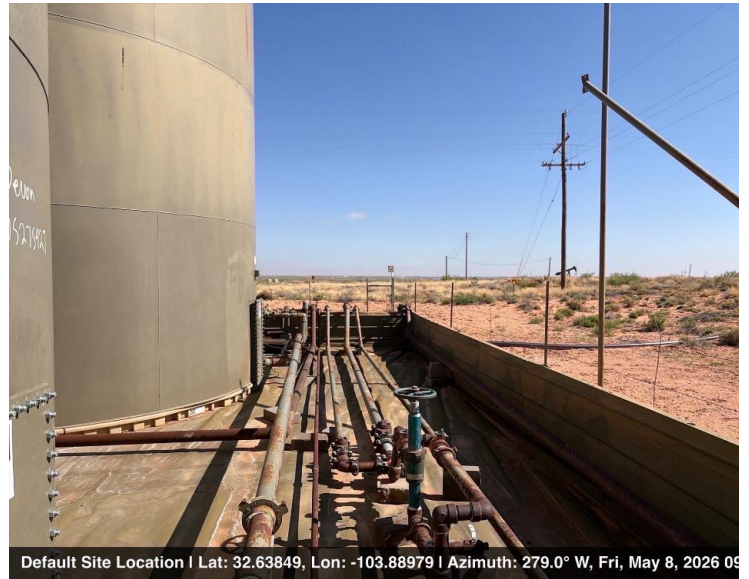
Date: 5/8/2026
 Time: 09:30
 Notes: The northeastern area is free of any holes, tears, or gashes
 Latitude: 32.63848611111111
 Longitude: -103.88979444444445
 Direction: W

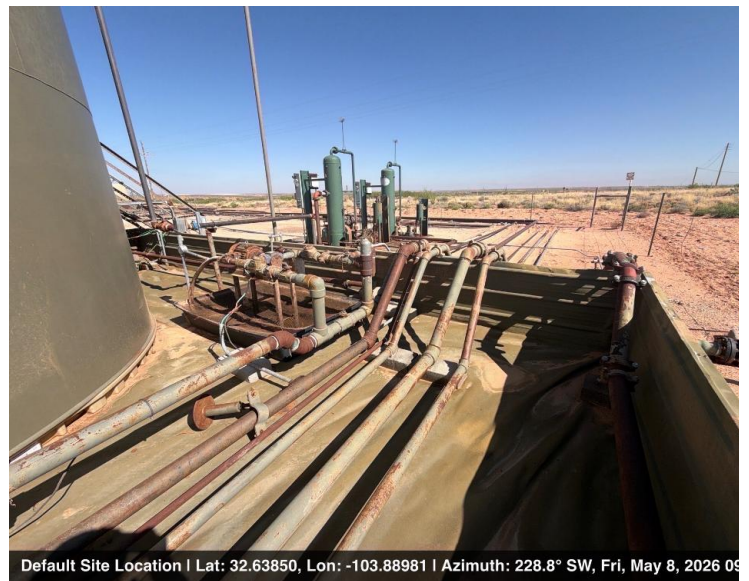
Date: 5/8/2026
 Time: 09:31
 Notes: The northern most area of the liner is free of any tears, holes, or gashes
 Latitude: 32.63849722222222
 Longitude: -103.88980833333333
 Direction: SW

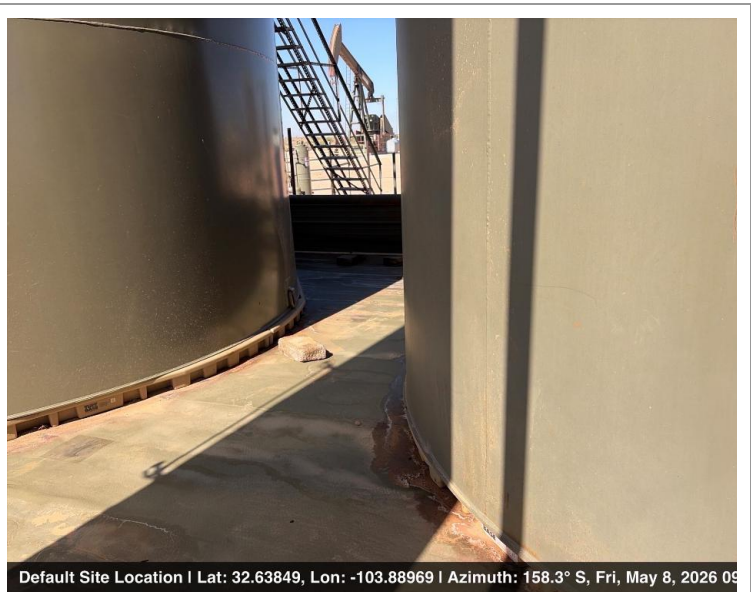
Date: 5/8/2026
 Time: 09:31
 Notes: The area between the tanks is free of any holes, tears, or gashes
 Latitude: 32.63848888888889
 Longitude: -103.88969444444444
 Direction: S

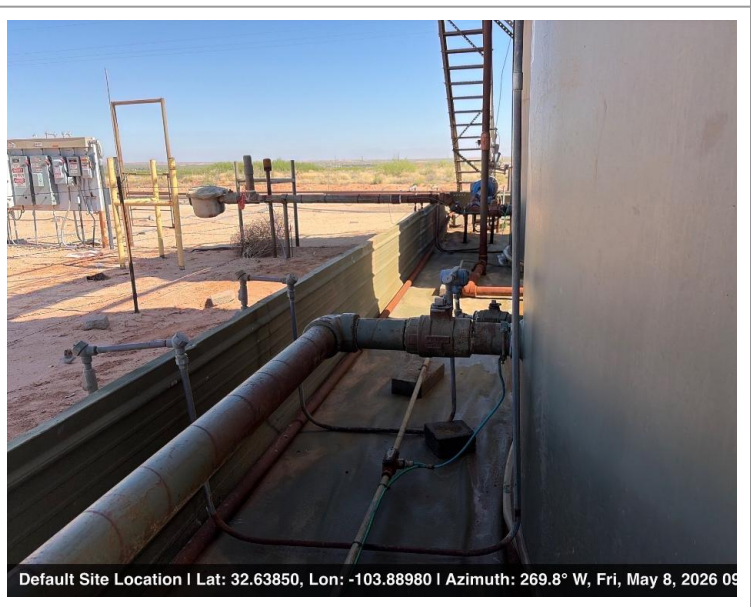
Date: 5/8/2026
 Time: 09:33
 Notes: Northwestern area of the liner is free of any holes, rips, or tears
 Latitude: 32.6385
 Longitude: -103.88980277777779
 Direction: W
