Remediation Work Plan

Corral Canyon Expansion

nAPP2610335677

ExxonMobil Production Company

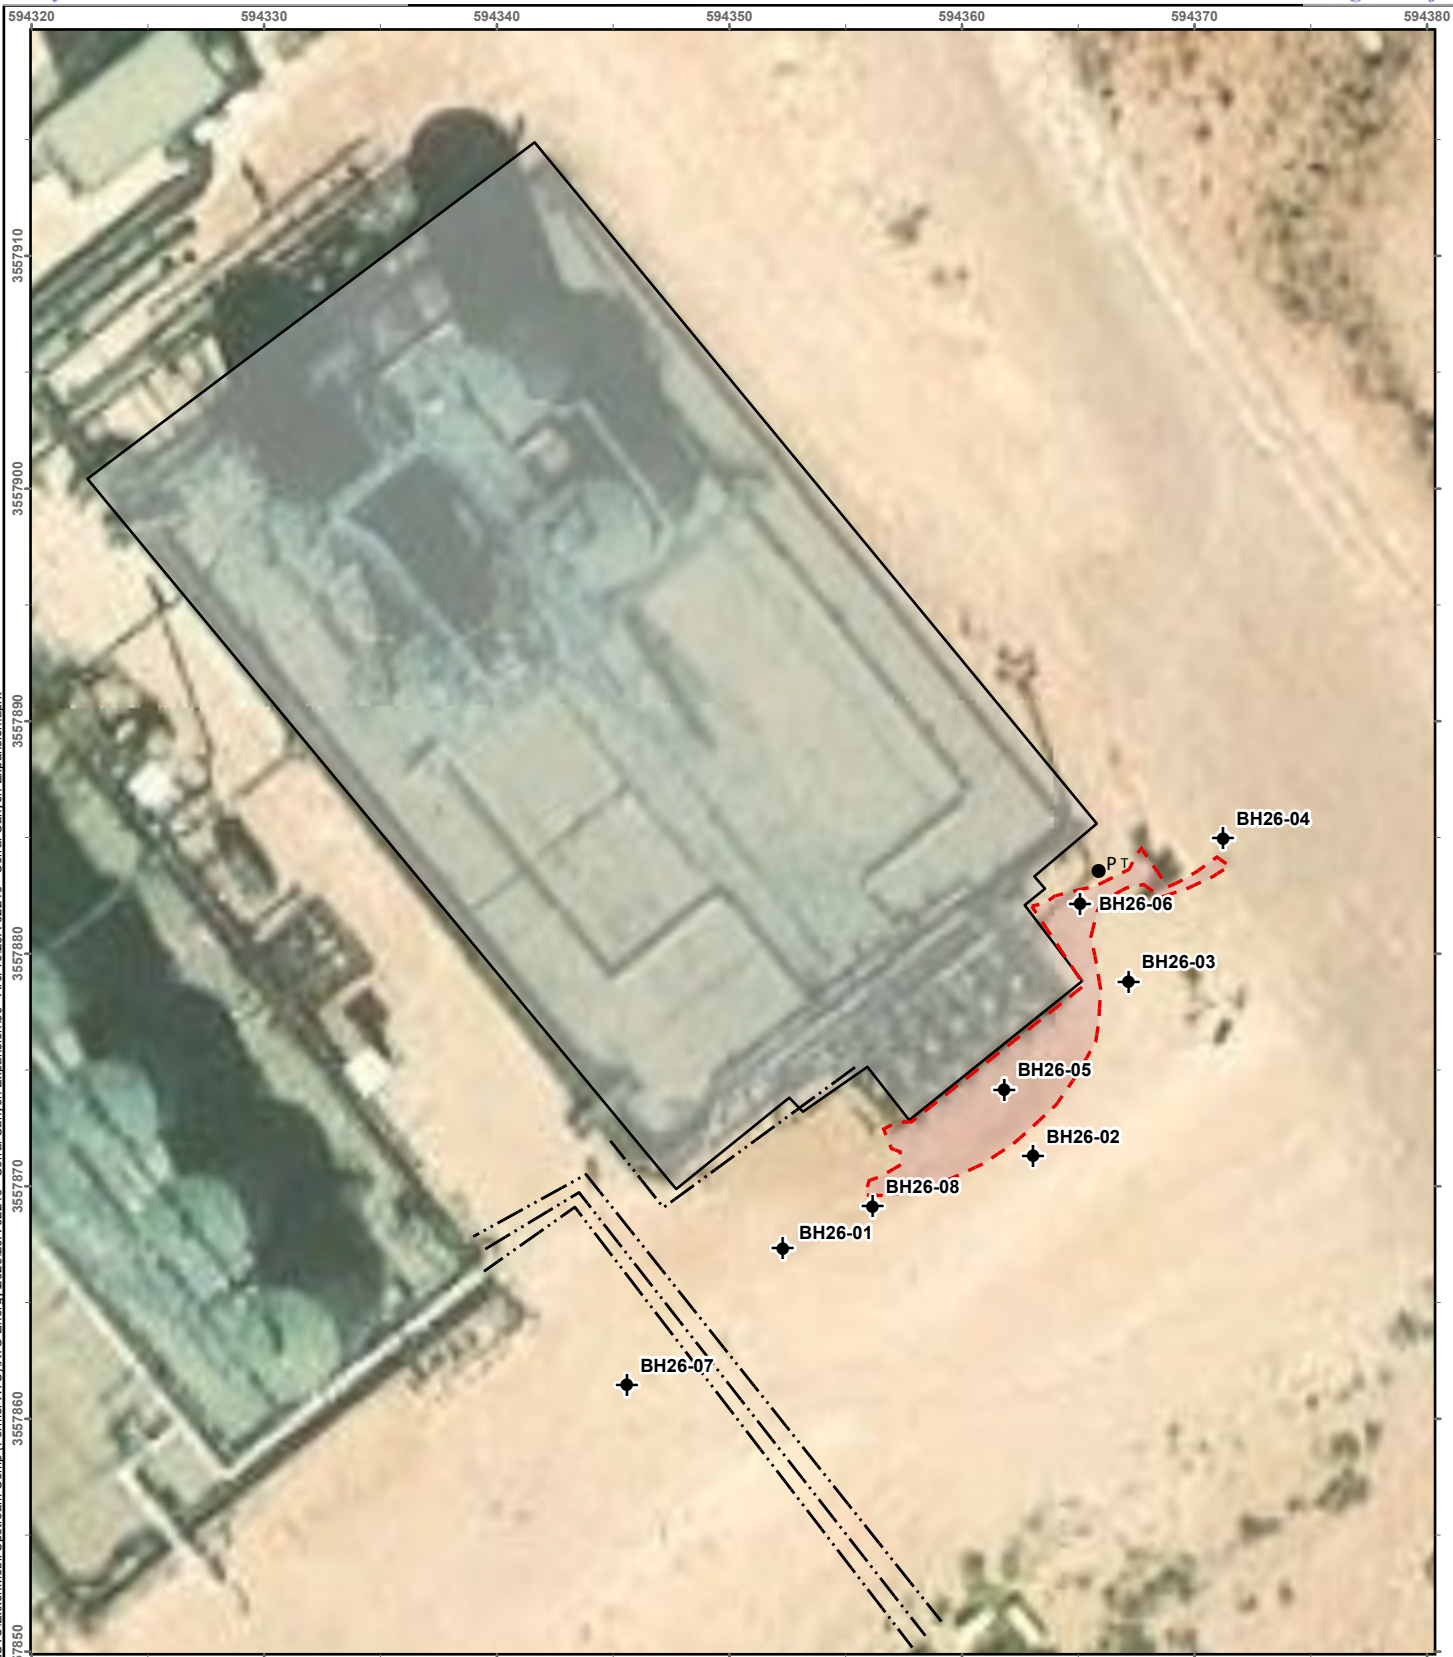
FIGURES

- ◆ Borehole
- PT Telephone Pole
- Pipeline (Underground)
- ▭ Production Equipment
- ▭ Approximate Release Extent (~491 sq. ft.)

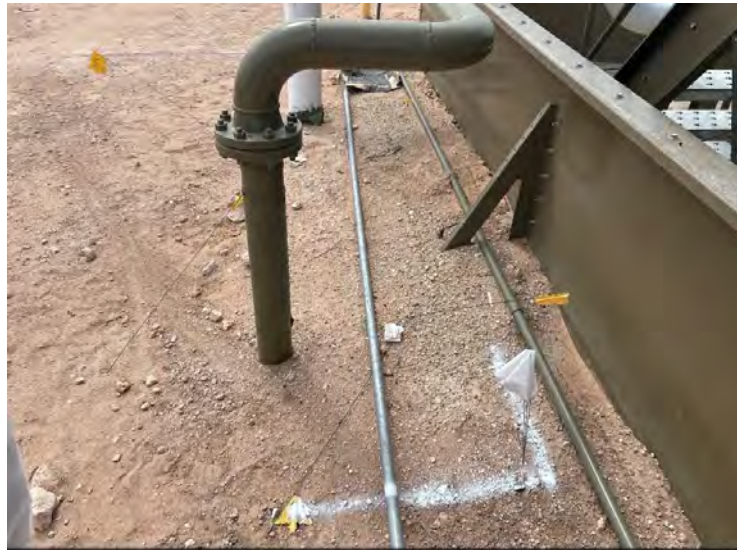
Date: 4/14/2026
Time: 10:35
Notes: 811 flags placed
Latitude: 32.15333888888889
Longitude: -103.99959444444444
Direction: E

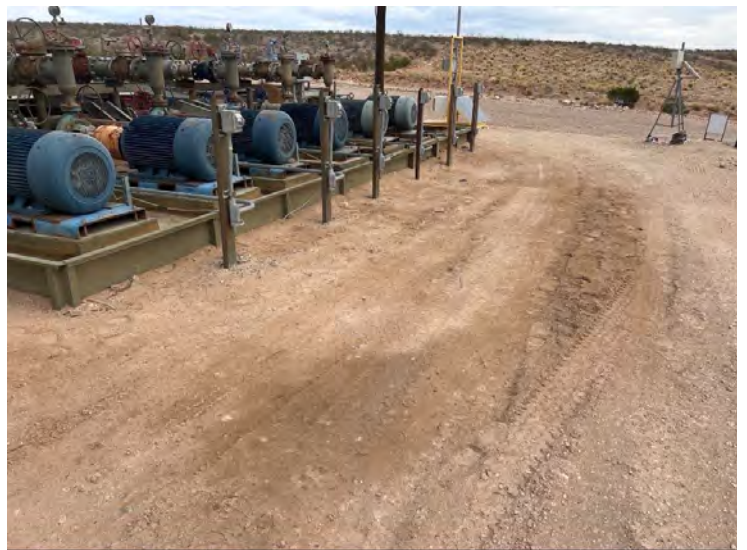
Date: 4/14/2026
Time: 10:40
Notes: Spill mapped
Latitude: 32.153327777777776
Longitude: -103.99938888888889
Direction: N

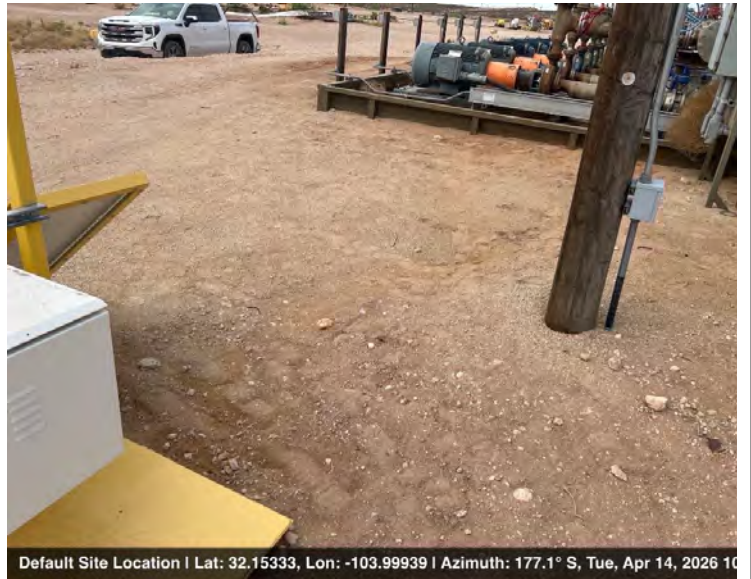
Date: 4/14/2026
Time: 10:40
Notes: Spill mapped
Latitude: 32.15332777777776
Longitude: -103.99938888888889
Direction: S

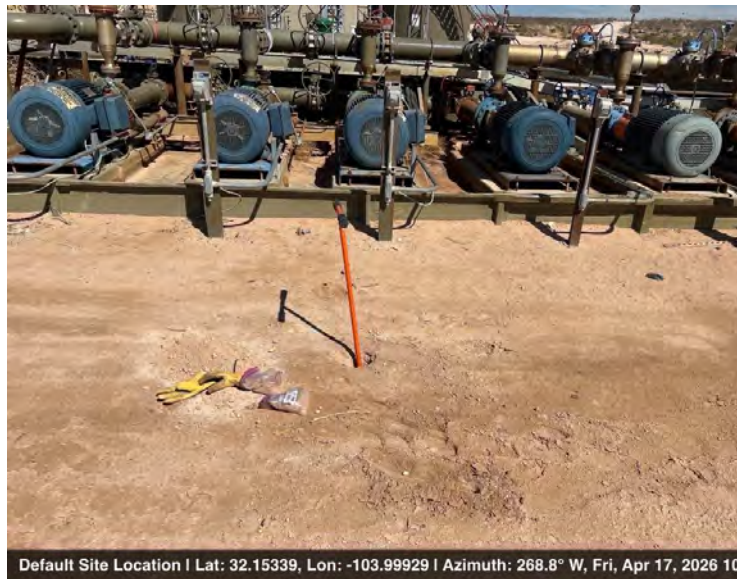
Date: 4/17/2026
Time: 10:22
Notes: BH26-05 @ 1'
BH26-05 @ 2'
Latitude: 32.153391666666664
Longitude: -103.99928888888888
Direction: W

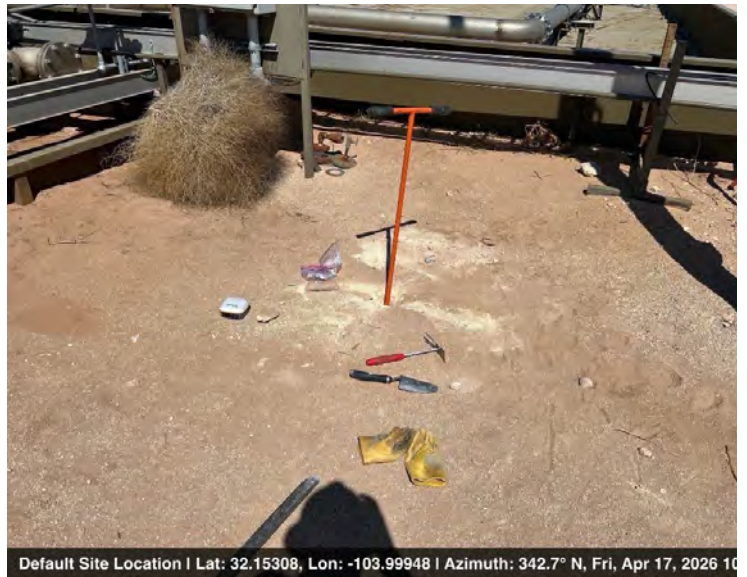
Date: 4/17/2026
Time: 10:34
Notes: BH26-06 @ 1'
BH26-06 @ 1.5
Latitude: 32.153083333333335
Longitude: -103.99948055555555
Direction: N

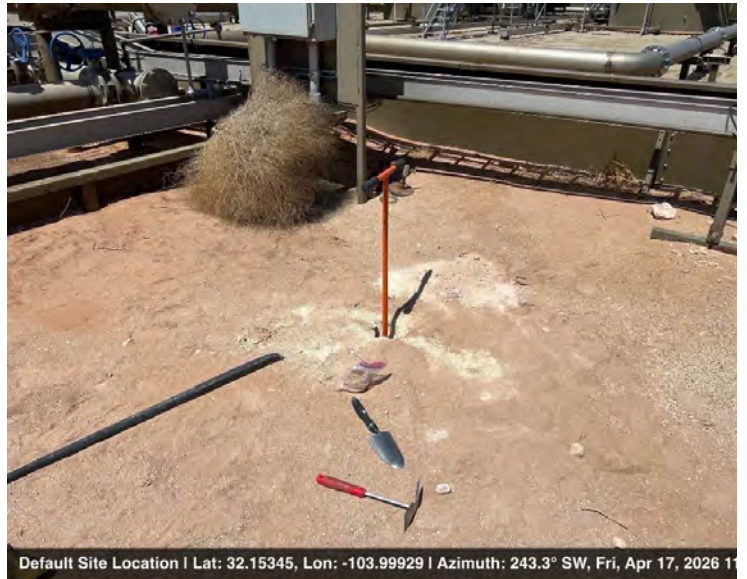
Date: 4/17/2026
Time: 11:45
Notes: BH26-06 @ 2.5 Refusal
Latitude: 32.15345277777778
Longitude: -103.99928888888888
Direction: W

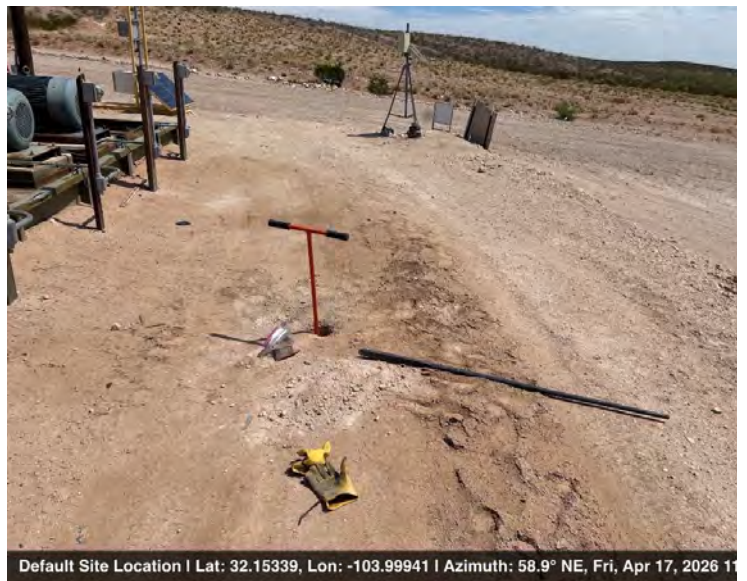
Date: 4/17/2026
Time: 11:49
Notes: BH26-05 @ 3' Refusal
Latitude: 32.15338888888889
Longitude: -103.99940555555555
Direction: NE

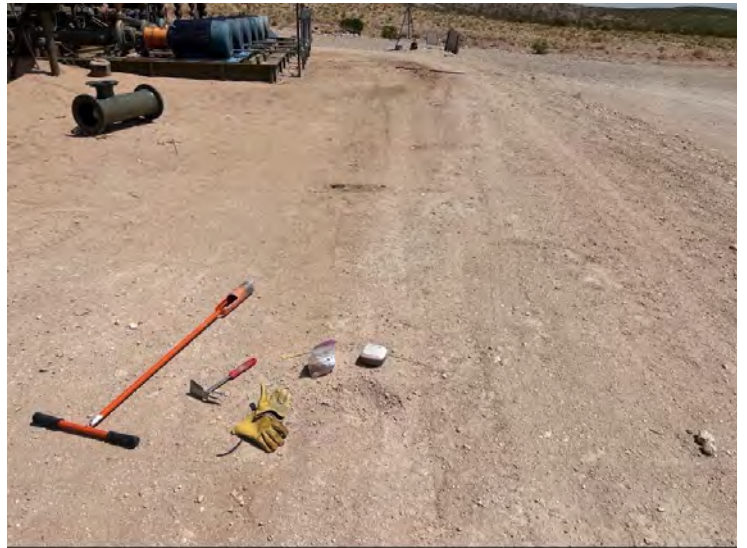
Date: 4/17/2026
 Time: 11:52
 Notes: BH26-01 was stepped back approximately 10'
 Latitude: 32.153349999999996
 Longitude: -103.99952777777779
 Direction: E

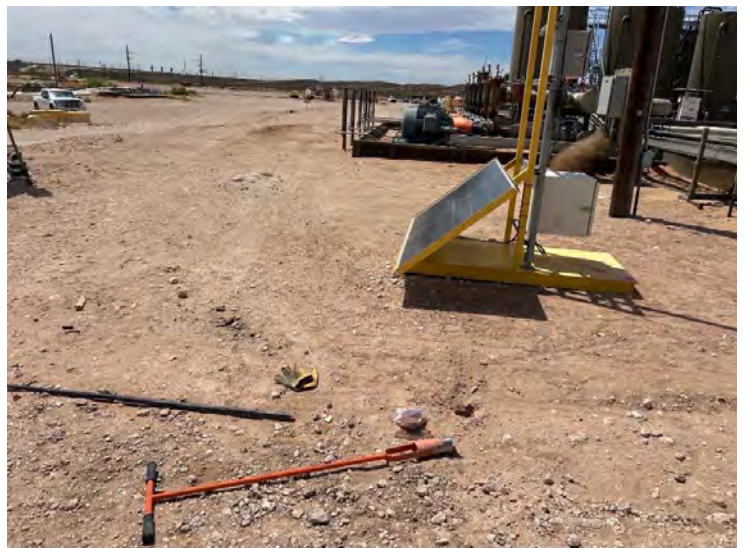
Date: 4/17/2026
 Time: 12:47
 Notes: BH26-04 @ 1'
 Latitude: 32.153183333333333
 Longitude: -103.999488888888889
 Direction: SW

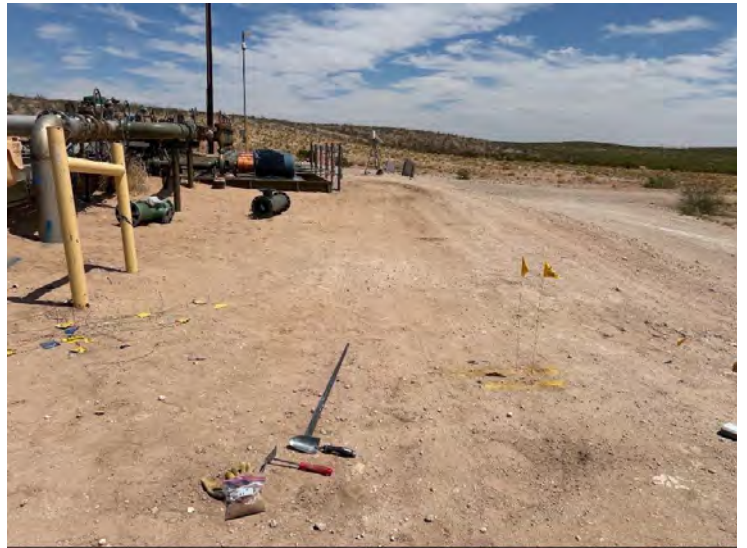
Date: 4/17/2026
Time: 12:34
Notes: BH26-07 @ 0'
Latitude: 32.15328888888889
Longitude: -103.99948888888889
Direction: E

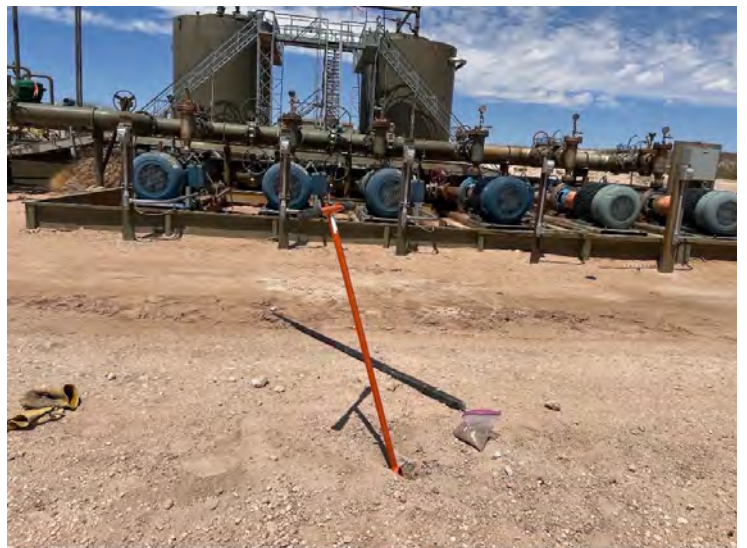
Date: 4/17/2026
Time: 12:39
Notes: BH26-02 @ 1'
Latitude: 32.15342777777778
Longitude: -103.999275
Direction: NW

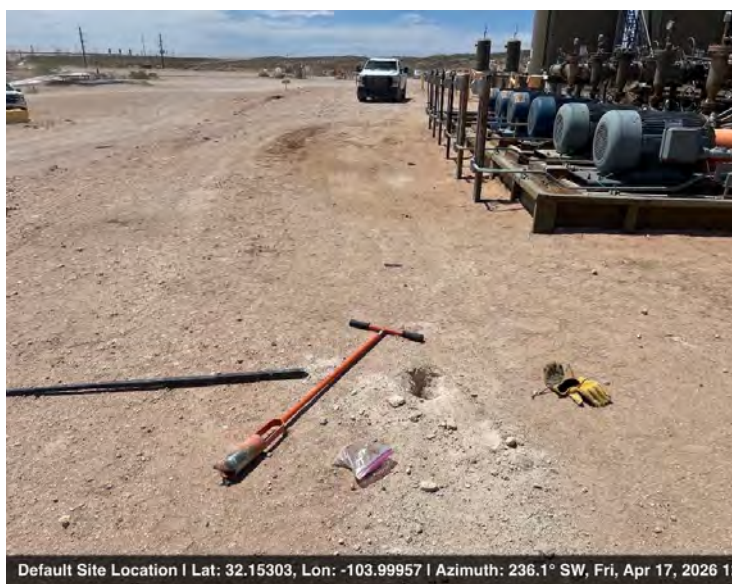
Date: 4/17/2026
Time: 12:44
Notes: BH26-03 @ 1'
Latitude: 32.1530305555555
Longitude: -103.9995722222223
Direction: SW

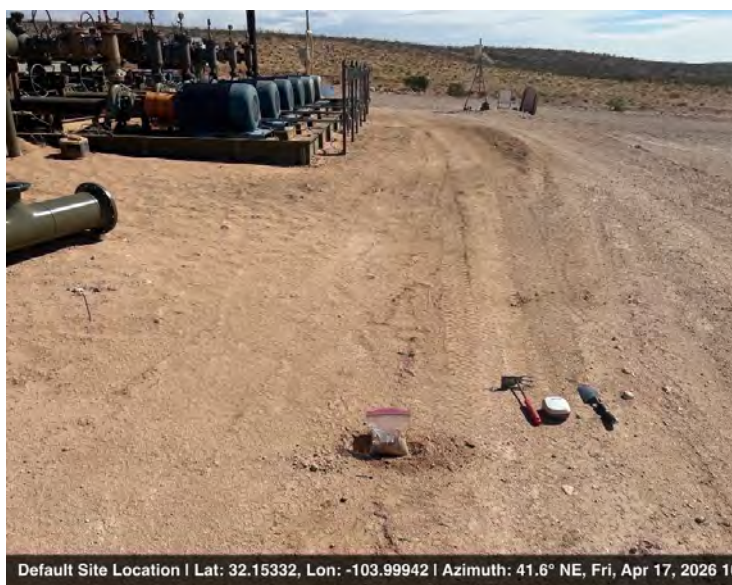
Date: 4/17/2026
Time: 10:04
Notes: BH26-01 @ 0'
Latitude: 32.153324999999995
Longitude: -103.999419444444444
Direction: NE

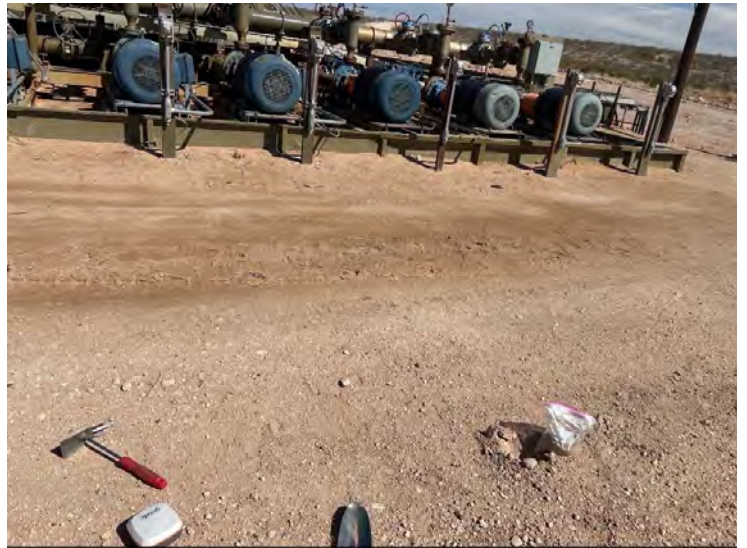
Date: 4/17/2026
Time: 10:06
Notes: BH26-02 @ 0'
Latitude: 32.15333888888889
Longitude: -103.99934444444445
Direction: N

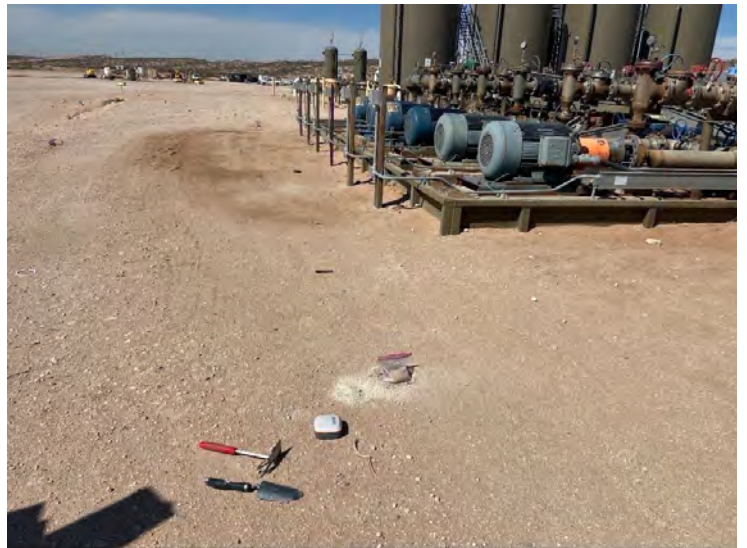
Date: 4/17/2026
Time: 10:08
Notes: BH26-03 @ 0'
Latitude: 32.15342222222222
Longitude: -103.99928333333334
Direction: SW

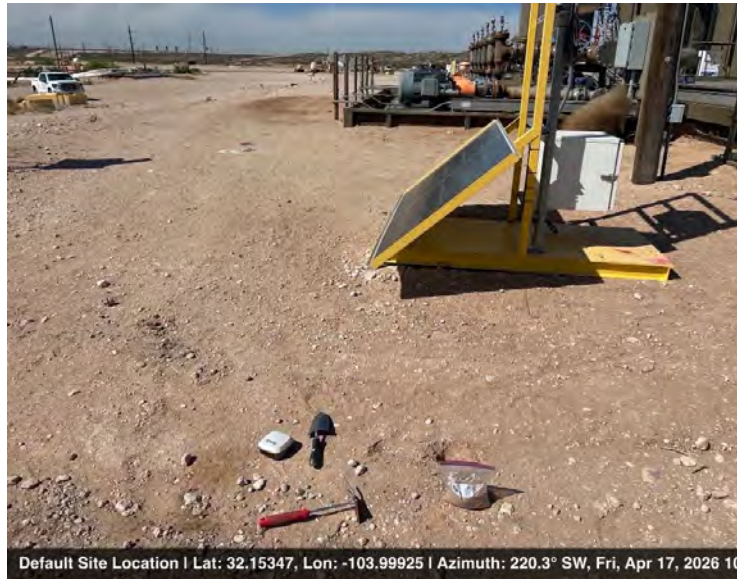
Date: 4/17/2026
Time: 10:11
Notes: BH26-04 @ 0'
Latitude: 32.1534666666667
Longitude: -103.9992527777778
Direction: SW

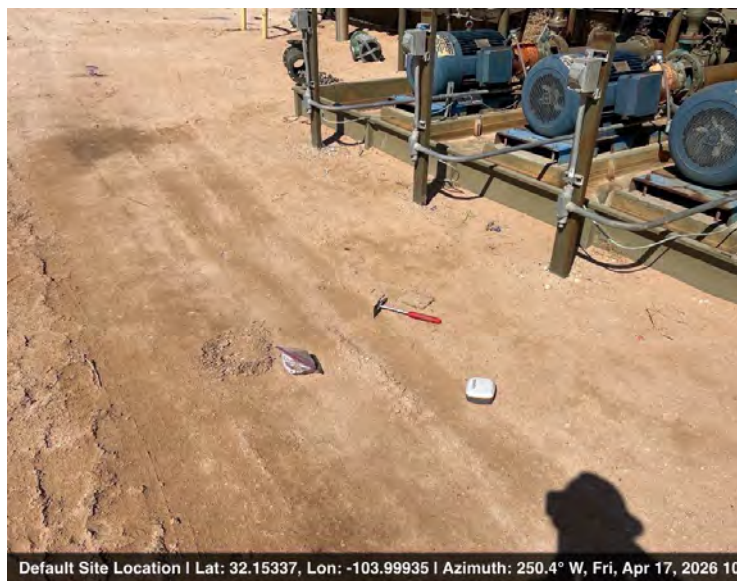
Date: 4/17/2026
Time: 10:12
Notes: BH26-05 @ 0'
Latitude: 32.153375
Longitude: -103.9993527777778
Direction: W

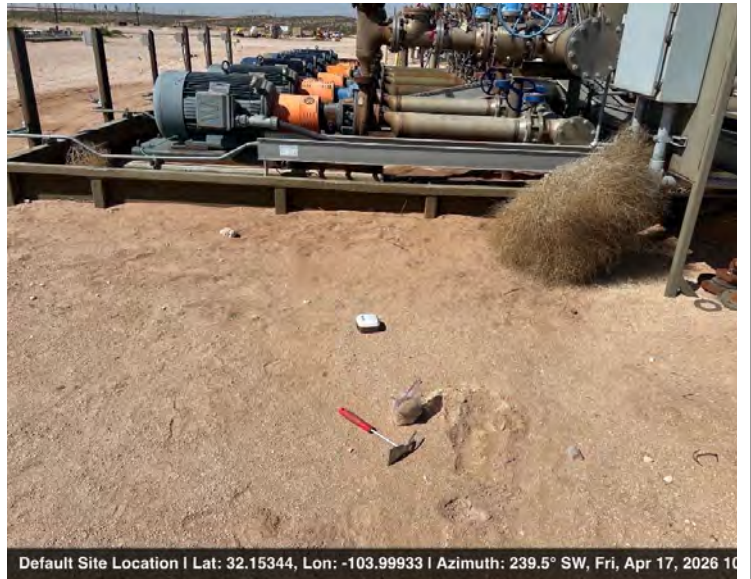
Date: 4/17/2026
Time: 10:14
Notes: BH26-06 @ 0'
Latitude: 32.153441666666666
Longitude: -103.99932777777778
Direction: SW

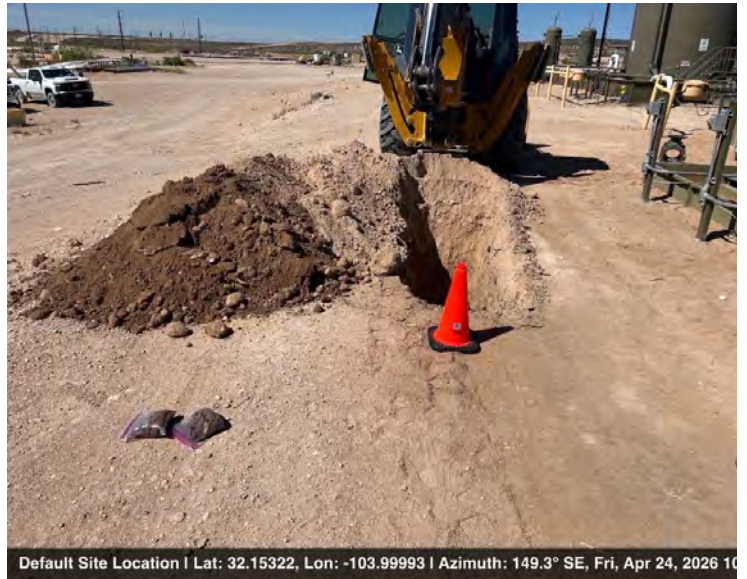
Date: 4/24/2026
Time: 10:13
Notes: BH26-05 @ 4'
BH26-05 @ 5'
Latitude: 32.15322222222222
Longitude: -103.99993055555555
Direction: SE

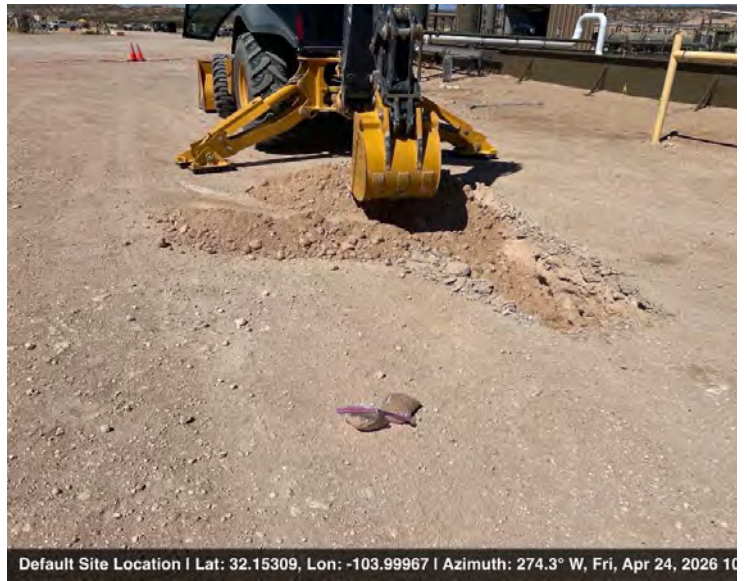
Date: 4/24/2026
Time: 10:26
Notes: BH26-07 @ 0'
BH26-07 @ 2'
Latitude: 32.15309444444444
Longitude: -103.99967222222222
Direction: W

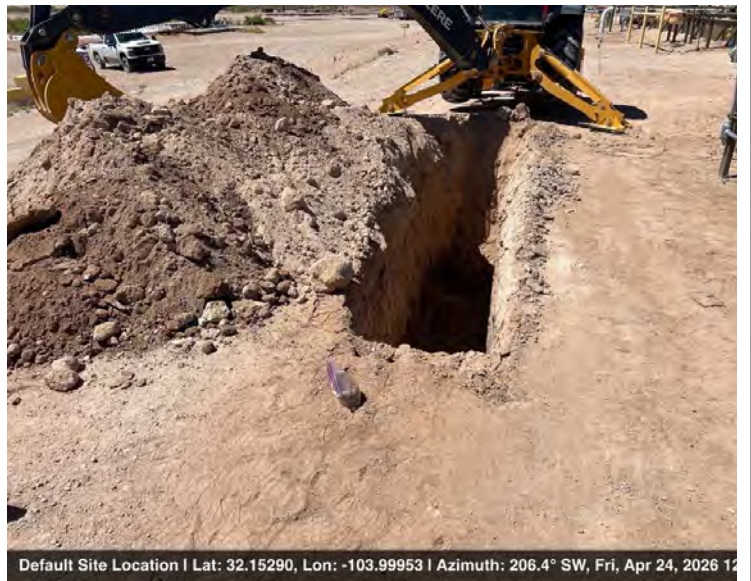
Date: 4/24/2026
Time: 12:19
Notes: BH26-05 @ 6'
BH26-05 @ 6.5' Refusal
Latitude: 32.15289722222222
Longitude: -103.99952777777779
Direction: S

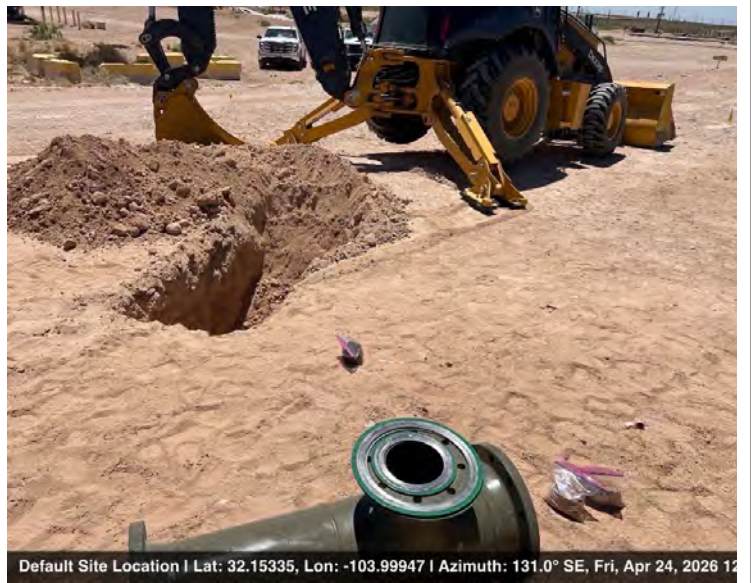
Date: 4/24/2026
Time: 12:39
Notes: BH26-08 @ 1'
BH26-08 @ 2'
BH26-08 @ 3'
Latitude: 32.15334722222222
Longitude: -103.99947222222222
Direction: SE
