SOIL CLOSURE REQUEST

SOUTH MONUMENT GATHERING SOUR
NW ¼, NE ¼, SECTION 5, TOWNSHIP 20 SOUTH, RANGE 37 EAST
LEA COUNTY, NEW MEXICO
PLAINS SRS # 2001-11193
NMOCD REF #1R-951

NOVA Safety and Environmental
2057 Commerce
Midland, Texas 79703

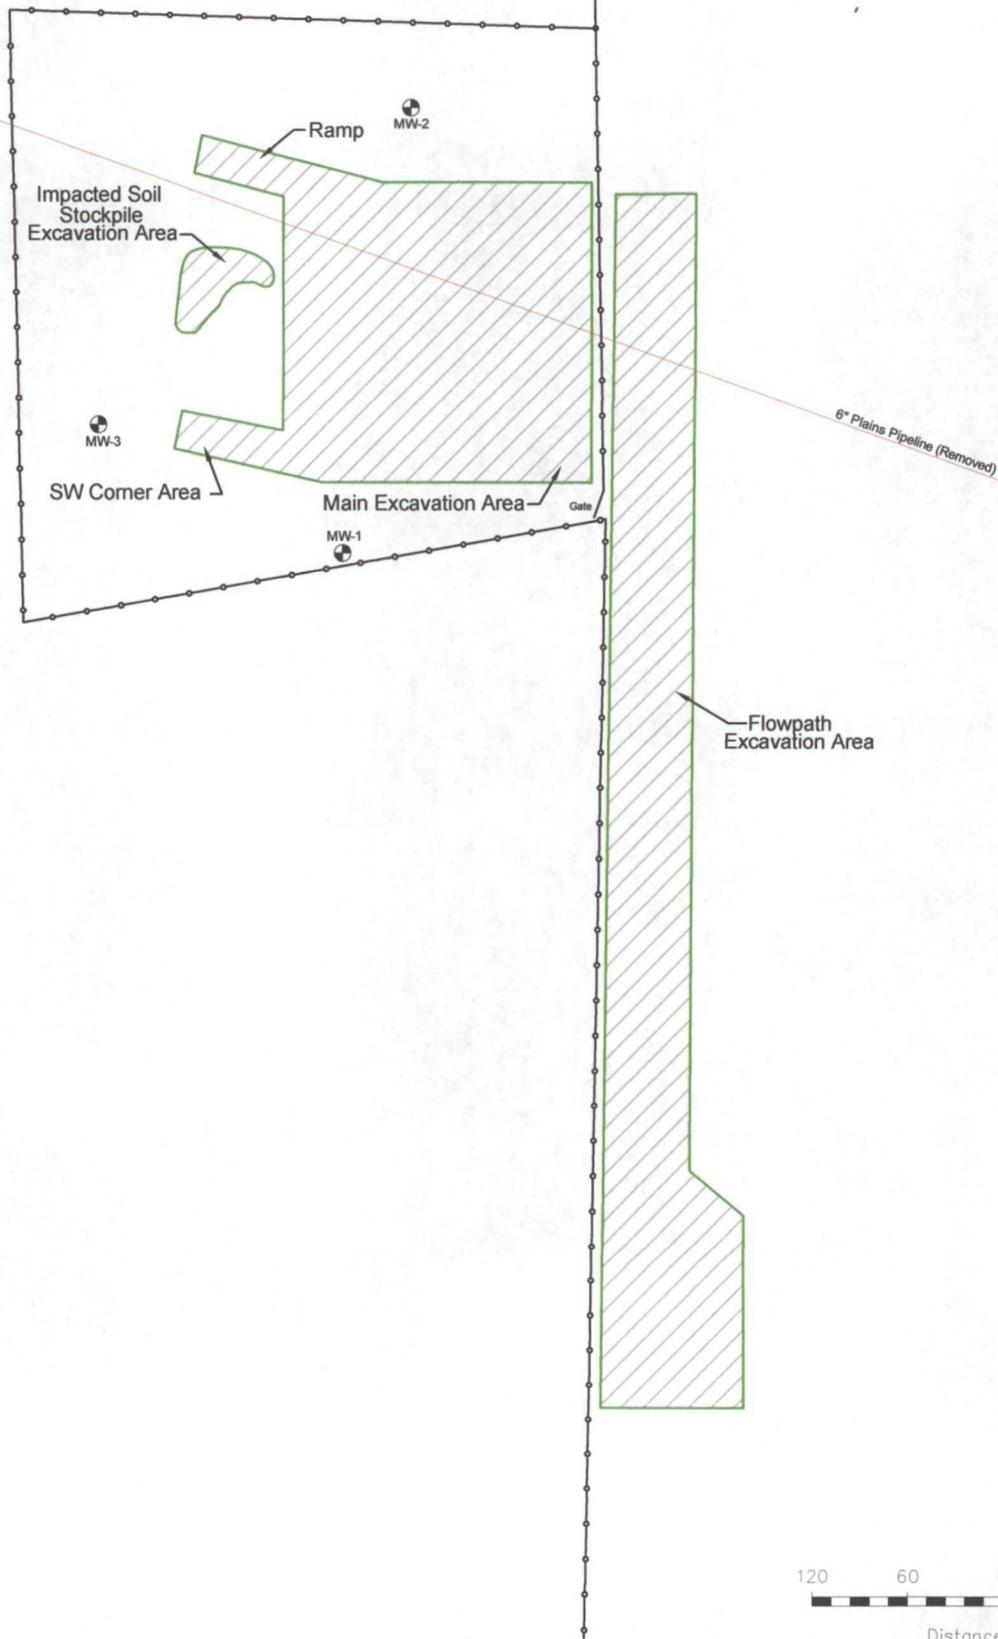
LEGEND: Monitor Well Location Pipeline Fence Excavation Areas	Figure 2 Excavation Areas Map Plains SRS# 2011-11193 Plains Marketing, L.P. South Monument Gathering Lea County, NM		 safety and environmental 2057 Commerce Drive Midland, Texas 79703 432.520.7720 www.novasafetyandenvironmental.com	
	May 18, 2011	Scale: 1" = 120'	CAD By: TA	Checked By: RKR

was transported off-site to an NMOCD approved landfarm. An excavator was utilized to remove impacted soil from the floor and sidewalls of two original excavation areas. Non-impacted overburden soils from the excavation areas was stockpiled on-site, pending laboratory analysis, and later used to backfill the upper three feet of the excavations. As excavation activities progressed, soil samples were collected from the sidewalls of the main excavation area and from the floors and sidewalls of the flow path excavation areas. Following removal of the impacted stockpile material, confirmation soil samples were also collected from beneath the impacted soil stockpiles. Based on visual and olfactory observations, the final dimensions of the main excavation area were approximately 185 feet in length (north-south) by 250 feet in width (east-west) and averaged approximately 27 feet below ground surface (bgs). The flow path excavation area measured approximately 755 feet in length (north-west) by 55 feet in width (east-west) and averaged approximately 13 feet bgs. An estimated 40,700 cubic yards of hydrocarbon impacted soil was brought to surface, combined with the existing impacted soil stockpile, and transported off-site to an NMOCD approved landfarm. Excavation activities were completed on April 20, 2011. Figure 2 is an Excavation Areas Map depicting the former pipeline location and the three excavation areas and other site details.

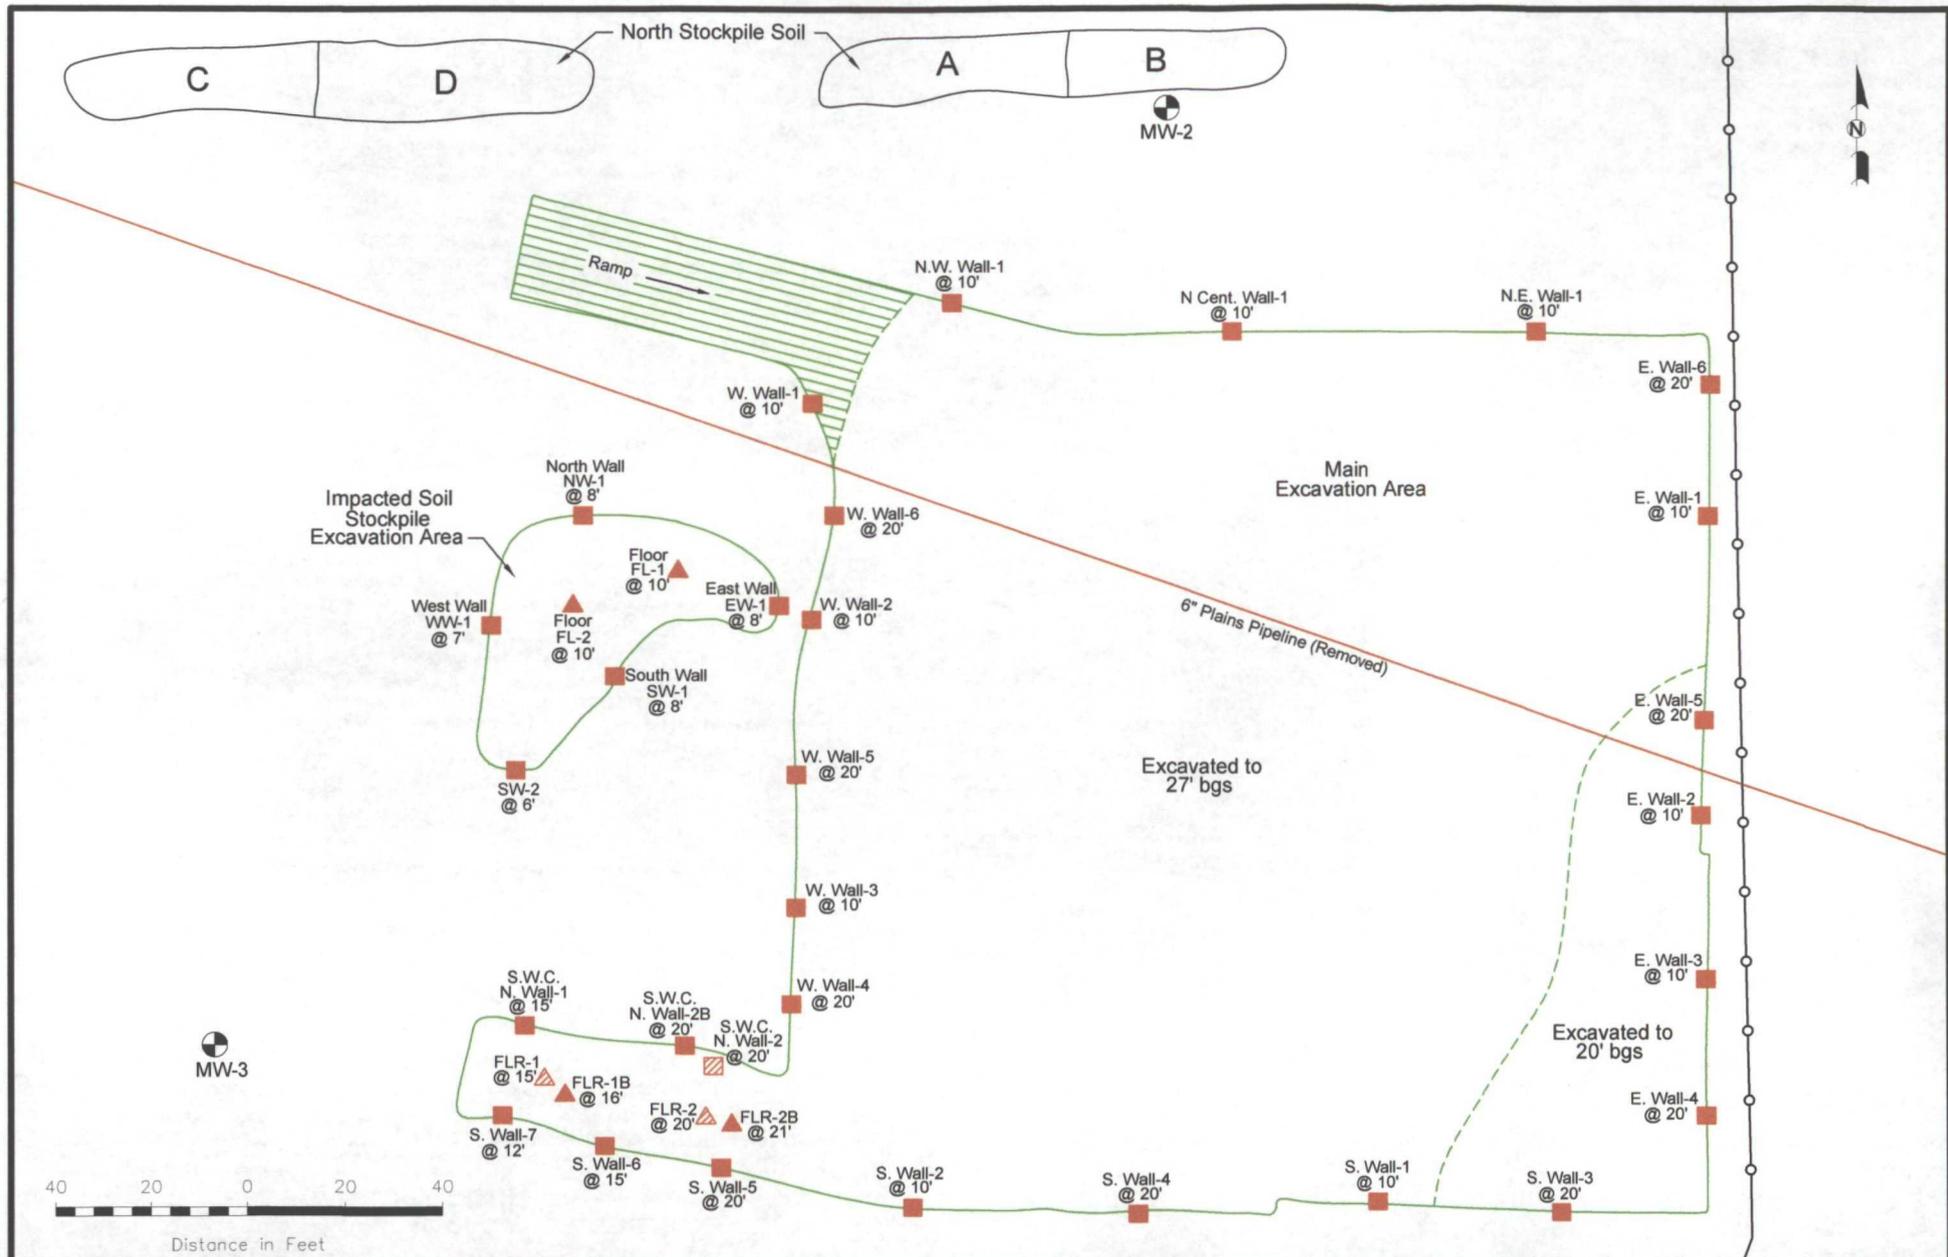
Figure 3
Main Excavation Area Map
 Plains SRS # 2011-11193
 Plains Marketing, L.P.
 South Monument Gathering
 Lea County, NM

On December 22, 2010, upon receipt of the analytical results, the area surrounding the impacted floors of the southwest corner extension were excavated an additional one foot in depth. Confirmation soil samples were collected from the floor area and submitted for laboratory analysis. The analytical results of these soil samples indicated TPH and BTEX concentrations were below the NMOCD regulatory standards of 100 mg/Kg and 50 mg/Kg, respectively. A Confirmation Sample Locations Map for the Main Excavation Area is provided as Figure 3.

During excavation activities, heavy oil staining was observed along the south wall and the southwest corner of the main excavation area. At Plains request, an interceptor sump was excavated at the southwest corner floor area to a depth of approximately 28 feet bgs. Groundwater was observed at approximately 27 feet bgs. The sump was initially constructed and measured approximately 25 feet by 15 feet with an approximate depth of 29 feet bgs in order to capture Phase Separated Hydrocarbons (PSH) observed on top of the groundwater. As the excavation activities progressed within the Main Excavation area, other sumps were excavated to groundwater in various locations along the main excavation floor to delineate the presence of PSH. The main excavation area consisted of fractured caliche approximately 17-19 feet thick overlying a massive silicious sandstone bed approximately 8-10 feet thick which overlies a confining red clay layer. The north, northeast, central, west and southwest portions of the floor were excavated down to the red clay layer. The impacted soil from the floor area was transported off-site for proper disposal and the entire area backfilled with clean, non-impacted material. Figure 3 illustrates the extent and depth of the extended floor excavation.

excavation activities. The impacted soil stockpile excavation area measured approximately 65 feet wide by 55 feet in length and averaged approximately 10 feet in depth. Analytical results of five confirmation soil samples collected from the floor and sidewalls indicated TPH concentrations below the NMOCD regulatory standards of 100 mg/Kg. A Confirmation Sample Locations Map for the Impacted Soil Excavation Area is provided as Figure 3.

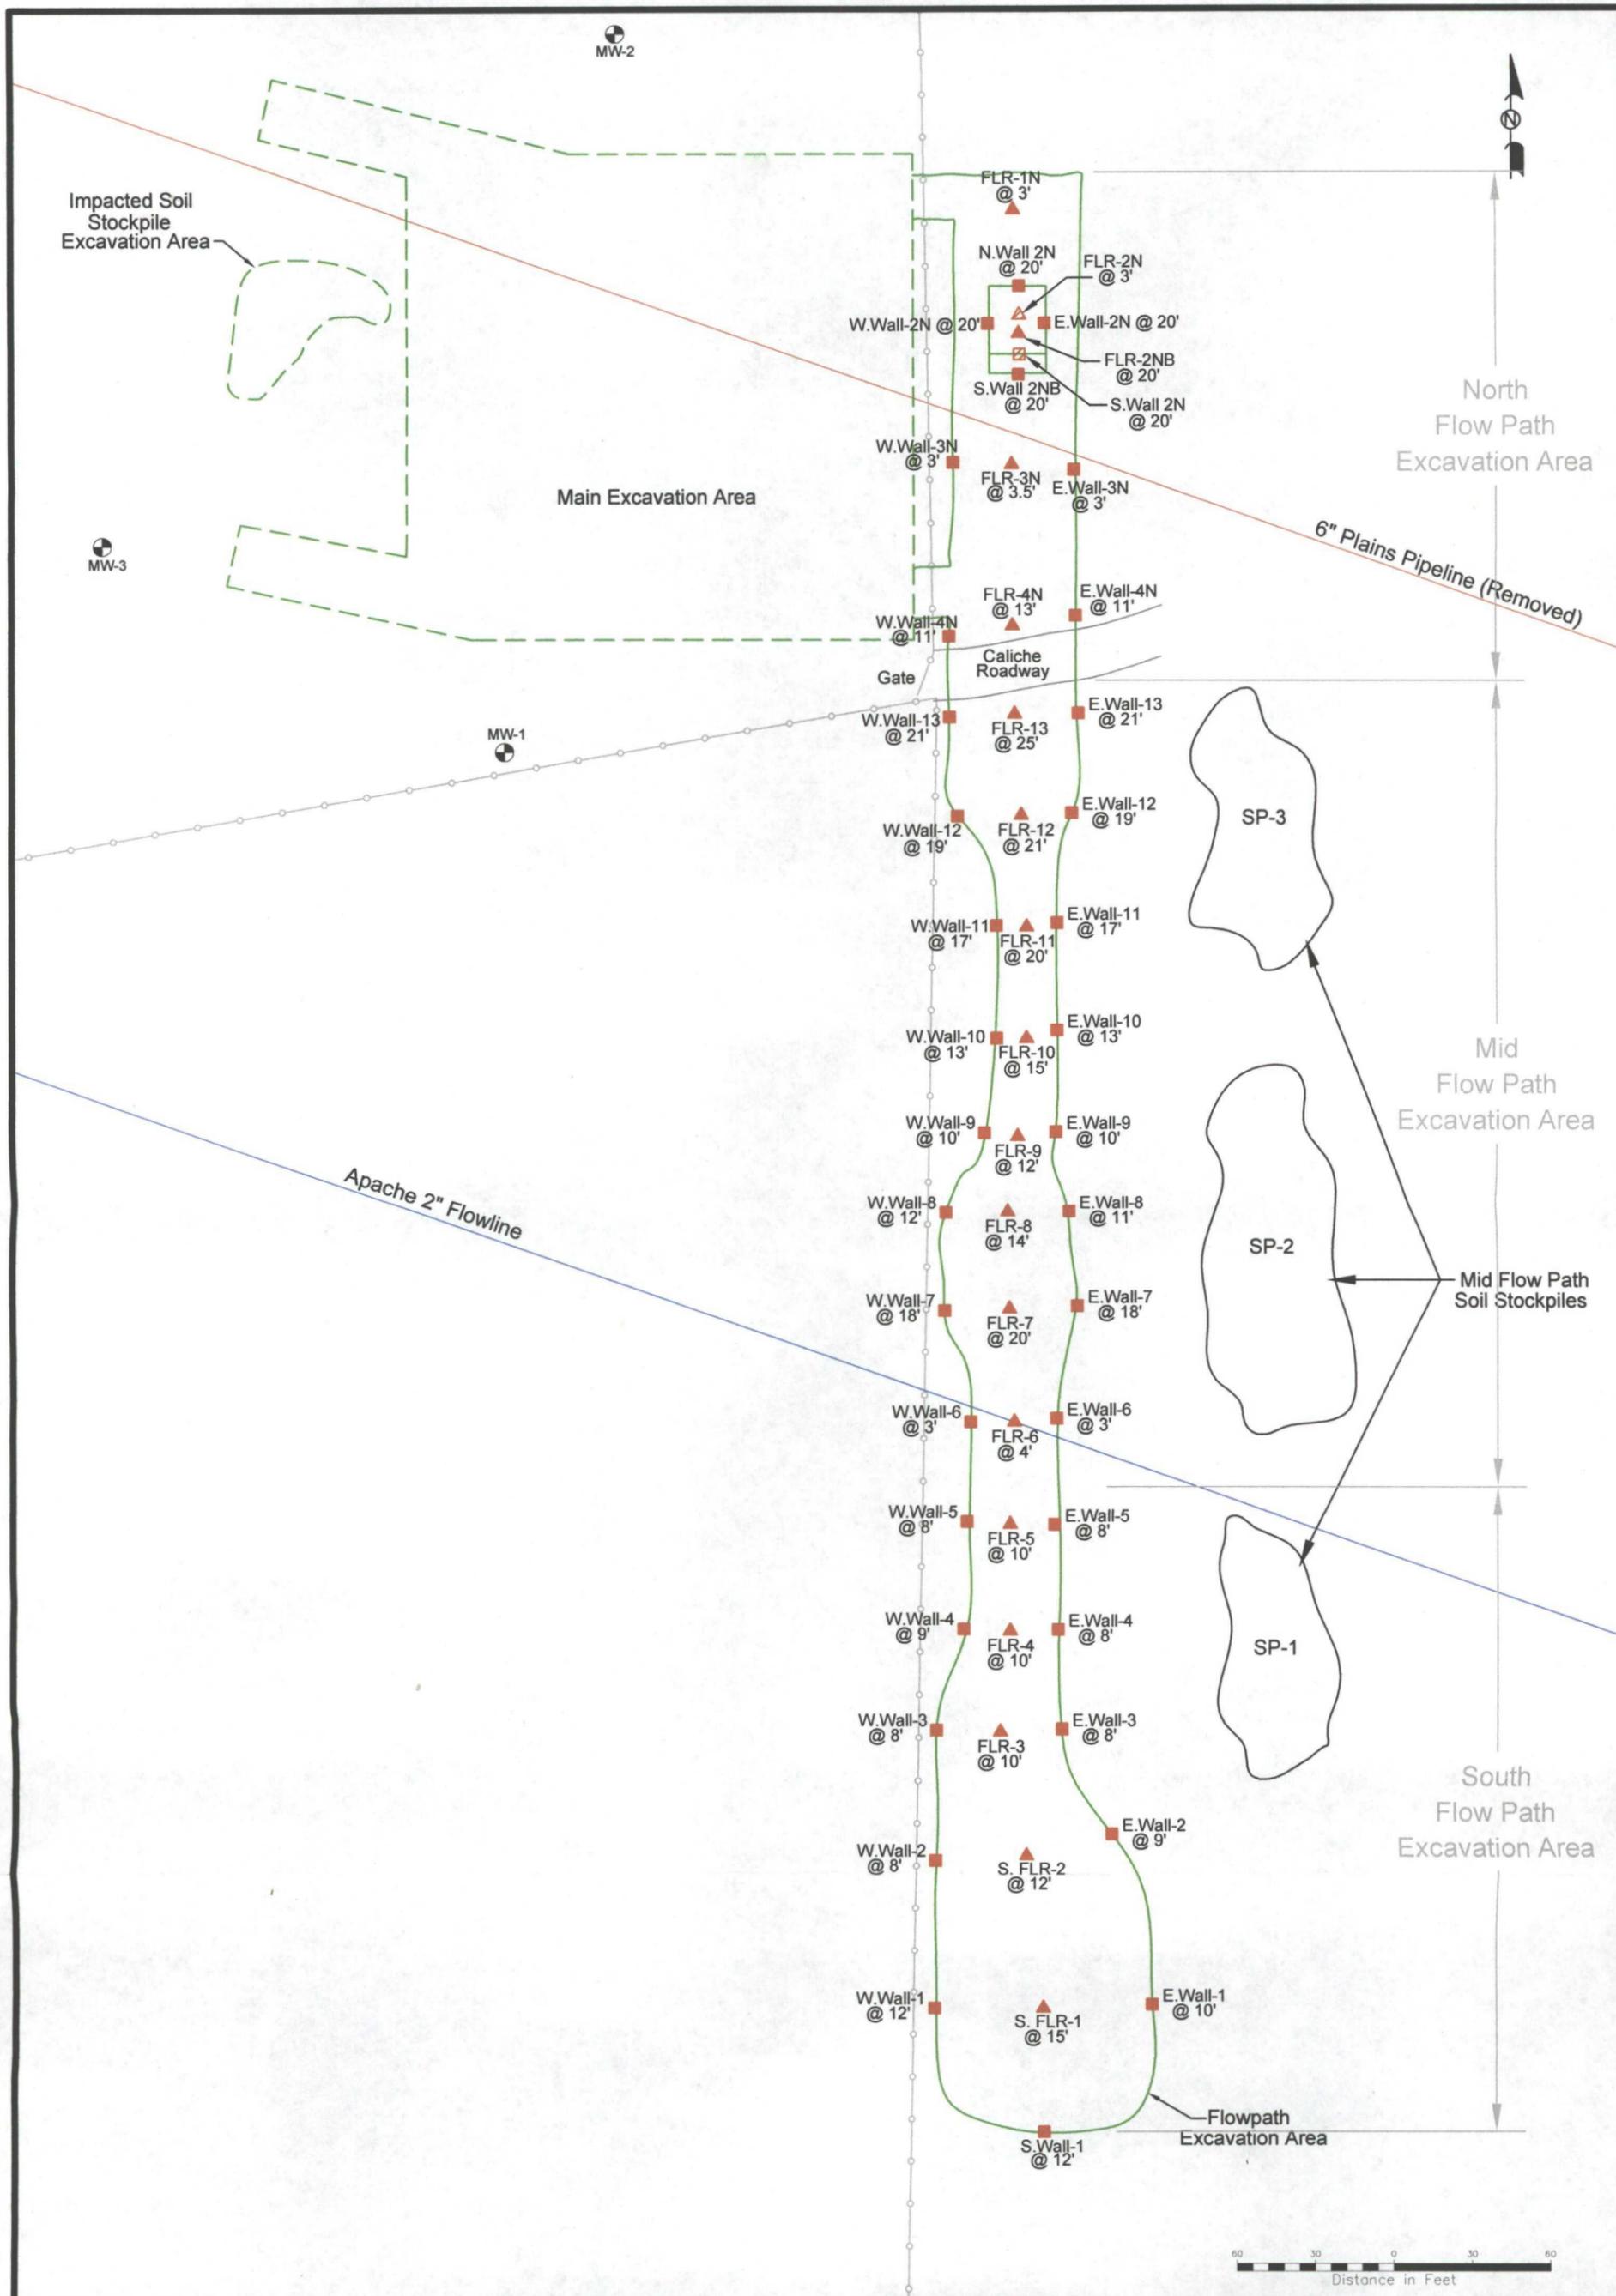
Figure 4
Confirmation Soil Sample Location Map
 Flow Path Excavation Areas
 Plains SRS# 2011-11193
 Plains Marketing, L.P.
 S. Monument Gathering Sour
 Lea County, NM

of these final soil confirmation samples indicated TPH and BTEX concentrations were below the NMOCD regulatory standards of 100 mg/Kg and 50 mg/Kg, respectively. The final dimensions of the Southern Flow Path Excavation Area measured approximately 245 feet in length (north to south and averaged approximately 55 feet in width (east to west). Please refer to Figure 4, Confirmation Sample Locations Map for the South Flow Path Excavation Area sample locations.

On October 5, 2010 and February 18, March 1, March 7 and March 11, 2011, confirmation soil samples were collected from the floor and sidewalls of the mid flow path excavation area. The analytical results of these soil samples indicated TPH and BTEX concentrations were below the NMOCD regulatory standards of 100 mg/Kg and 50 mg/Kg, respectively. The final dimensions of the Mid Flow Path Excavation Area measured approximately 315 feet in length (north to south and averaged approximately 43 feet in width (east to west). Please refer to Figure 4, Confirmation Sample Locations Map for the Mid Flow Path Excavation Area sample locations.

On March 25, 2011, upon receipt of the analytical results, the area surrounding the sample area identified as N Flow Path S. Wall-2N, 20 Ft. was further excavated approximately five feet to the south. One confirmation soil sample was collected from the South wall area and submitted for laboratory analysis. The analytical results of this soil sample indicated TPH concentrations were below the NMOCD regulatory standards of 100 mg/Kg. Please refer to Figure 4, Confirmation Sample Locations Map for the North Flow Path Excavation Area sample locations.

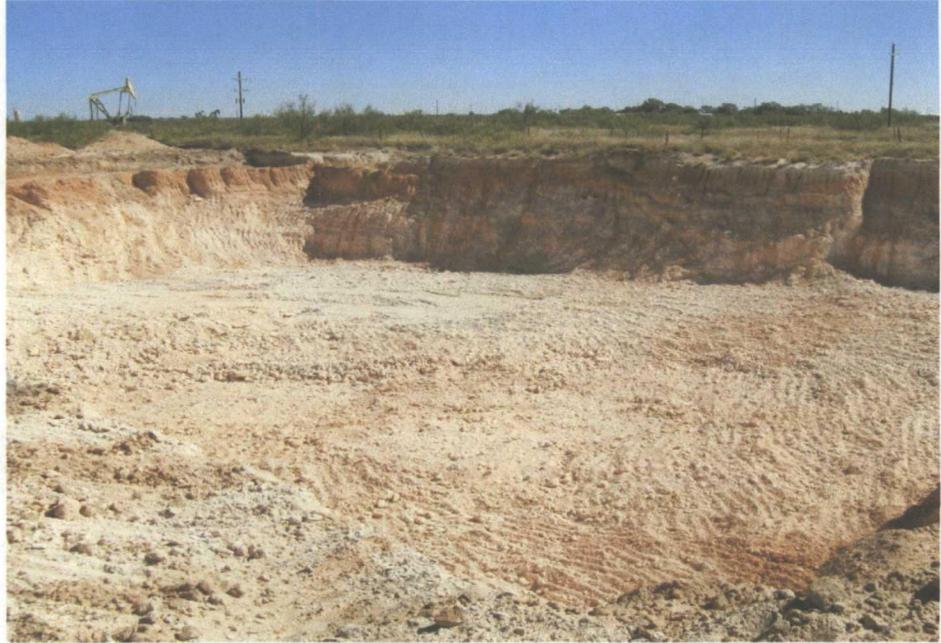
Photograph No. 1

Description: View of the Main Excavation Area.

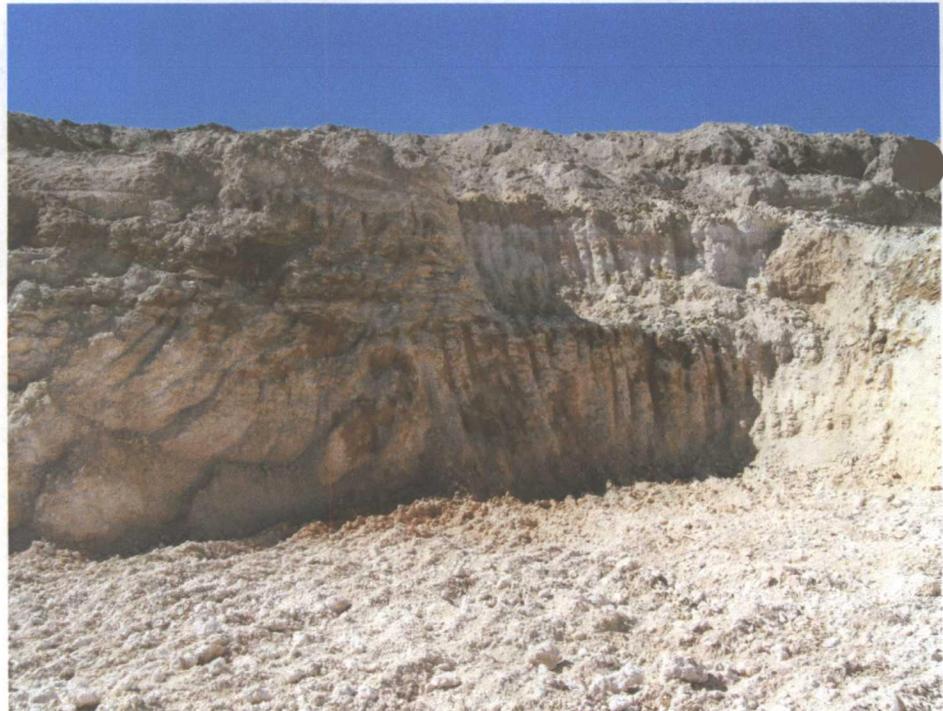
Photograph No. 2

Description: View of the southwest corner of the Main Excavation Area.

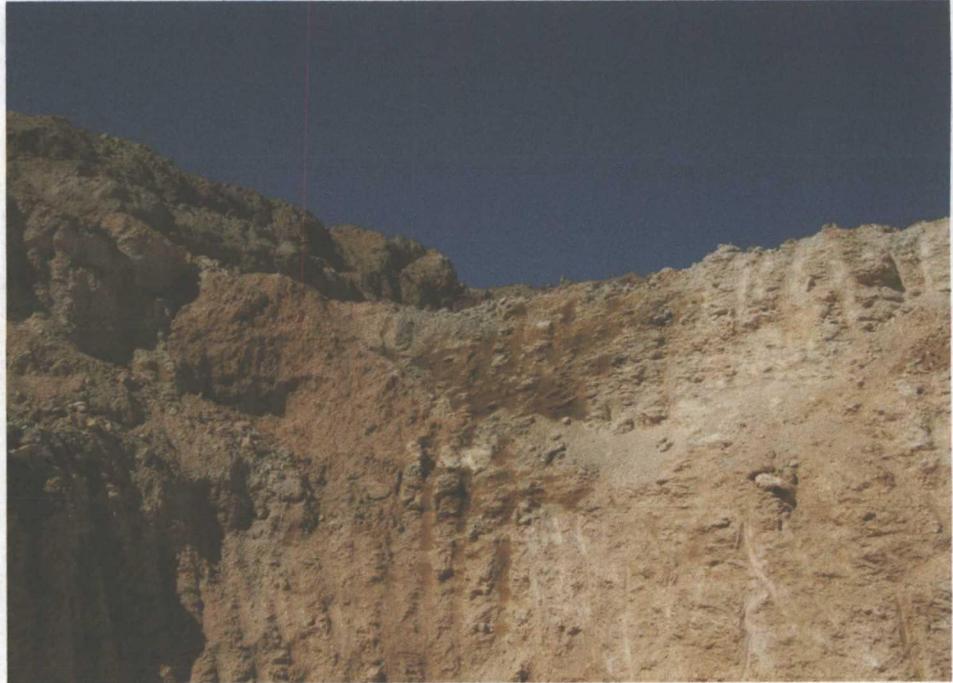
Photograph No. 3

Description: View of the oil stained southwest corner of the Main Excavation Area.

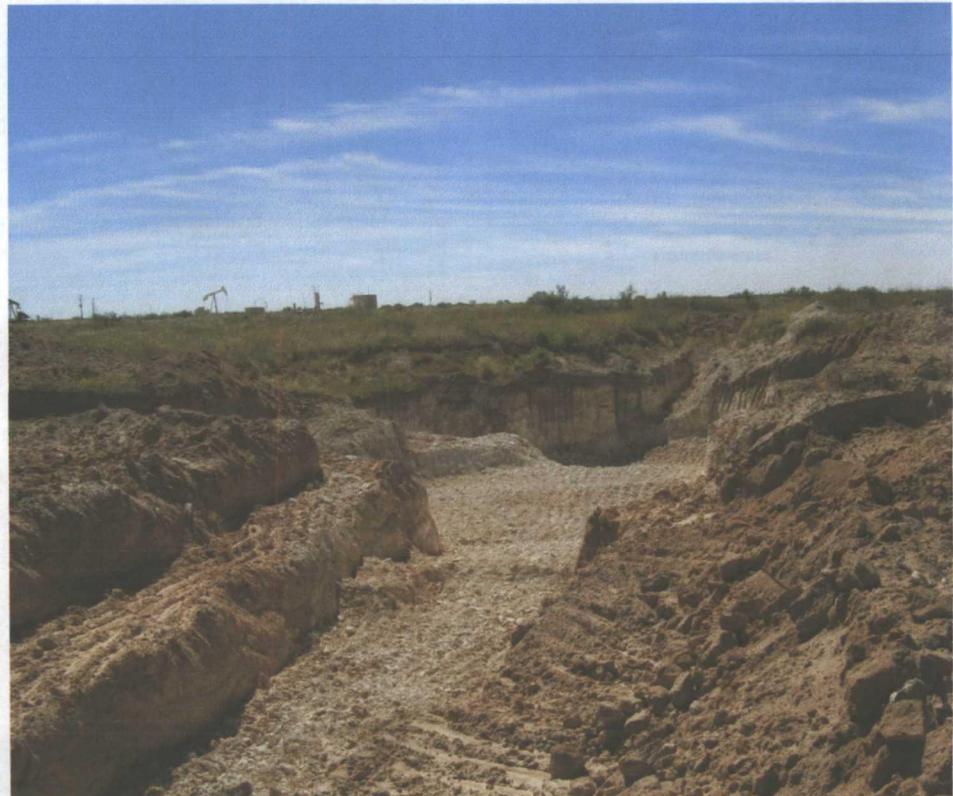
Photograph No. 4

Description: View of the southern end of the South Flow Path Excavation area.

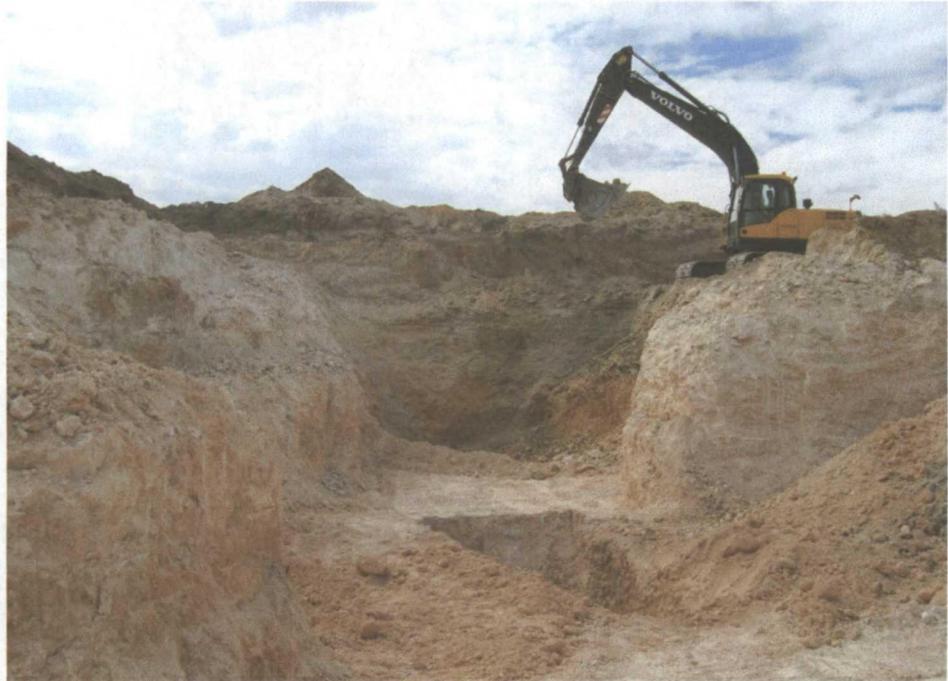
Photograph No. 5

Description: View to the west of the southwest corner excavation area.

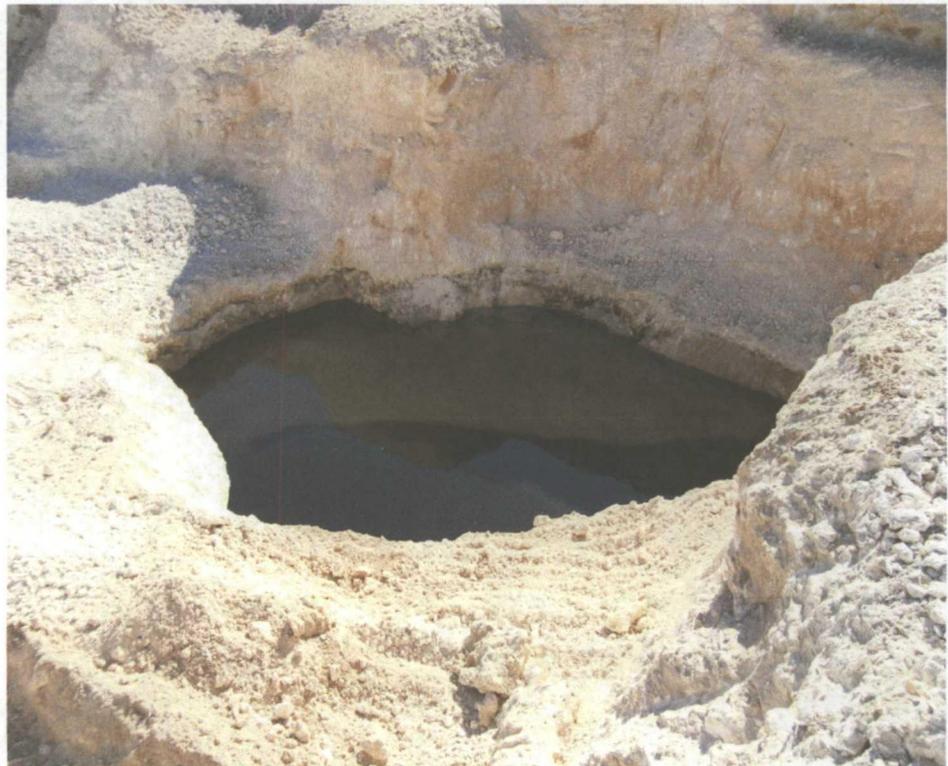
Photograph No. 6

Description: View to the south of the southwest corner sump excavation.

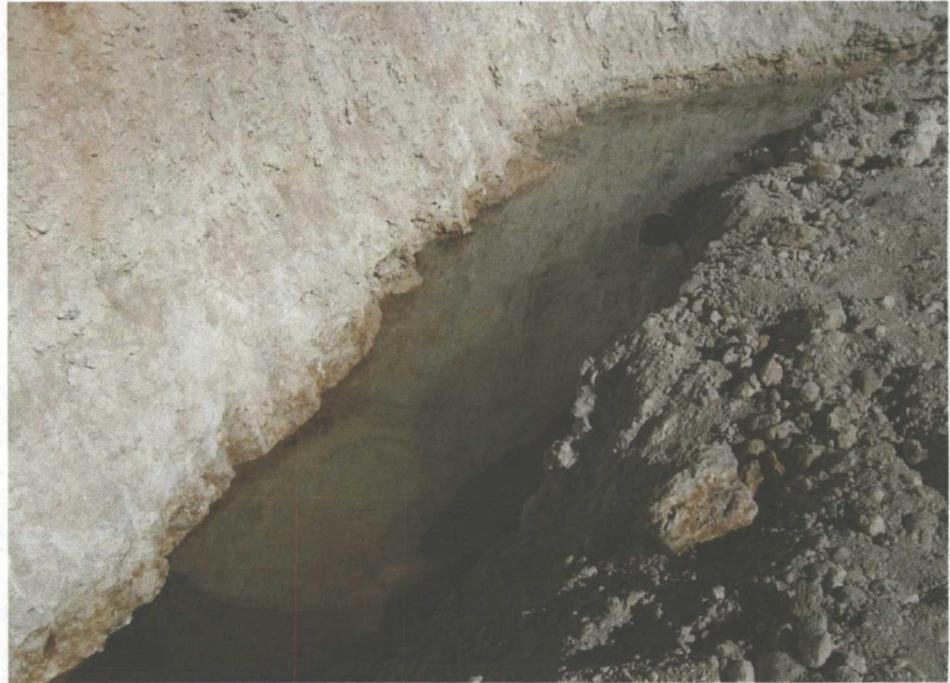
Photograph No. 7

Description: View to the north of the northwest corner floor sump excavation adjacent to the west wall.

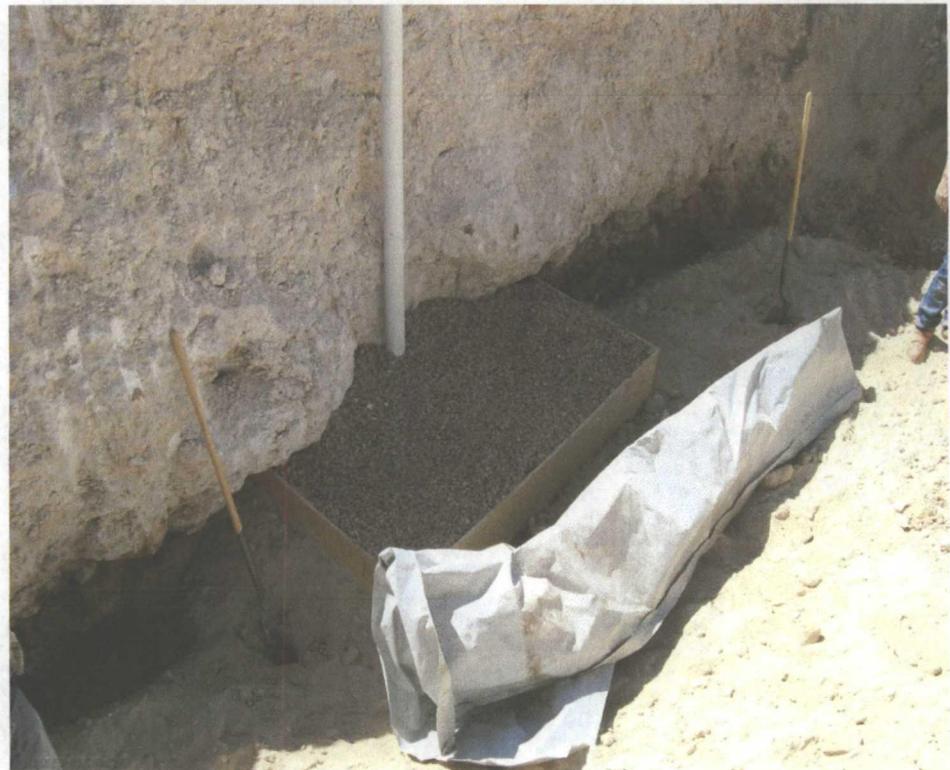
Photograph No. 8

Description: View of the PSH Recovery well installed within the southwest corner sump.

During the excavation of the main floor excavation area, PSH and impacted groundwater within the sumps was evacuated using a vacuum truck. From January 14, 2010 through March 9, 2011, approximately 2,250 barrels of impacted groundwater and oil were recovered from the various sumps along the main floor excavation area. On March 9, 2011, a 35 foot deep recovery well was constructed within the sump along the south wall to continue PSH recovery. At the time the recovery well and sump were constructed, the amount of PSH present on the water table had diminished to a sheen in the southwest portion of the excavation. The groundwater in the other areas of the excavation appeared to be free of PSH.
