**RE: CAP Report and Termination Request
Rice Operating Company – Vacuum SWD System
Vacuum C-36 EOL (1R425-103): UL/C sec. 36 T17S R34E**

Corrective Action Plan Report

Vacuum C-36 EOL (1R425-103)
Unit Letter C, Section 36, T17S, R34E

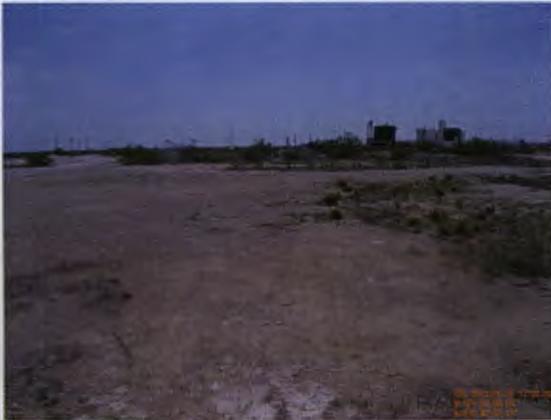
Site prior to excavation, facing east 6/25/2013

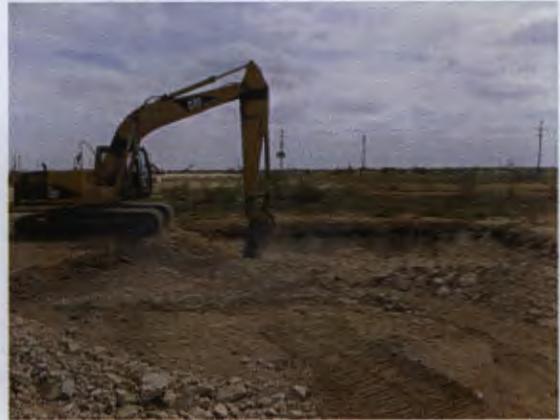
Excavating, facing south 8/28/2013

Beginning on August 27th, 2013, REC personnel were on site to begin excavating for liner installation. The site was excavated to 30 ft x 39 ft to a depth of 3 to 3.5 ft bgs. The site could not be excavated any deeper, due the caliche/sandstone layer. As the site was excavated, the excavated soil was screened to remove the rock. The rock was stored on site to use as backfill and 200 yards of residual, excavated soil was taken to a NMOCD approved facility for disposal. 192 yards of soil were imported to the site from two sources to use as backfill. Soil samples from each source were field tested for hydrocarbons and returned readings of 2.4 ppm and 1.5 ppm. The samples were then taken to a commercial laboratory for analysis and returned chloride values of non-detect.

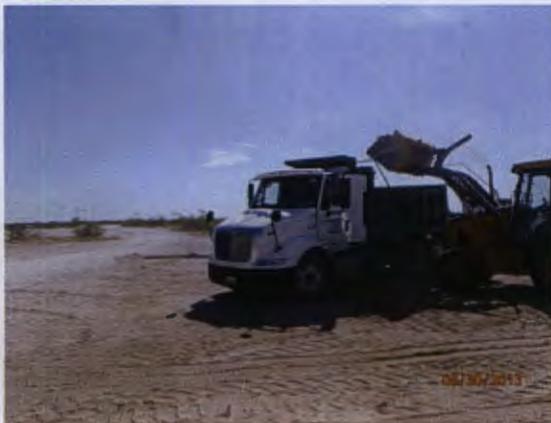
Exporting soil, facing east 8/30/2013

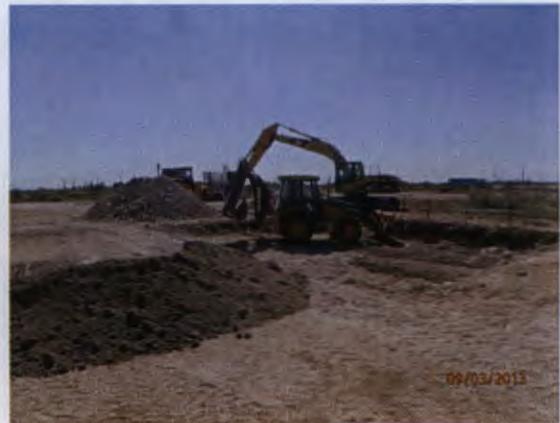
Padding the completed excavation, facing southeast 9/3/2013

The base of the excavation was padded with 6 inches of blow sand to protect the liner from punctures. A 20-mil reinforced poly liner was installed and properly seated into the base of the excavation and was padded with an additional 6 inches of blow sand. The screened rock was then backfilled into the excavation and the remaining imported soil was used to backfill the site to ground surface. The site was contoured to the surrounding location and a silt net fence was placed around the excavation to prevent erosion and maintain seed integrity. On September 10th, 2013, soil amendments were added to the site and the site was seeded with a blend of native vegetation. Documentation of these activities can be found in Appendix A.

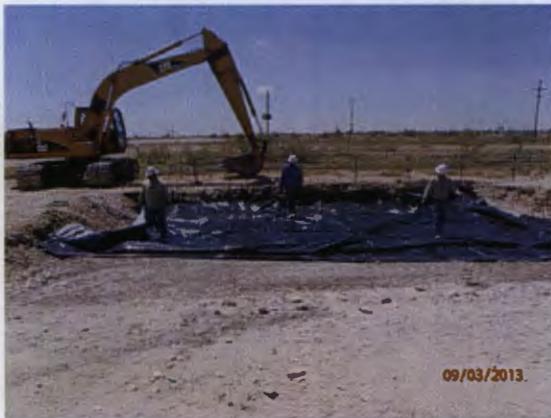
Installing liner, facing south 9/3/2013

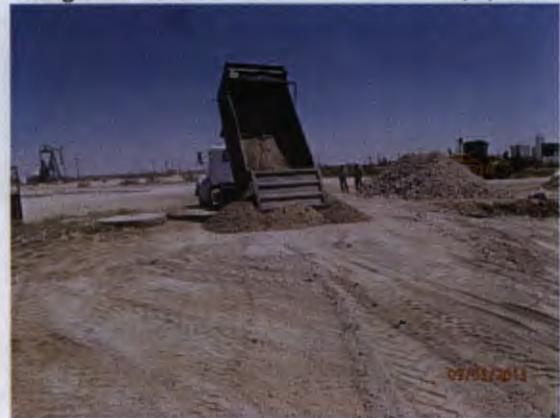
Importing, facing west 9/3/2013

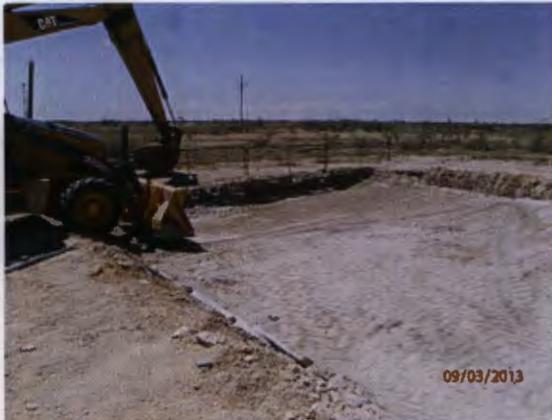
Padding above the liner, facing southwest
9/3/2013

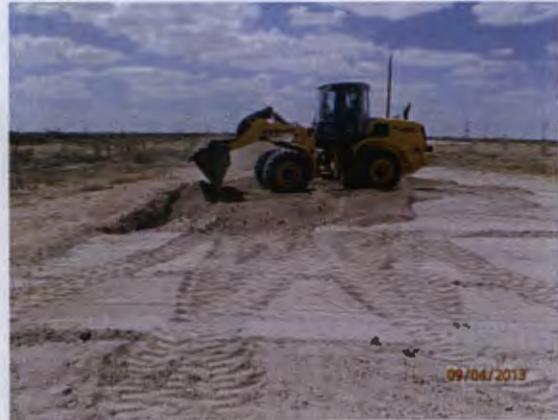
Backfilling excavation, facing west 9/4/2013

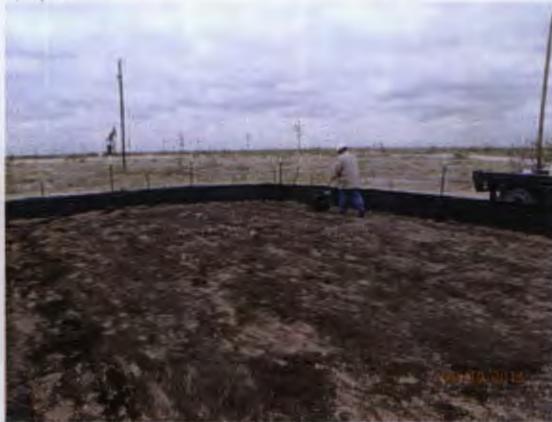
Spreading amendments, facing northwest
9/10/2013

Fertilizer	<input type="checkbox"/> Hay	<input checked="" type="checkbox"/> Other
Type:	Describe: 3 bags of Restore Nhance, 10 bags of potting soil, 1 bag of manure, 10 bags of Pete Moss	
Lbs/acre:

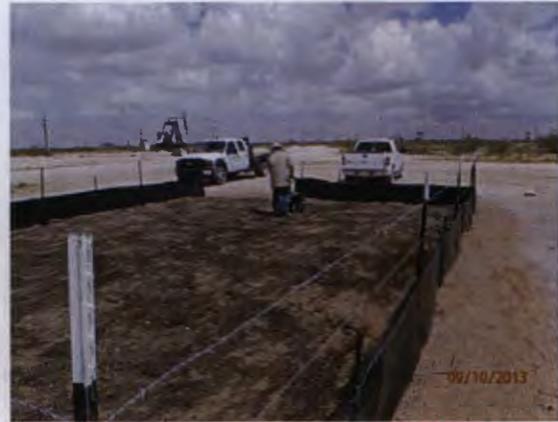
Spreading seed, facing northwest 9/10/2013

Custom Seed Mix	<input checked="" type="checkbox"/> Prescribed Mix	Seed Mix Name: 5 lbs. side oats 5 lbs. blue grama, 5lbs. Sudan	Date: 9/10/2013
Broadcast	Push Broadcast Seeder	Method	With Broadcast Seeder
Soil conditions during seed:	<input type="checkbox"/> Dry	<input checked="" type="checkbox"/> Damp	<input type="checkbox"/> Wet
Observations:	The seed and amendments were raked into the soil

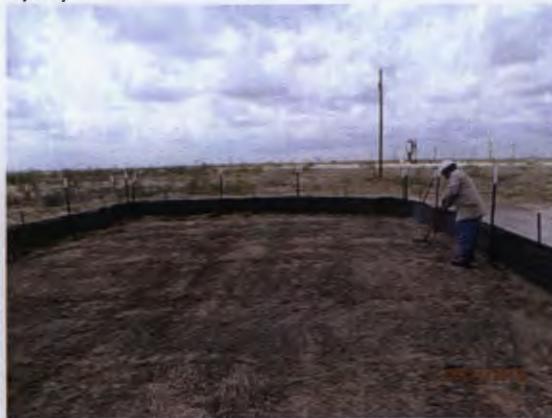
Raking seed, facing west 9/10/2013

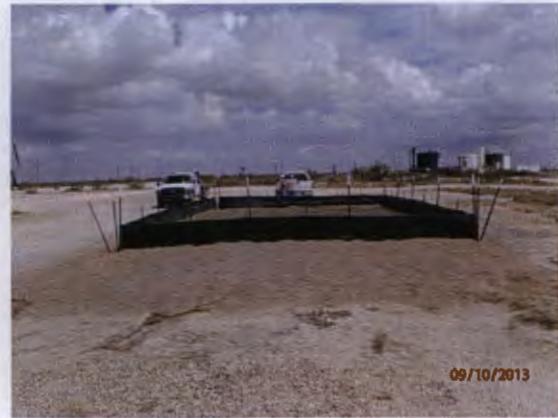
Site complete, facing east 9/10/2013
