**RE: Termination Request  
for the Rice Operating Company's  
EME Jct. Q-6-2 Site  
Unit Letter Q, Section 6, T21S, R36E, NMPM, Lea County, New Mexico  
(1R427-144) Termination**

RE: Termination Request  
EME Jct. Q-6-2 (1R427-144): UL/Q, Sec. 6, T21S, R36E  
RICE Operating Company – Eunice Monument Eumont (EME) SWD System

**RICE OPERATING COMPANY  
JUNCTION BOX FINAL REPORT**

# EME Jct. Q-6-2 (1R427-144)

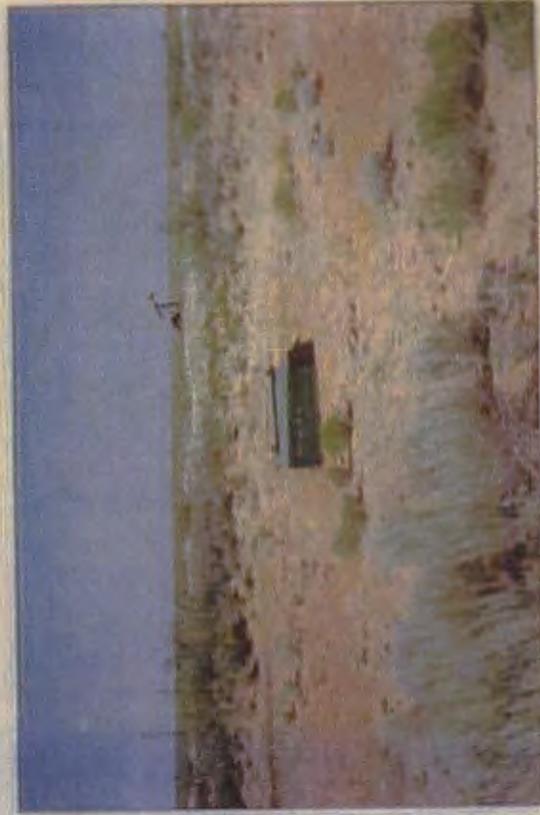
7/22/2003

undisturbed junction box

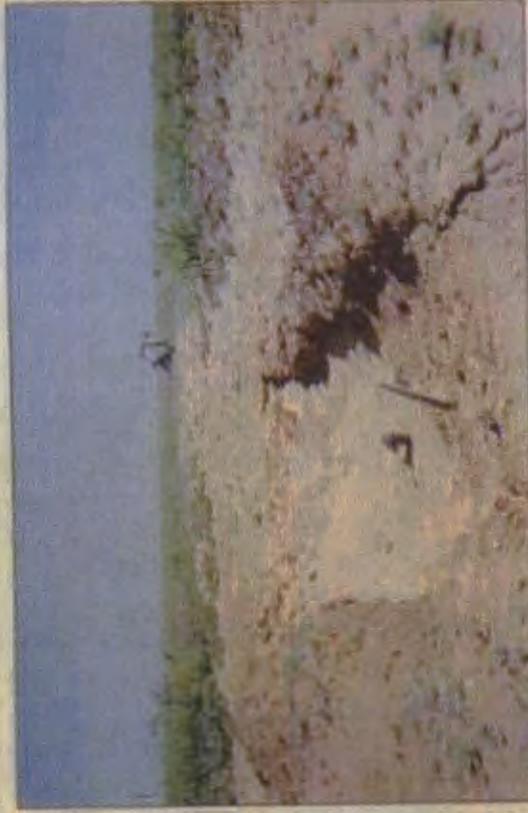
5/5/2004

junction box removed

General Description of Remedial Action: The lumber from this box was removed during the NORM survey and the junction was removed as the new pipeline was plumbed straight through at this location. Upon environmental observation, there was no physical evidence of TPH or chloride impact. Samples were collected using a hand auger and field tested for chloride. All tests indicated low concentrations. Lab results yielded NMOCD TPH and BTEX guidelines were met and very low chloride was confirmed. The hole where the box had been was backfilled with 60 yds of clean, imported soils. On 8/5/2004, the disturbed surface was seeded with a blend of native vegetation.

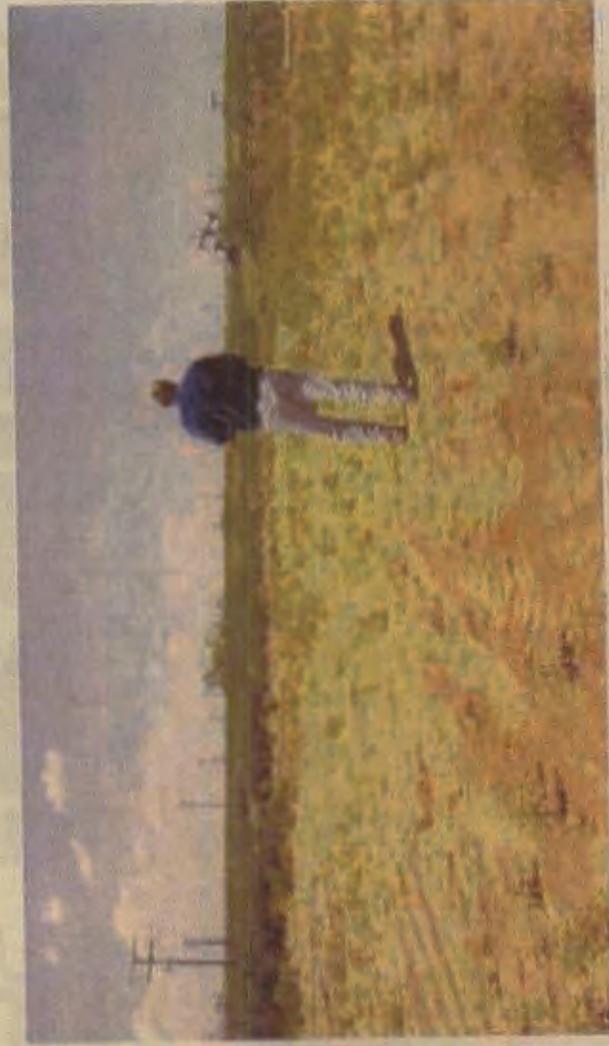
8/5/2004

seeding backfilled site

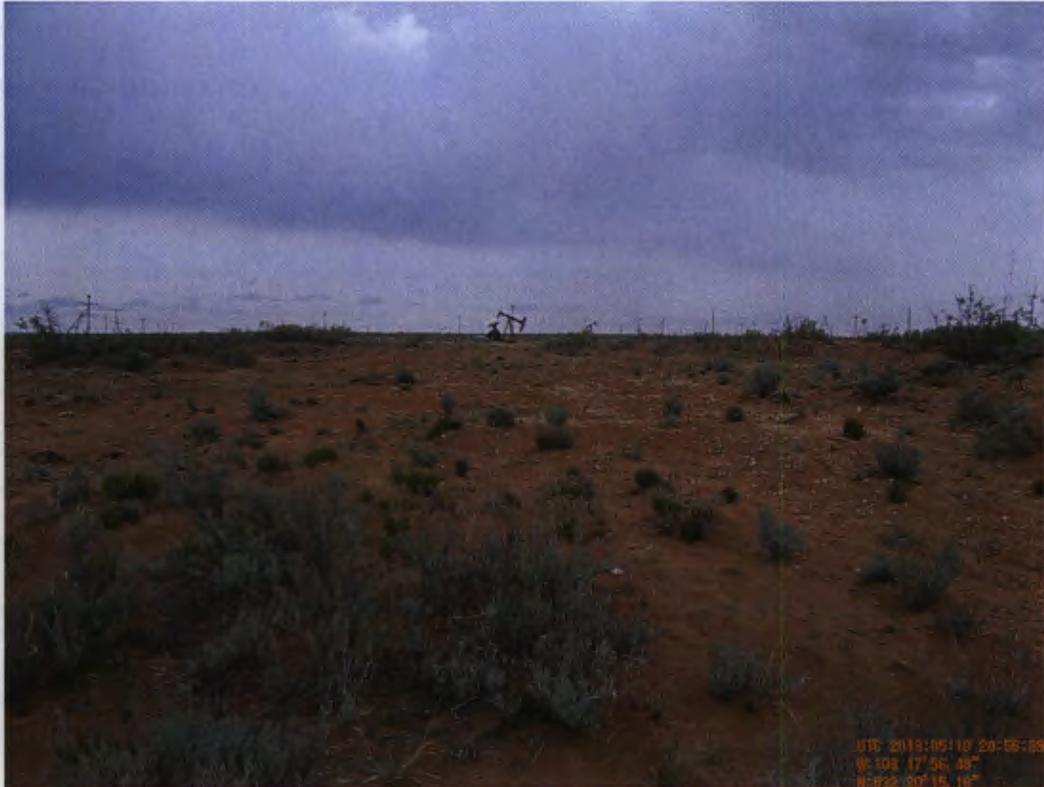
5/10/2013

Facing North

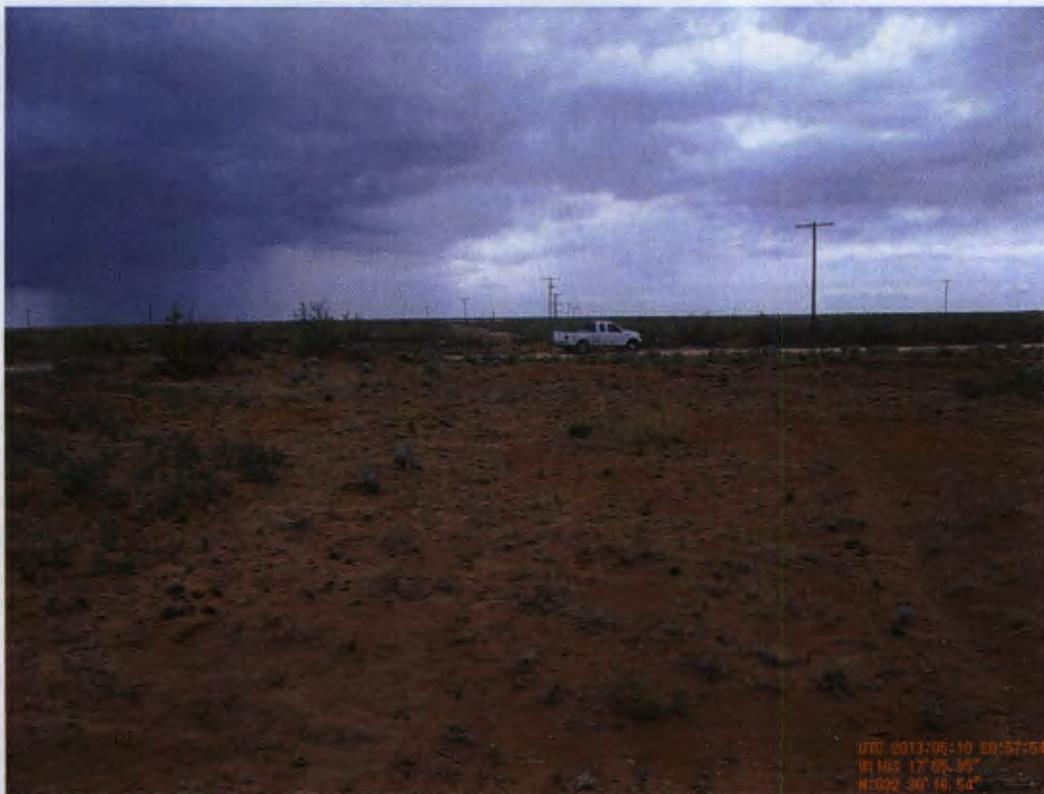
5/10/2013

Facing South
