**LANDFILL
SITING
REPORT**

Avalon Facility
Section 36, Township 26 South, Range 31 East
Eddy County, New Mexico

Project No. 11-0131-02

Prepared for:
R360 Environmental Services, Inc.
16945 Northchase Drive, Suite 2200
Houston, Texas 77060

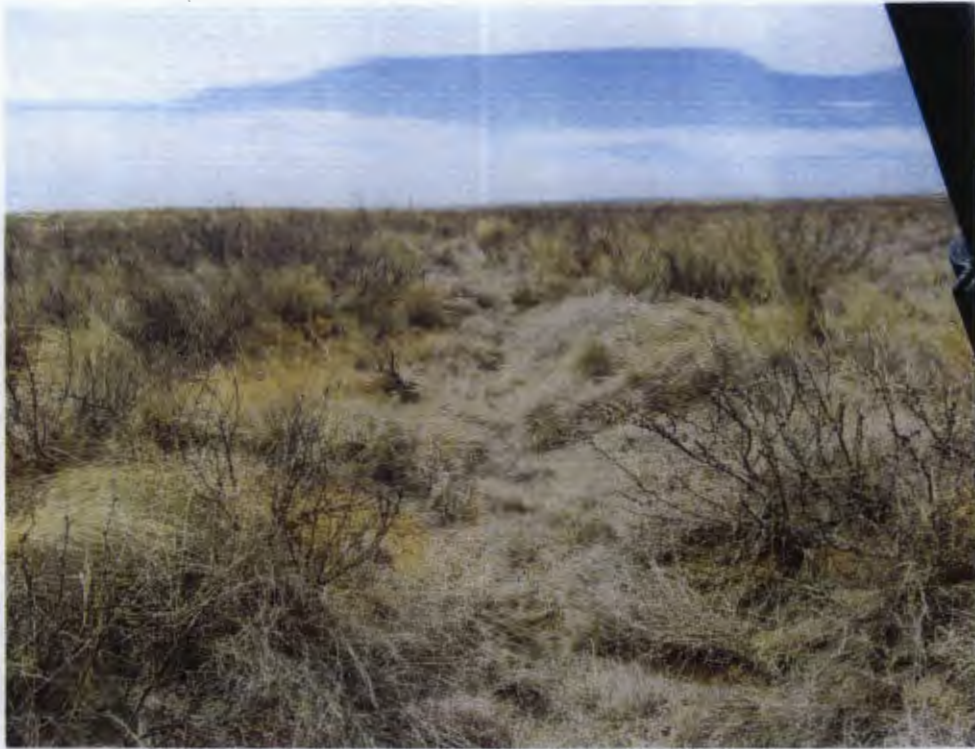
1. Drainage 1 – Upstream Viewing Southwest, March 12, 2012

Drainage 1 is located near the southwest corner of the property and is approximately 500 feet long. The drainage terminates on the property. Drainage 1 is shown in photographs 1 through 4.

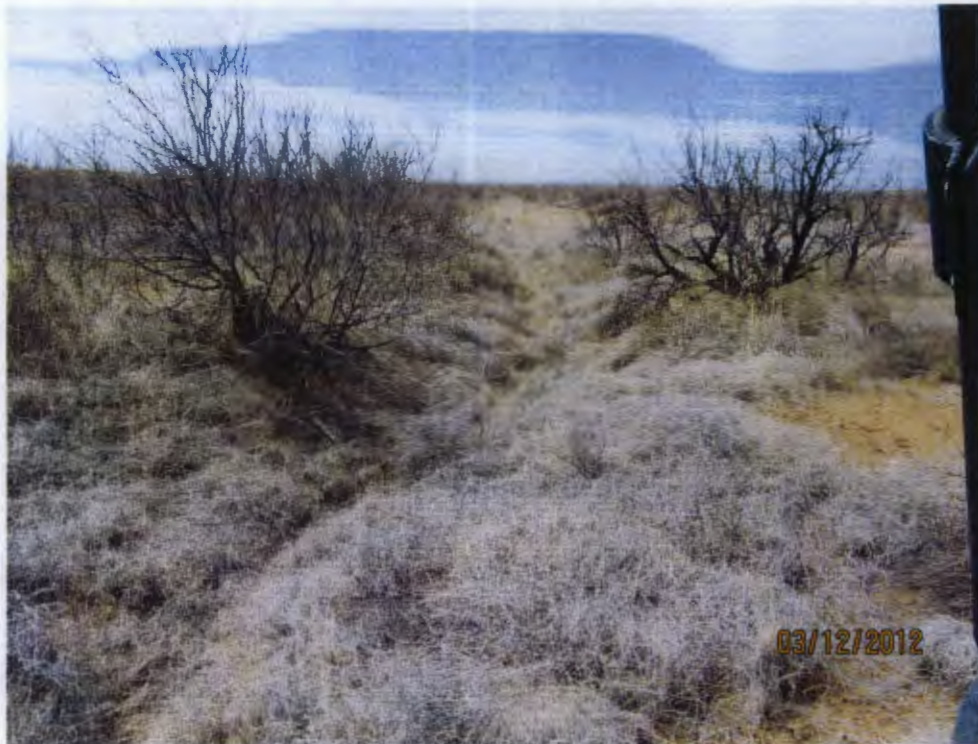
2. Drainage 1 - Midstream Viewing Southwest, March 12, 2012

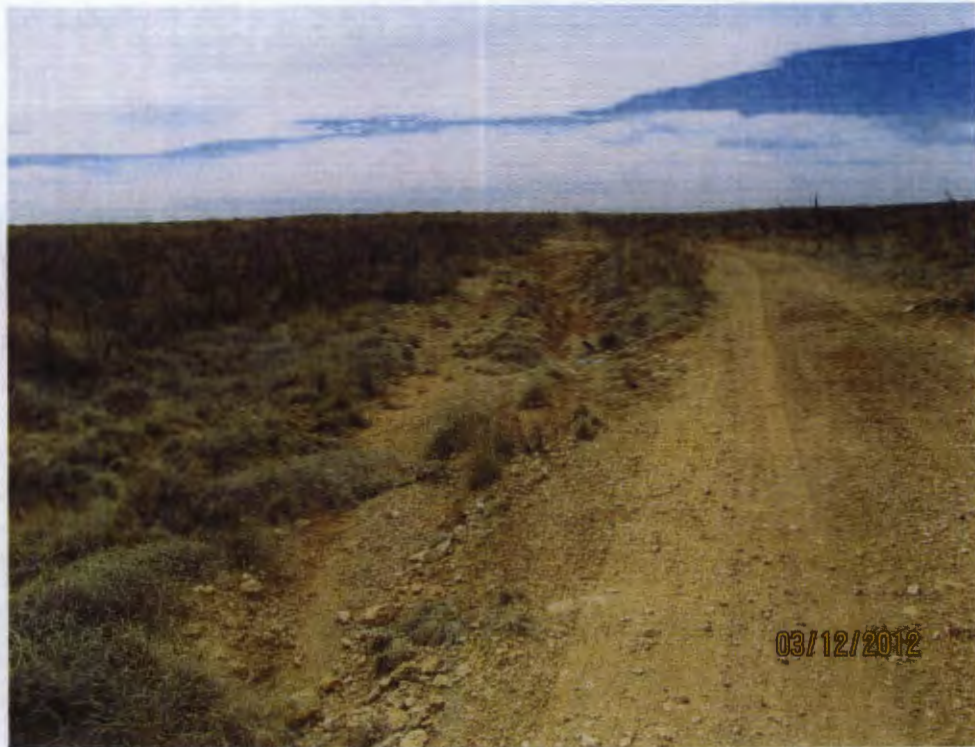
3. Drainage 1 - Downstream Viewing Southwest, March 12, 2012

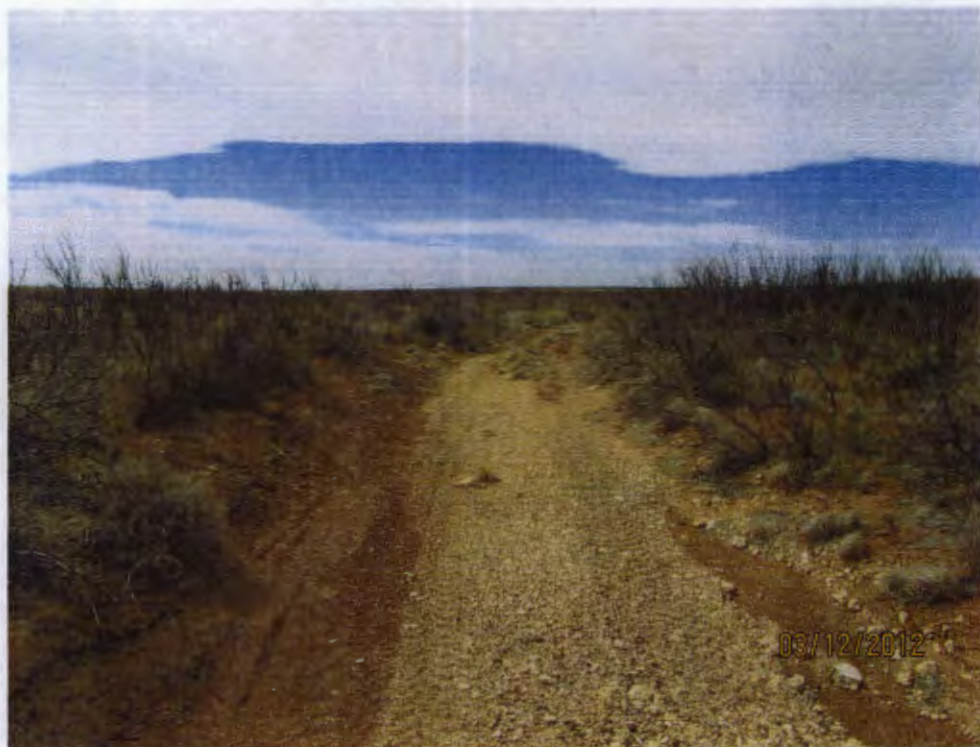
4. Drainage 1 - Termination Viewing Southwest, March 12, 2012

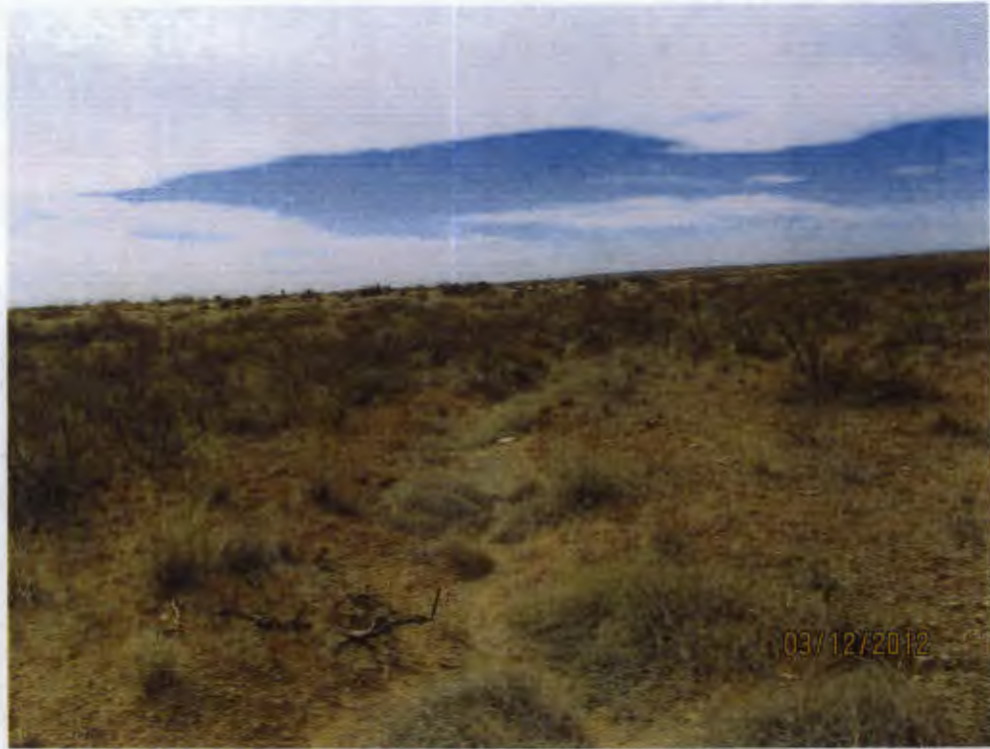
5. Drainage 2 – Upstream Viewing Southwest, March 12, 2012

Drainage 2 is located near the north central area of the property and is approximately 500 feet long. The drainage flows southwest and terminates on the property. Drainage 2 is shown in photographs 5 through 7.

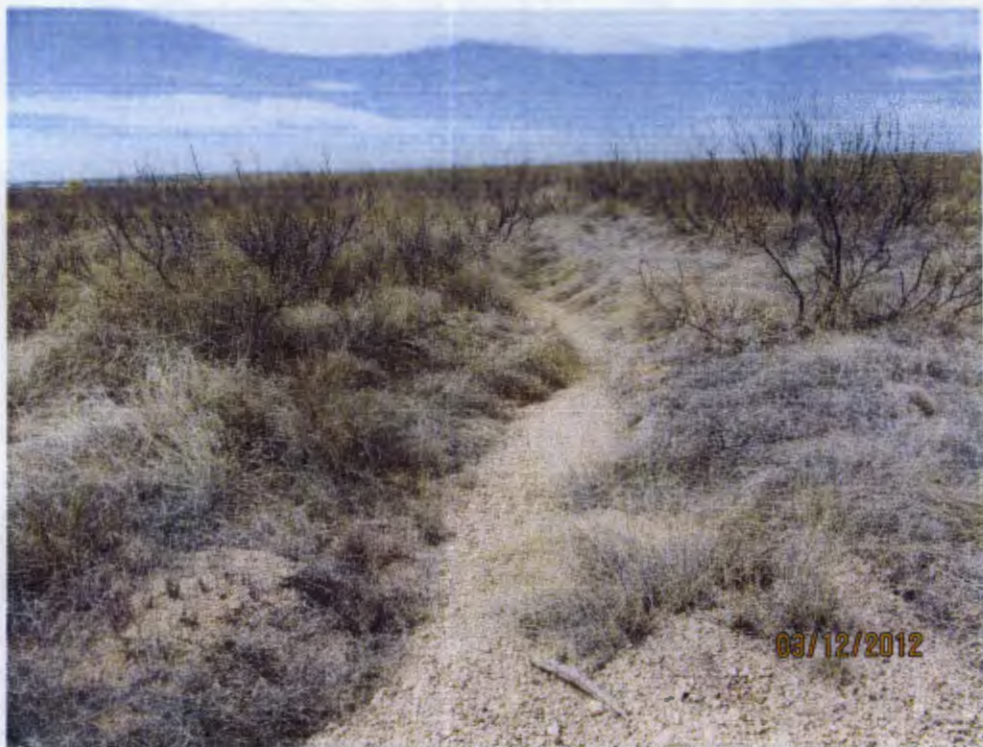
6. Drainage 2 – Midstream Viewing Southwest, March 12, 2012

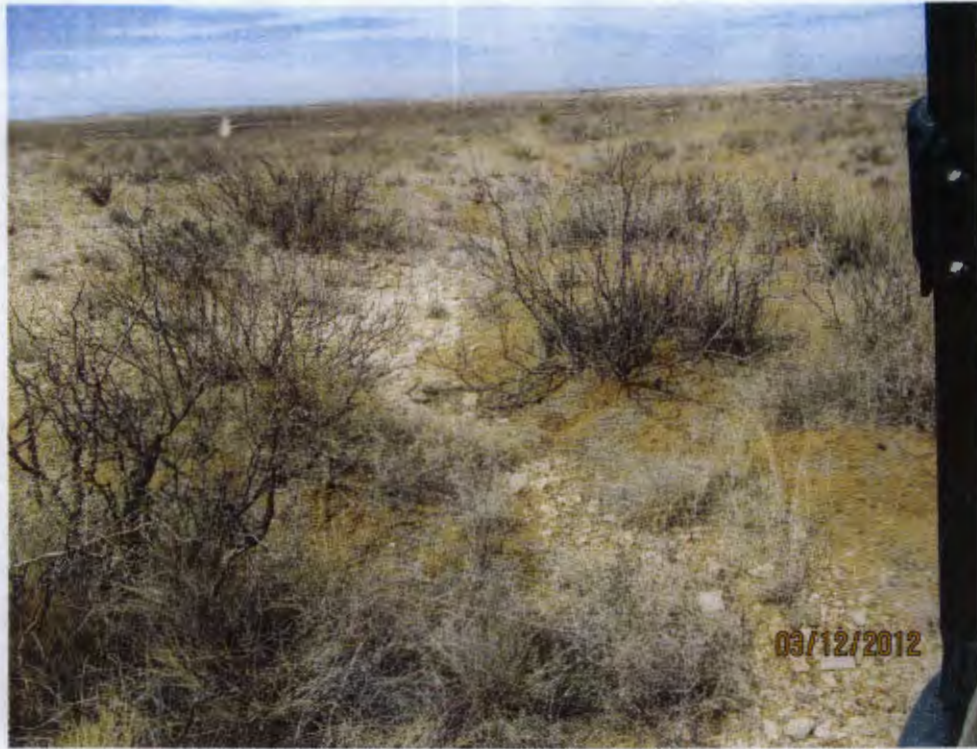
7. Drainage 2 – Termination Viewing Southwest, March 12, 2012

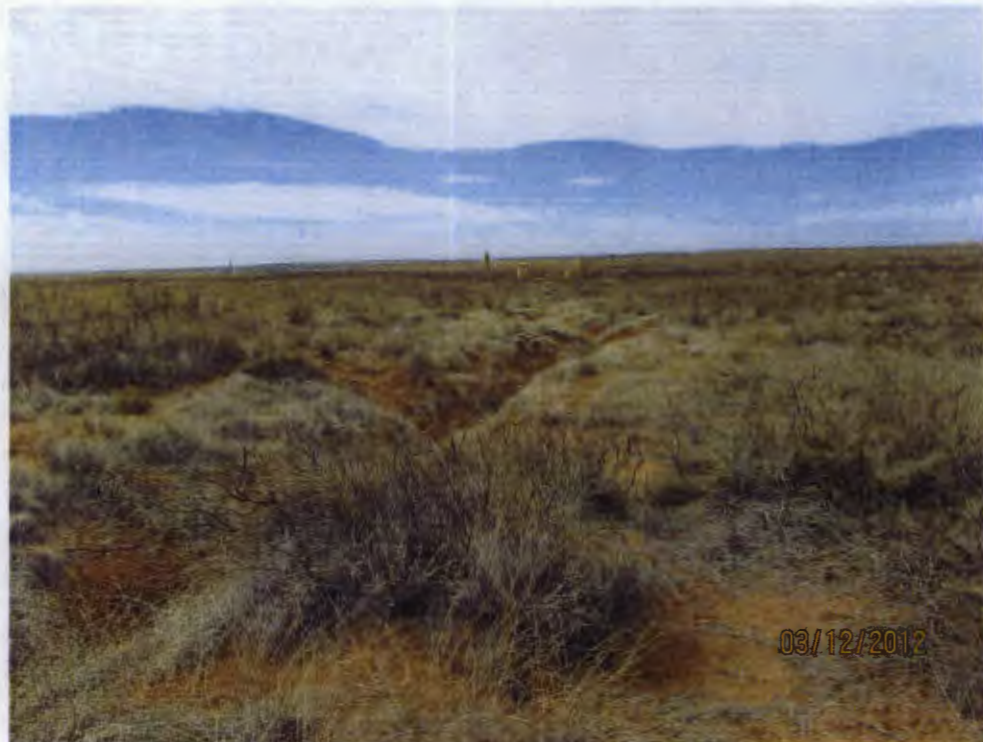
8. Drainage 3 – Upstream Viewing Southwest, March 12, 2012

Drainage 3 is located near the east central area of the property and is approximately 1000 feet long. The drainage flows to the southwest and terminates on the property. Drainage 3 is shown in photographs 8 through 10.

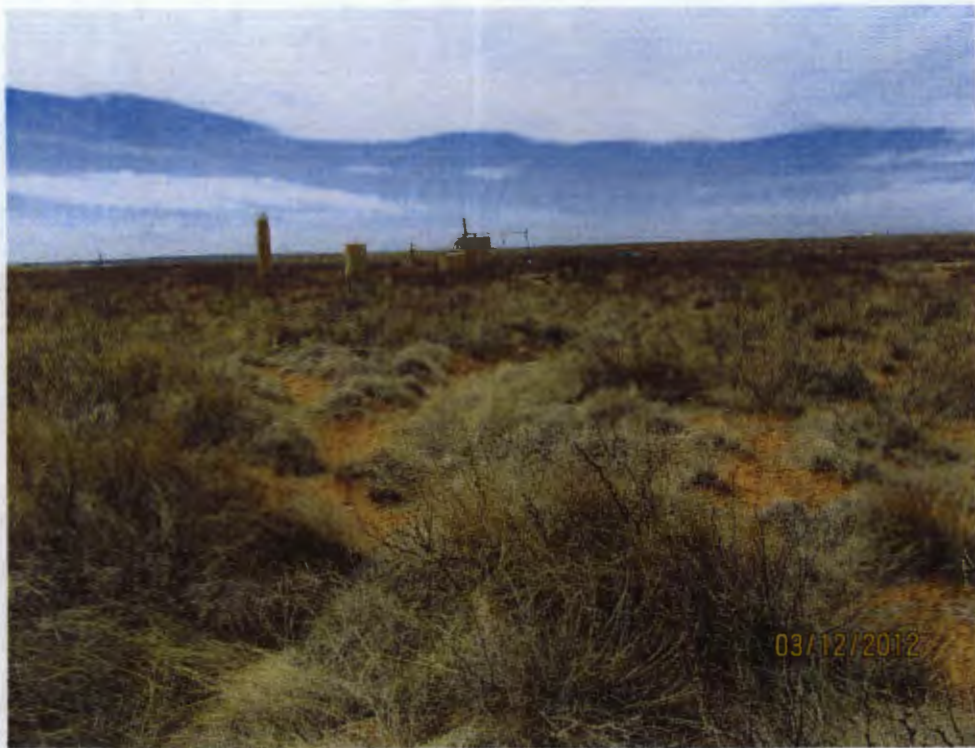
9. Drainage 3 – Downstream Viewing Southwest, March 12, 2012

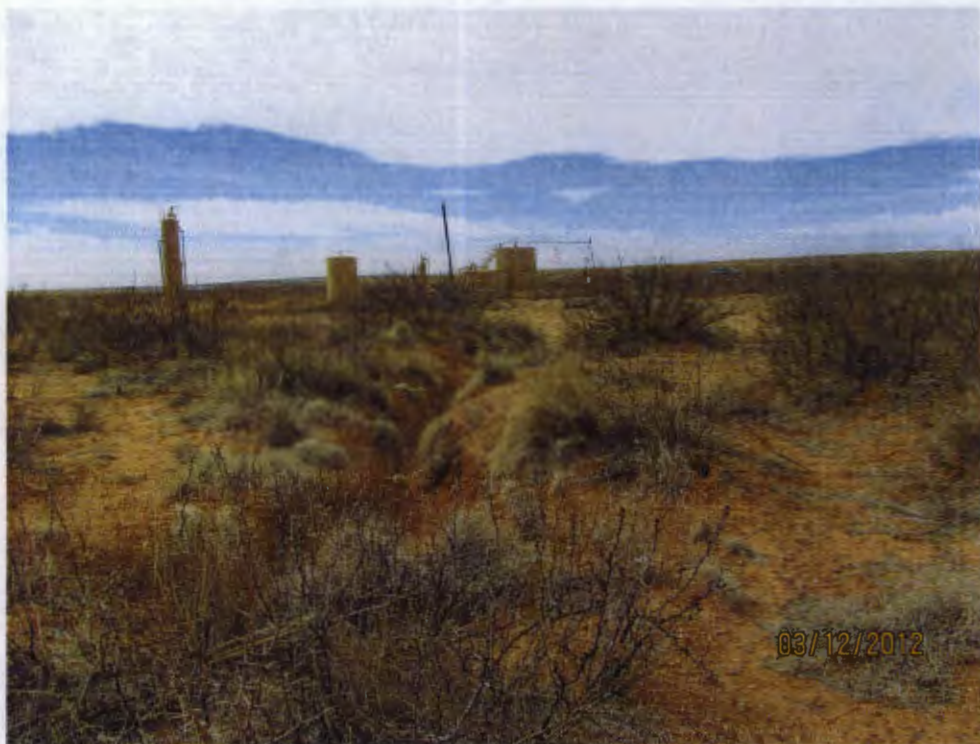
10. Drainage 3 – Termination Viewing Southwest, March 12, 2012

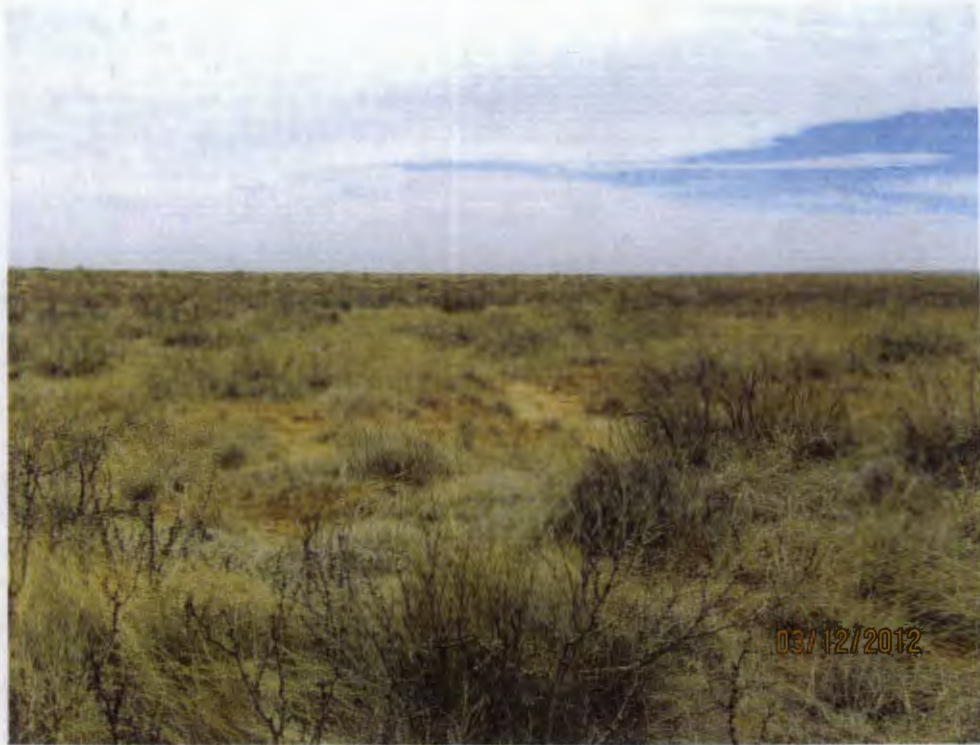
11. Drainage 4 – Upstream Viewing Southwest, March 12, 2012

Drainage 4 is located near the east side of the property and is approximately 2400 feet long. The drainage flows southwest and terminates on the property. Drainage 4 is shown in photographs 11 through 15.

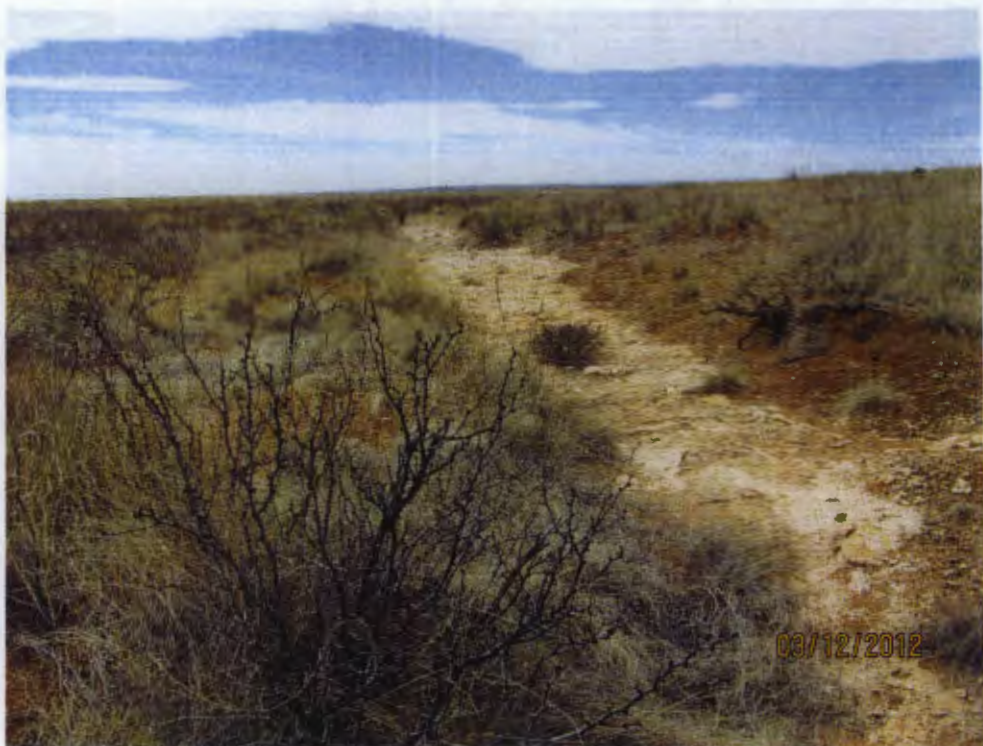
12. Drainage 4 - Midstream Viewing Southwest, March 12, 2012

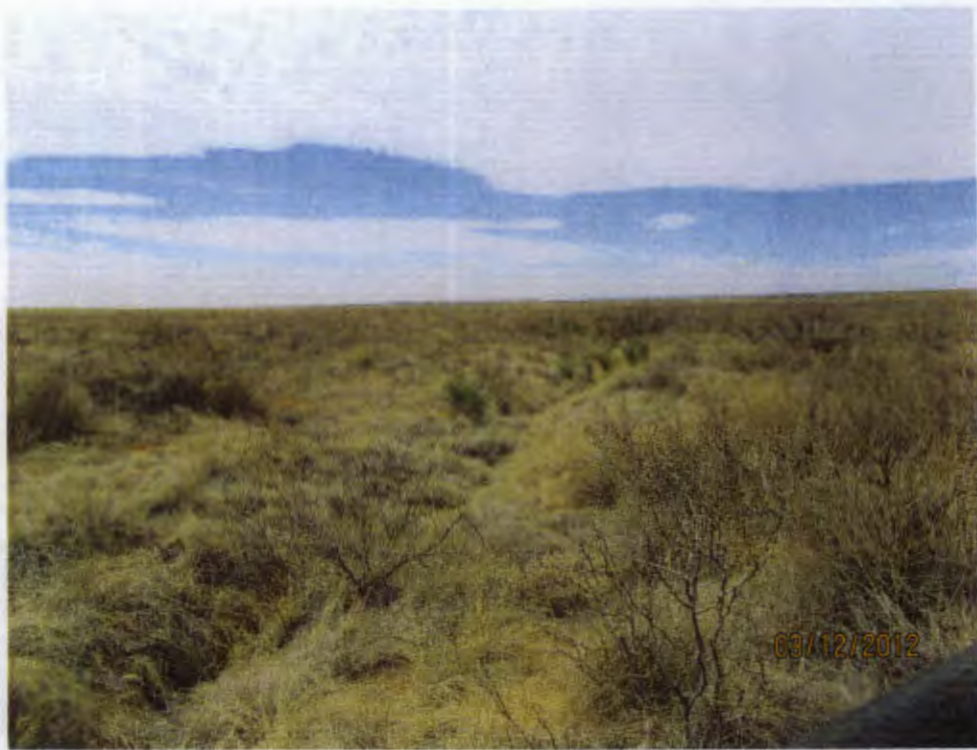
13. Drainage 4 - Downstream Viewing Southwest, March 12, 2012

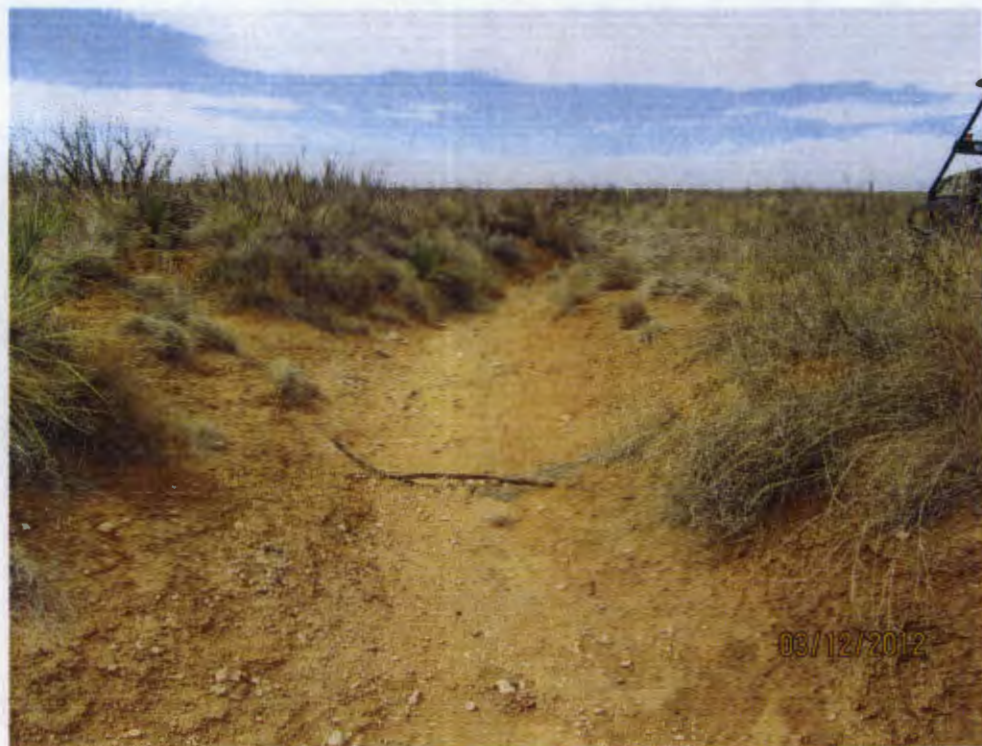
14. Drainage 4 - Downstream Viewing Southwest, March 12, 2012

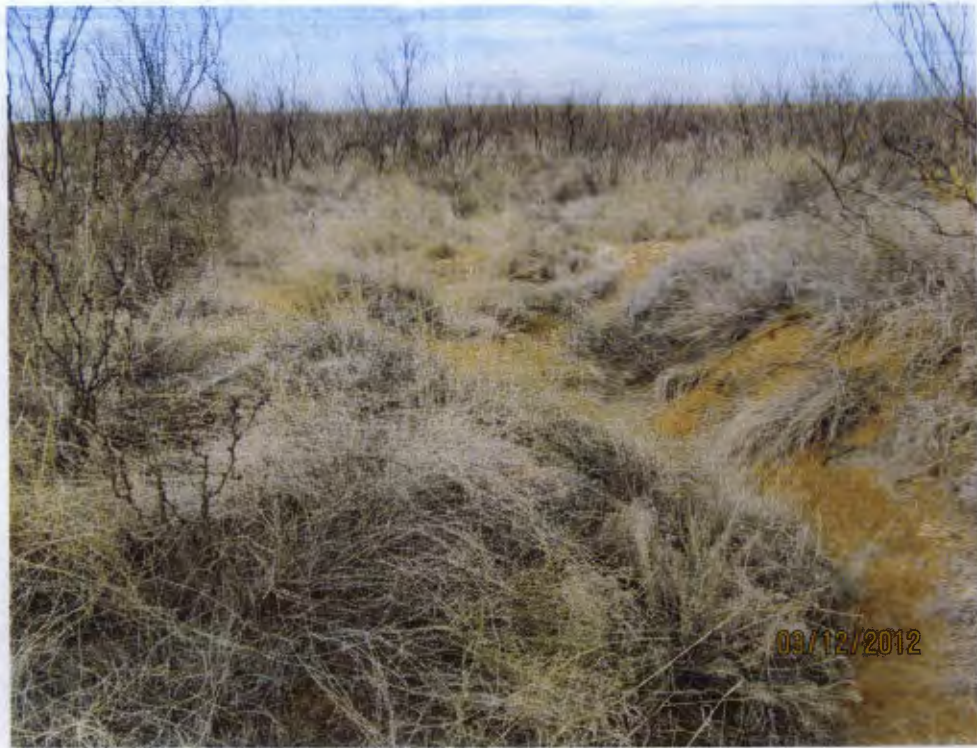
15. Drainage 4 – Termination Viewing Southwest, March 12, 2012

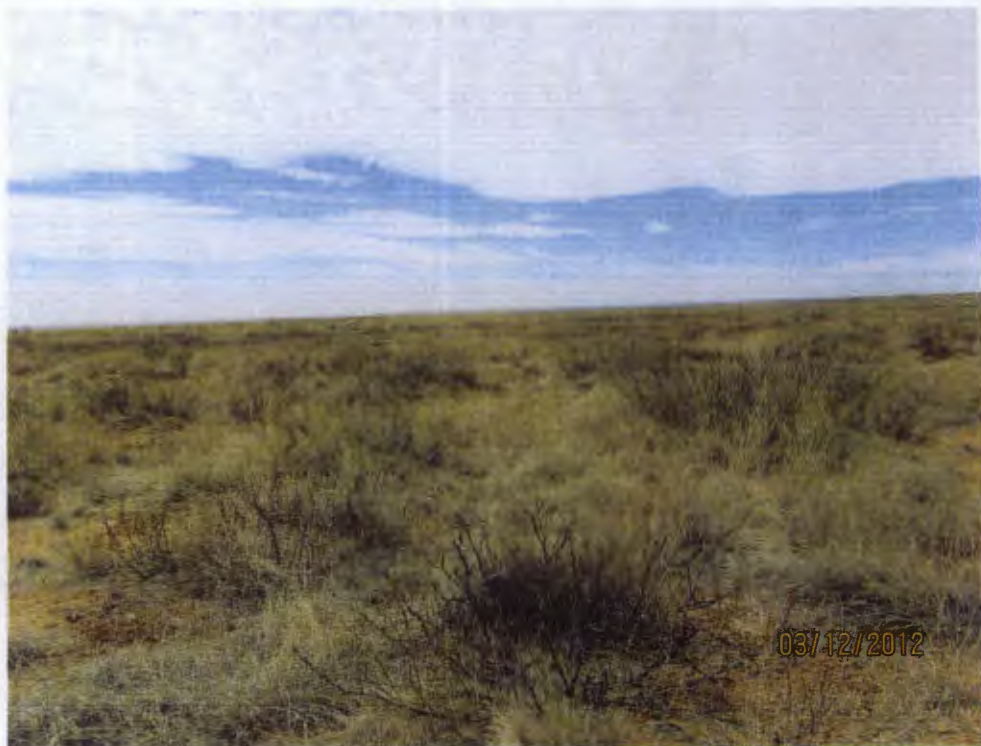
16. Drainage 5 – Upstream South, March 12, 2012

Drainage 5 is located near the southeast corner of the property and is about 300 feet long. The drainage flows south and intersects drainage 6 near the south property line. Drainage 5 is shown in photographs 16 through 18.

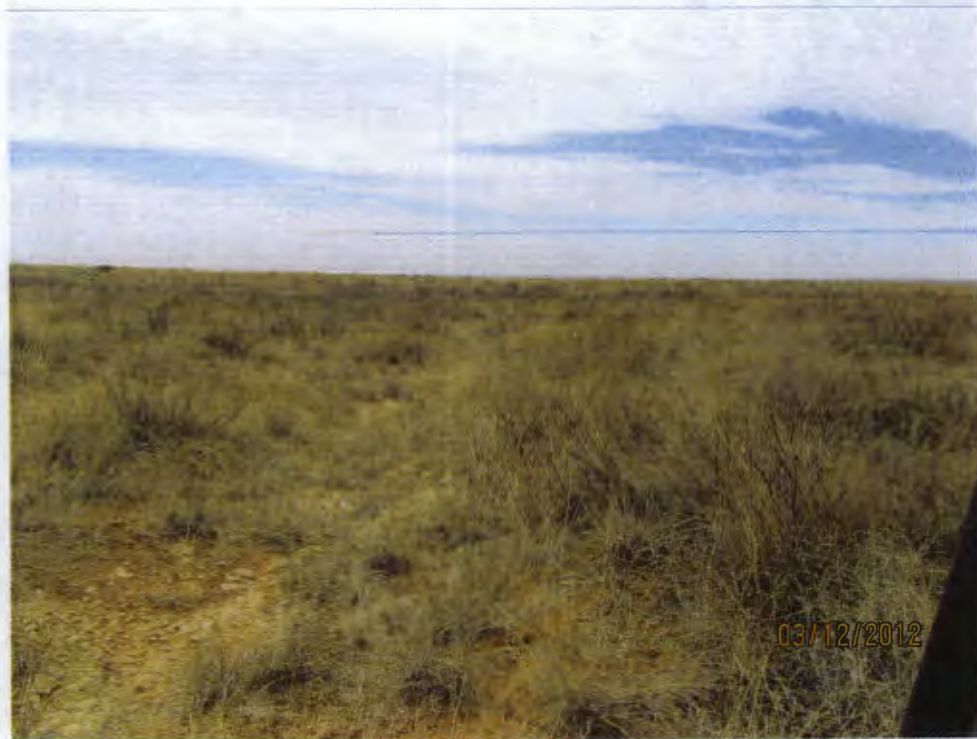
17. Drainage 5 – Midstream Viewing South, March 12, 2012

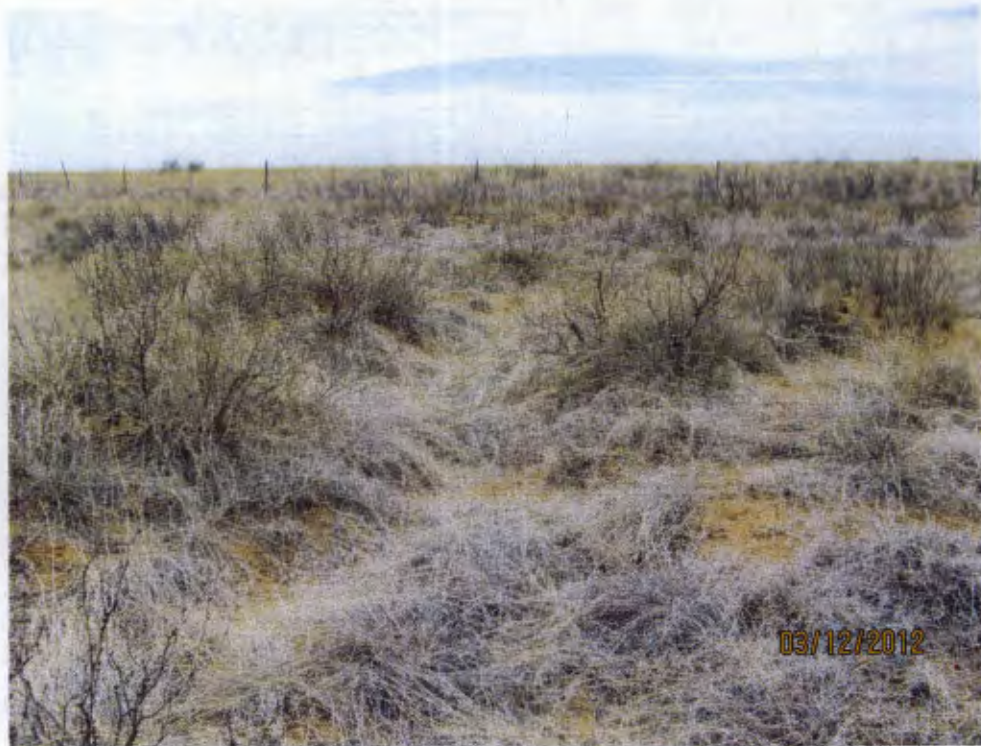
18. Drainage 5 – Termination Viewing South, March 12, 2012

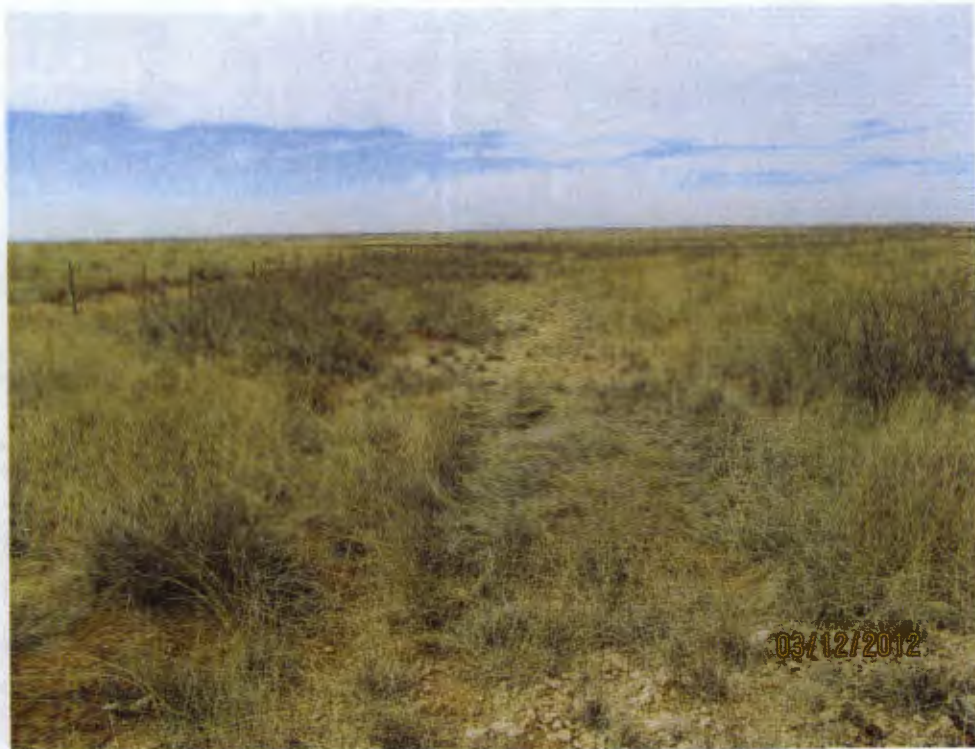
19. Drainage 6 – Upstream Viewing West, March 12, 2012

Drainage 6 is located near the southeast corner of the property and is approximately 660 feet long. The drainage appears to be developed on an abandoned trail that runs west and parallel to the south property line. Drainage 6 terminates at an oilfield lease road located south of the property. Drainage 6 is shown in photographs 19 through 24.

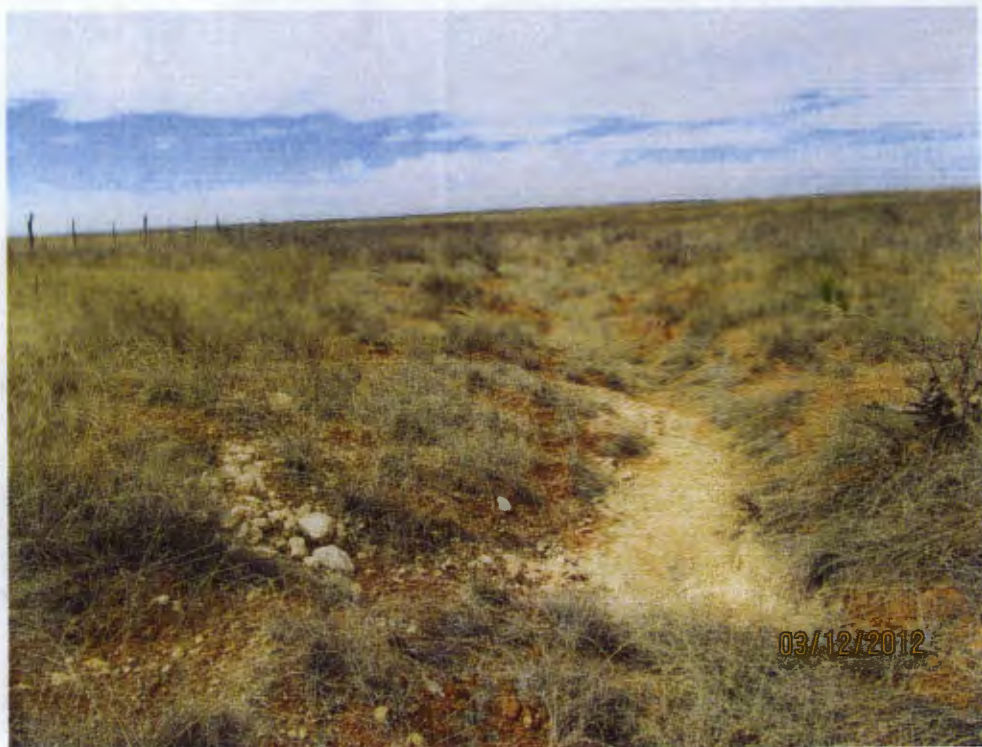
20. Drainage 6 – Midstream Viewing West, March 12, 2012

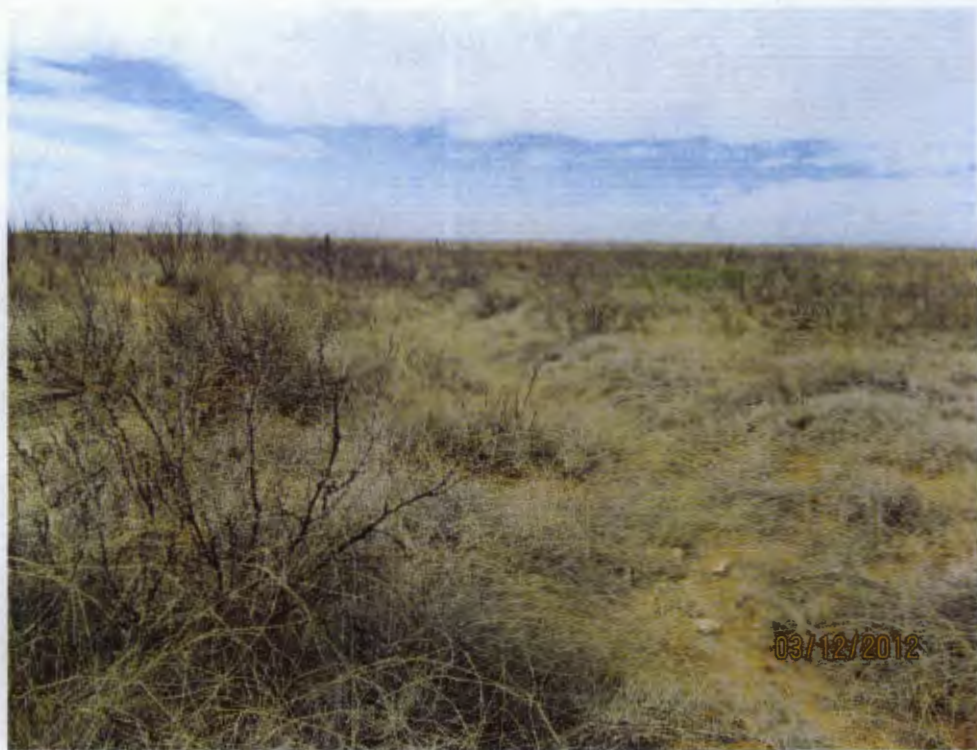
21. Drainage 6 - Downstream Viewing Southwest, March 12, 2012

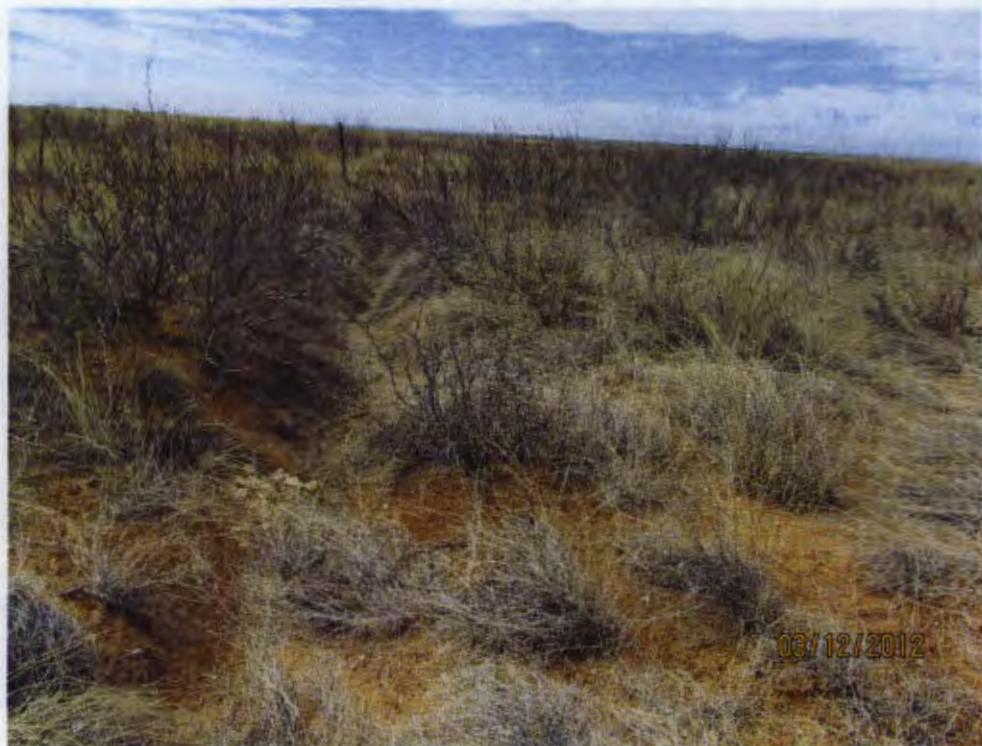
22. Drainage 6 - Downstream Viewing Southwest, March 12, 2012

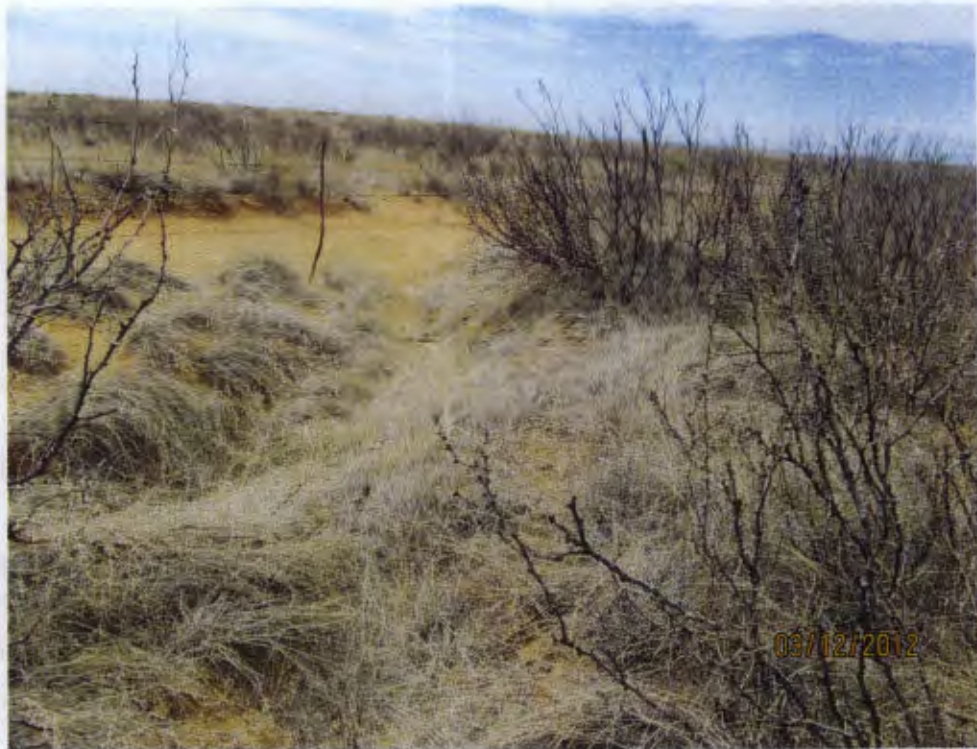
23. Drainage 6 – Termination Viewing Southwest, March 12, 2012

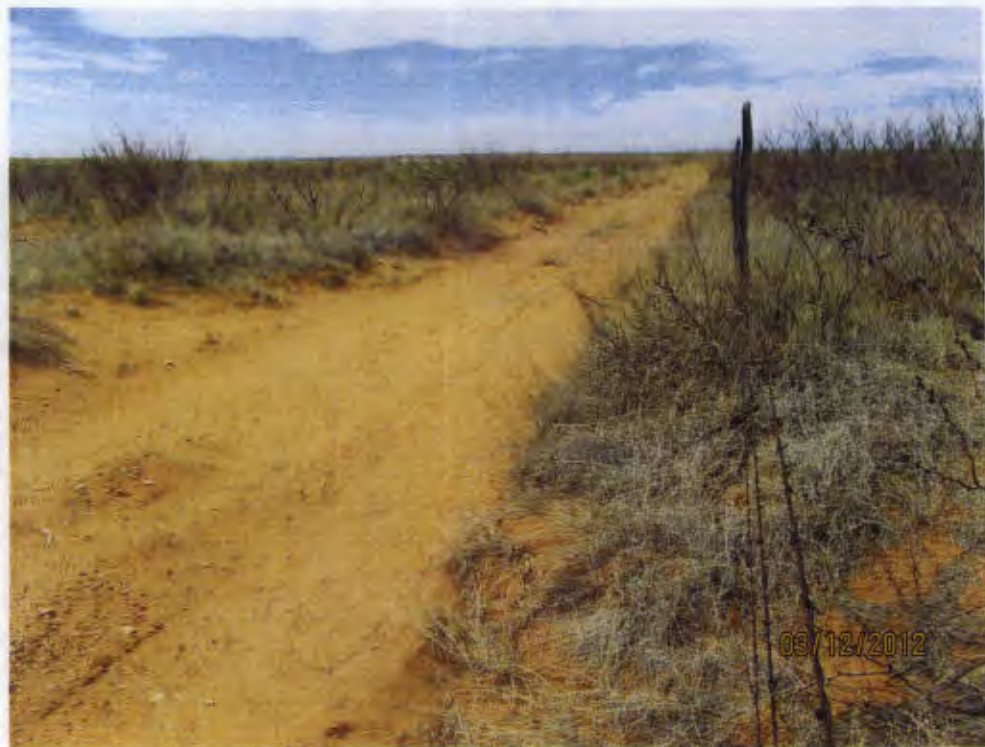
24. Drainage 6 – Termination Viewing West, March 12, 2012

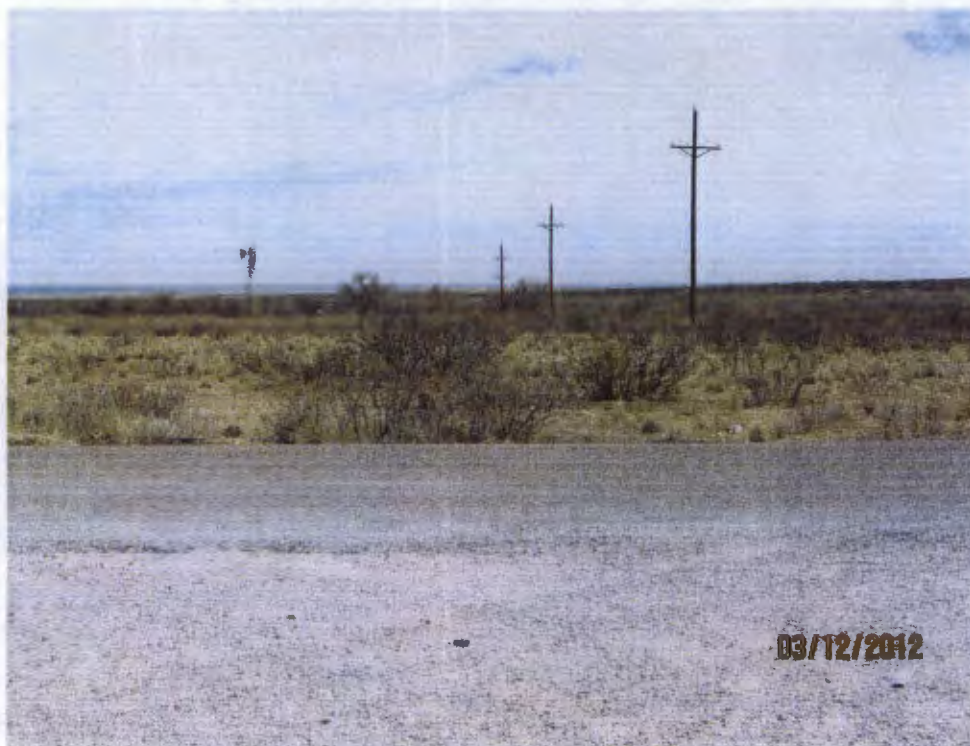
34. Windmill Located East of CR-1 Viewing East at State Line Road, March 12, 2012

Groundwater was measured in a windmill located east of the property in Unit D (NW/4, NW/4), Section 31, Township 26 South, Range 32 East, in Lea County, New Mexico. On November 2, 2011, LAI measured the water level at 177 feet below ground surface (bgs). The saturated thickness is from approximately 70 feet. The base of the aquifer occurs at approximately 240 feet bgs. Table 1 presents a summary of depth to groundwater measurements.

Photographs 25 through 33 show the general topography of the east side of the property. Photograph 34 shows the windmill located east of the property.
