BD Jct. G-31

**RICE OPERATING COMPANY
JUNCTION BOX DISCLOSURE* REPORT**

SWD SYSTEM	JUNCTION	UNIT	SECTION	TOWNSHIP	RANGE	COUNTY	BOX DIMENSIONS - FEET		
Blaineby-Drinkard (BD)	Jct. G-31	G	31	22S	38E	Lea	Length 5'	Width 7'	Height 3'
							Moved 125' east

General Description of Remedial Action: This junction box was eliminated during the pipeline replacement/upgrade program. After the former junction box was removed, an investigation was conducted using a backhoe to collect soil samples at regular intervals producing a 30x30x12 ft deep excavation. Chloride field tests performed on each sample resulted in concentrations that did not relent with depth. Organic vapors were measured using a PID, which yielded low concentrations. The excavated soil was blended on site, and representative composite samples of the excavation bottom, the excavation walls, and the blended backfill were sent to a commercial laboratory for analysis of chloride and TPH. A total of 528 yards of contaminated soil was transported to a NMOCD approved disposal facility. On 11/26/13, a 20-mil reinforced poly liner was installed in between a 6" pad below and above the liner. The excavation was benched 5 ft to the nor

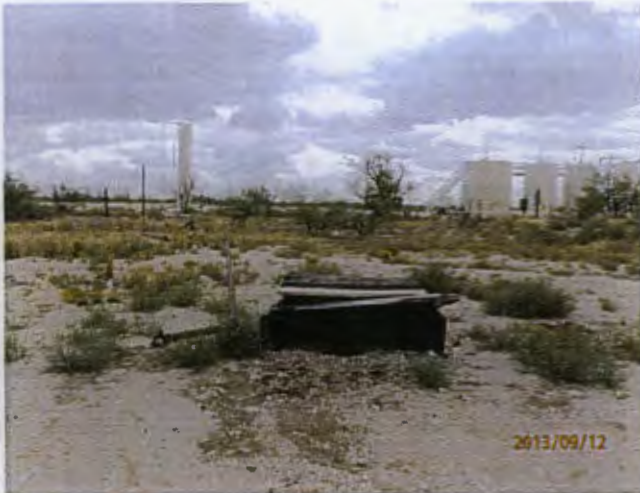
9/12/13

Site prior, facing south

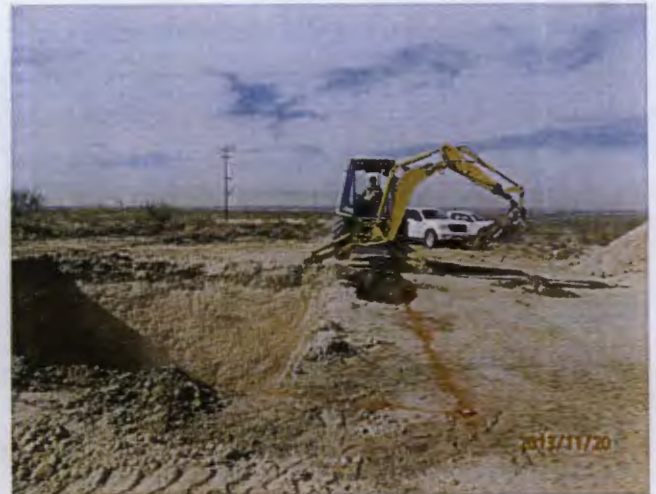
11/20/13

Digging vertical, facing south

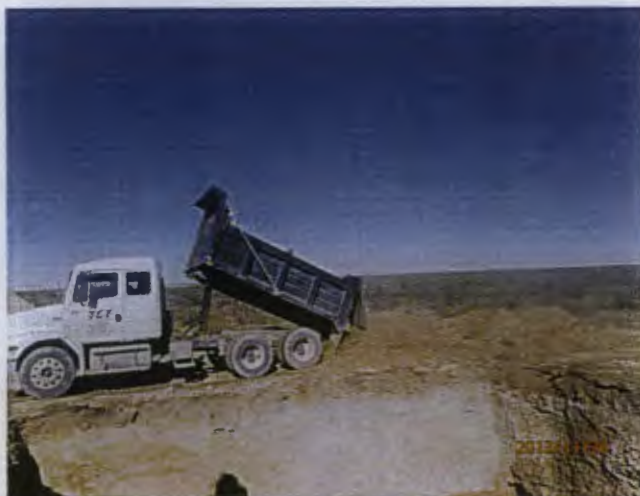
11/26/13

Importing top soil, facing north

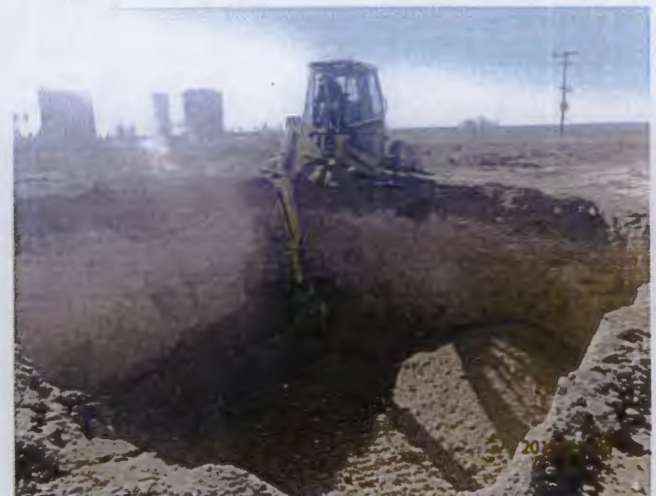
11/26/13

Installing 6" sand pad at base of excavation, facing southwest

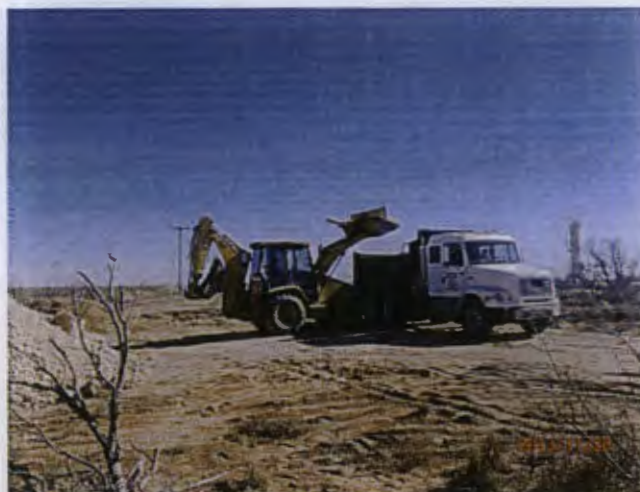
11/26/13

Exporting soil, facing east

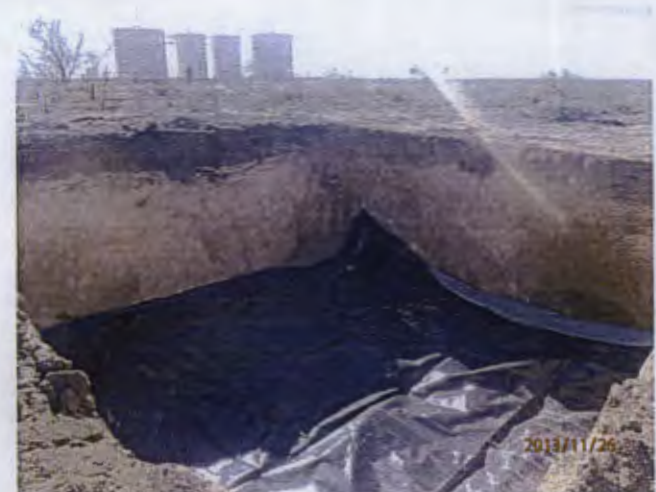
11/26/13

Installed 30'x30', 20-mil poly liner at 11.5', facing southwest

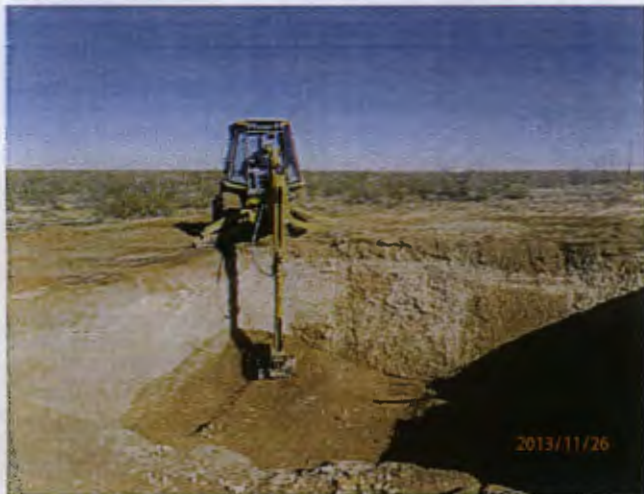
Installed 6" pad above liner, facing northeast
11/20/13

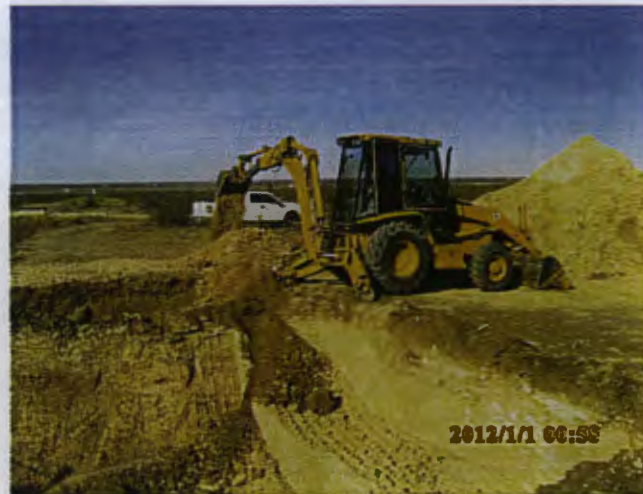
Benching excavation, facing west
12/2/13

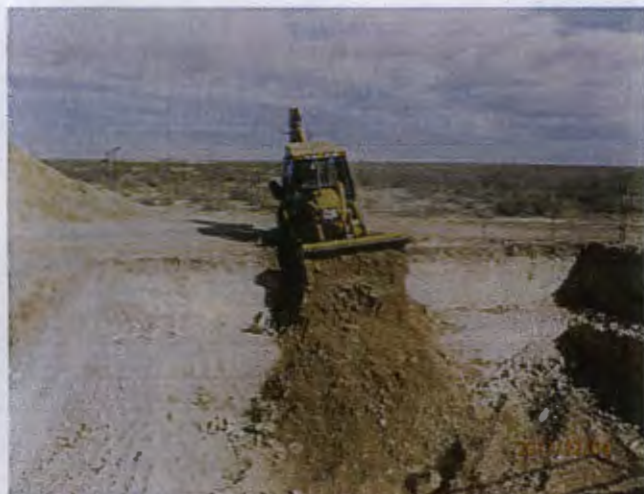
Backfilling excavation, facing north
12/4/13

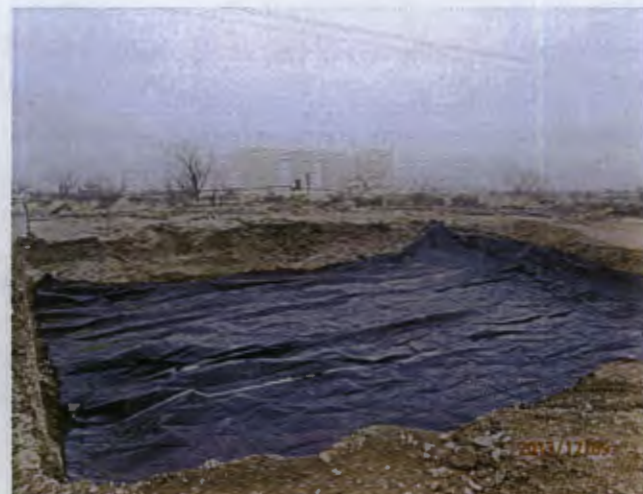
Installed 35'x40', 20-mil poly liner at 4.5 ft bgs,
facing southwest
12/9/13

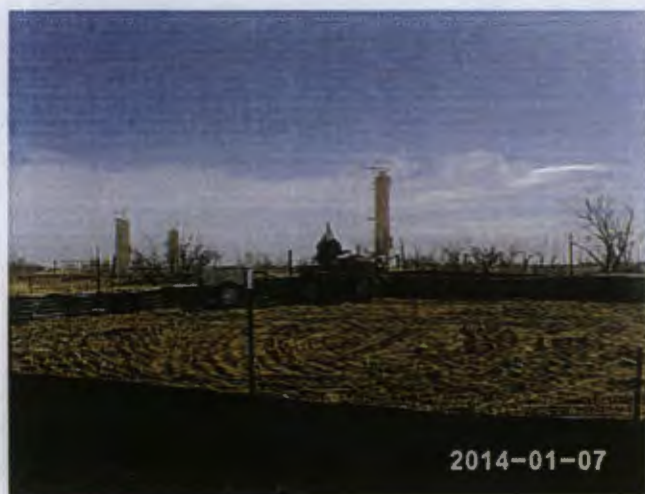
Seeding site, facing northeast
1/7/14

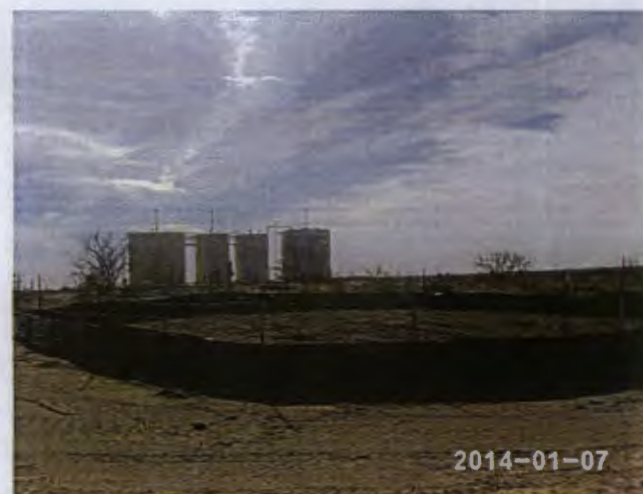
Site completed, facing southwest
1/7/14

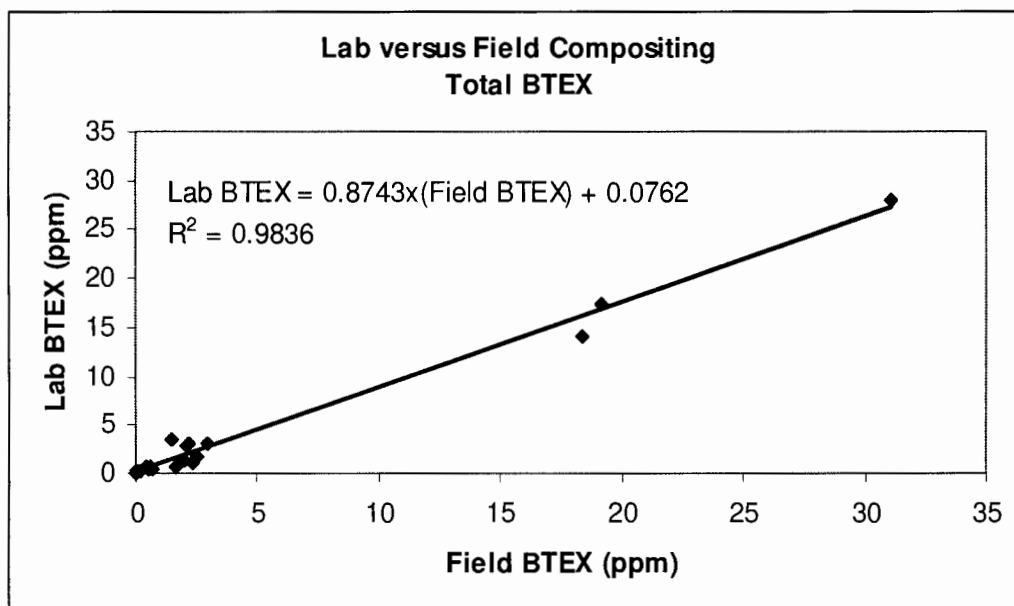
A comparison of lab-composited soil samples versus field-composited soil samples revealed a close correspondence for total BTEX between the two methods (Figure 1).

Figure 1 - Laboratory versus field-composited soil samples analyzed for BTEX.

The high R^2 value (0.9836) of the best-fit statistical regression line indicates a high degree of reliability in using the field-compositing method over the range of values observed. Below a “field-composited BTEX” value of 0.61 ppm the “lab-composited BTEX” values are slightly lower. However, above a field-composited BTEX value of 0.61 the lab-composited values run slightly lower. In other words, the field-composited values tended to produce slightly higher BTEX numbers above the point at which BTEX concentrations become significant.

There is a reason for this. BTEX is volatile and quickly biodegradable. The compositing and “packaging” of soil samples in the field minimize the handling and aeration that occur in the laboratory. Thus, field-composited soil samples lose less BTEX to evaporation and/or biodegradation prior to laboratory analysis. In other words, the field compositing and packaging of soil samples better preserves sample integrity, and for this reason would appear to represent the better method of procuring soil samples for subsequent analysis of BTEX.
