BD M-28 EOL

RE: Termination Request

BD M-28 EOL: UL/M, Sec. 28, T22S, R38E

**RICE OPERATING COMPANY
JUNCTION BOX FINAL REPORT**

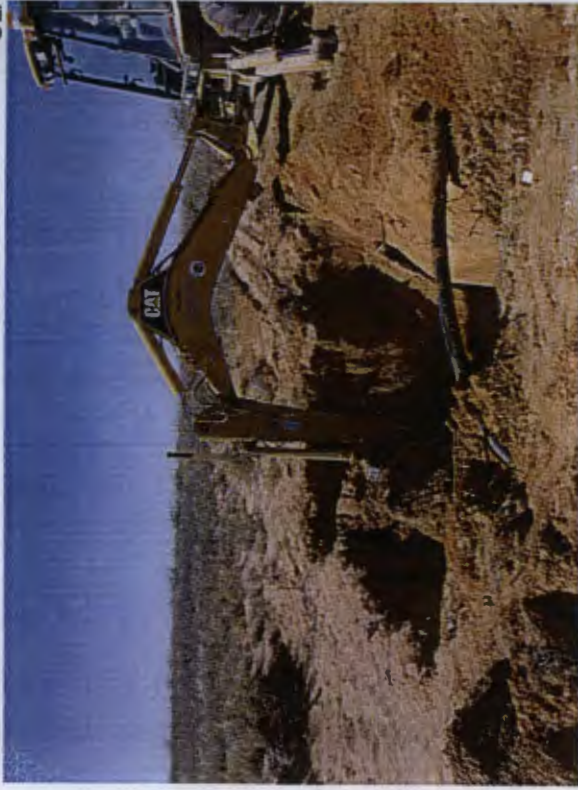
Excavating site, facing west 10/23/2013

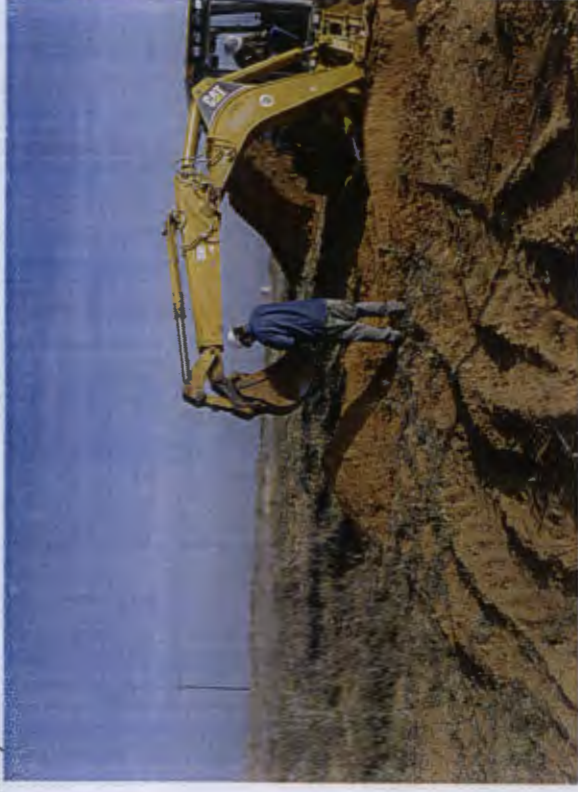
Collecting sample, facing north 10/28/2013

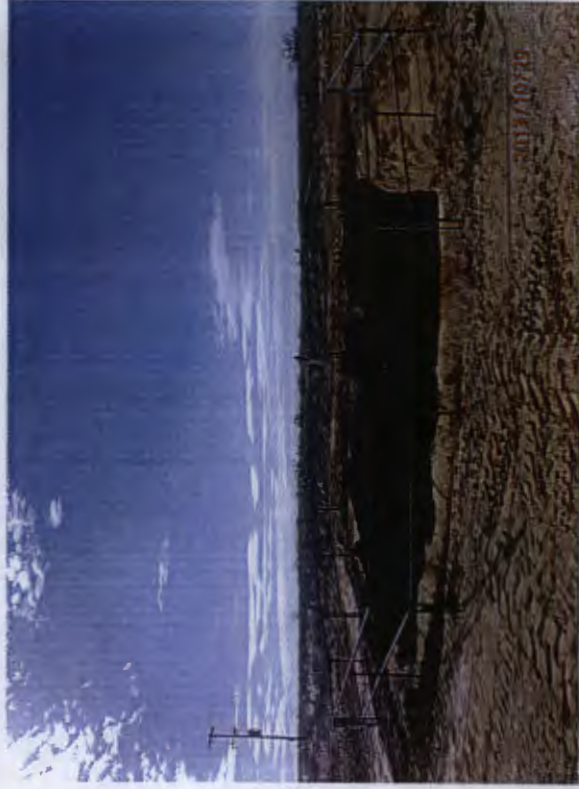
Completed excavation, facing west 10/29/2013

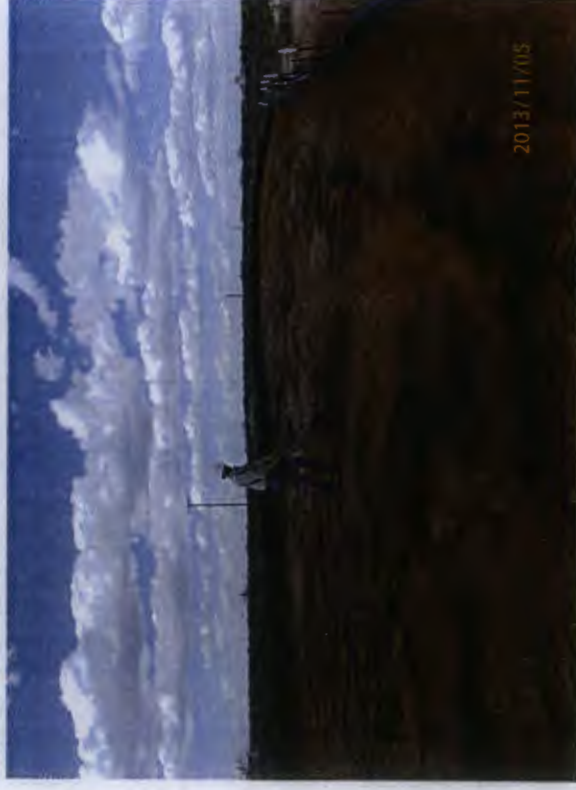
Seeding site, facing north

11/5/2013

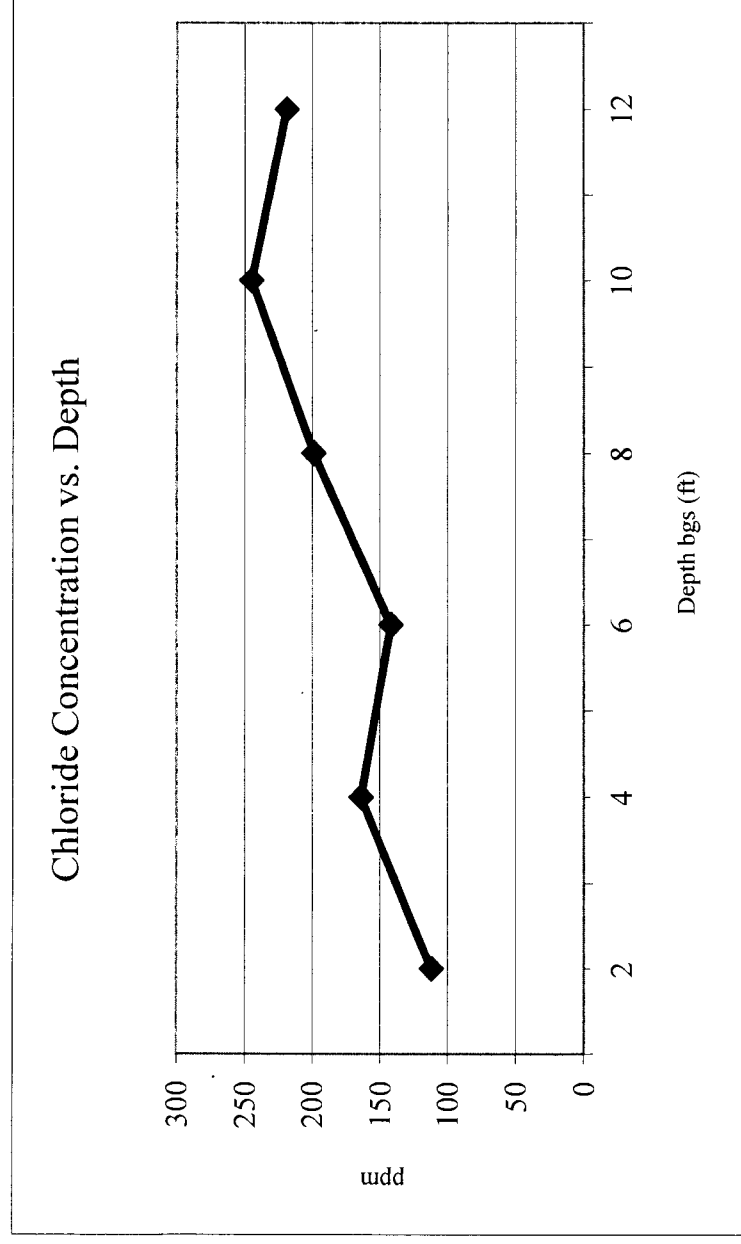
CHLORIDE CONCENTRATION CURVE

Backhoe samples at 10' east of the junction (source)

Depth bgs (ft)	[Cl ⁻] ppm
2	112
4	164
6	142
8	199
10	245
12	219

Groundwater = 124 ft
