EME E-21 EOL

RE: Termination Request

EME E-21 EOL: UL/E, Sec. 21, T20S, R37E

**RICE OPERATING COMPANY
JUNCTION BOX FINAL REPORT**

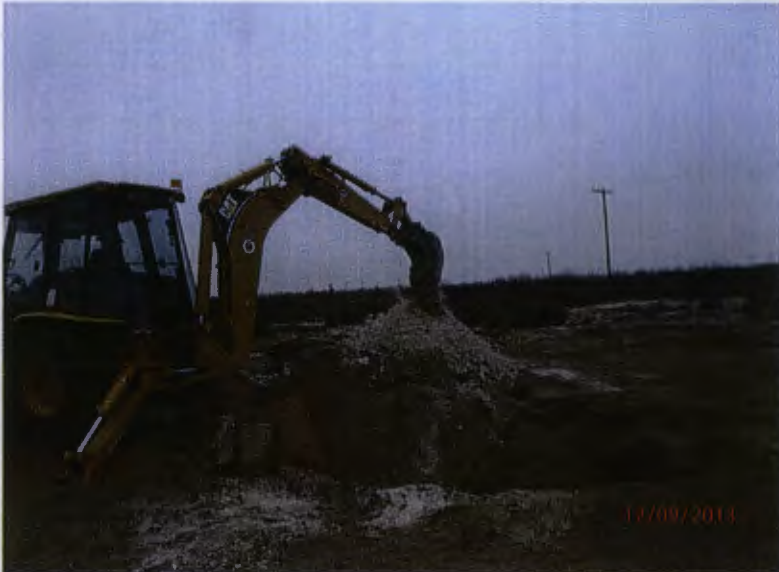
Excavating site, facing west

removed, an investigation was conducted, using a backhoe to collect soil samples at regular intervals, creating a 5x7x7 ft deep excavation. Chloride field test performed on each sample yielded low concentrations of chloride.

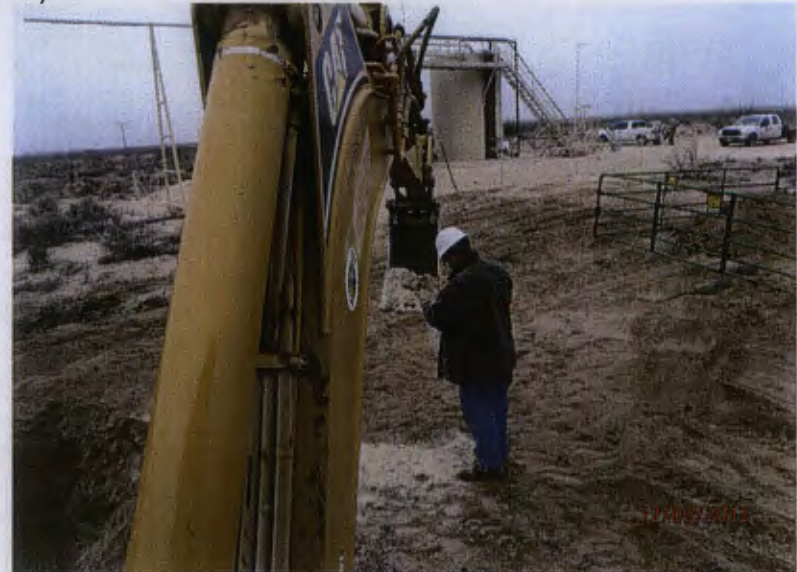
Collecting sample, facing northeast

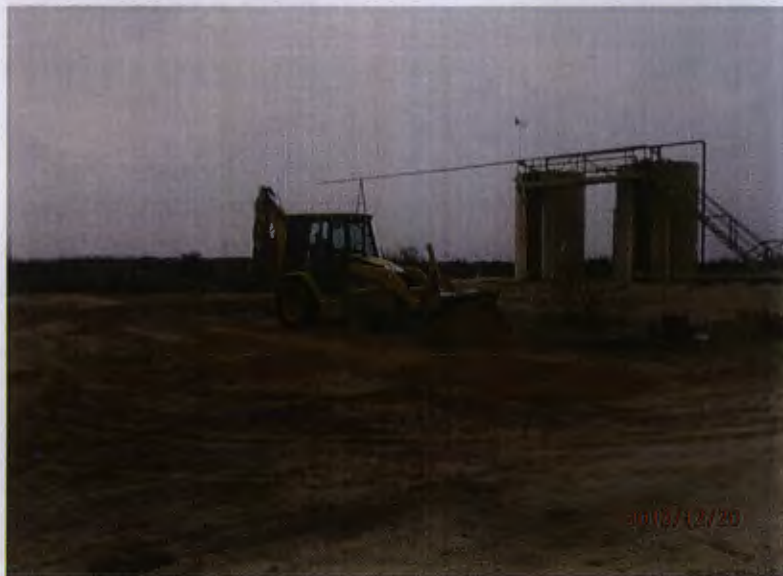
Backfilling excavation, facing northwest

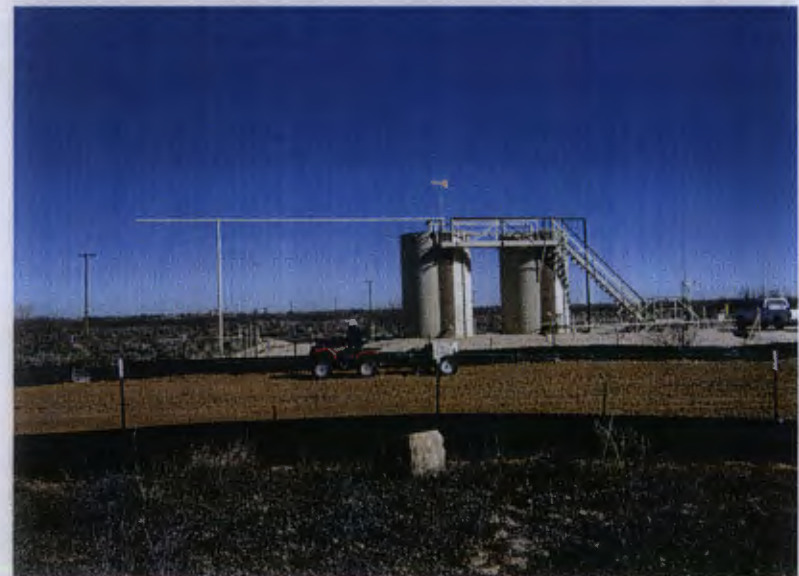
Seeding site, facing south

| Custom Seed Mix | <input checked="" type="checkbox"/> | Prescribed Mix | Seed Mix Name: | 6 lbs. of Blue Gramma, 6 lbs. Side Oats, & 6 lbs of Winter Wheat | Date: | 1/8/2014 |
| Observations: The amendments and seed were raked into the soil. | | | | | | |

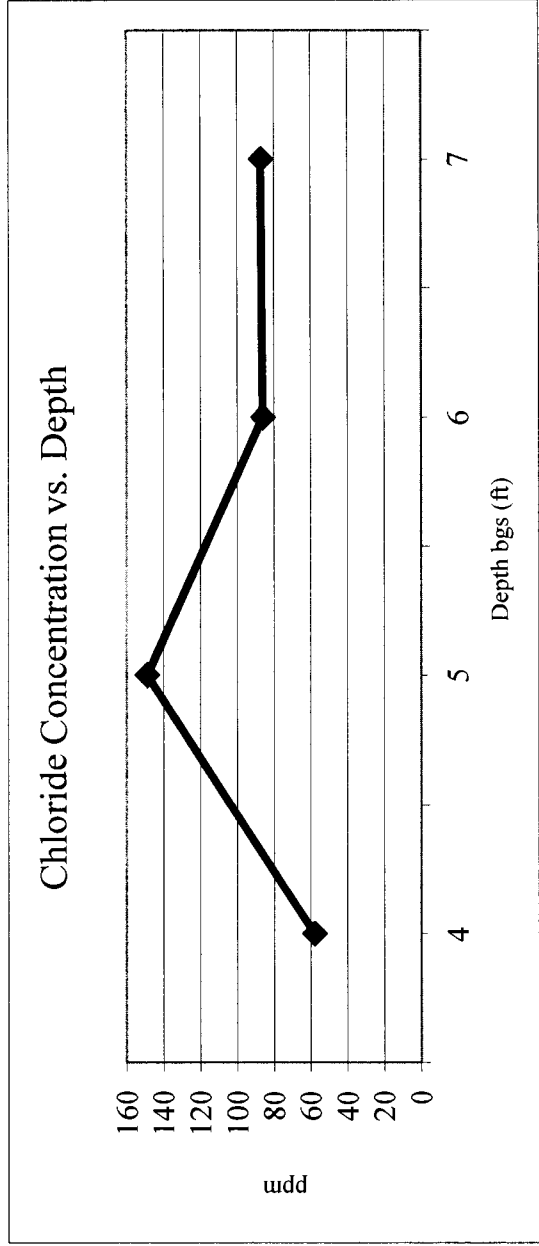
EME E-21 EOL

Backhoe samples at junction (source)

Groundwater = 26 ft

| CHLORIDE FIELD TESTS | | |
|--|---|---|
| vertical delineation trench at the junction (source) | 4' | 58 |

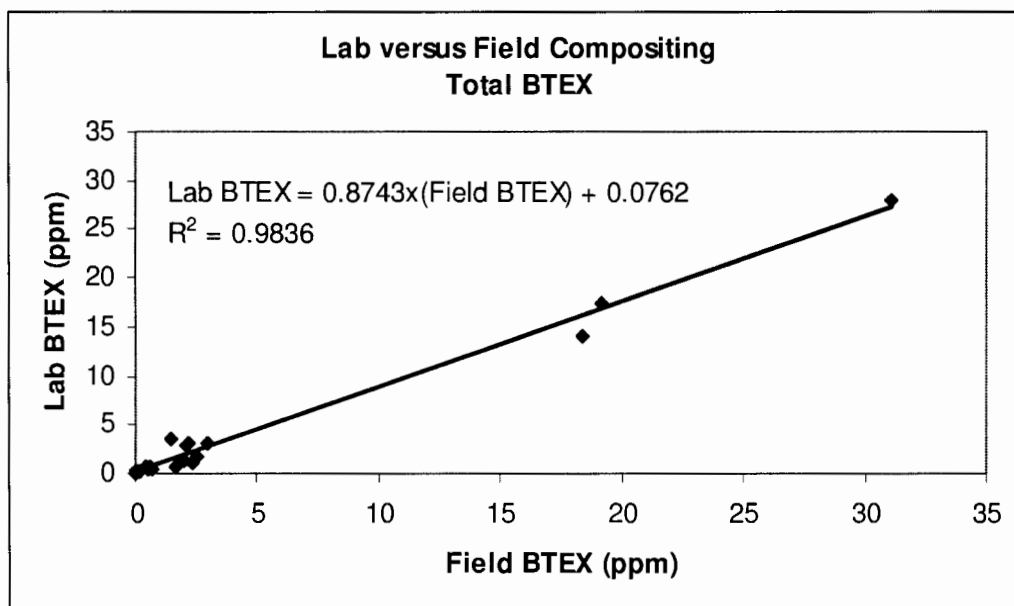
Figure 1 - Laboratory versus field-composited soil samples analyzed for BTEX.

The high R^2 value (0.9836) of the best-fit statistical regression line indicates a high degree of reliability in using the field-compositing method over the range of values observed. Below a “field-composited BTEX” value of 0.61 ppm the “lab-composited BTEX” values are slightly lower. However, above a field-composited BTEX value of 0.61 the lab-composited values run slightly lower. In other words, the field-composited values tended to produce slightly higher BTEX numbers above the point at which BTEX concentrations become significant.

A comparison of lab-composited soil samples versus field-composited soil samples revealed a close correspondence for total BTEX between the two methods (Figure 1).

There is a reason for this. BTEX is volatile and quickly biodegradable. The compositing and “packaging” of soil samples in the field minimize the handling and aeration that occur in the laboratory. Thus, field-composited soil samples lose less BTEX to evaporation and/or biodegradation prior to laboratory analysis. In other words, the field compositing and packaging of soil samples better preserves sample integrity, and for this reasons would appear to represent the better method of procuring soil samples for subsequent analysis of BTEX.

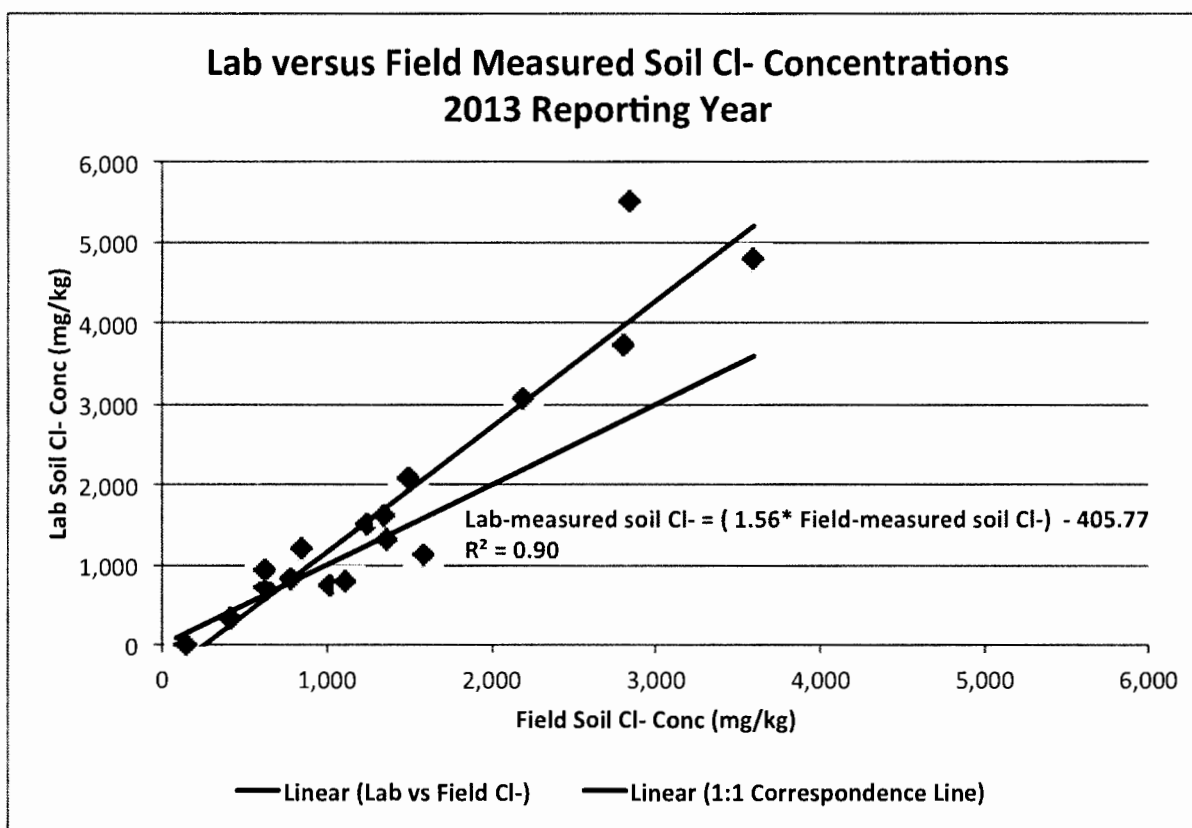
Figure 1 – Laboratory versus field measured soil chloride measurements (n = 29 paired sets).

A straight line fit to the data confirms a general linear trend over a wide range of soil chloride concentrations, and the R^2 value (0.90) indicates that field measurements provide a reliable approximation of laboratory-measured values. Based on the best-fit line of lab vs field measured values, field measured values overestimate lab measure values below a field measured value of 723 mg/kg and above this underestimate the lab-measured values. This is indicated in the graph where the (blue) best-fit line of lab vs field measured chlorides crosses the (black) line which would indicate a 1:1 correspondence.

A representative sample of 29 pairs of laboratory versus field measured soil chloride values was compared to determine how well field measurements matched laboratory measurements. It is assumed that laboratory measurements better represent the “true” values due to the controlled environment that a laboratory provides. A simple plot of the laboratory versus field measured soil chloride values is given below (Figure 1).
