PART 36 PERMIT APPLICATION

Crowe Blanco Properties, LLC

Surface Waste Management Facility (19.15.36 NMAC)

Permit Application (4th Submittal) Reply to Tentative Decision

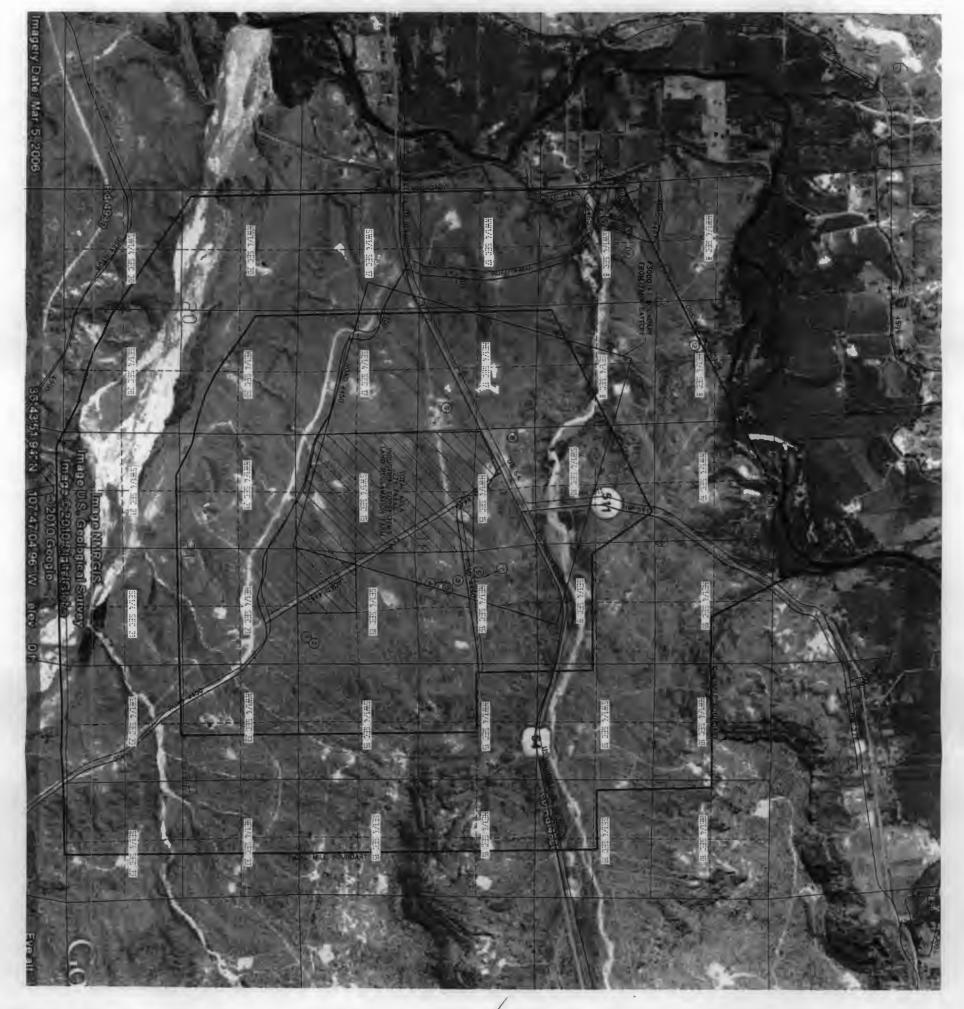
DATE:02/26/2013
DRAWN BY: LH
PROJ. 09467
SCALE:1"= 1000"
FILE:094670NEMILE
SHEET
11
0F
17

HOMES WITHIN ONE MILE CROWE BLANCO PROPERTIES, LLC

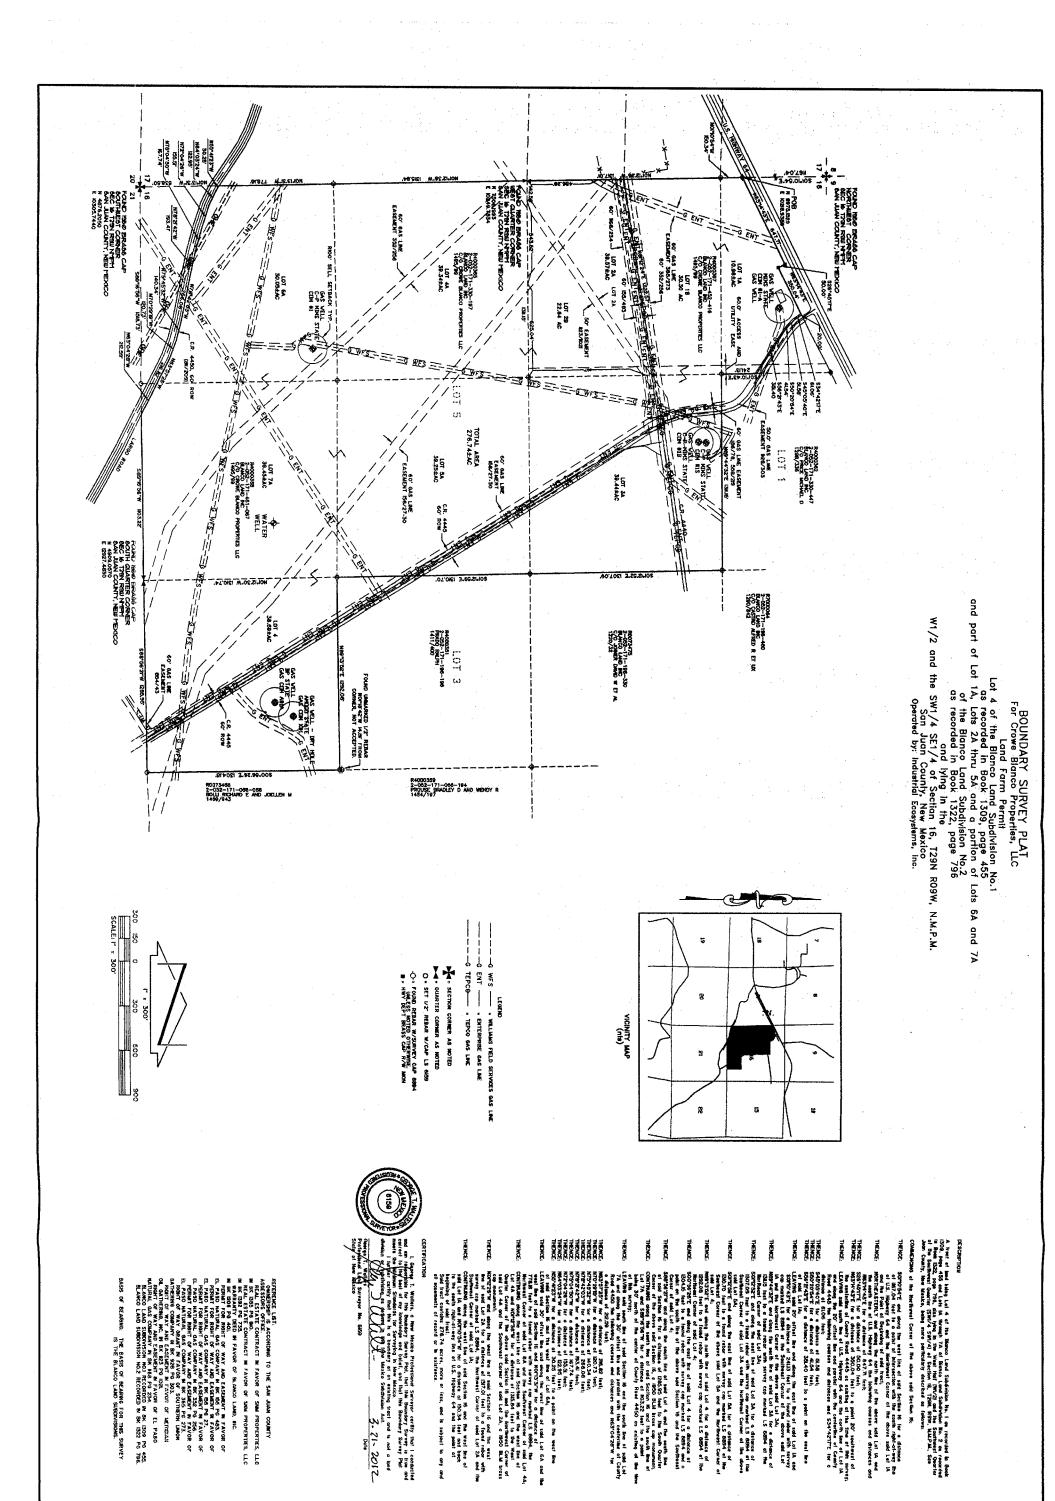
DATE:02/20/2012
DRAWN BY: LH
PROJ. 09467
SCALE:1"= 300'
FILE:09467
SHEET
1
0F
0F

BOUNDARY SURVEY CROWE BLANCO PROPERTIES, LLC

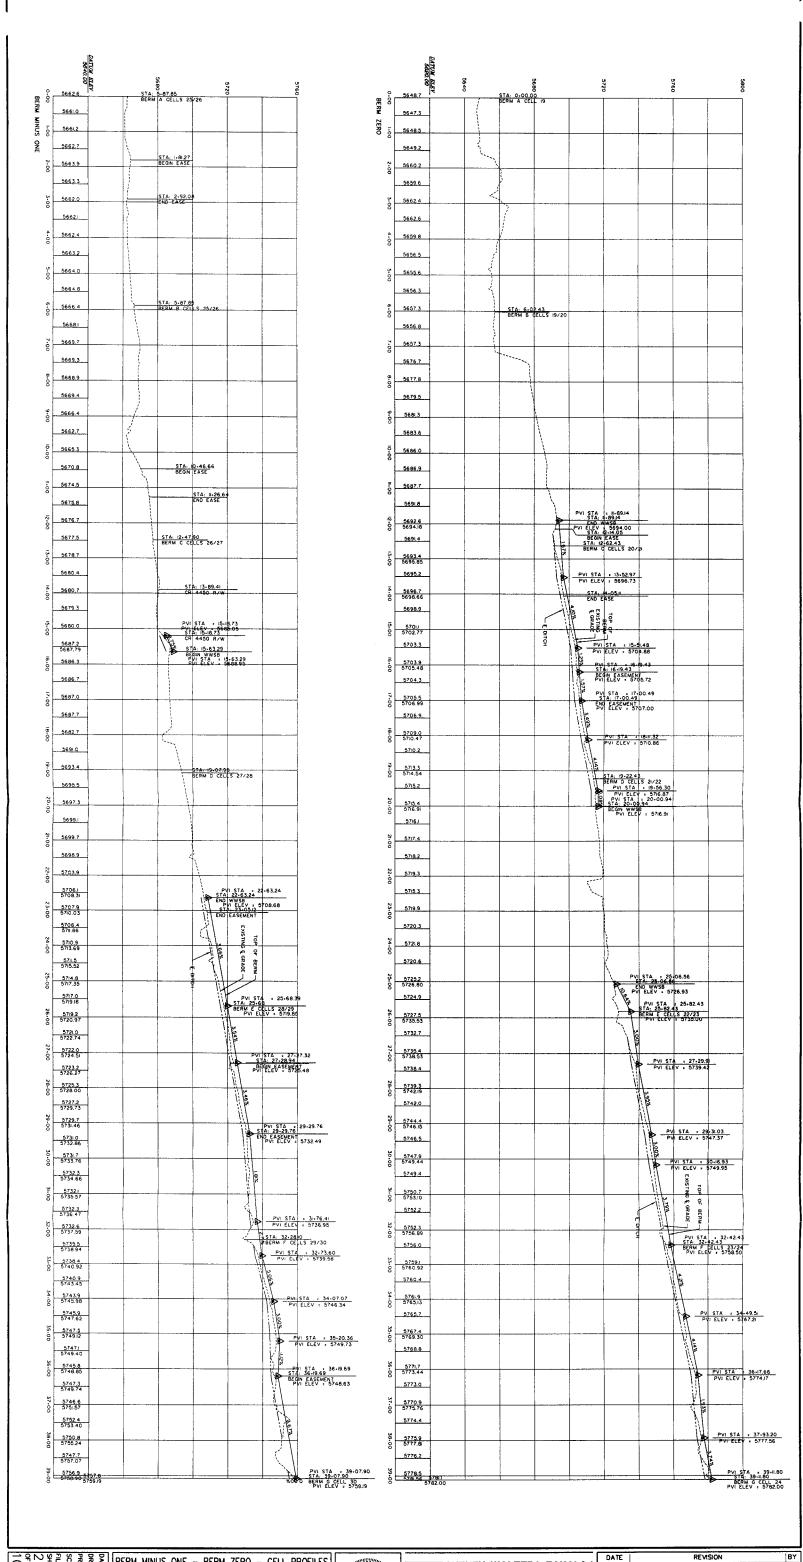
BERM MINUS ONE - BERM ZERO - CELL PROFILES

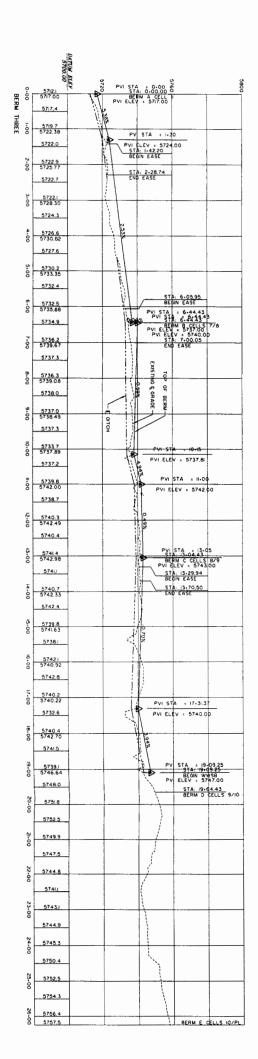
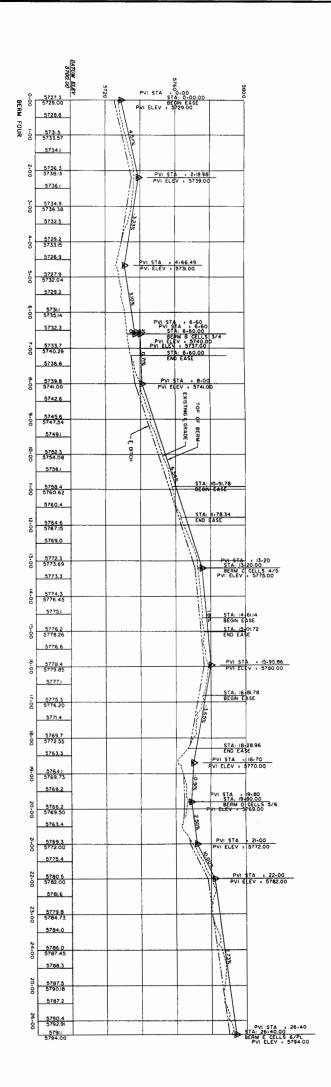
DATE:02/22 DRAWN BY: LI PROJ. 09467 SCALE:[1=100 FILE:096785WI SHEET

BERM THREE BERM FOUR - CELL PROFILES
CROWE BLANCO PROPERTIES, LLC

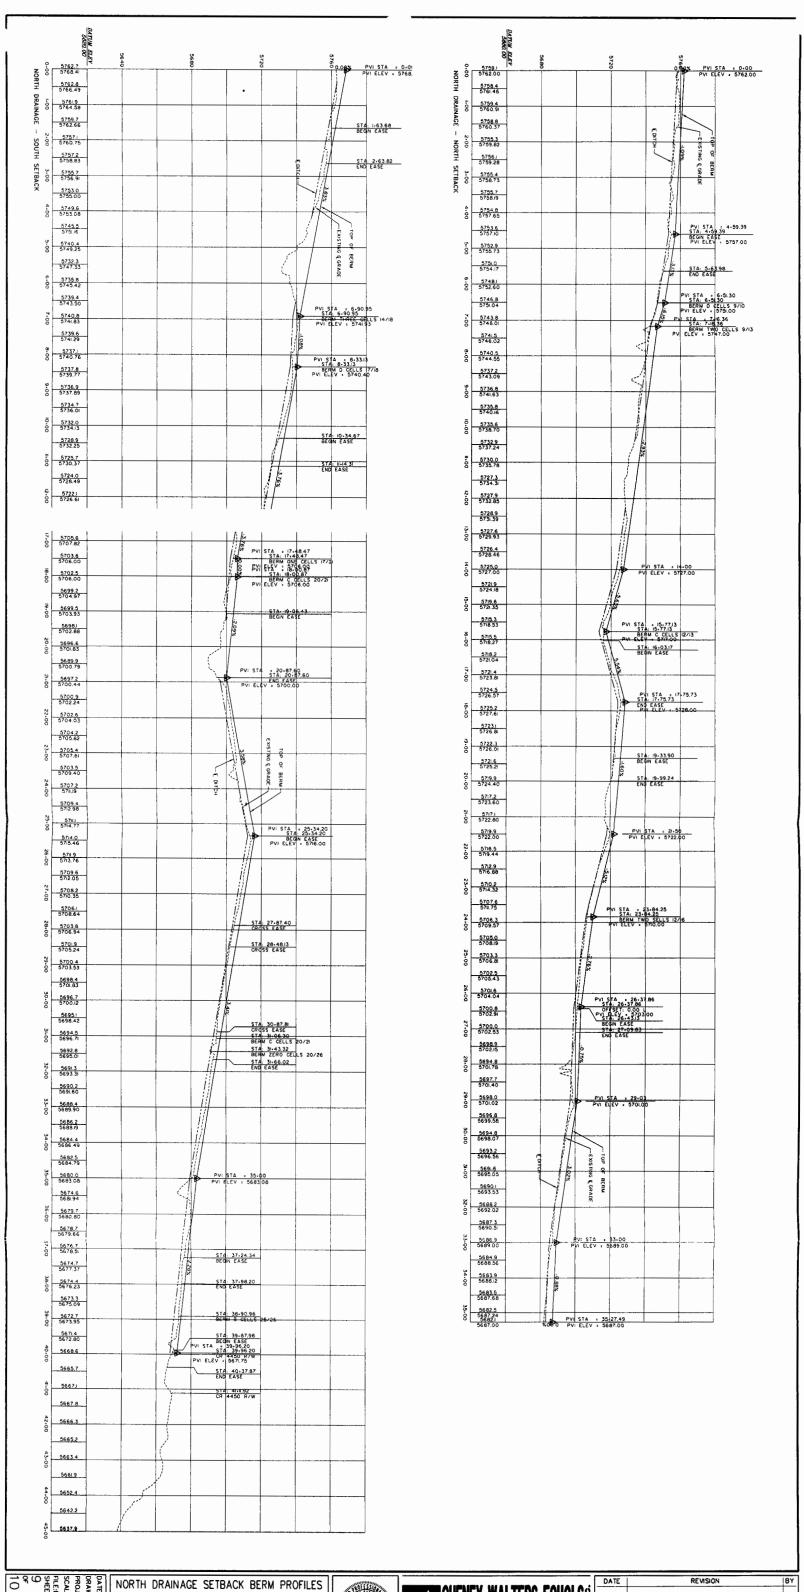
NORTH DRAINAGE SETBACK BERM PROFI
CROWE BLANCO PROPERTIES, LLC

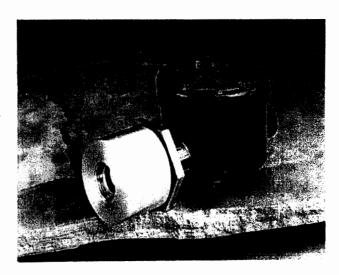
Sierra Monitor toxic gas sensor modules utilize electrochemical technology to achieve the most accurate and reliable monitoring of gas concentration. All Sentry 5100 Series sensor modules easily interface to the Sentry controller. Each module has a unique address, which allows signals from multiple modules to be multiplexed for communication with the controller on the same cable. All Sierra Monitor gas sensor modules are designed for hostile or hazardous environments and are in enclosures approved for Div. 1, Class 1, Groups C, D locations.

Gas	Model Number	Sensor Type	Range	Time Response	Sensor Life	Operating Temperature	Relative Humidity
Carbon Monoxide	5100-16	Electrochem	0-2,000 PPM	90% <35 sec.	2 yr.	4° to 122° F (-20° to 50° C)	15-99% RH
(Hydrogen Tolerant to	•						
2,000 PPM H2) Nitric Oxide	5100-19	Electrochem	0-20 PPM	90% <15 sec.	3 vr	4° to 122° F (-20° to 50° C)	15-99% RH
Hydrogen Cyanide	5100-13	Electrochem	-,	90% <70 sec.	•	4° to 122° F (-20° to 50° C)	15-99% RH
Ethylene Oxide	5100-27	Electrochem		90% <90 sec.	. •	4° to 122° F (-20° to 50° C)	15-99% RH

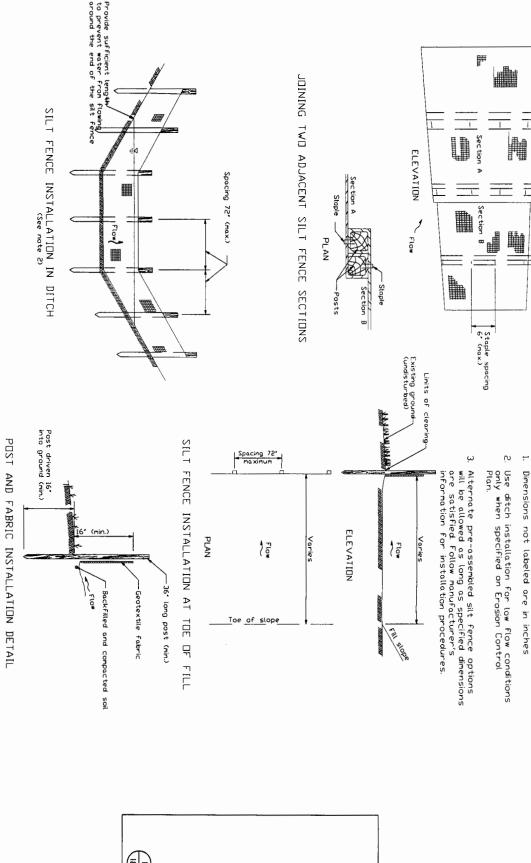
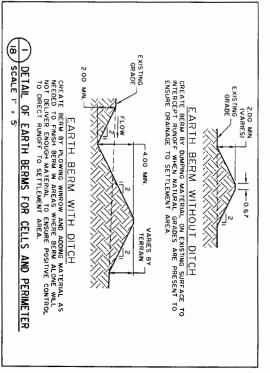
DATE:02/26/2013
DRAWN BY: LH
PROJ. 09467
SCALE:NOTED
FILE:09467SET
SHEET
17
OF

STORM WATER POLLUTION PREVENTION DETAILS CROWE BLANCO PROPERTIES, LLC
