RE: TERMINATION REQUEST  
Rice Operating Company – BD SWD System  
BD P-19 EOL (1R-499): UL/P sec. 19 T21S R37E

**Rice Operating Company – BD P-19**

Re-vegetation form and Photo documentation

BD P-19 EOL  
Unit P, Section 19, T21S, R37E

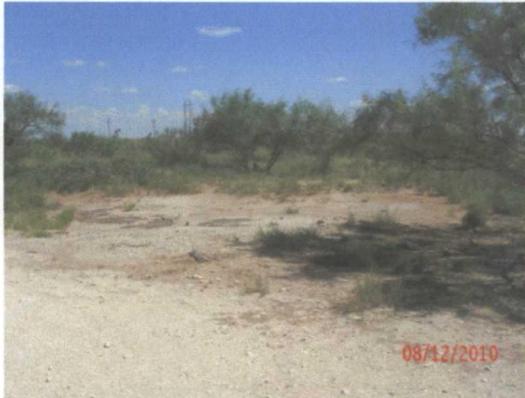
site prior to surface restoration,  
facing south

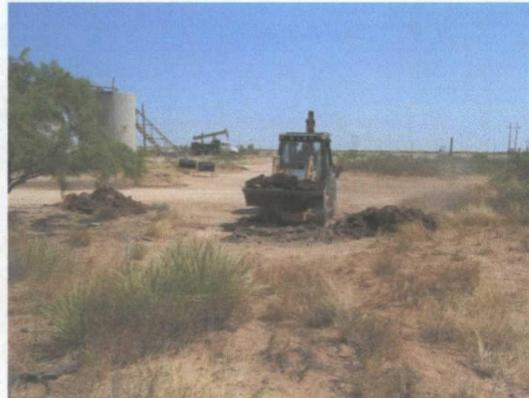
scraping to a depth of 6 inches,  
facing north

As part of the approved CAP, ROC scraped the upper six inches of soil from the affected areas outside of the caliche lease road and disposed of the material at a NMOCD approved disposal facility on June 15th, 2011. A total of 48 yards were taken to Sundance Services for disposal. 72 cubic yards of clean soil was imported from Wallach in Eunice to the site, spread over the scraped areas and contoured to the natural terrain (Appendix A). Hay was mixed into the topsoil and the site was seeded with native vegetation (Appendix B). A silt

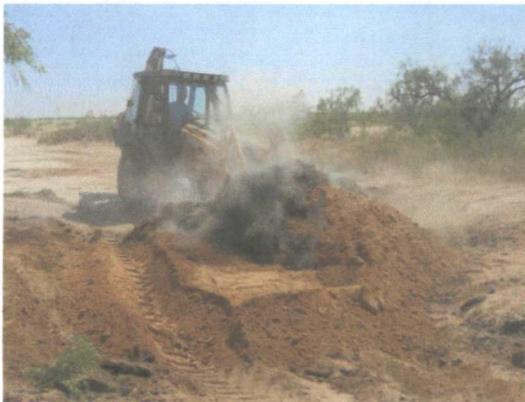
blending the imported soil with peanut hay

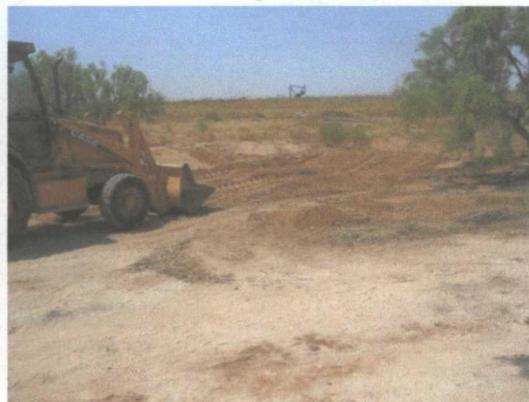
backfilling the scraped area,  
facing south

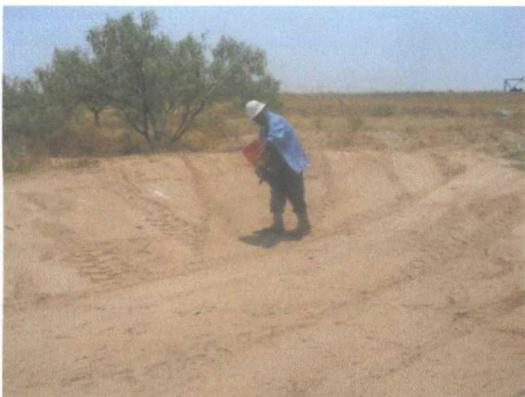
seeding the backfilled area,  
facing south

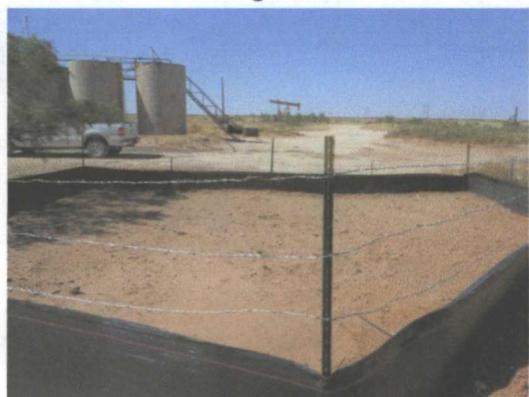
site complete,  
facing north

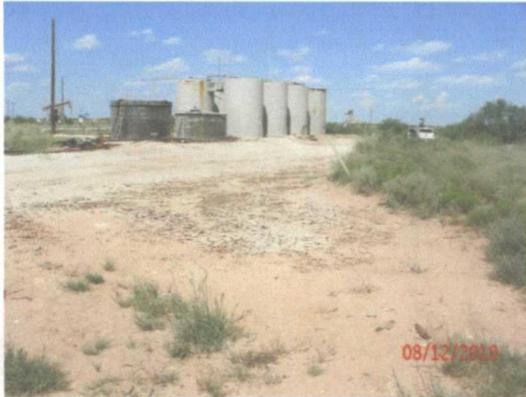
site prior to scraping,  
facing northeast

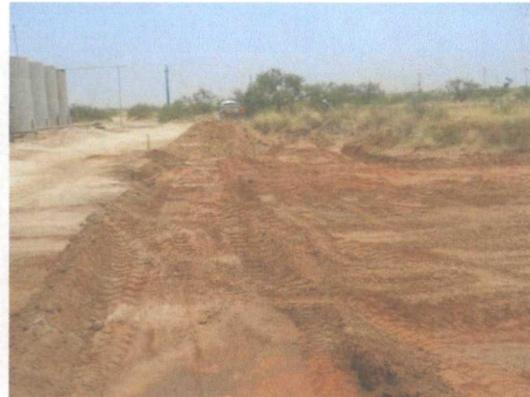
site scraped to a depth of 6 inches,  
facing east

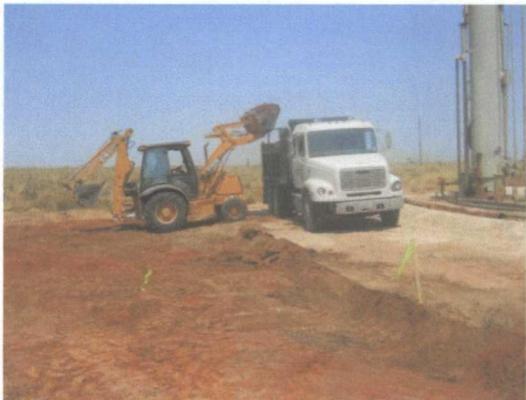
scraping the site to a depth of 6 inches and  
hauling off soil, facing west

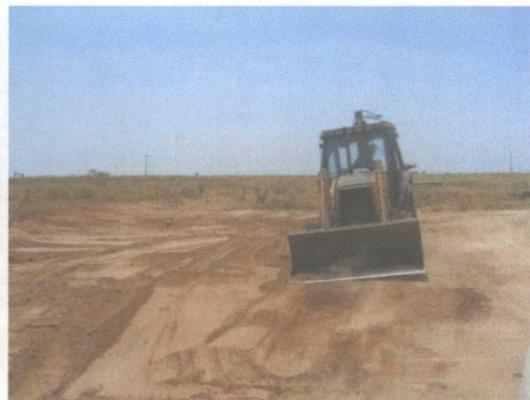
backfilling the scraped area,  
facing west

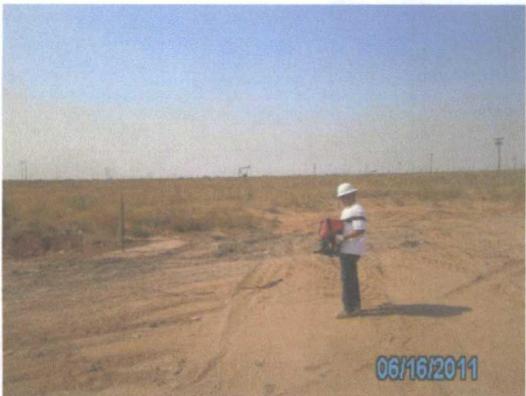
seeding the backfilled area,  
facing south

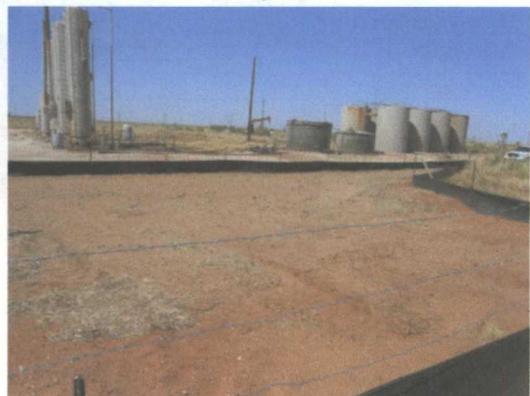
site complete,  
facing southwest
