REMEDATION SUMMARY RECEIVED AND SITE CLOSURE REQUEST

**PLAINS PIPELINE, LP (231735)
14-Inch Vac to Jal Legacy
Lea County, New Mexico
Plains SRS # 2009-092**

**UNIT LTR "F" (SE ¼ /NW ¼), Section 25, Township 25 South, Range 37 East
Latitude 32° 06' 10.7" North, Longitude 103° 07' 10.3" West
NMOCD Reference # 1RP-2162**

November 2010

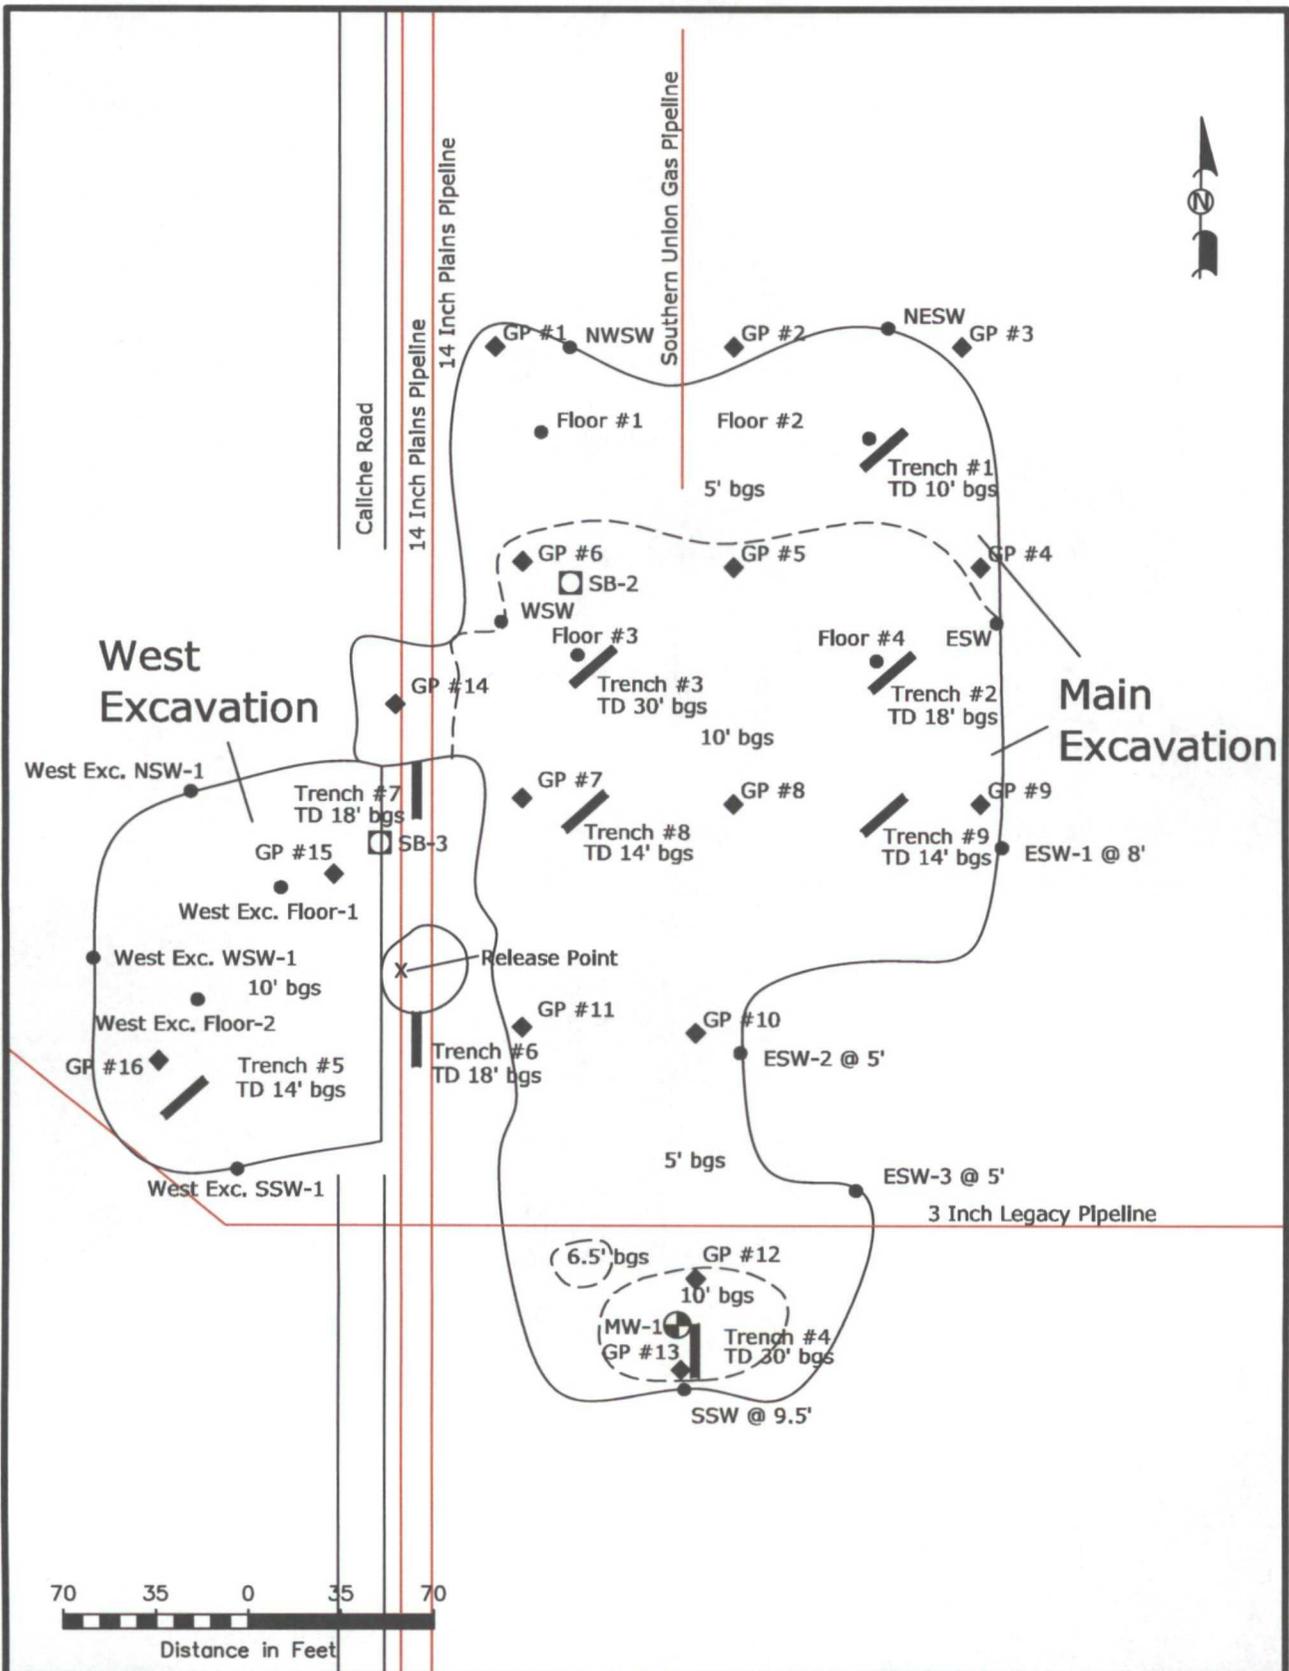
- Soil Sample Location
- Pipeline
- - - Excavation Extent
- ⊕ Monitor Well Location
- Soil Boring Location

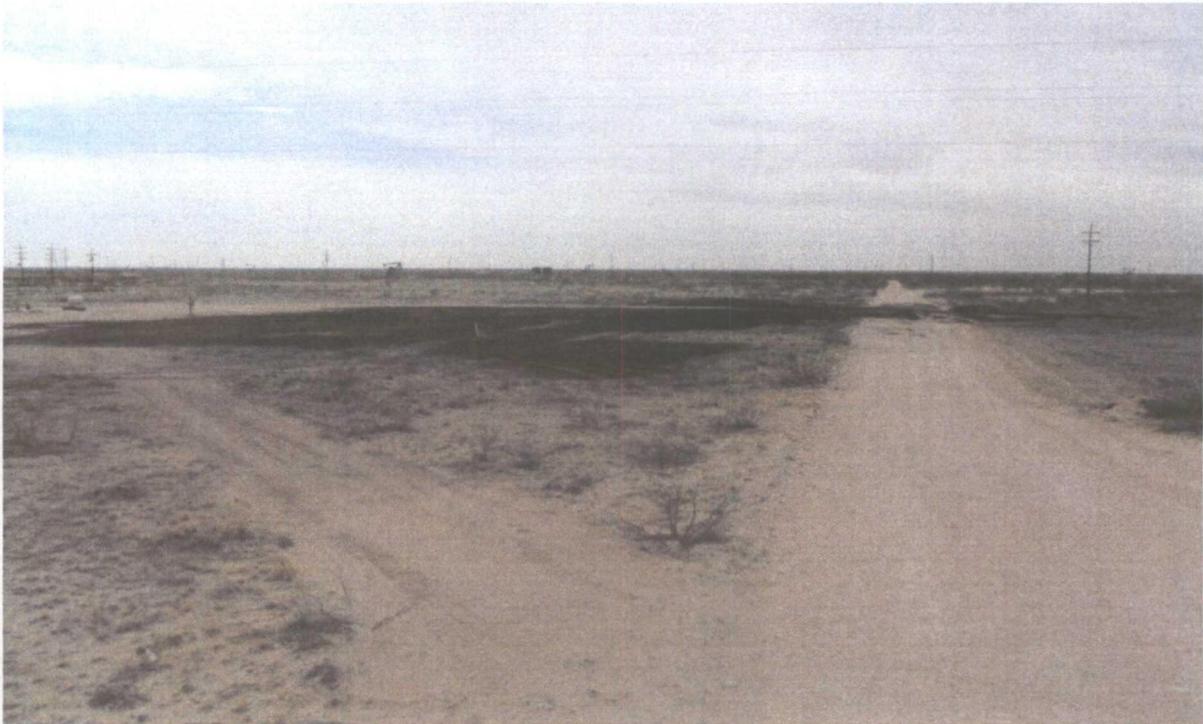
14 Inch Vac to Jal Legacy Initial Release

On April 9, 2009, Plains discovered a crude oil release from a fourteen (14)-inch steel pipeline. The cause of the release was attributed to external corrosion of the pipeline and was reported to the New Mexico Oil Conservation Division (NMOCD) on April 9, 2009. During initial response activities, Plains installed a temporary clamp on the pipeline to mitigate the release. Approximately two hundred fifty (250) barrels of crude oil was released from the pipeline, with no recovery. General photographs of the site are provided as Appendix C.

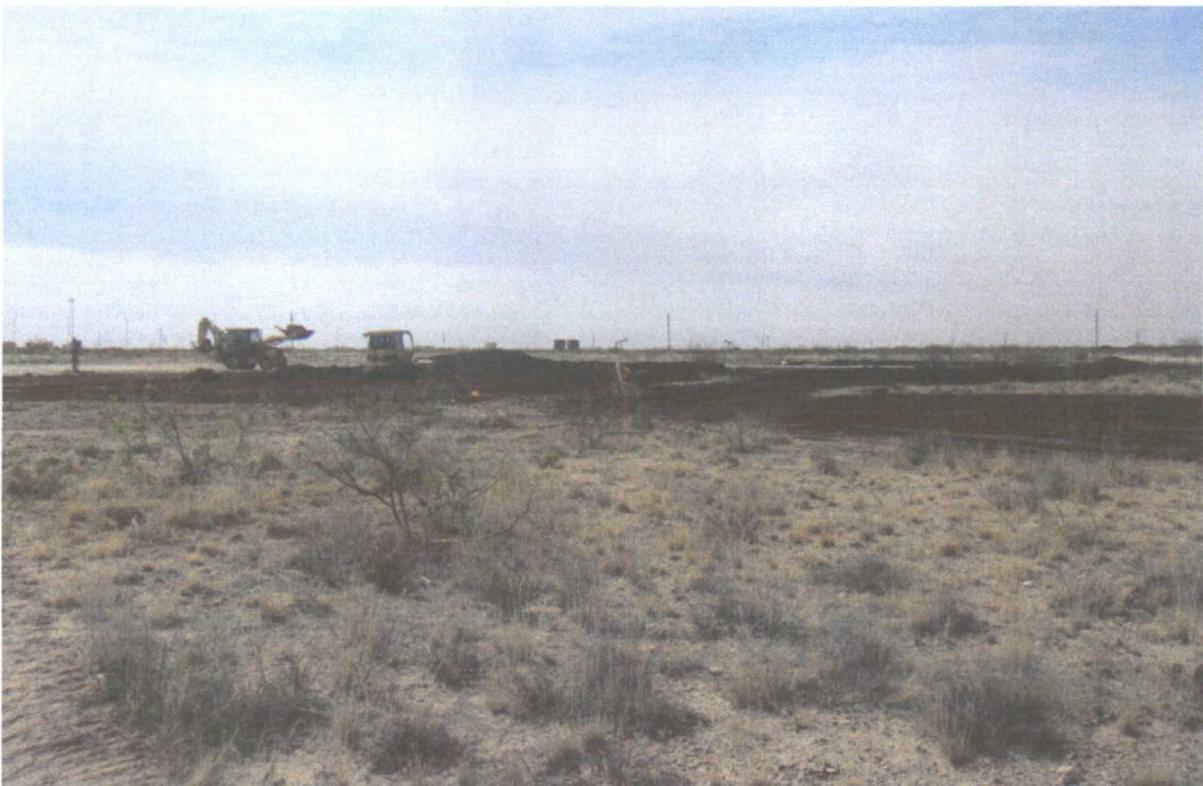
Excavation Activities at the 14 Inch Vac to Jal Legacy Release Site

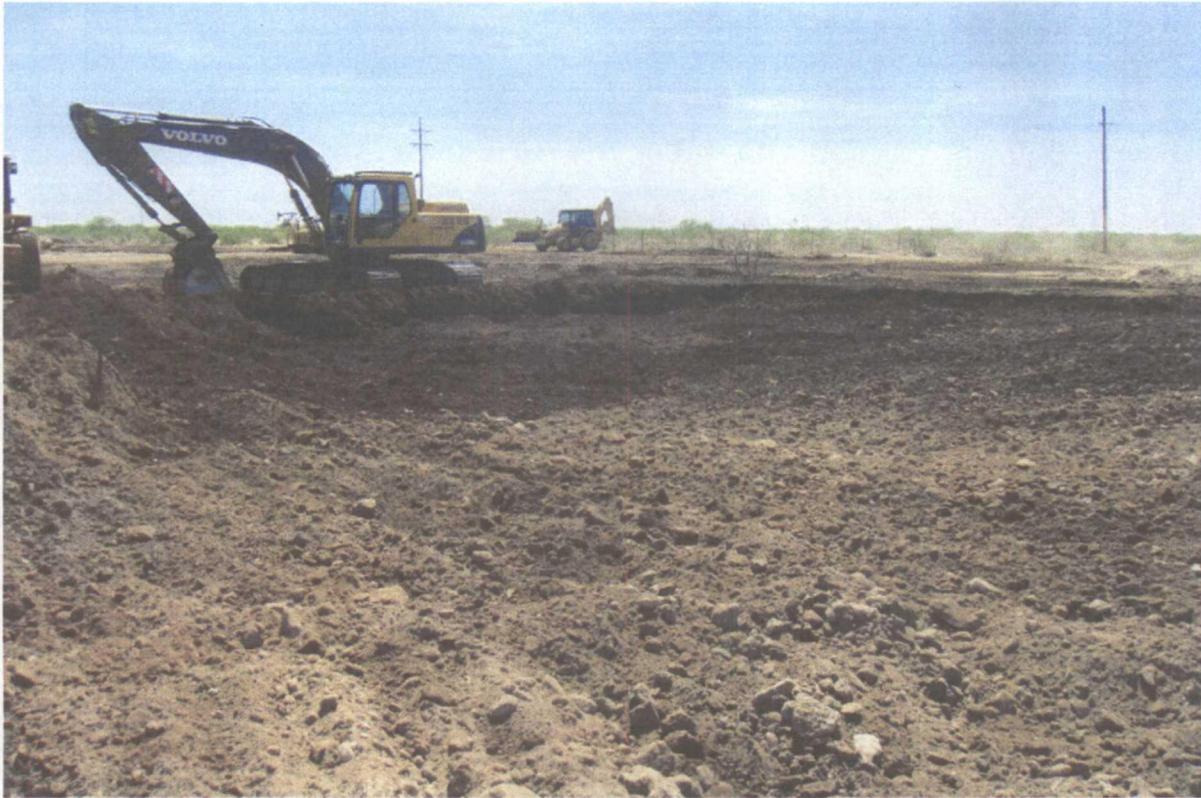
Excavation Activities at the 14 Inch Vac to Jal Legacy Release Site

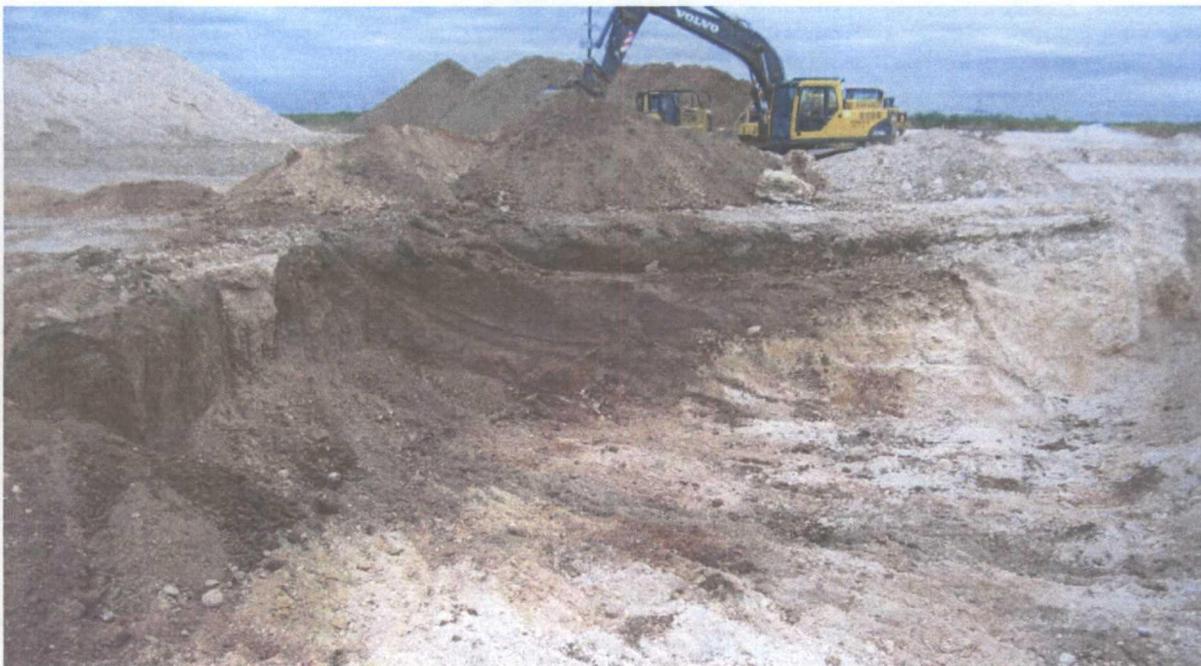
Excavation Activities at the 14 Inch Vac to Jal Legacy Release Site

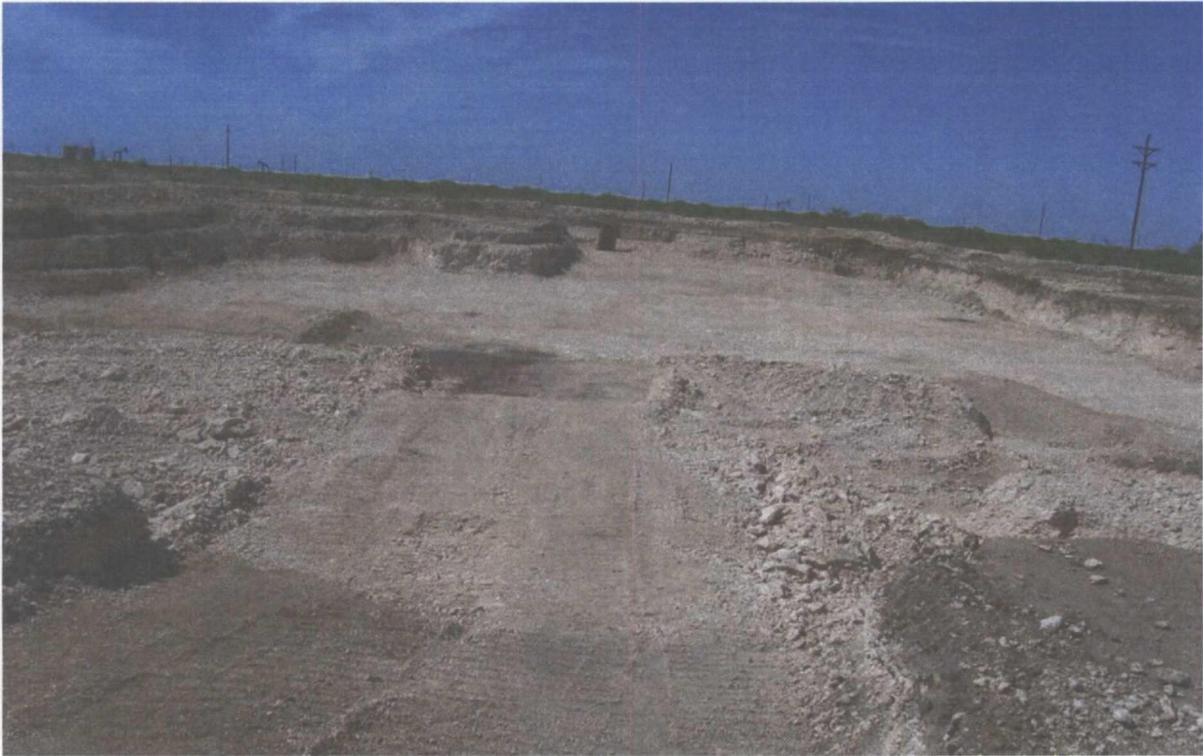
14 Inch Vac to Jal Legacy Release Site Looking South

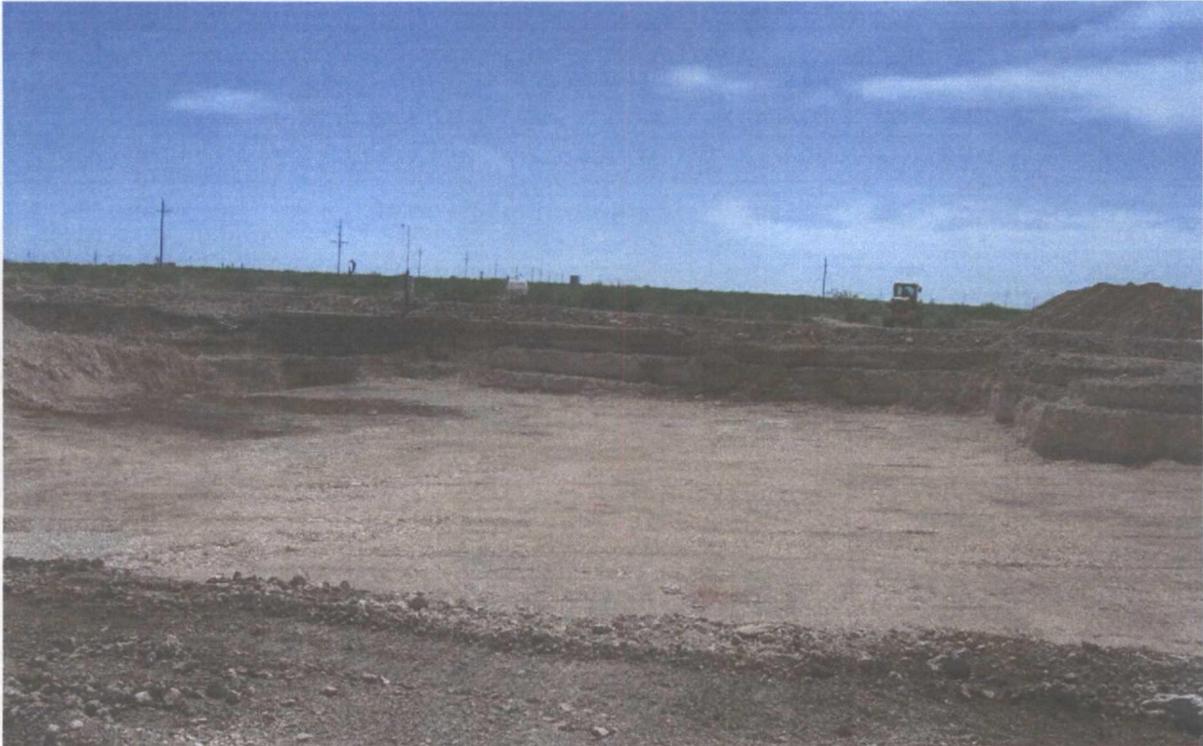
14 Inch Vac to Jal Legacy Release Site Looking East

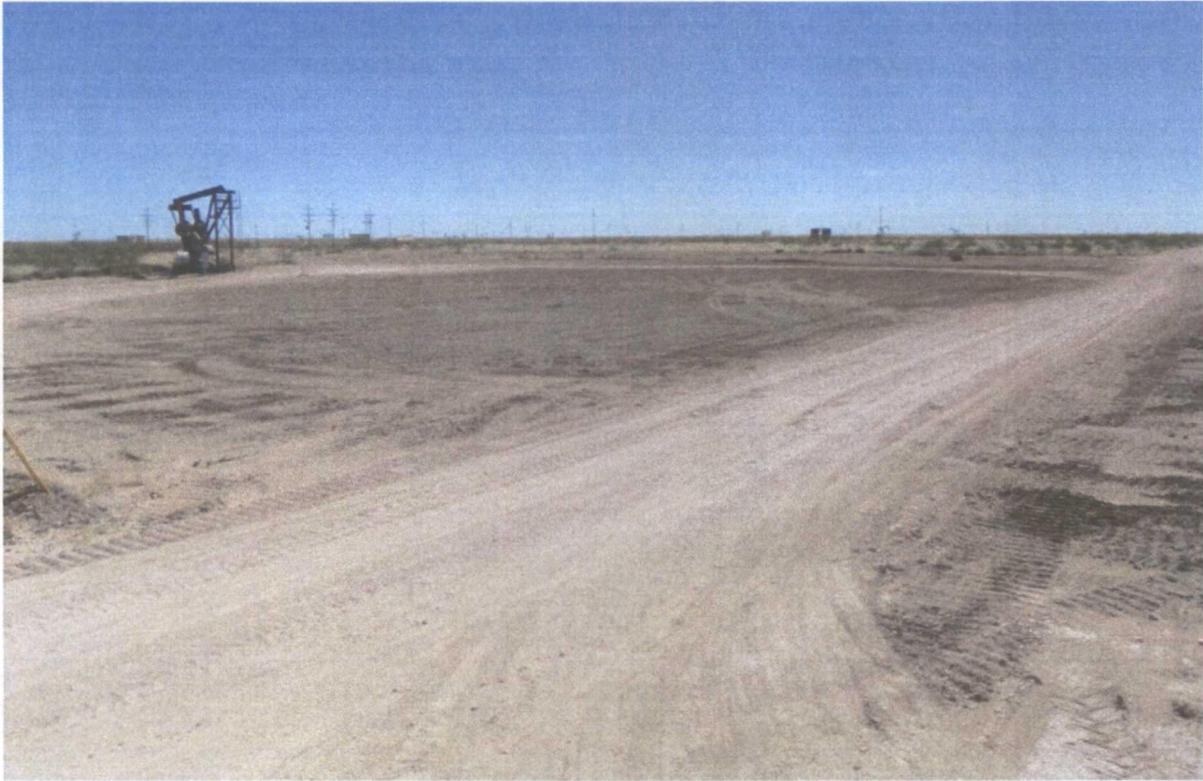
Completion of Remediation Activities at the 14 Inch Vac to Jal Legacy Release Site

Basin recommends that Plains request site closure status for the 14-Inch Vac to Jal Legacy release site. The activities conducted at the site met the objectives set forth in the “Remediation Summary and Proposed Soil Closure Strategy”. It is recommended that Plains not conduct any further remediation activities at the site.

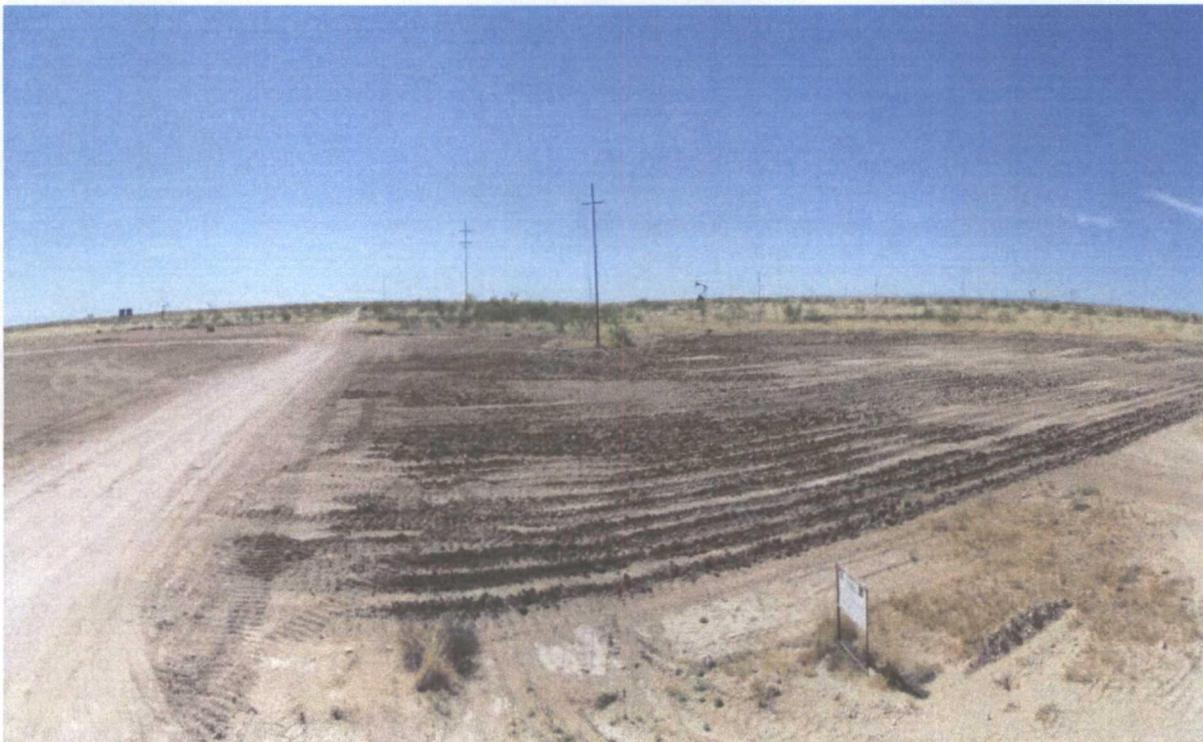
Completion of Remediation Activities at the 14 Inch Vac to Jal Legacy Release Site
