Re: Project Update  
Rice Operating Company – Vacuum SWD System  
Vacuum F-34 Vent Boot UL F, Sect 34, Township 17S, Range 35E  
NMOCD Case Number 1R425-67

Rice Operating Company (ROC) has completed the installation of a double synthetic subsurface soil liner and surface restoration as the vadose zone protective remedy for the Vacuum F-34 Vent Boot project (location map given in Figure 1), as summarized in the previously submitted (November 26<sup>th</sup>, 2010) Notification of Groundwater Impact and Addendum submitted December 22, 2010. This work, which was completed in April and May of this year, is summarized, below:

## VAC F-34 Vent Boot

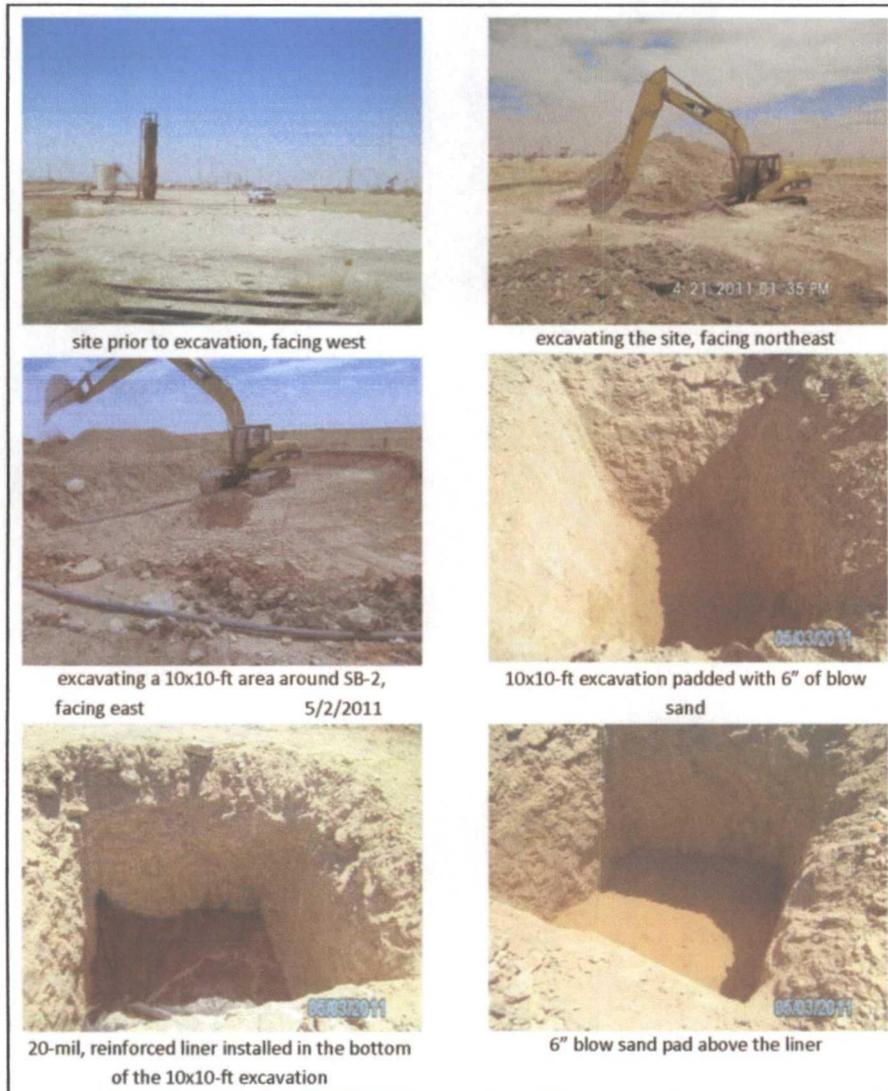
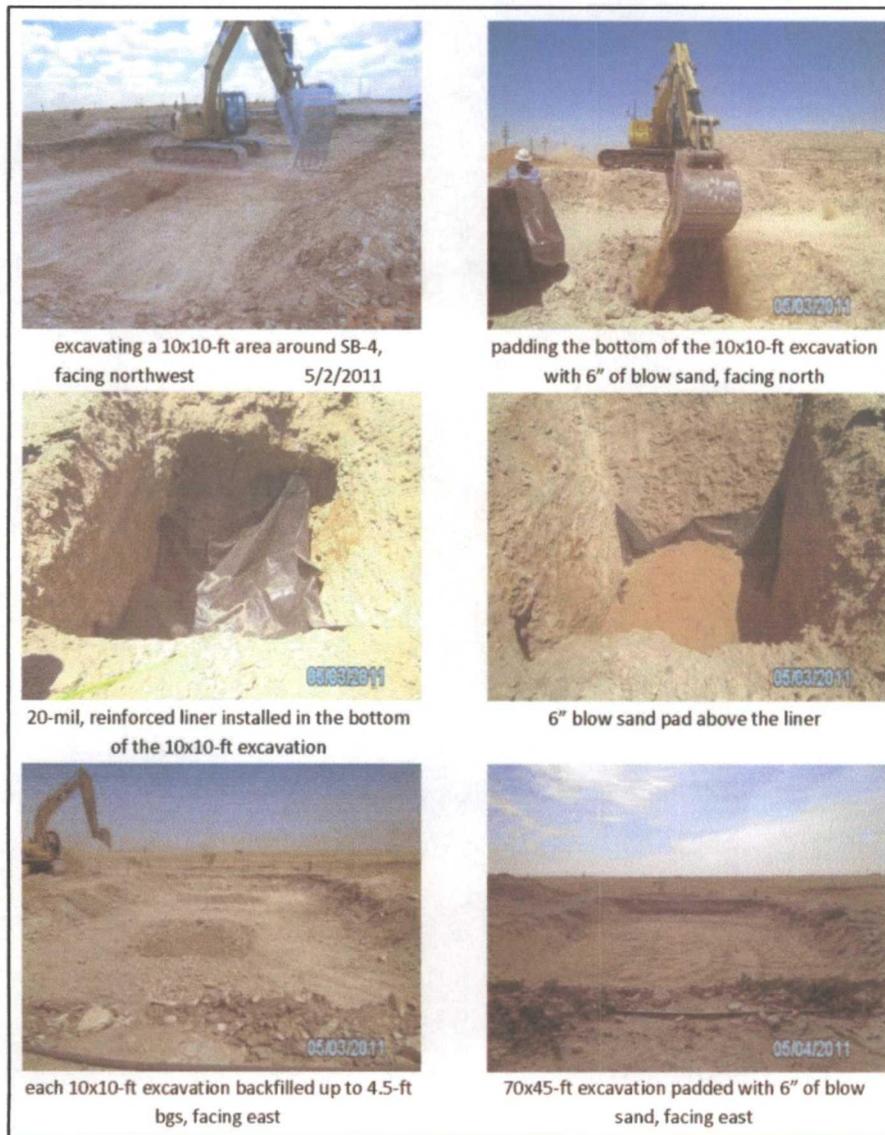
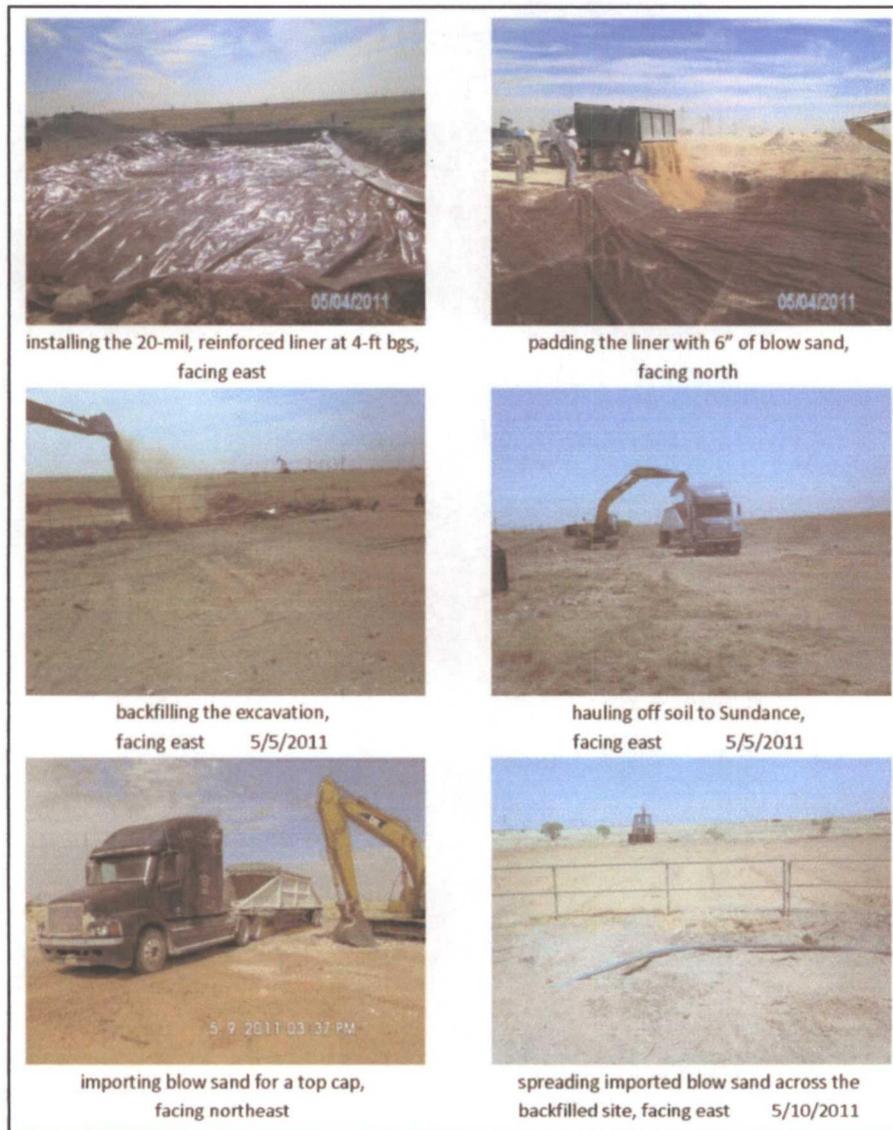
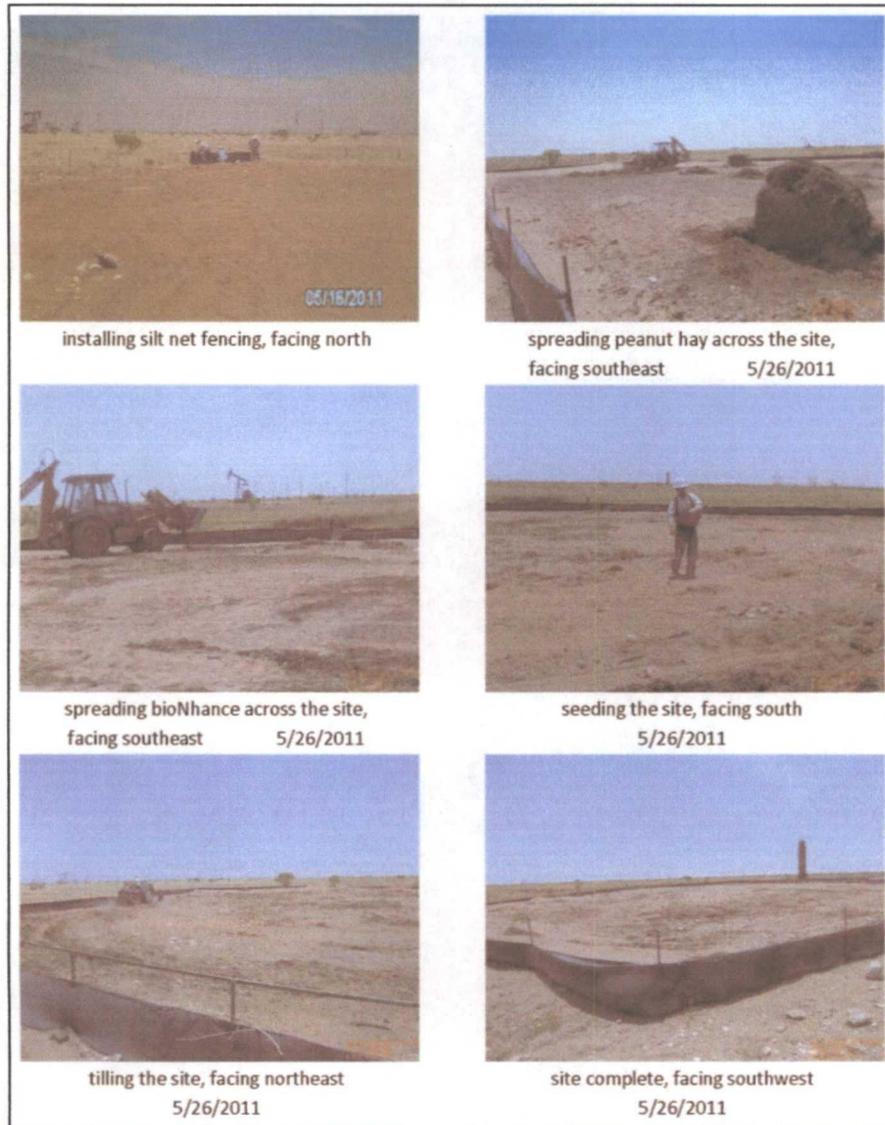
**Figure 2a** – Photo-chronology of double-liner installation and soil restoration.

Figure 2b – Photo-chronology of double-liner installation and soil restoration.

**Figure 2c** – Photo-chronology of double-liner installation and soil restoration.

**Figure 2d** – Photo-chronology of double-liner installation and soil restoration.

- Soils were excavated to 4.5 ft bgs over an area of approximately 75 by 45 ft, encompassing the surface footprint of the affected area. Large rocks were sifted and removed to Sundance Disposal.

- Additional soil material was excavated to a depth of 16 ft bgs from two separate excavations, each encompassing an area of approximately 10 by 10 ft and surrounding the soil borings, which previously indicated more significant subsurface chloride contamination (SB-2 and SB-4).

- Six inches of clean blow sand (PID = 3.1, lab chlorides < 16 mg/kg) was added as padding to the bottoms of these two, deeper excavations and a 20 mil reinforced liner was installed into each one. The liner was then padded with six inches of clean blow sand and blended backfill (PID = 38.3, lab chlorides 1,650 mg/kg) was backfilled into each 10 by 10 ft excavation to the base of the larger excavation (at 4.5 ft bgs). Six inches of clean blow sand was added as padding over the 75 by 45 ft area.

- A 20 mil reinforced liner was installed over the 75 by 45 ft excavation and six inches of clean blow sand was added as padding above it. Clean, pond-bottom soil (PID = 1.8, lab chlorides = 16 mg/kg) was then backfilled to near the surface and clean blow sand was added and contoured to the original ground surface.

- Silt fencing was installed around the restored area. 850 lbs of bioNhance and 4 bales of peanut hay were added as soil amendment. Following this, the site was seeded with 10 lbs of warm season mix, 7.5 lbs of blue gramma grass and 20 lbs of race horse oats. The soil amendments and seed were incorporated into the soil using a tractor.

A photographic chronology of this work is given in Figure 2. A total of 520 cubic yards of rock and contaminated soil material was hauled to and disposed at Sundance Disposal. A total of 608 cubic yards of blow sand and pond bottom soil was imported and used as liner padding and backfill. Field PID
