Re: Sulfuric Acid Spill Investigation and Remediation Report, Targa Midstream Services, L.P., Monument Gas Plant (GW-025), Lea County, New Mexico, June 28, 2011

**SULFURIC ACID SPILL INVESTIGATION
AND REMEDIATION REPORT**

Monument Gas Plant
(GW-025)
Lea County, New Mexico

June 28, 2011

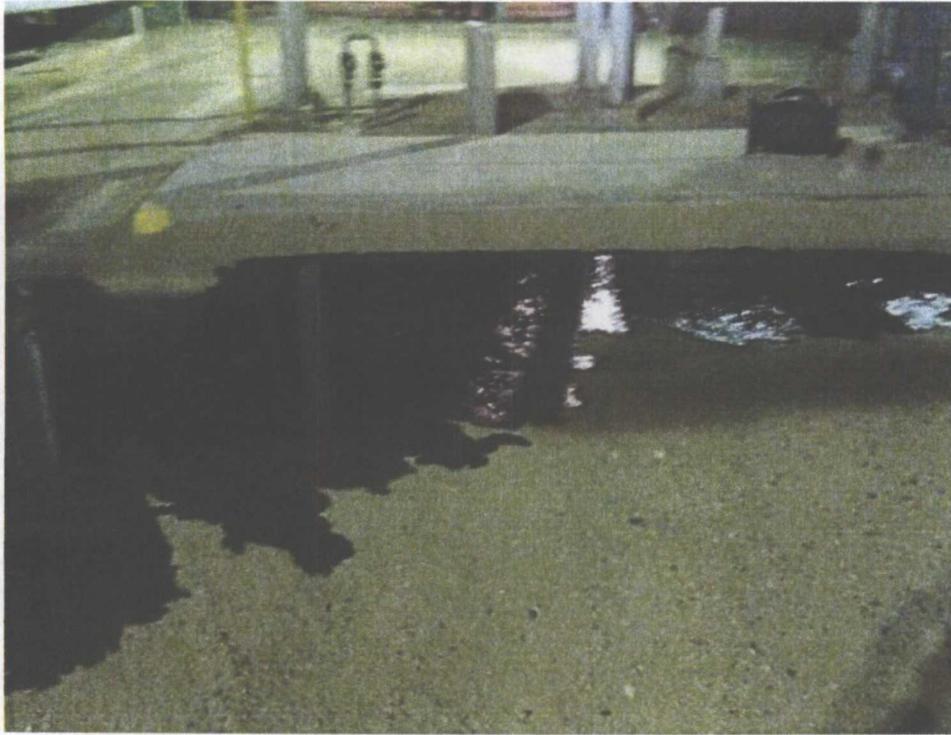
Sulfuric Acid Spill near Source (Targa, April 6, 2011)

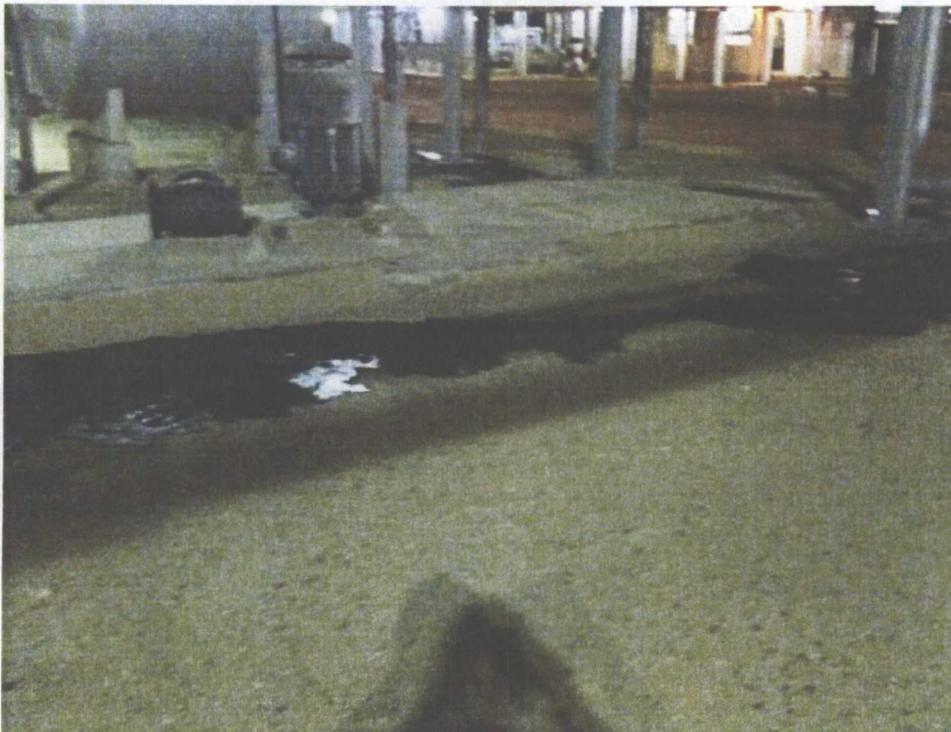
Sulfuric Acid Spill East of Tank (Targa, April 6, 2011)

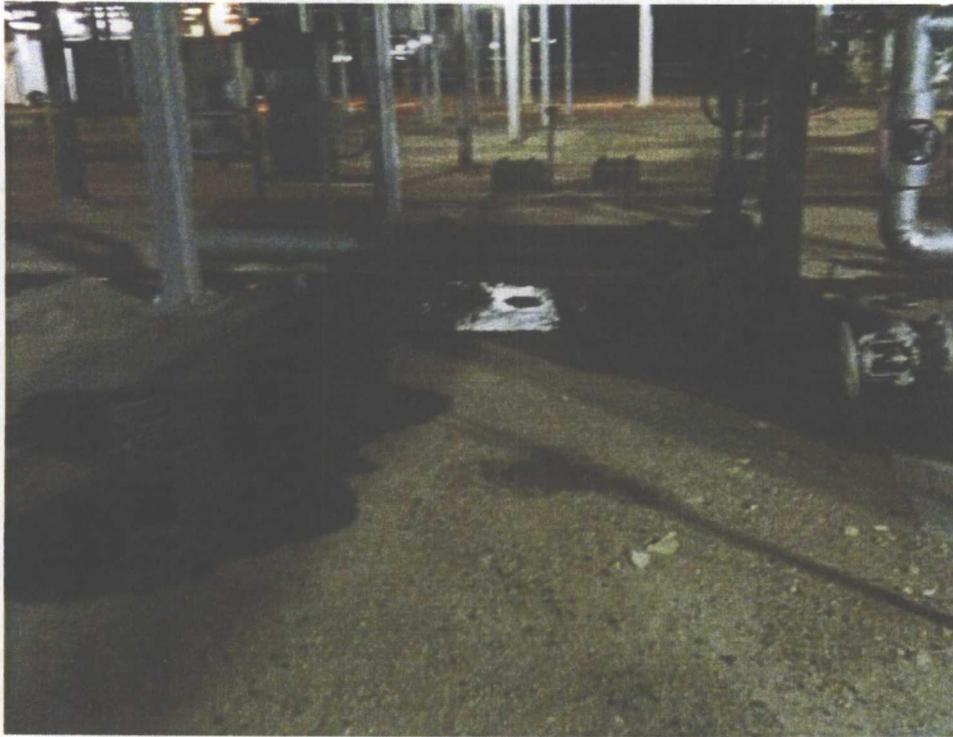
Sulfuric Acid Spill East of Tank (Targa, April 6, 2011)

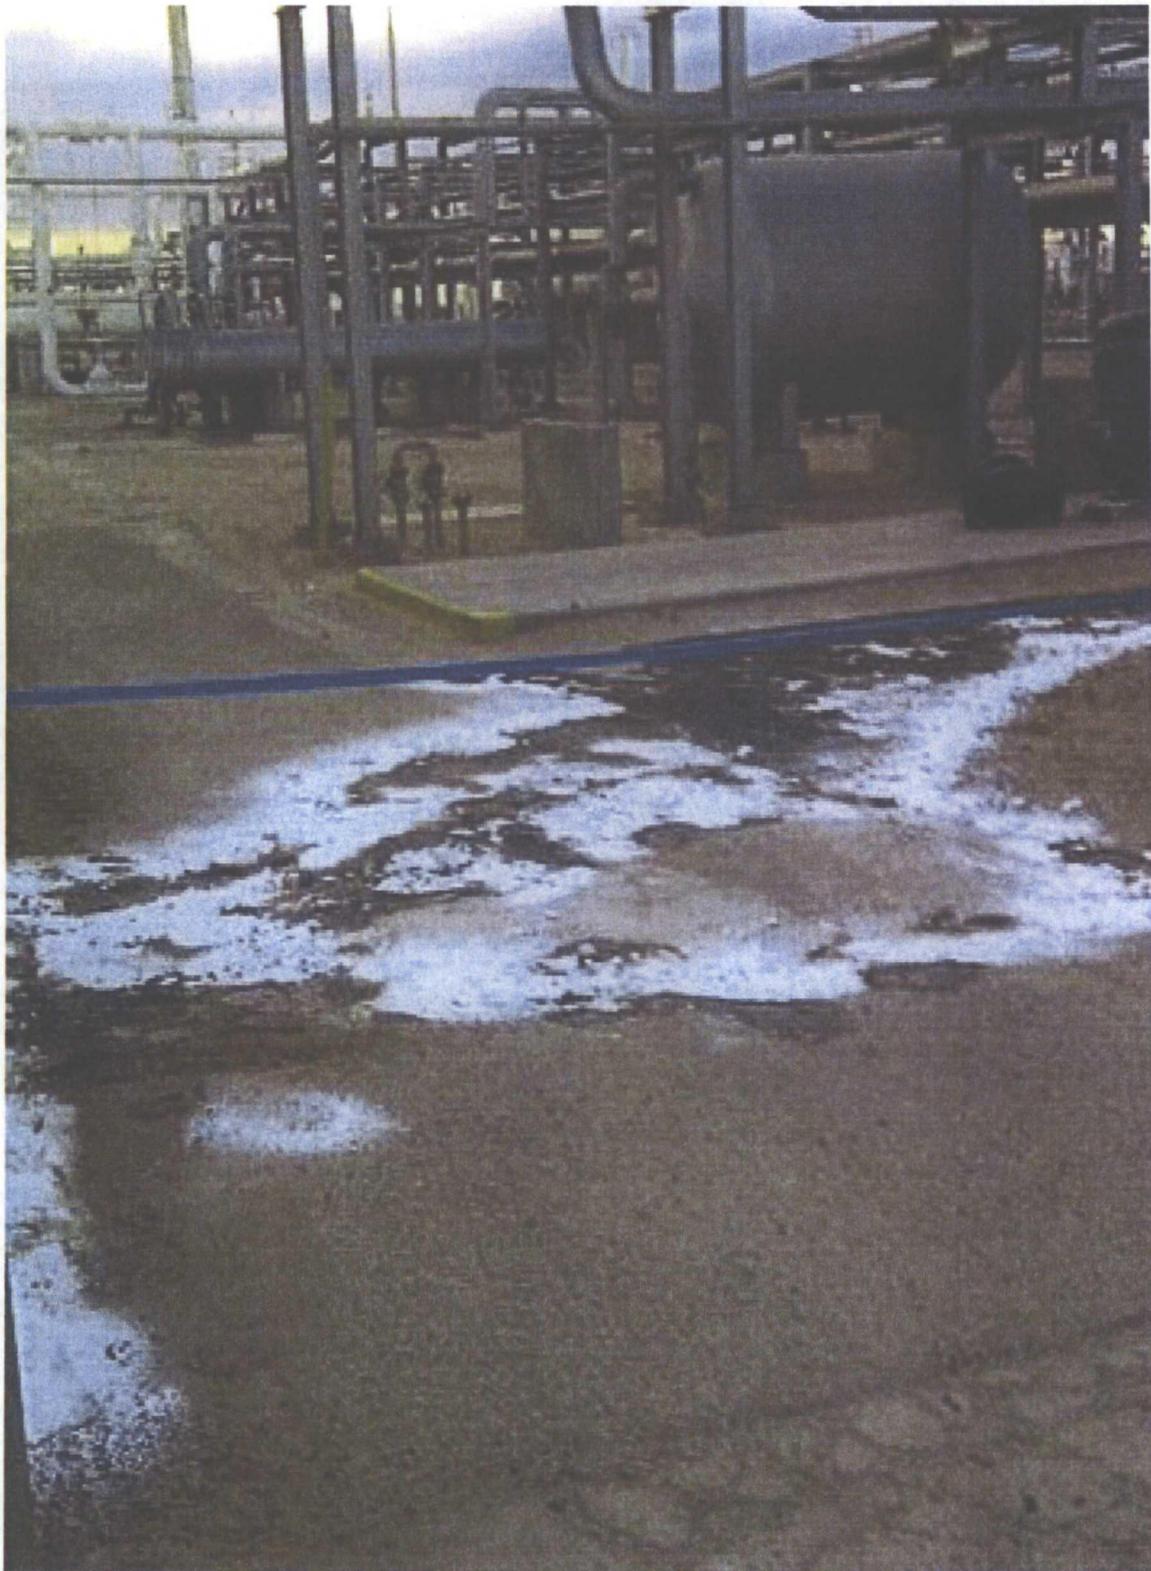
Sulfuric Acid Spill after Neutralizing with Soda Ash (Targa, April 7, 2011)

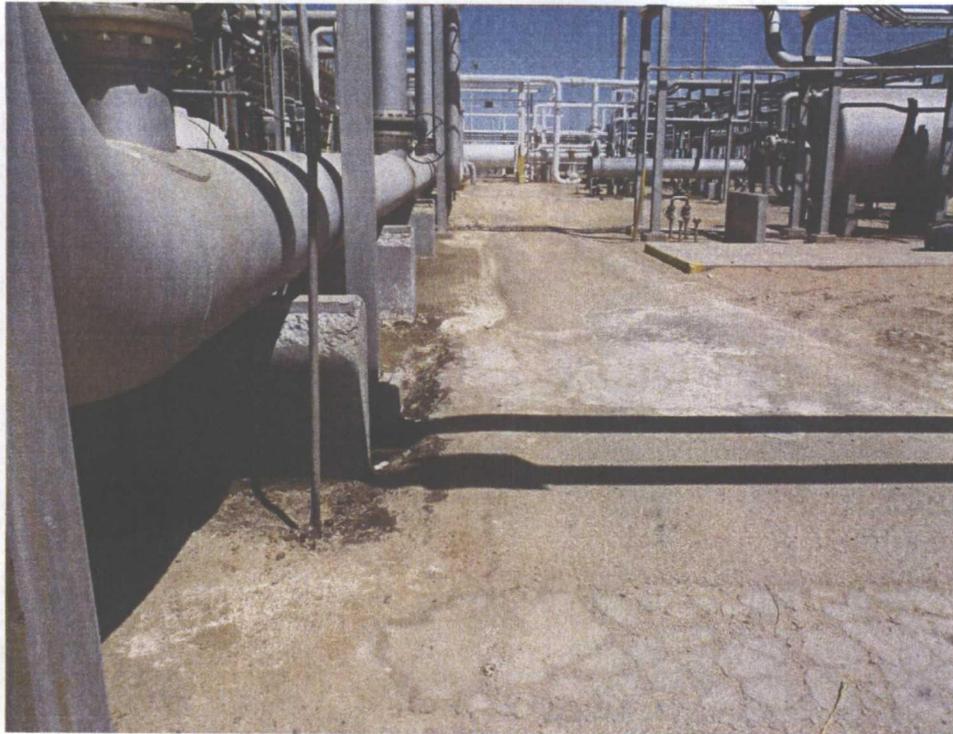
Sulfuric Acid Spill after Cleanup, April 19, 2011

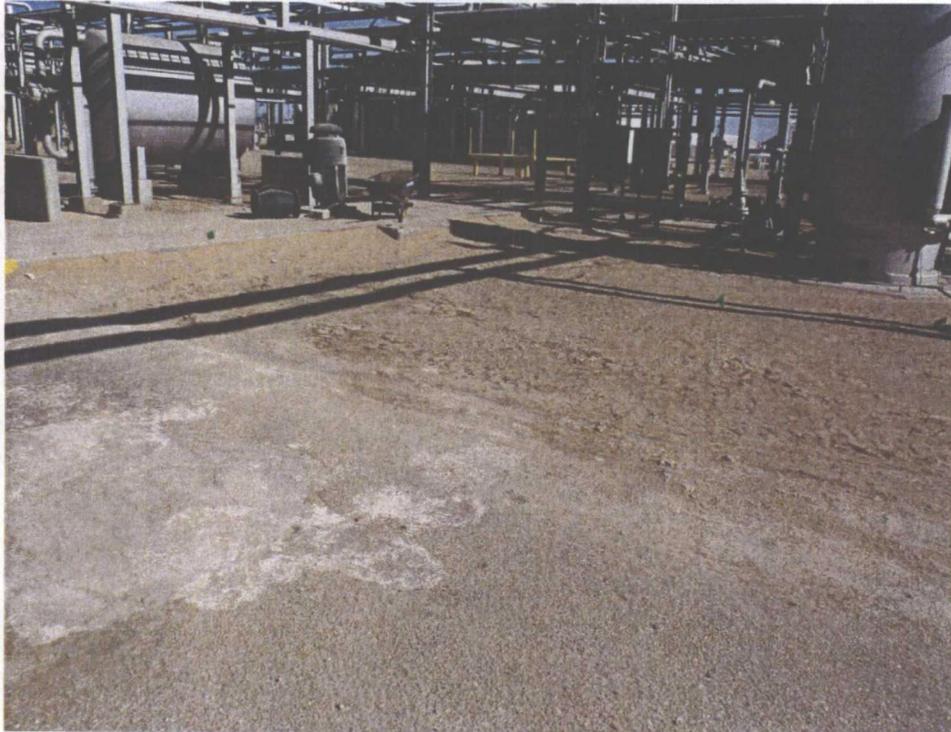
Sulfuric Acid Spill after Cleanup, April 19, 2011

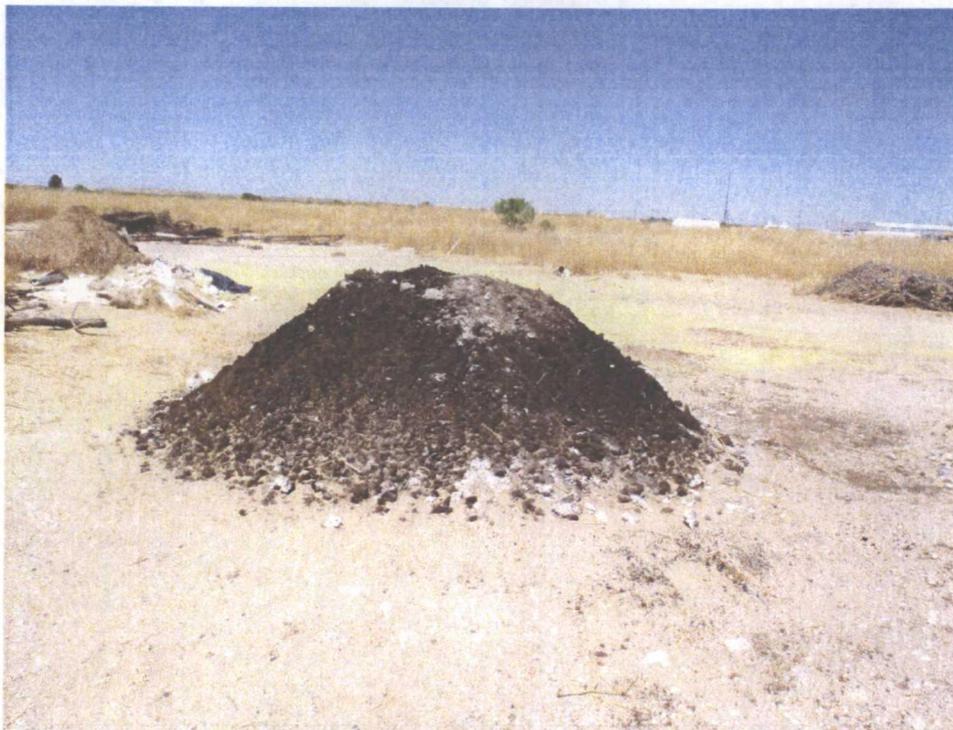
Contaminated Soil Pile, April 19, 2011

The blended soil, estimated to be about 10 to 20 cubic yards, will be disposed at Lea Land Landfill or Sundance Disposal, Inc. Targa will submit a letter to the OCD along with the waste manifest following disposal of the contaminated soil.
