Subject:
INITIAL CORRECTIVE ACTION PLAN (CAP) REPORT
NMOCD Case # 1R426-101
Blinebry-Drinkard (BD) H-14
T22S, R37E, Section 14, Unit H, Eunice, Lea County, New Mexico

On behalf of Rice Operating Company (ROC), ARCADIS respectfully submits this Initial Corrective Action Plan Report for the BD H-14 site located in the Blinebry-Drinkard (BD) Salt Water Disposal (SWD) System.

BD H-14 (1R426-101)
Unit H, Section 14, T22S, R37E

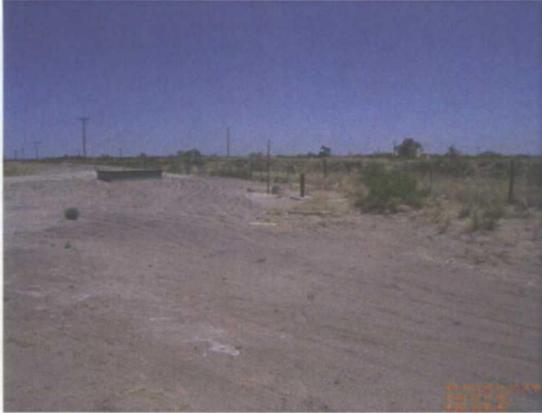
site prior to excavation, facing north

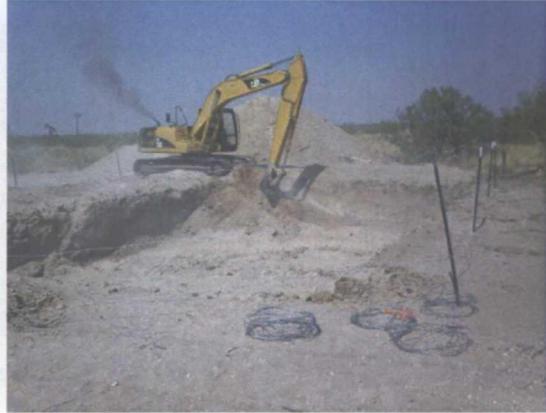
excavating the north side of the site to a depth of 7 ft bgs, facing southwest 6/8/2011

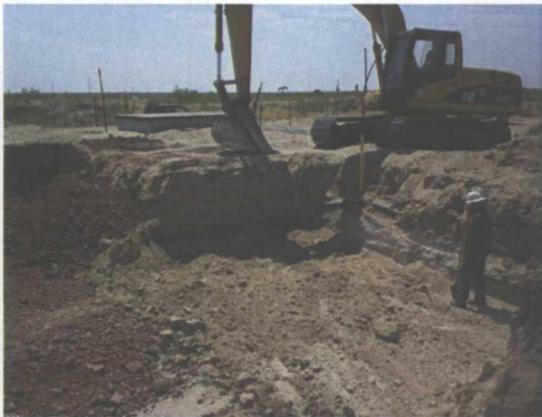
completed excavation with the existing clay barrier located, facing east 6/9/2011

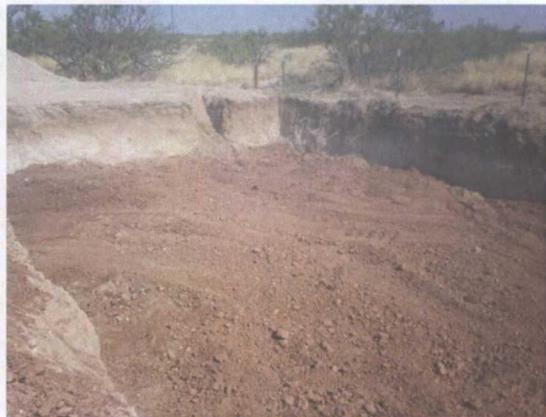
clay barrier installed on the north side of the site, facing west 6/10/2011

The liner was extended per the approved addendum to the CAP. Excavation and liner placement activities were conducted from June 6, 2011 through June 28, 2011. The existing 38x36 ft clay barrier was located and matched with a 58x84 ft clay barrier installed from 7 to 6 ft bgs. A compaction test was performed on the north side of the site on June 10, 2011 with a result of 93.8% and was backfilled with soil containing a chloride concentration of 256 mg/kg and a PID reading of 46.8 ppm. A compaction test was performed on the south side of the site on June 23, 2011 with a result of 94.3% and was backfilled with soil containing a chloride concentration of 192 mg/kg and PID reading of 10.5 ppm. On July 15, 2011 a soil amendment (RestoreNhance) was added to the backfilled site and the site was seeded with black grama seed. A summary of excavation activities, laboratory analytical reports of blended and composite backfill, compaction test results, proctor test results, hydraulic conductivity report, ROC sampling PID reports, vegetation form and site photographs are attached.

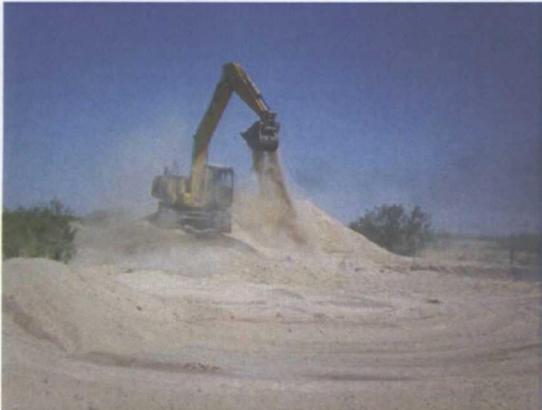
blending the excavated soil, facing west 6/10/2011

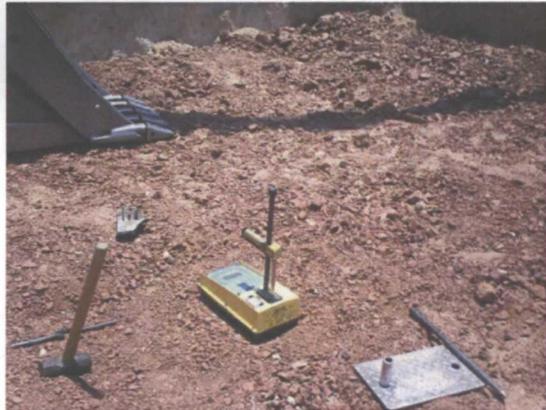
clay compaction test on the north side excavation 6/13/2011

Test No.	Location	Dry Density		Depth
		% Max	% Moisture	
SG 1	Approximately 10' N. & 10' W. of SE Corner	*95.2	11.0	7' Below Natural Ground
RT SG 1	Approximately 20' W. & 10' N. of SE Corner	93.8	9.1	7' Below Natural Ground

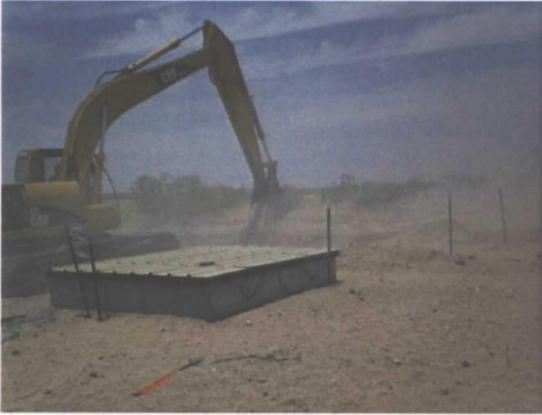
backfilling the north side of the excavation with blended backfill, facing northwest 6/13/2011

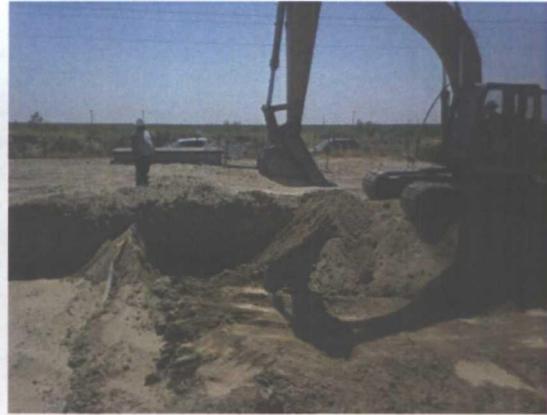
excavating the south side of the site to a depth of 7 ft bgs, facing east 6/17/2011

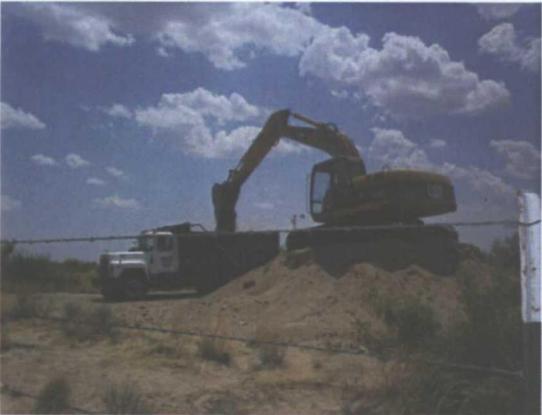
hauling excavated soil to Sundance for disposal, facing southwest 6/22/2011

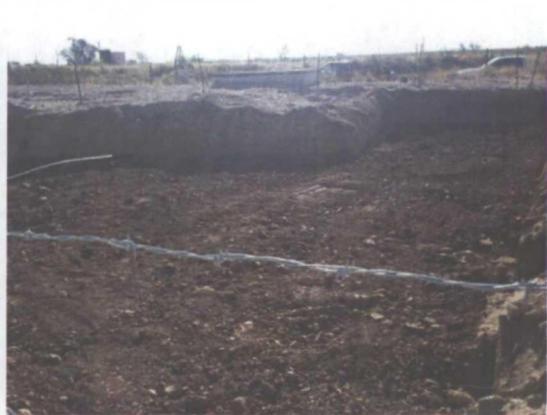
completed excavation with the clay barrier installed on the south side of the site, facing northeast 6/24/2011

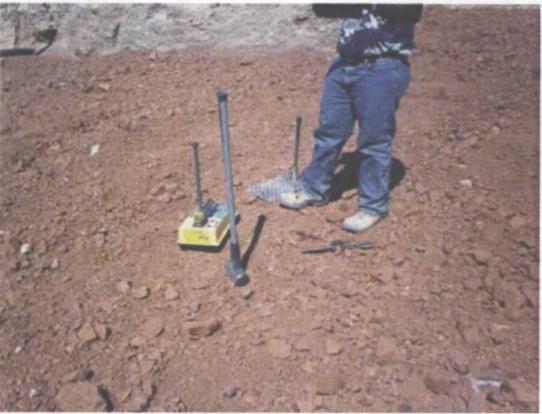
clay compaction test on the south side excavation 6/23/2011

Test No.	Location	Dry Density % Max	% Moisture	Depth
SG 2	BD Junction H-14	94.3	10.0	FSG

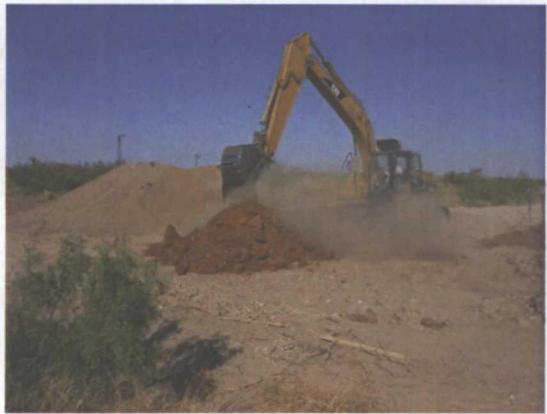
blending excavated soil with imported soil, facing southwest 6/25/2011

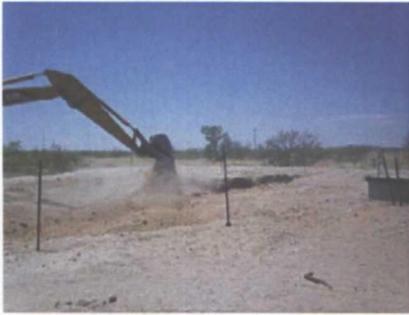
backfilling the south side of the excavation with blended backfill, facing northwest 6/27/2011

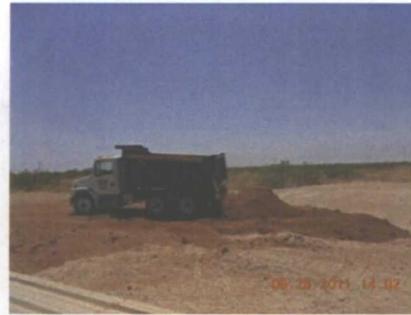
importing clean blow sand, facing west 6/28/2011

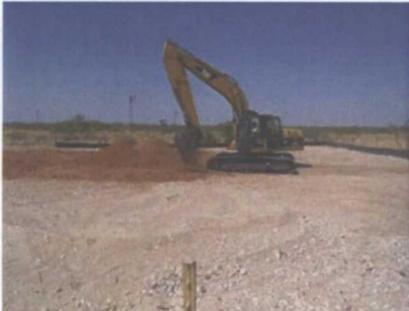
contouring the site to the surrounding area, facing south 6/30/2011

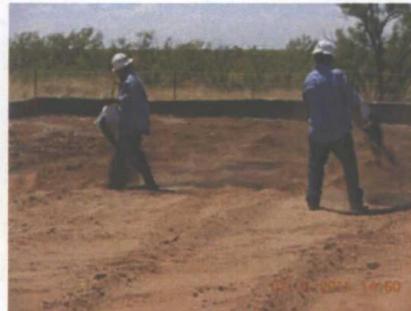
adding restorNhance to the backfilled site, facing northwest 7/15/2011

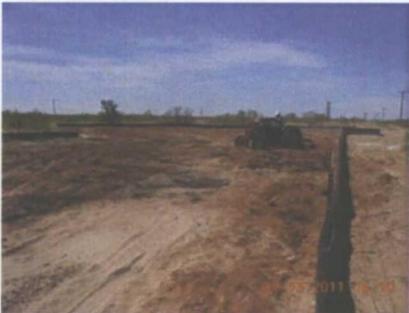
tilling the restorNhance into the soil, facing north 7/15/2011

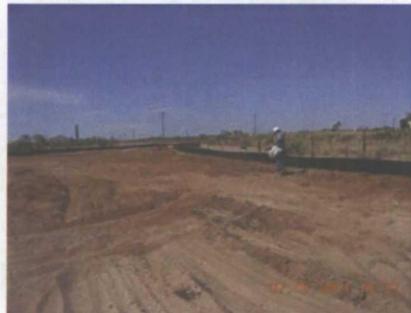
seeding the backfilled site, facing northeast 7/15/2011

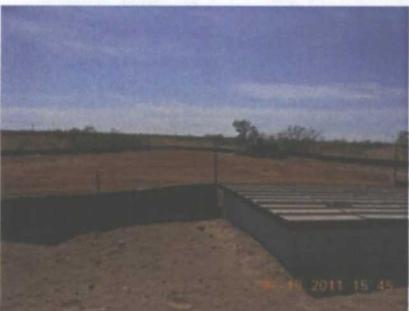
tilling the seed into the soil, facing north 7/15/2011

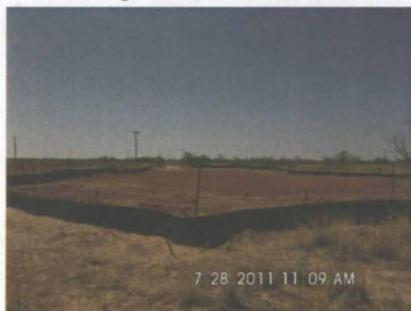
site complete, facing south 7/28/2011
