**RE: CAP REPORT AND TERMINATION REQUEST
Rice Operating Company – EME SWD System
EME I-13 EOL (1R427-95): UL/I sec. 13 T19S R36E
(formerly EME P-13 EOL)**

Corrective Action Plan Report

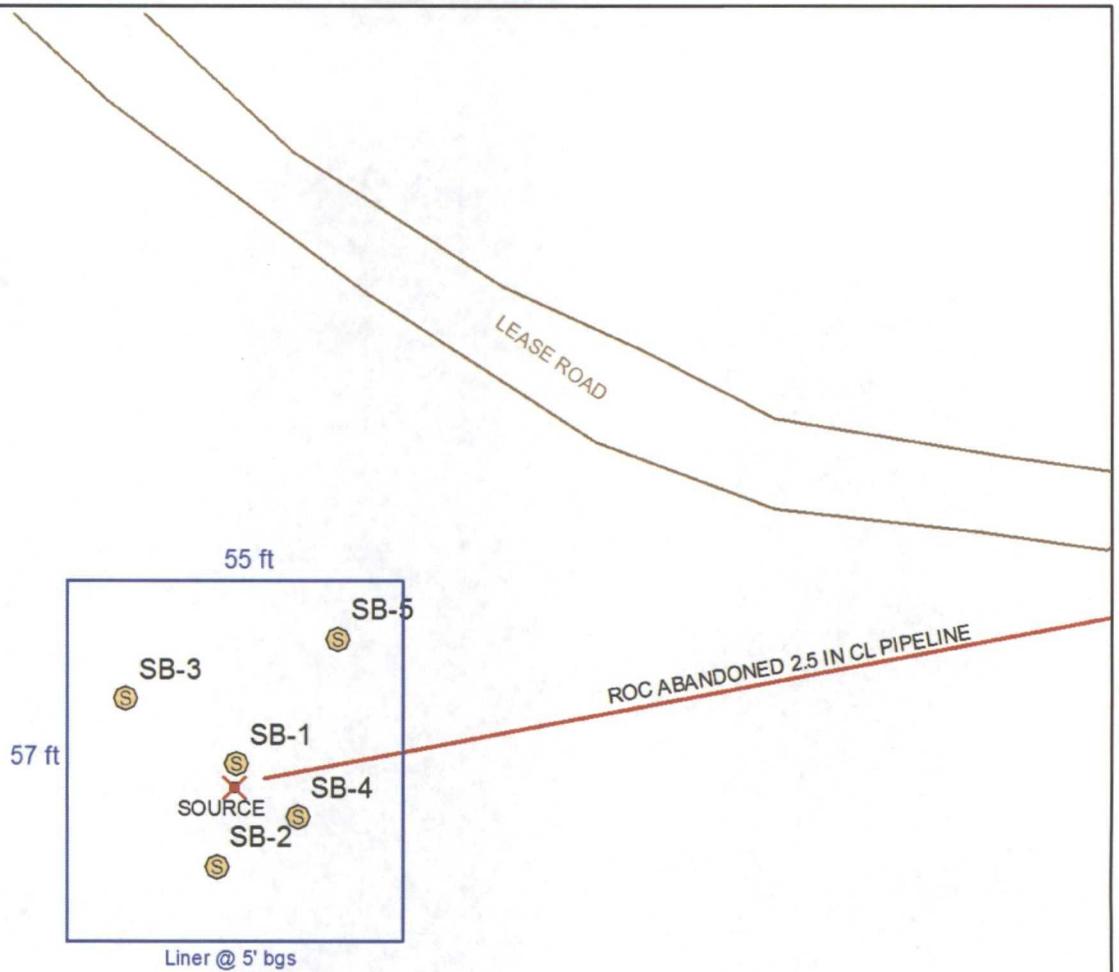
Figure 2

Liner Excavation

SB-1						
Depth	CI-	PID	LAB	CI-	GRO	DRO
15	454	37.7	448		<10	<10
20	178	9.6				
25	178	6.8				
30	147	5.5	64		<10	<10

SB-2						
Depth	CI-	PID	LAB	CI-	GRO	DRO
SS	87	0				
5	1059	1.2				
10	1097	2.9	1200		<10	<10
15	293	1.2				
20	197	3.4	176		<10	<10

SB-3						
Depth	CI-	PID	LAB	CI-	GRO	DRO
SS	110	0.2				
5	735	2.4	688		<10	40.5
10	571	0.4				
15	418	5.6				
20	181	0.8	176		<10	40

SB-4						
Depth	CI-	PID	LAB	CI-	GRO	DRO
SS	88	0.2				
5	435	3.4				
10	891	0.6	1020		<10	40.2
15	288	0.7				
20	165	0.5	96		<10	<10

SB-5						
Depth	CI-	PID	LAB	CI-	GRO	DRO
SS	84	0				
5	492	1.3				
10	1263	1.1	1300		<10	<10
15	419	0.6				
20	196	0.1	144		<10	64.9

DGW = 51 ft

As part of the Investigation and Characterization Report and Corrective Action Plan approved by NMOCD on August 17th, 2011, ROC began the infiltration liner excavation on August 24th, 2011 (Figure 2). The site was dug to 57 ft x 55 ft x 5 ft deep and 300 yards of the excavated soil was disposed of at an NMOCD approved facility. The remainder of the excavated soil was blended on site to use as backfill. A sample of the blended soil was field tested with a photo-ionization detector (PID) for hydrocarbons and gave a reading of 0.9 ppm. The sample was then taken to a commercial laboratory for chloride analysis. The chloride laboratory reading for the blended backfill returned a result of 448 mg/kg (Appendix A).

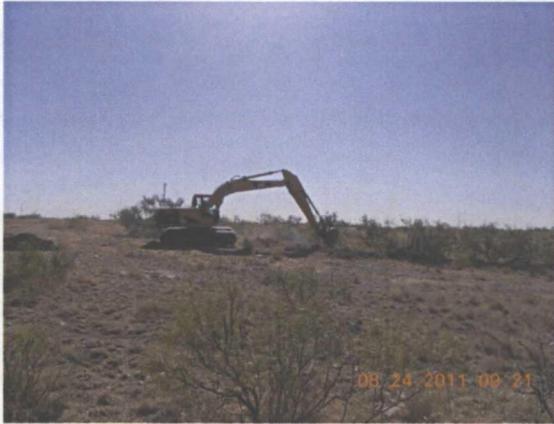
Beginning excavation, facing east 8/24/11

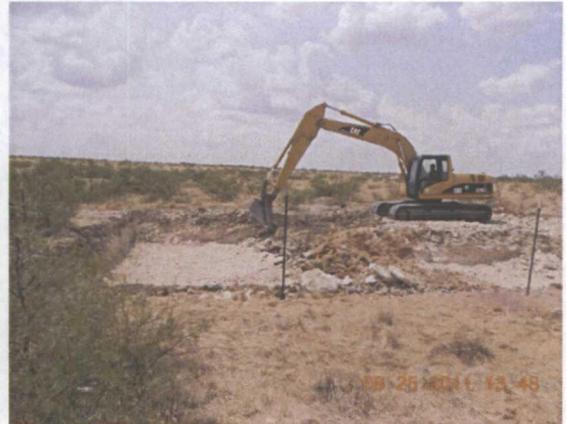
Excavating site, facing west 8/25/11

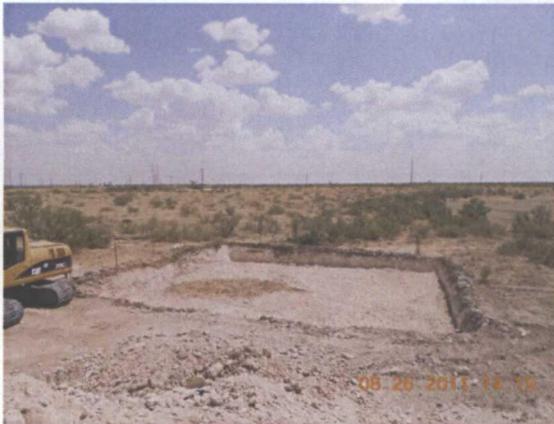
Completed excavation, facing south 8/26/11

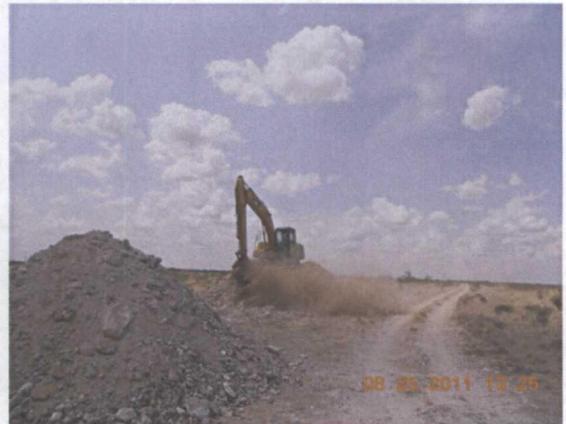
Blending the backfill, facing west 8/25/11

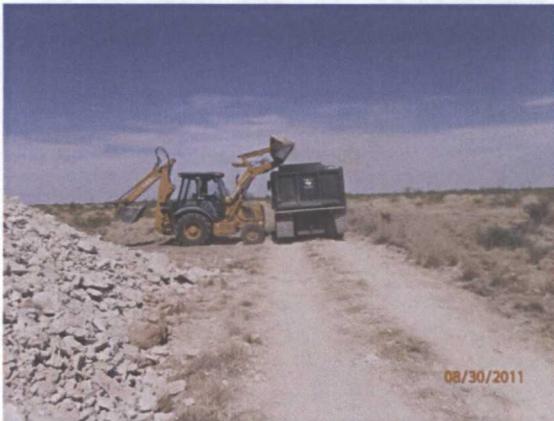
Exporting the spoil pile, facing west 8/30/11

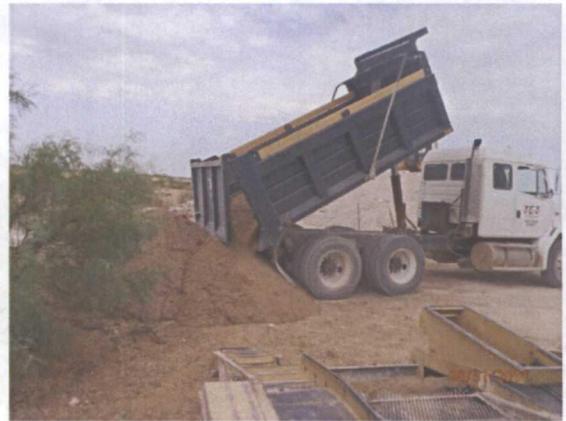
Importing blow sand, facing west 8/31/11

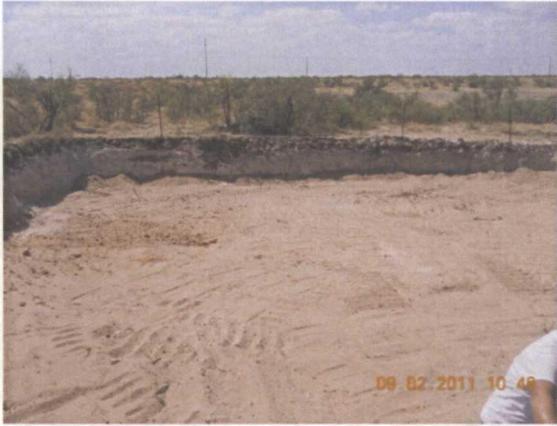
Pad installed below liner, facing south 9/2/11

Imported soil was used to pad the liner. A six inch pad was placed below and above the liner to protect it from punctures. The imported soil was field tested with a PID meter and returned a result of 0.0 ppm. The sample was then taken to a commercial laboratory for analysis of chlorides. The chloride laboratory reading of the imported soil returned a result of non-detect (Appendix B). A 20-mil reinforced poly liner was installed throughout the excavation on September 2nd, 2011. The excavation was then backfilled with the blended soil to a depth of 6 inches. Imported soil was used to complete the

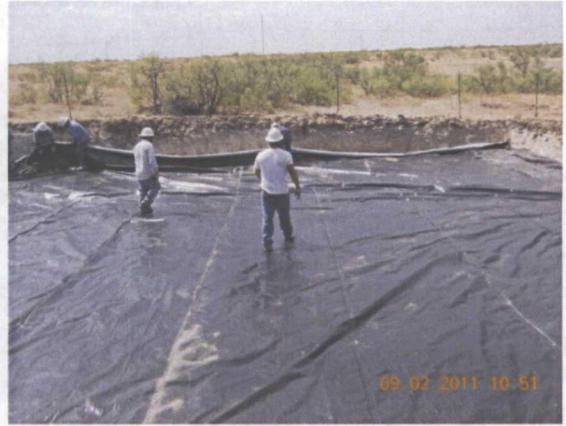
Installing the liner, facing south 9/2/11

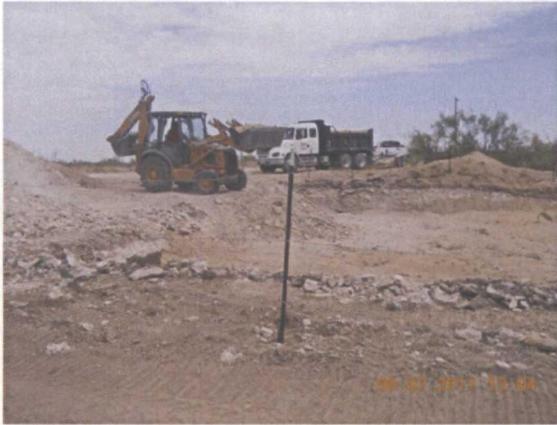
Backfilling over padded liner, facing east 9/8/11

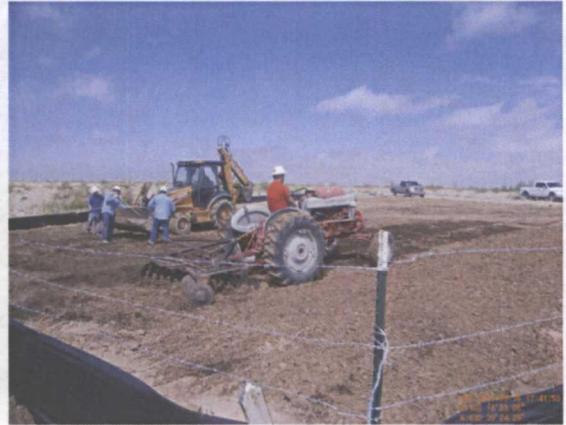
Adding soil amendments and disking, facing west 9/16/11

On September 16th, 2011, the site was disked and soil amendments were added. The site was seeded with a blend of native vegetation and is expected to return to normal vegetative capacity (Appendix C). Photo for the infiltration liner excavation are located in Appendix D.

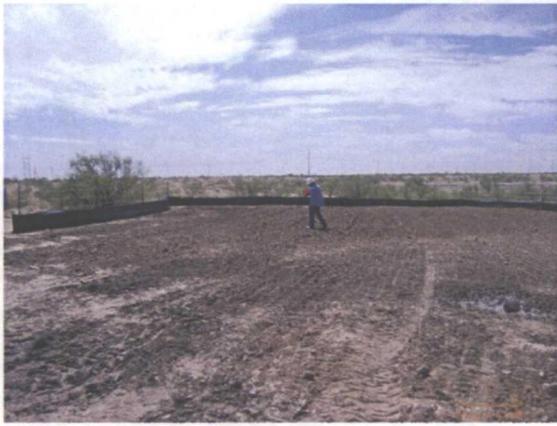
Seeding the site, facing south 9/16/11

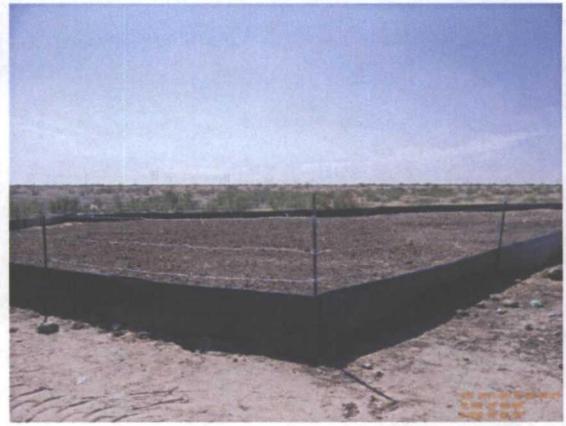
Site completed, facing west 9/16/11
