1R - 427-282

September 20th, 2011

**RE: ICP Report and Termination Request
Rice Operating Company – EME SWD System
EME K-9 vent (1R427-282): UL/K sec. 9 T20S R37E**

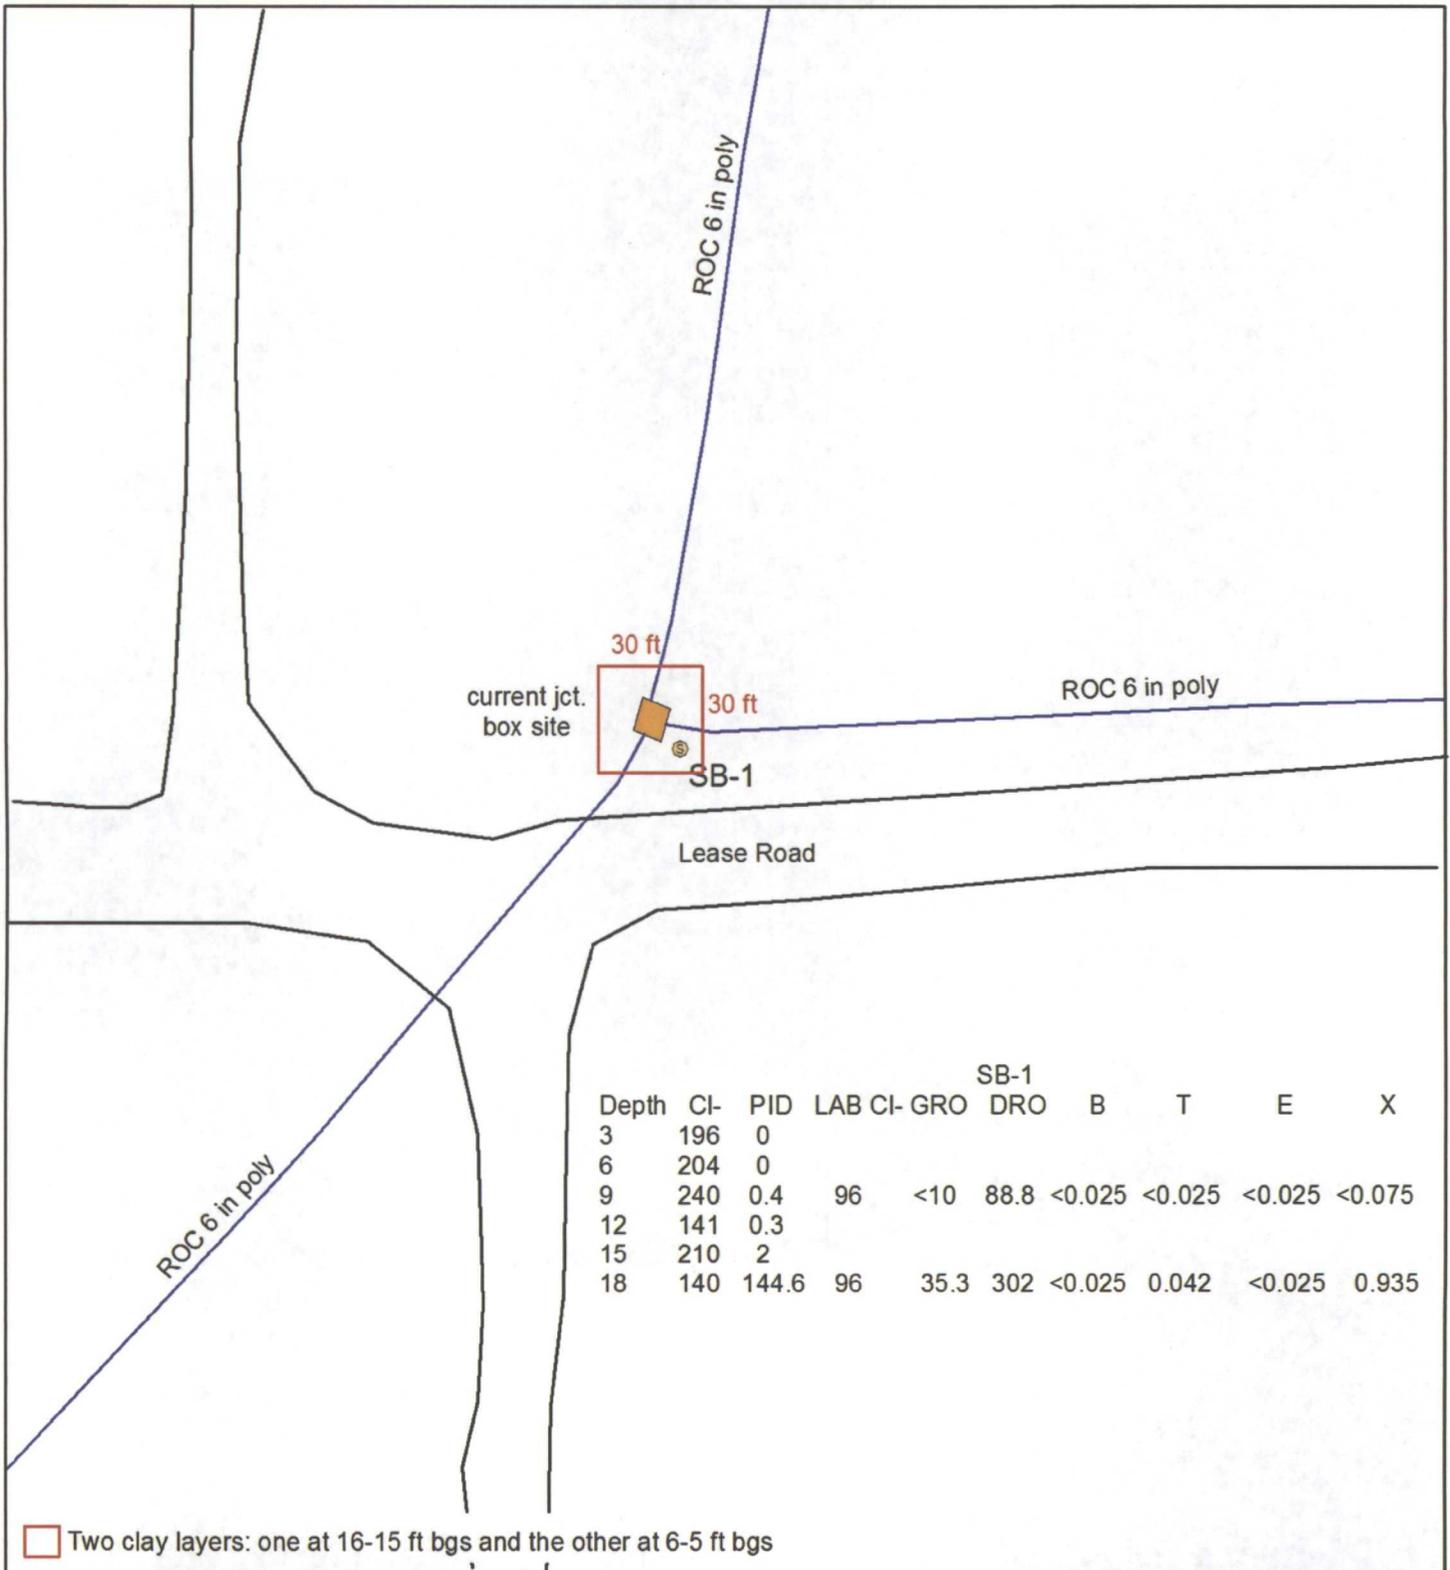
Figure 2

As part of the Investigation and Characterization Plan approved by NMOCD on August 24th, 2010, one soil bore was advanced through the former junction box site to a depth of 18 ft bgs on September 14th, 2010 (Figure 2). ROC personnel field tested the soil for chlorides and screened for hydrocarbons in the field with a photo-ionization detector (PID). Representative samples from the bore were taken to a commercial laboratory for confirmation of chloride and hydrocarbon field numbers (Appendix A). Chloride concentrations were low throughout the soil bore (SB-1) confirming residual chlorides would not contribute to the degradation of groundwater in the area. PID readings were also low throughout SB-1 but peaked in the capillary fringe at 18 ft below ground surface (bgs) with a reading of 144.6 ppm. Laboratory analysis of the 18 ft bgs sample yielded a benzene concentration of non-detect and a total BTEX concentration of 1.027 mg/kg. The GRO concentration was 35.3 mg/kg and the DRO concentration was 302 mg/kg. BTEX and GRO concentrations in the 9 ft bgs sample were non-detect and the DRO concentration was 88.8 mg/kg.

Soil bore installation

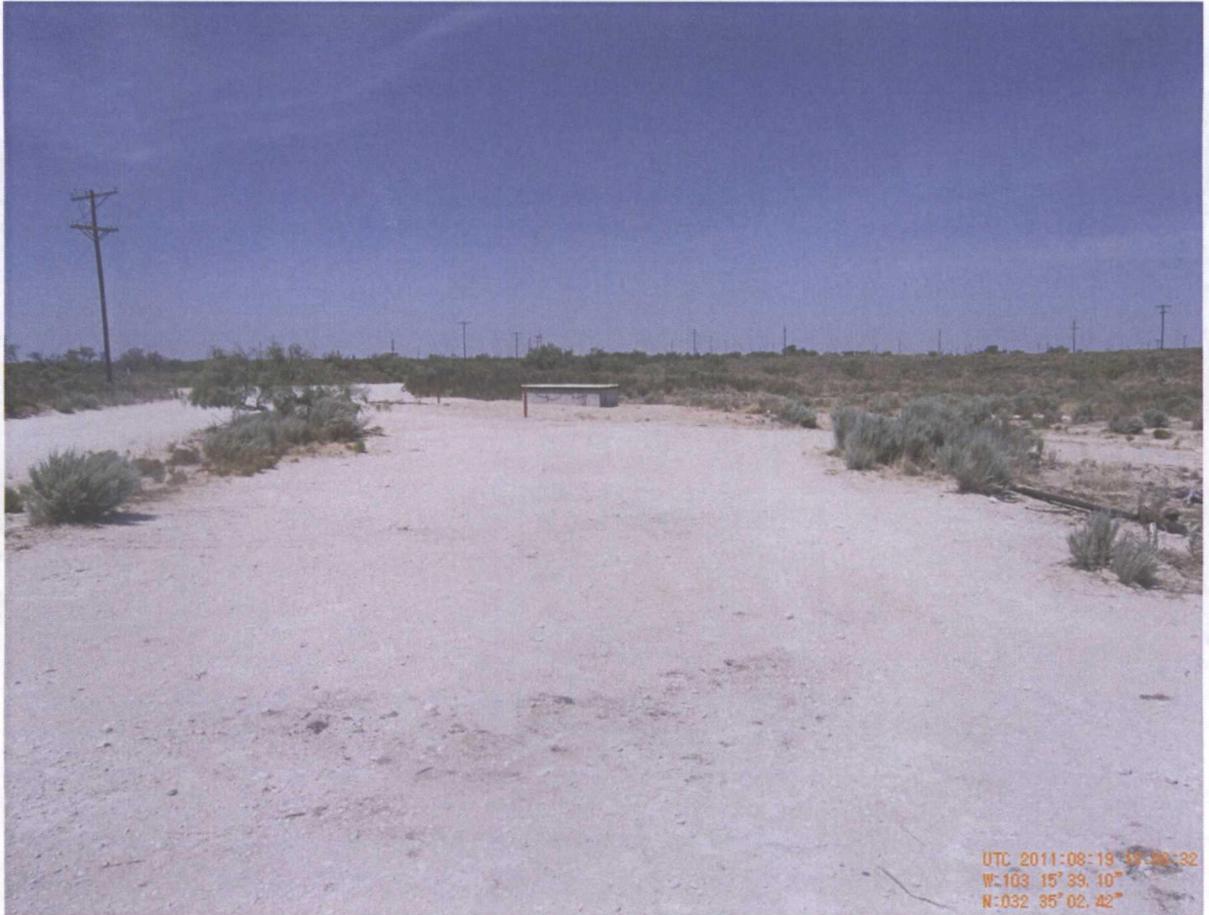
Site photo, facing WSW

This site is located at the intersection of two lease roads, and a concrete box was built in the same location (Figure 3). Vegetation surrounding this area has recovered and seeding is not required.

Since BTEX is non-detect throughout the site and relatively low in the 18 ft bgs sample, it seems evident that the hydrocarbons are wicking up from the groundwater below the site. In addition, benzene is also non-detect throughout the site and chloride levels are low. The existing clay layers will inhibit migration of any residual constituents through the vadose; as such, we believe the site in no way contributed to the degradation of the groundwater. Therefore, we asked that the site be given termination status and the regulatory file closed.
