RE: **Remediation Termination Request**
Rice Operating Company
Vacuum K-35-1 Boot, UL K, Sec 35, T17S, R35E
OCD Case Number 1R425-03

**Rice Operating Company
Vacuum K-35-1 Boot Remediation Project
NMOCD Case No. 1R425-03**

Corrective Action Plan Report and Termination Request

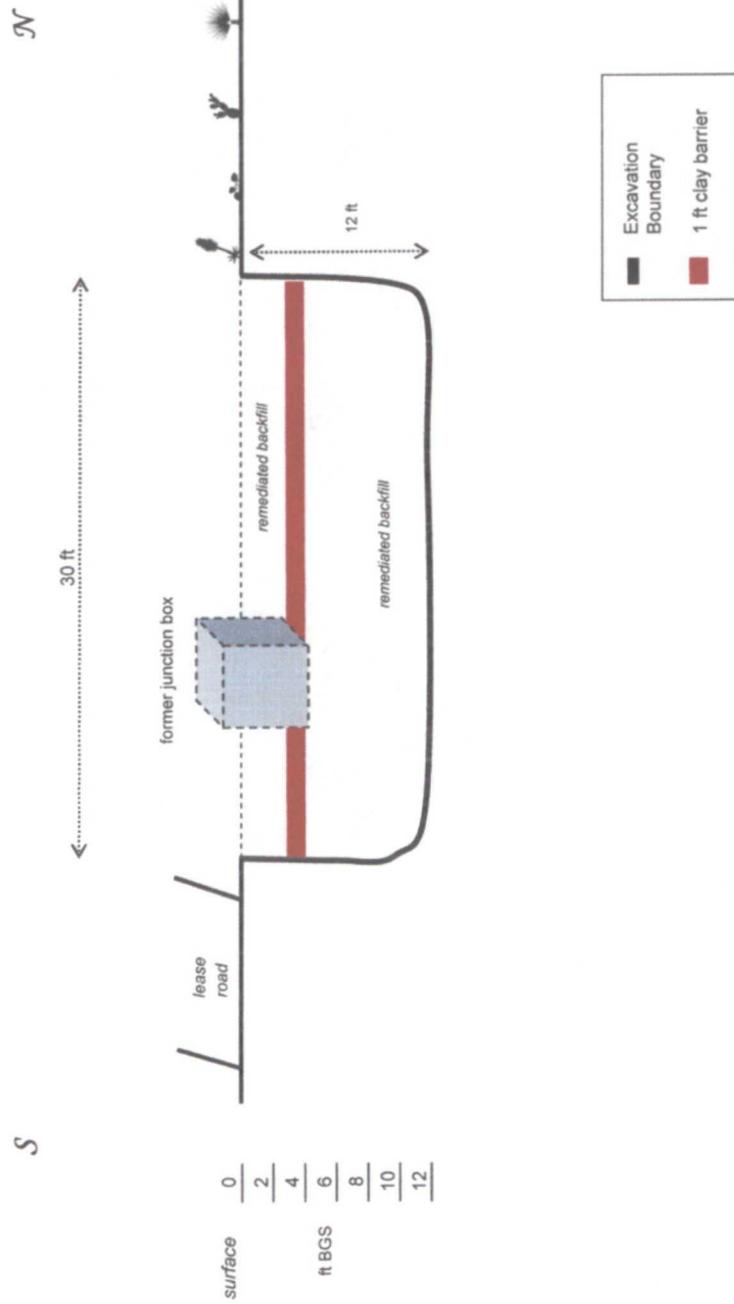
Figure 4 – Excavation cross section and design schematic of clay liner.

30 x 30 x 12 ft

Excavation Cross-Section

The old, wooden junction box was removed and soils beneath it were excavated to a depth of approximately 12 feet. The excavated soil was blended on site and then backfilled into the excavation to a depth of 4 feet below ground surface. At 4 feet depth, a compacted clay barrier was installed to inhibit further downward migration of any remaining chlorides above this level. The excavation was then backfilled with native material (Figures 3 & 4).

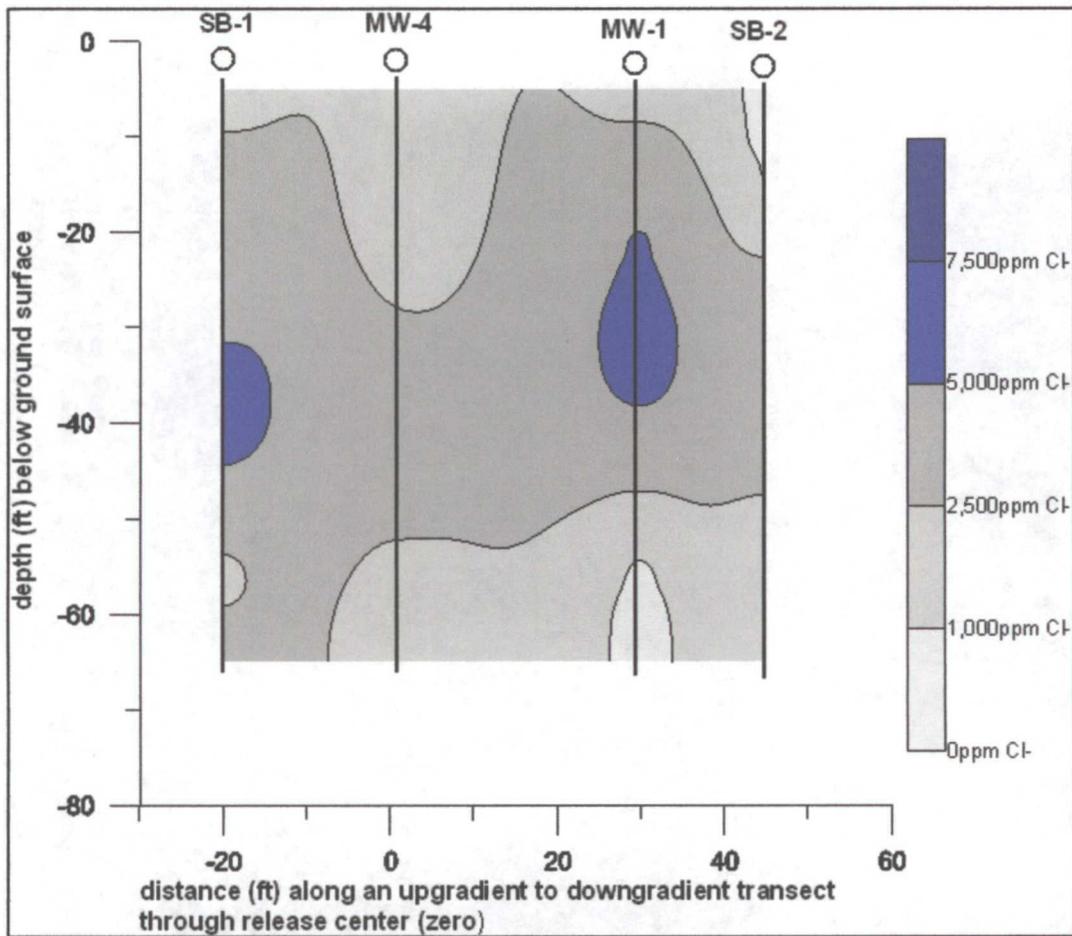
Figure 6 – Interpolated soil chloride concentrations in a vertical slice along an up-gradient to down-gradient transect across the former boot (from SB-1 to SB-2).

Elevated soil chloride concentrations were found near the surface and with depth in samples taken at the former boot and approximately 50 ft down-gradient (southeast) of the former junction box (Figure 6). More distant soil samples (taken at MW-2 and MW-3) had chloride levels below 125 ppm throughout their depth. It is of note that all of the affected soils were located within the area of impaired vegetation.

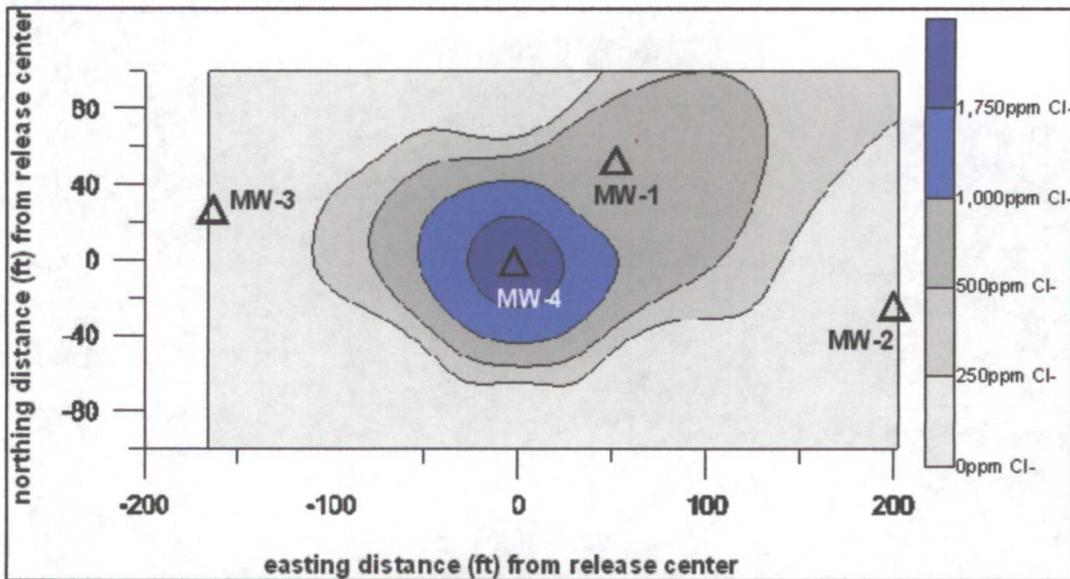
Figure 7 – Interpolated groundwater chloride concentrations sampled June 2006 (plan-view).

The center of mass of groundwater chlorides, sampled in June of 2006, was clearly located beneath the former junction box, MW-4 (Figure 7).

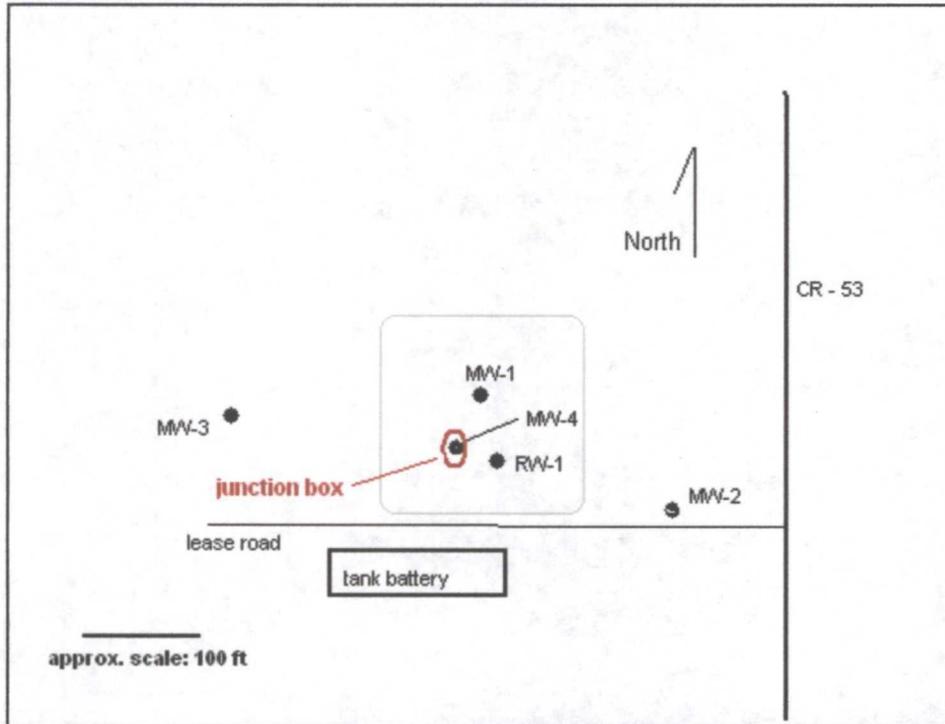
Figure 8 – Approximate monitor well (MW) and Recovery well (RW-1) locations.

A recovery well (RW-1) was installed approximately 35 ft down-gradient (southeast) of the former junction box location, MW-4 (Figures 8 & 9).

The rationale for locating the recovery well slightly down-gradient from the former junction box and center of groundwater chloride mass was to ensure that all of the water entrained into this well was high in chlorides. That is, pumping would cause low-chloride up-gradient water to sweep chlorides from beneath the former junction box. (If water were to have been pumped from MW-4 it is likely that it would have been diluted with clean, up-gradient water. This would have resulted in inefficient removal of chlorides.)

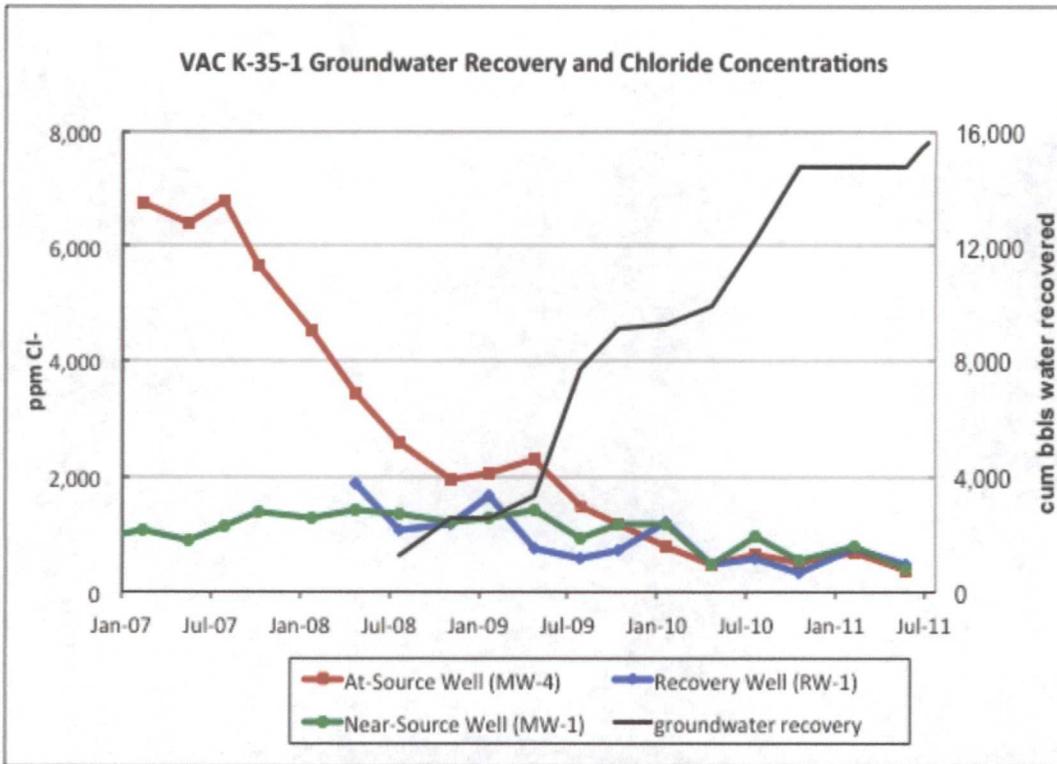
Figure 10 – Cumulative groundwater removal (right axis) and groundwater chloride concentrations (left axis).

Approximately 16,000 bbls of chloride impacted groundwater have been removed since pumping began in the spring of 2008, and over this time the chloride concentrations in the affected wells has declined dramatically (Figure 10, Table 1). Of particular note is that the groundwater chloride concentrations from the entire affected area (MW-4, MW-1 and RW-1) have all declined to less than 500 mg/kg and are trending to decline toward the up-gradient background concentration of 150 +/- mg/kg (MW-3).

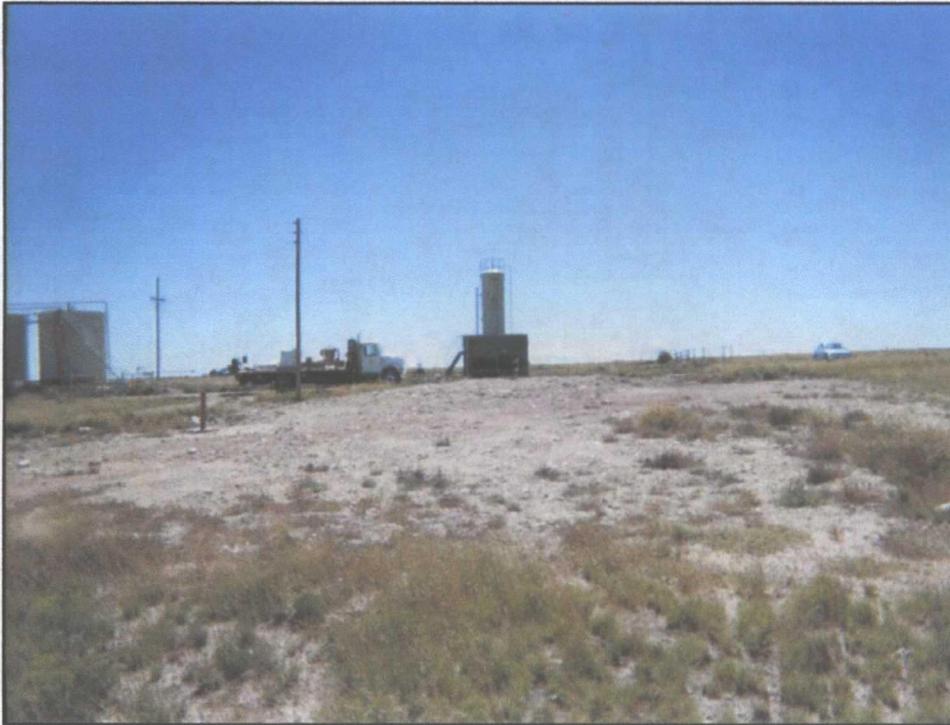
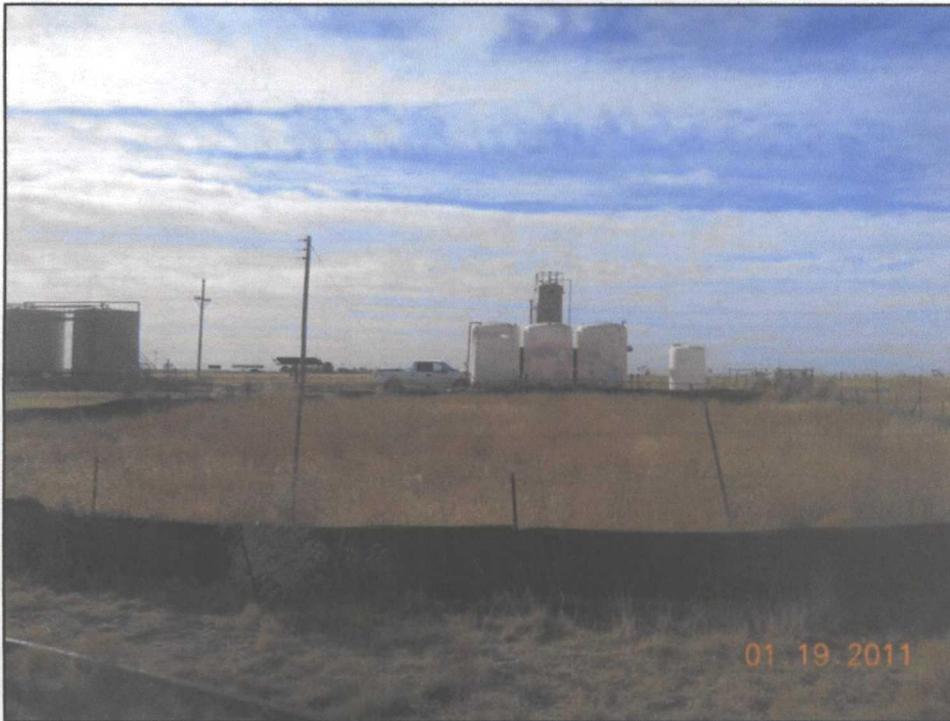
Figure 11 – View south toward VAC K-35-1 junction box in October 2006 (upper photograph) and January 2011 (bottom photograph).

Over the past three years ROC has sifted soils and removed rock, graded and blended soils, seeded the site to natural vegetation, watered the site and fenced the area to protect the new growth. The results of this work are evident in comparing the before photograph (October 2006) with the after photograph (January 2011), in Figure 11.
