**STAGE 2
WORKPLAN**

Stage 2 Abatement Plan

Pride Energy

State QE 13 #1

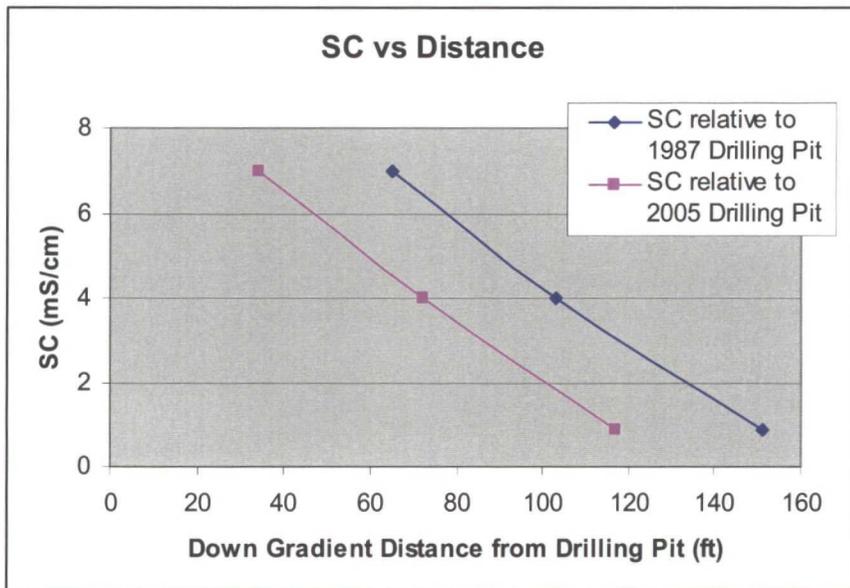
Figure 1: SC decreases with distance from drilling pits

Furthermore, as shown in Figure 2, specific conductance in ground water during drilling activities decreases from 6.99 mS/cm to 0.88 mS/cm as the downgradient distance increases from the drilling pits.

We conclude that brine released from the 1986 and possibly the 2005 drilling pit have impaired ground water at MW-01. MW-01 Deep shows no impairment. Impairment of ground water quality at SB-03 is most likely from the 1987 drilling pit. SB-04 shows no signs of impairment but chloride may be background concentrations. Background chloride concentrations in nearby water wells range from 39 (OSE water well L3005) to 116 mg/L (MW-02 at the South Four Lakes Tank Battery).

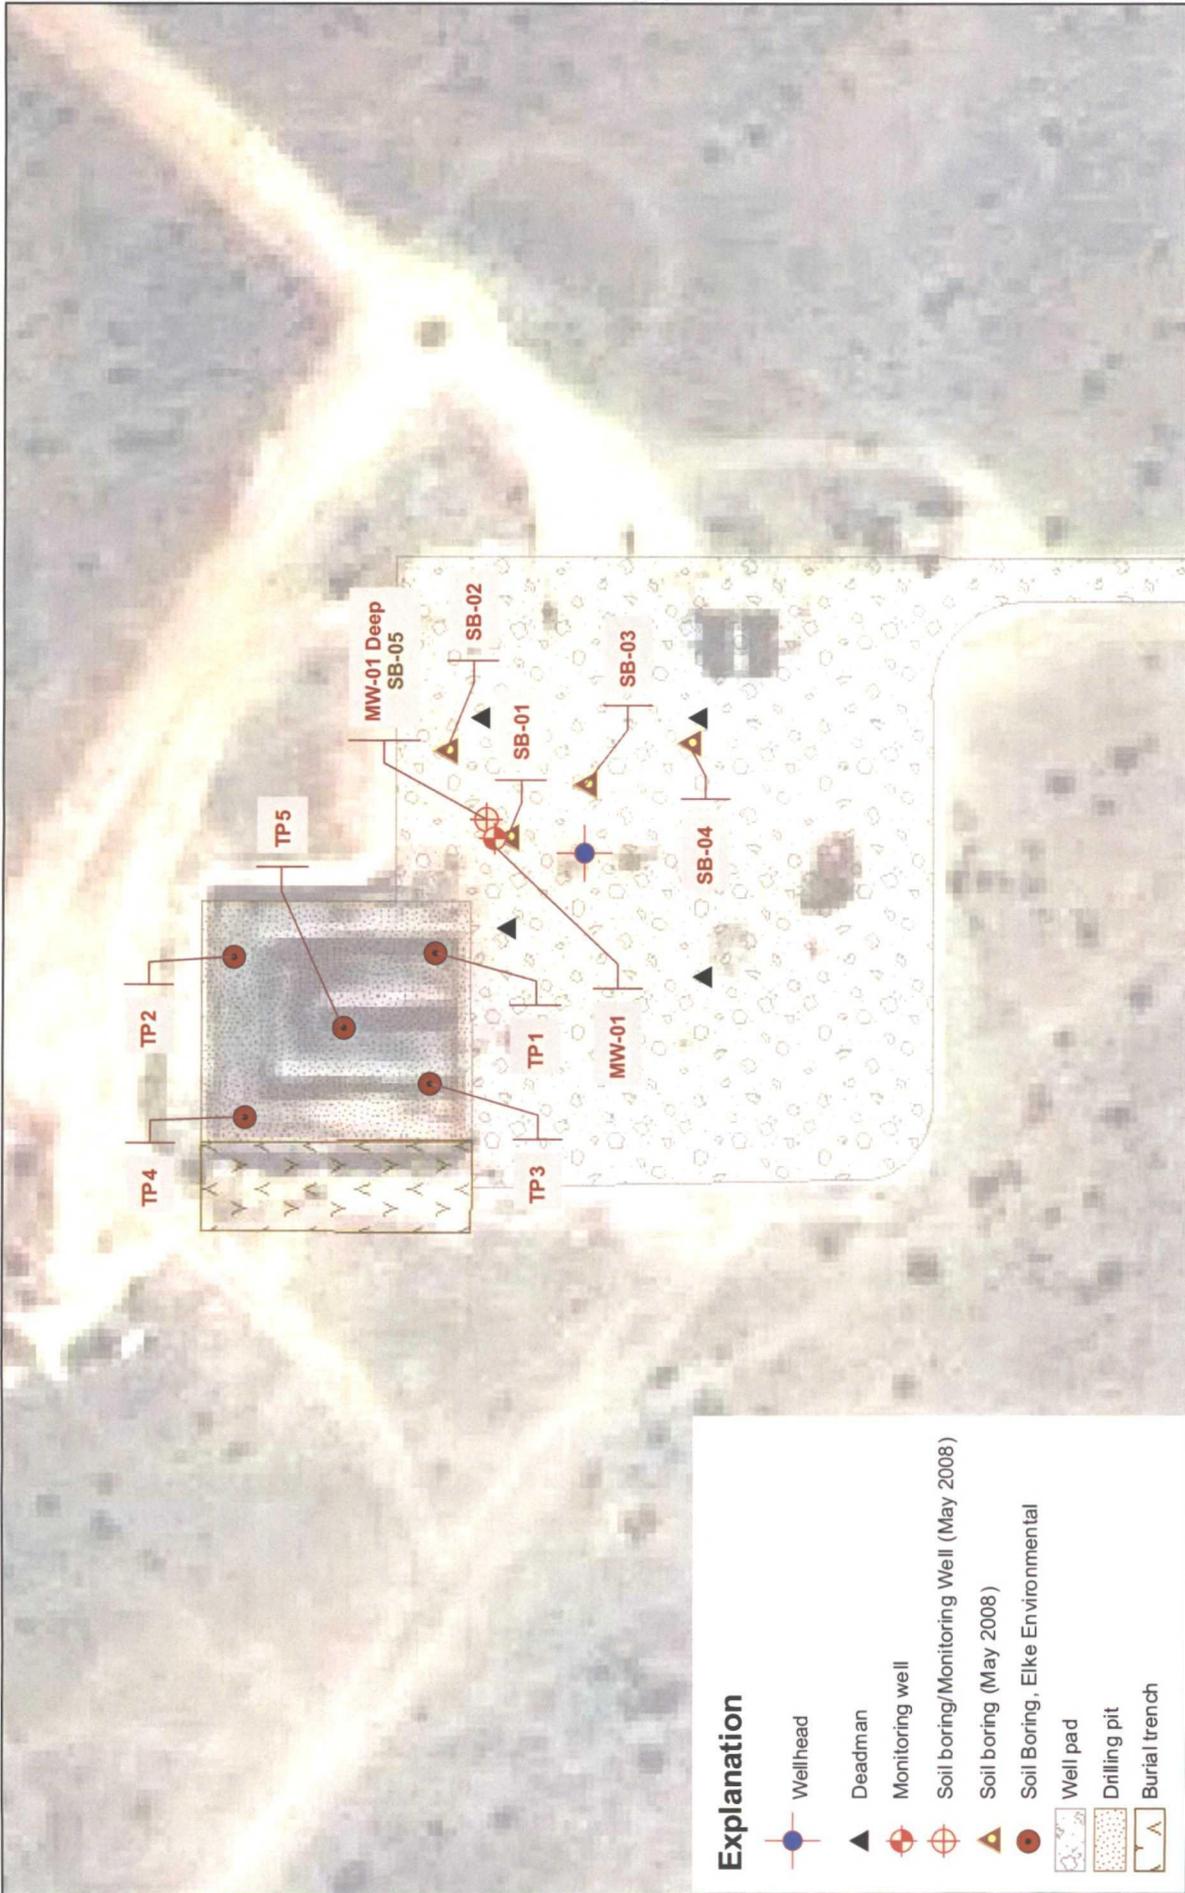
Plate 1
 October 2008

Plate 1 is a site map showing these features plotted on a 2005 aerial photograph that also shows the location of the Pride Energy drilling pit.

Site Map
 Pride Energy: State QE 13 #1

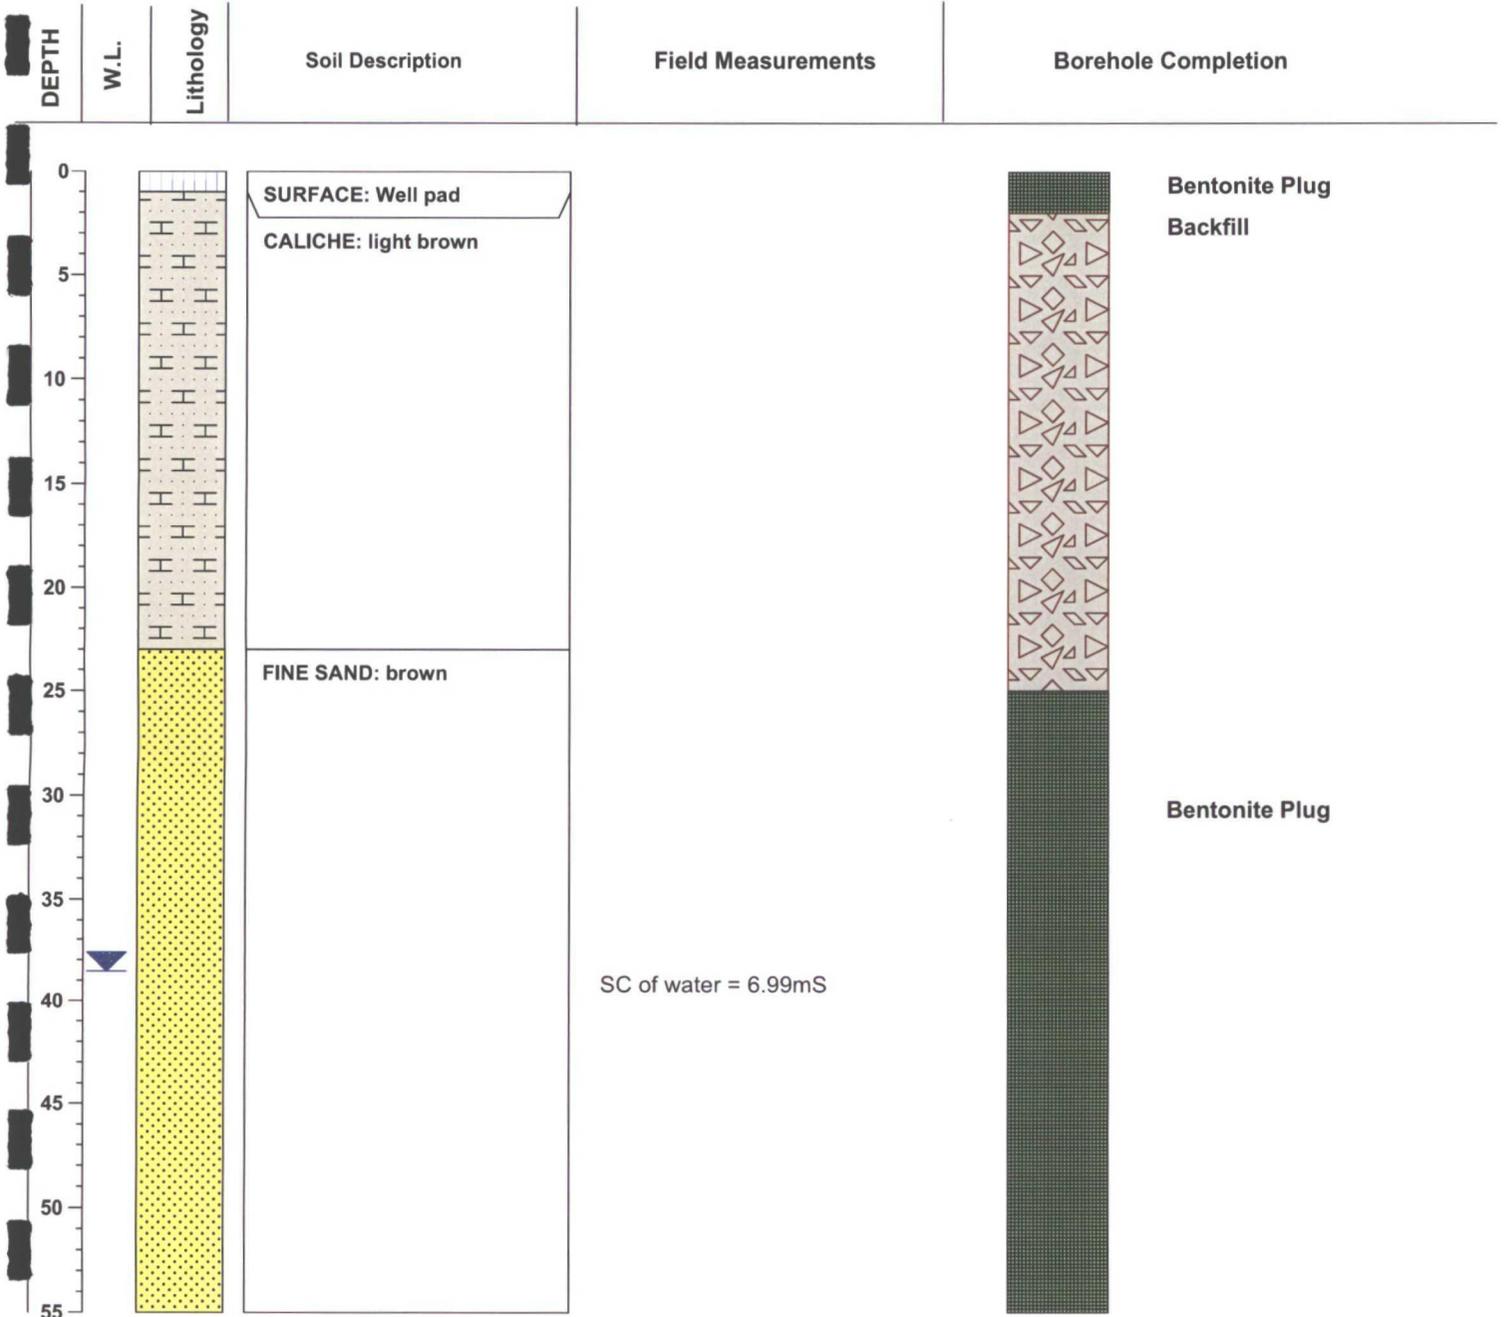
SB-01 is located approximately 31-feet southeast from the southeast corner of the former drilling pit. The borehole log is shown on Plate 3.

Total depth of this borehole is 55-feet. The upper 23-feet consist of caliche. Twenty-three to 55-feet below ground surface (bgs) is composed of fine sand.

Ground water was encountered at 38.5-feet bgs. Field measurements indicate SC in ground water at the ground water table is 6.99 mS/cm.

Originally, SB-01 was to be completed as a deep monitoring well. However, the borehole was within the deadman zone. Therefore, we drilled SB-05 and completed the well as MW-01 Deep. SB-05 is discussed below.

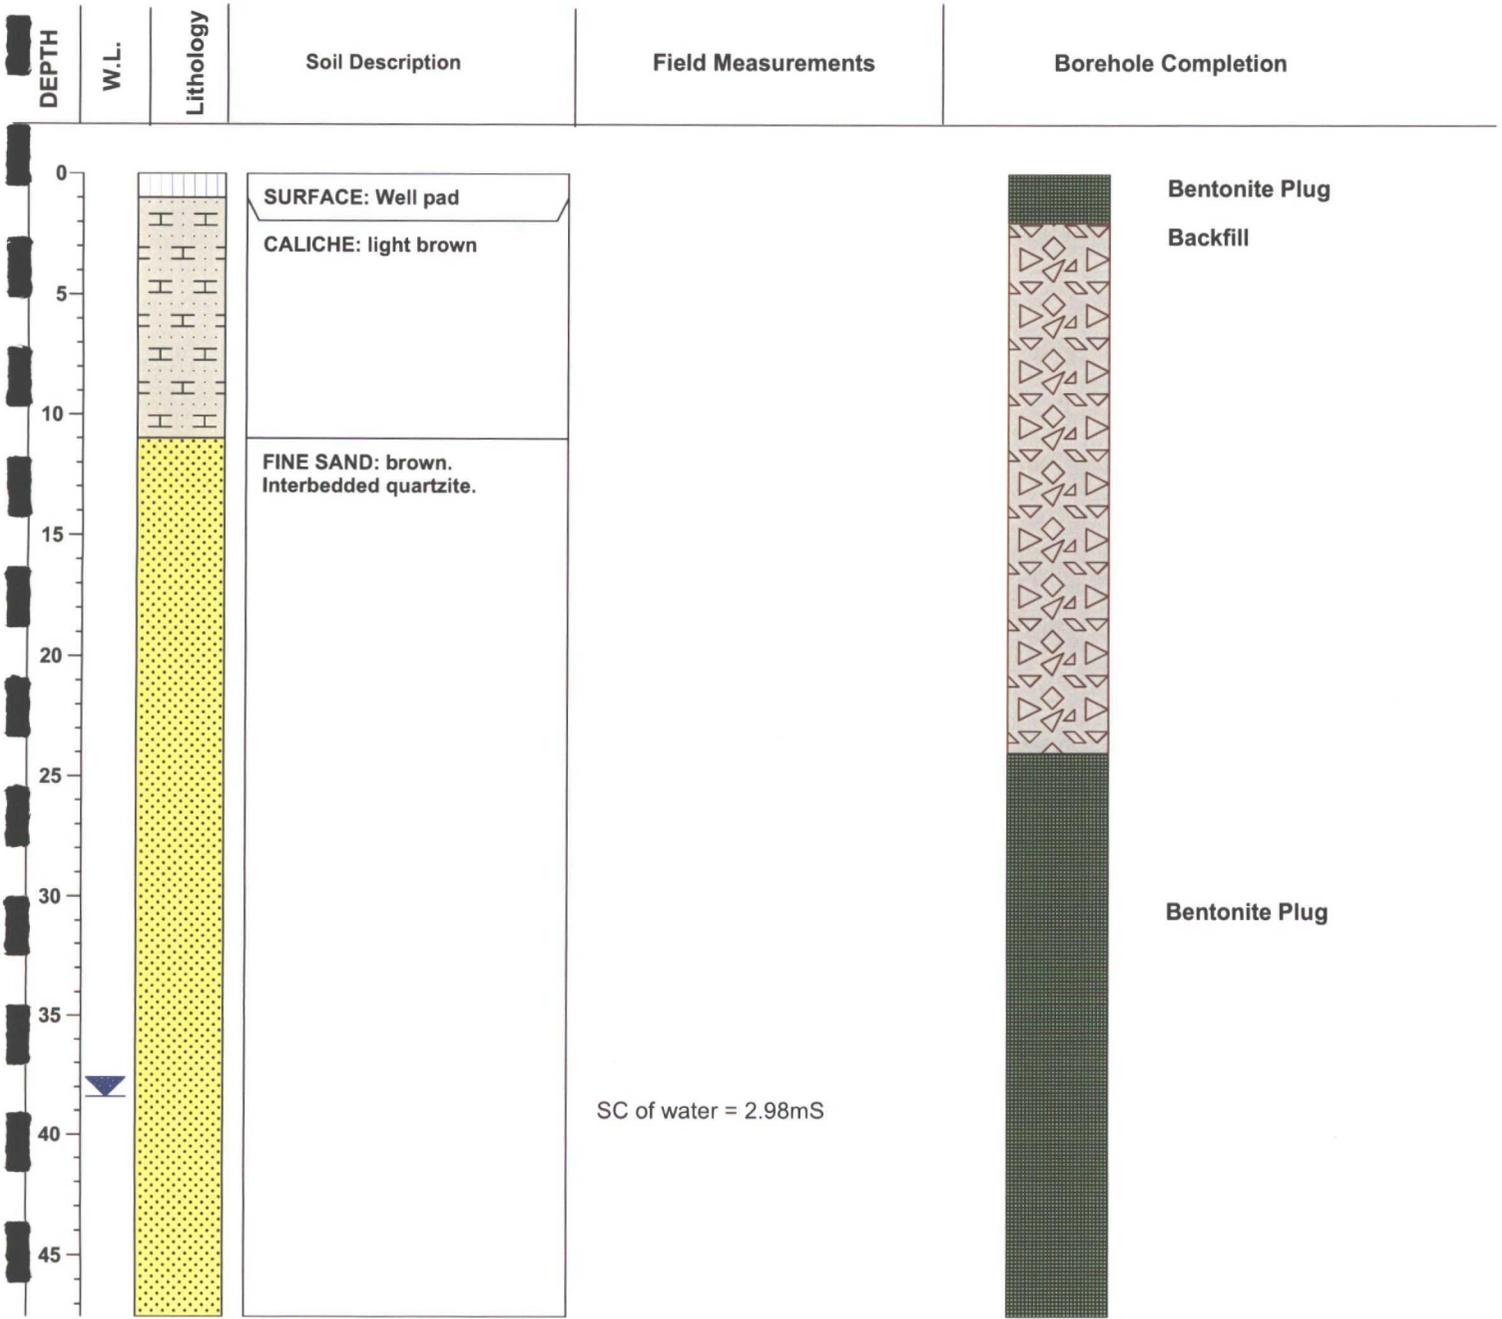
SB-02 is located cross gradient approximately 65-feet east from the southeast corner of the former drilling pit. The borehole log is shown on Plate 4.

Total depth of this borehole is 47.5-feet. The upper 11-feet consist of caliche. Eleven to total depth is composed of fine sand with interbedded quartzite.

Ground water was encountered at 38.4-feet bgs. Ground water was encountered at 38.5-feet bgs. Field measurements indicate SC in ground water at the ground water table is 2.98 mS/cm.

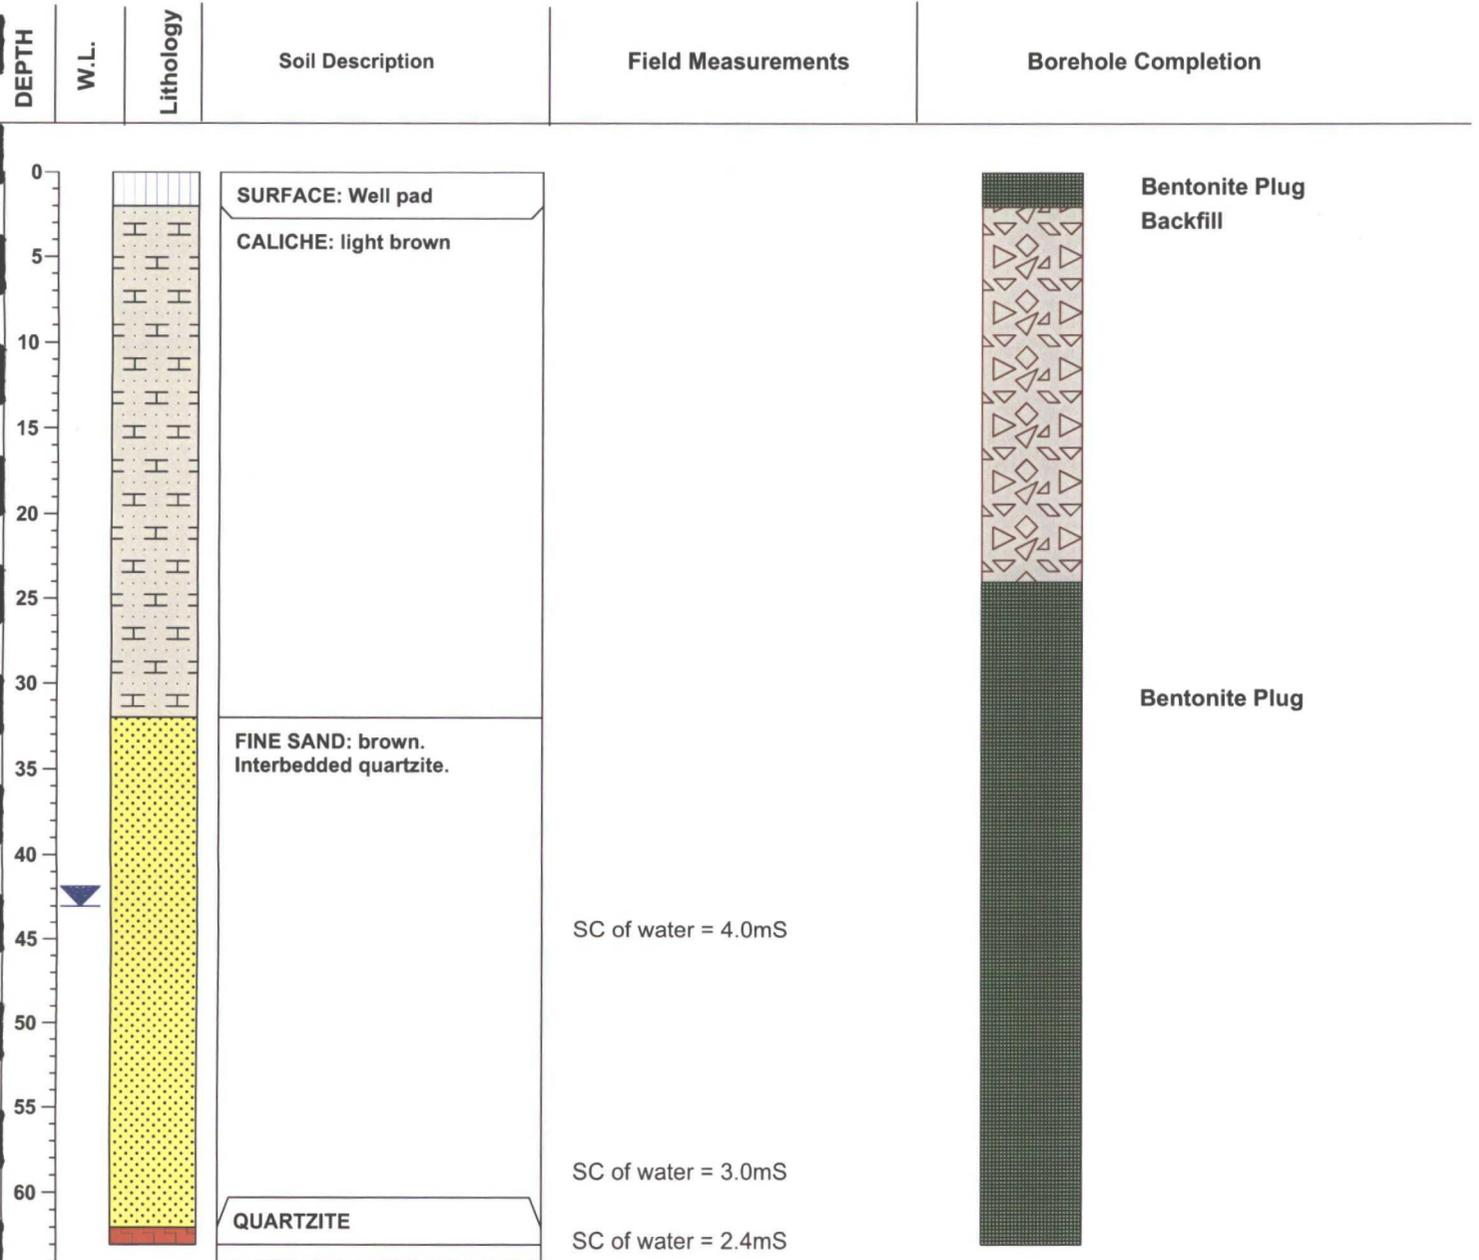
SB-03 is located down gradient approximately 70-feet south southeast from the southeast corner of the former drilling pit. The borehole log is shown on Plate 5.

Total depth of this borehole is 63-feet. The upper 32-feet consist of caliche. Thirty-two to 62-feet is composed of fine sands and interbedded quartzite. From 62-feet to total depth is composed of hard quartzite.

Ground water was encountered at 43-feet bgs. We obtained field measurements at 43.6, 58, and 63-feet bgs. Field measurements indicate SC decreases with depth, from 4.0 mS/cm at 43.6-feet bgs to 2.4 mS/cm at 63-feet bgs. We obtained sufficient sample volume for laboratory analysis of ground water at 58-feet bgs. Field and laboratory analysis of ground water samples is shown in Table 2, below.

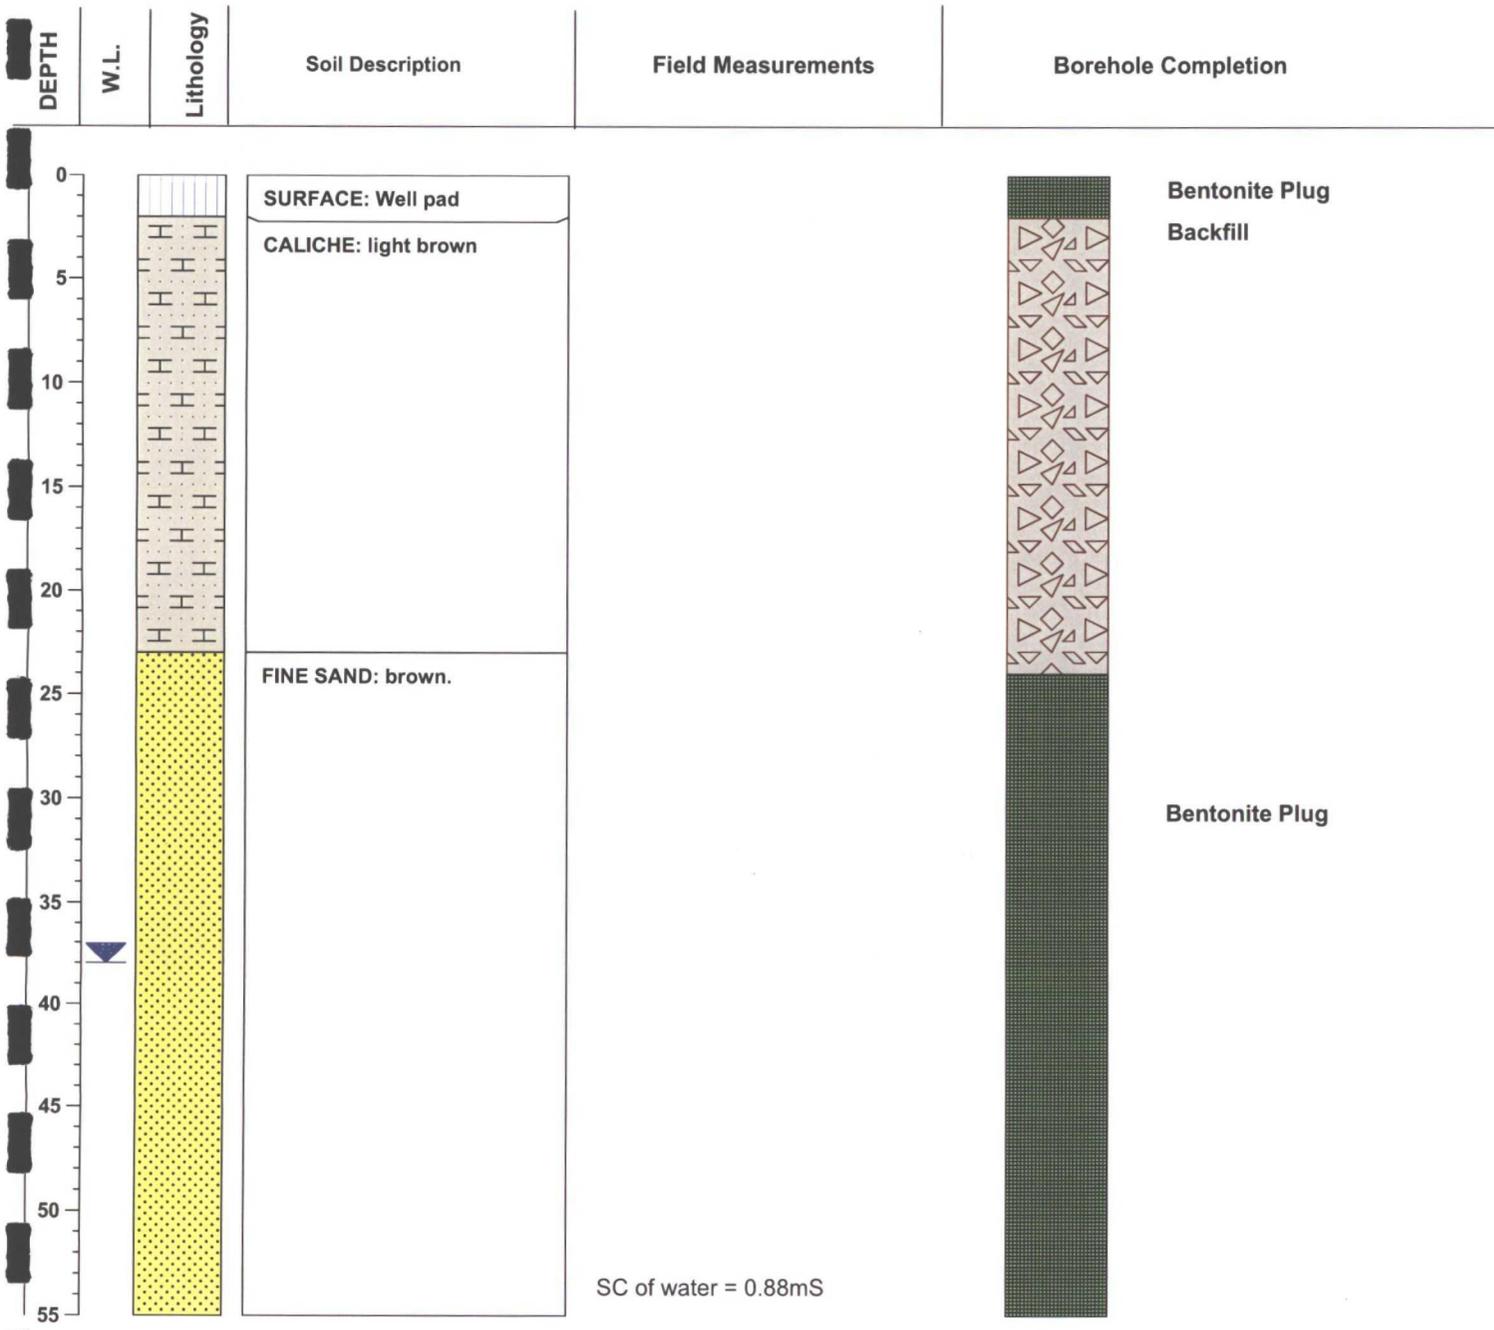
SB-04 is located down gradient approximately 116-feet southeast from the southeast corner of the former drilling pit. The borehole log is shown on Plate 6.

Total depth of this borehole is 55-feet. The upper 23-feet consist of caliche. Twenty-three to 55-feet is composed of fine sand.

Ground water was encountered at 38-feet bgs. We obtained field measurements at 53-feet bgs. Field measurements indicate SC 0.88 mS/cm at 53-feet bgs. We obtained sufficient

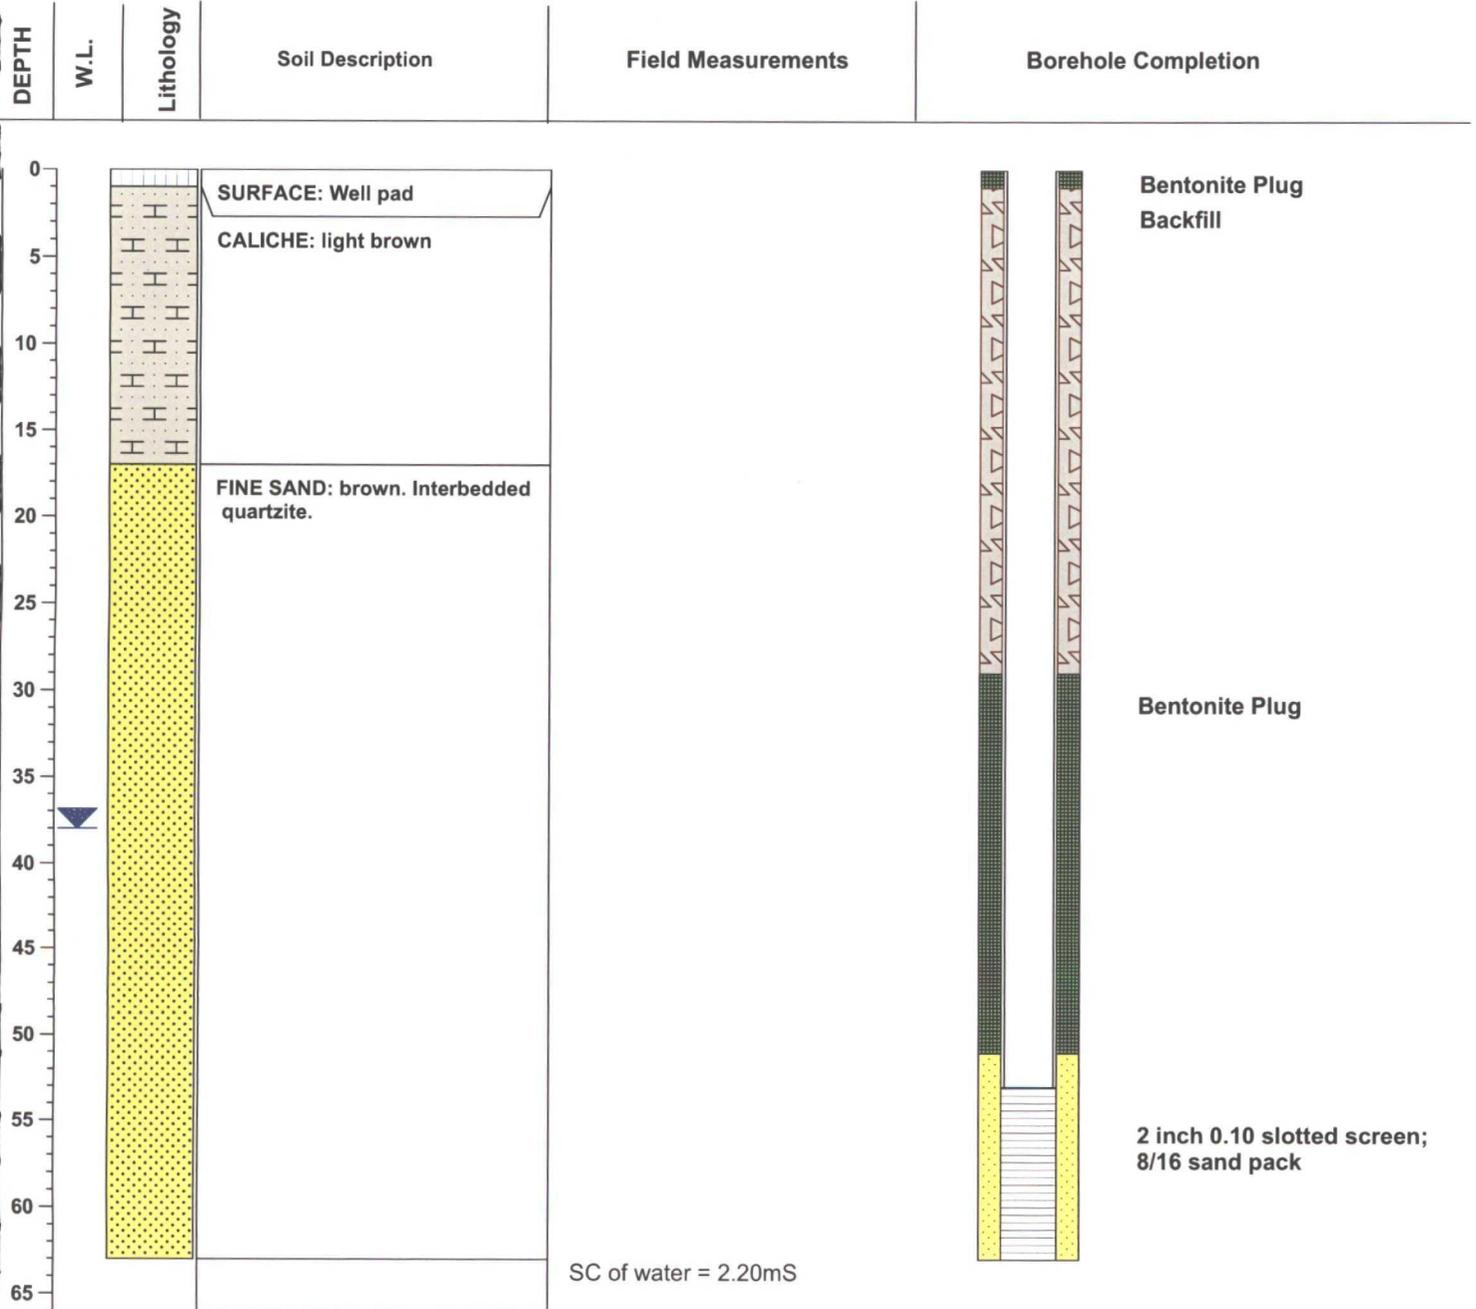
Plate 7

SB-05 is located down gradient approximately 35-feet east southeast from the southeast corner of the former drilling pit; adjacent to MW-01. The borehole log is shown on Plate 7.

Total depth of this borehole is 63-feet. The upper 17-feet consist of caliche. Seventeen to 63-feet is composed of fine sands and interbedded quartzite.

Ground water was encountered at 38-foot bgs. We obtained field measurements at 63-foot bgs. Combining field measurements at SB-01 and SB-05, measurements indicate SC decreases with depth, from 6.99 mS/cm at 38.55-foot bgs to 2.20 mS/cm at 63-foot bgs.

We completed SB-05 as monitoring well MW-01 Deep. Total depth of MW-01 Deep is 63-foot with 10-foot of screen from 53 to 63-foot bgs.

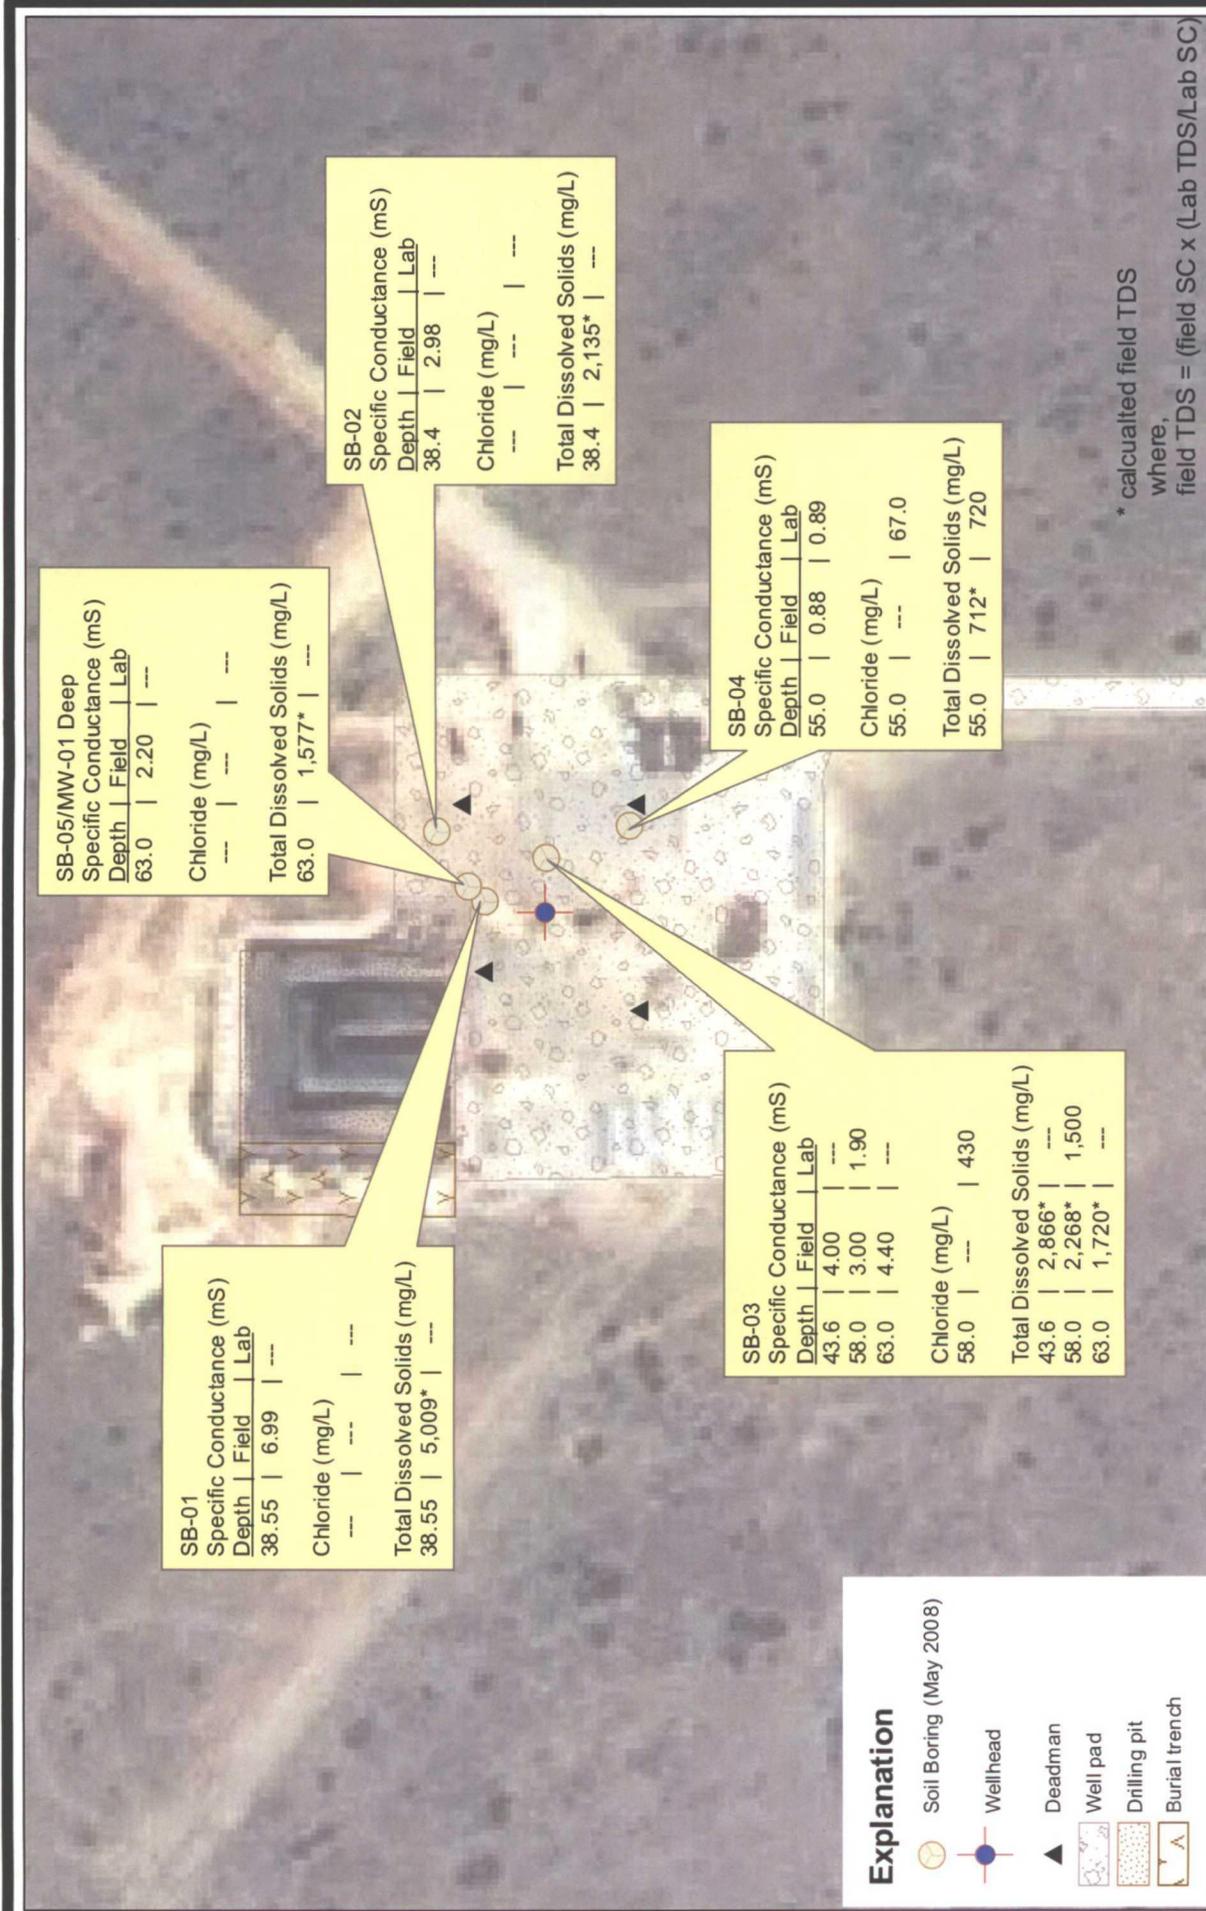
Plate 8
 October 2008

Table 2 presents all of the data obtained during the boring program and Plate 8 shows the data in relation to the site.

Chemistry of Ground Water During
 Soil Boring Activities
 Pride Energy: State QE 13 #1

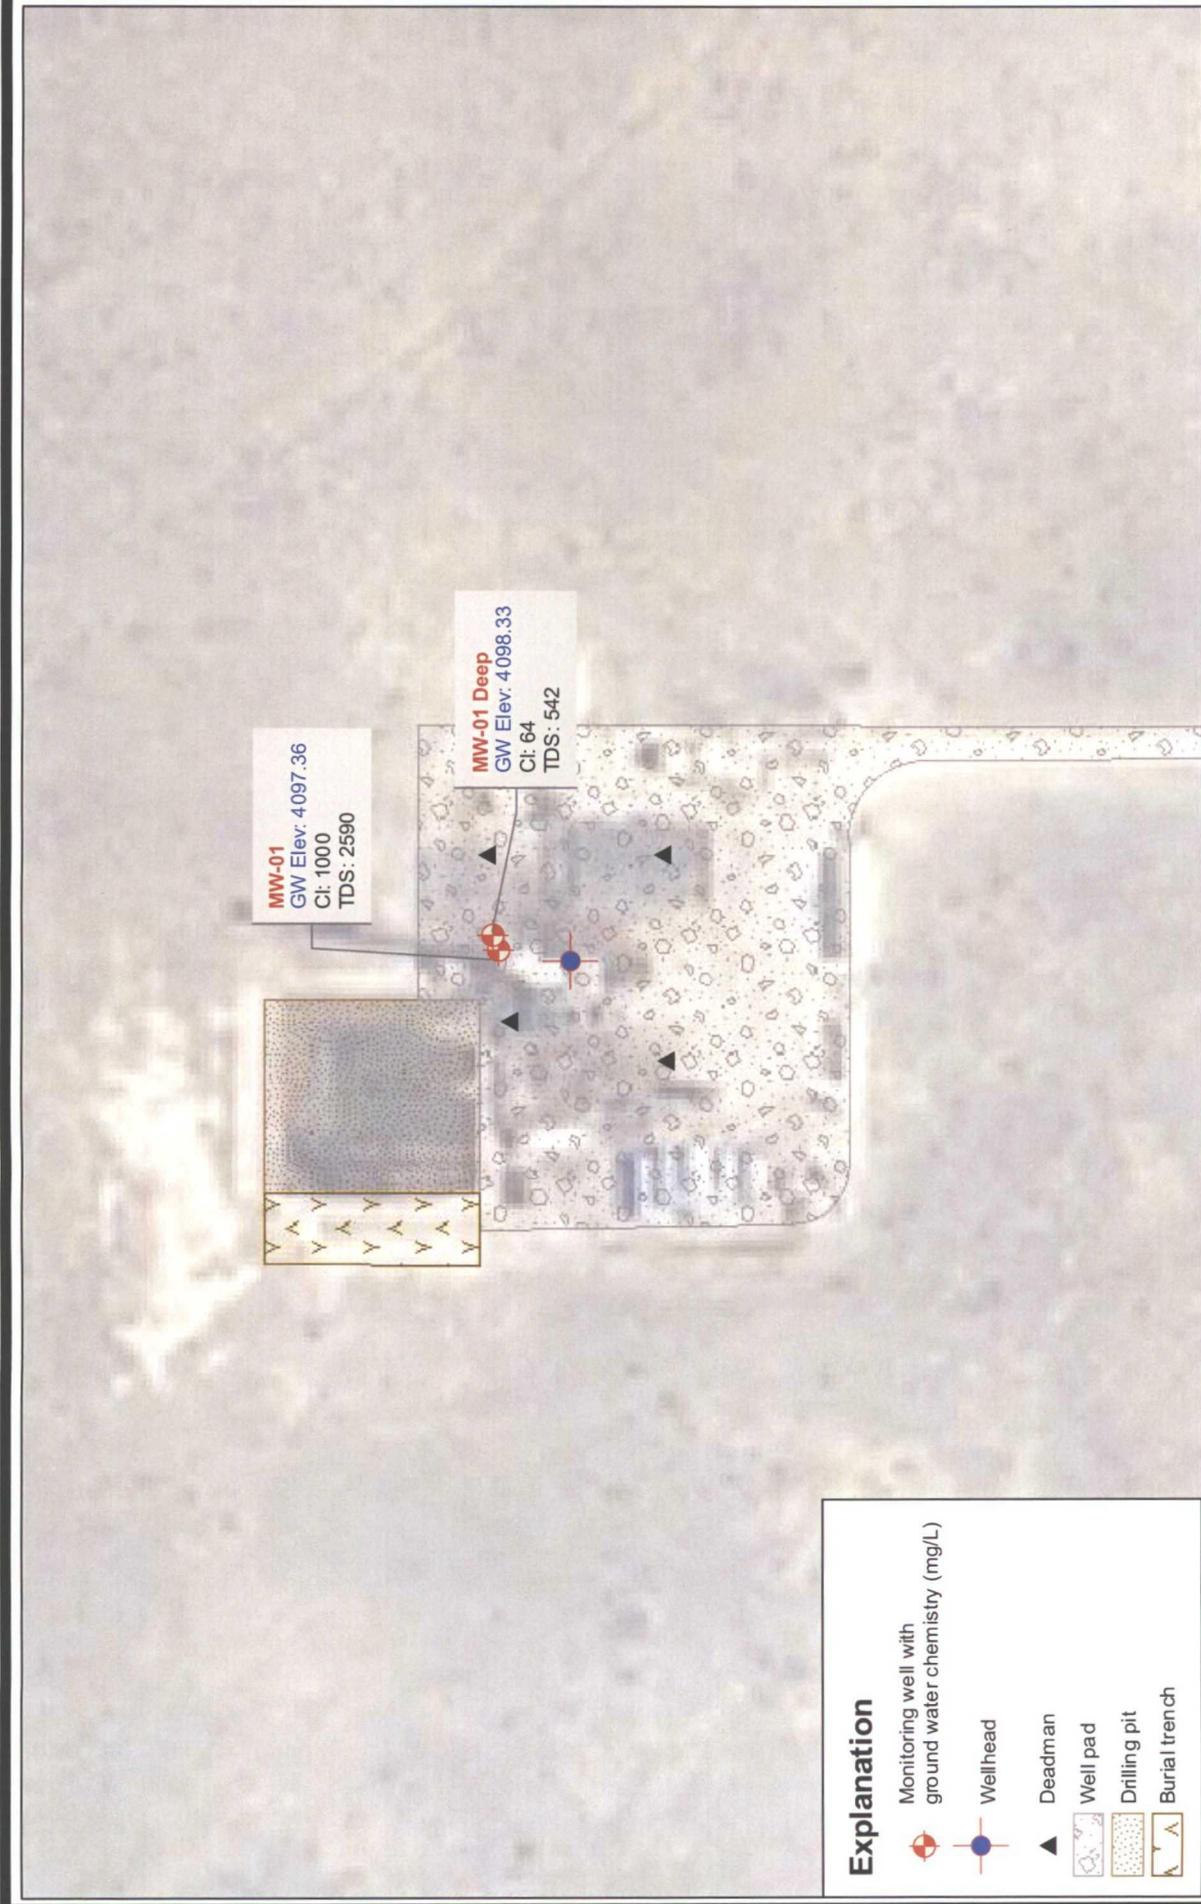
| Chloride and TDS in Ground Water (Sept 09, 2008) | Plate 9 |

MW-01
 GW Elev: 4097.36
 Cl: 1000
 TDS: 2590

MW-01 Deep
 GW Elev: 4098.33
 Cl: 64
 TDS: 542

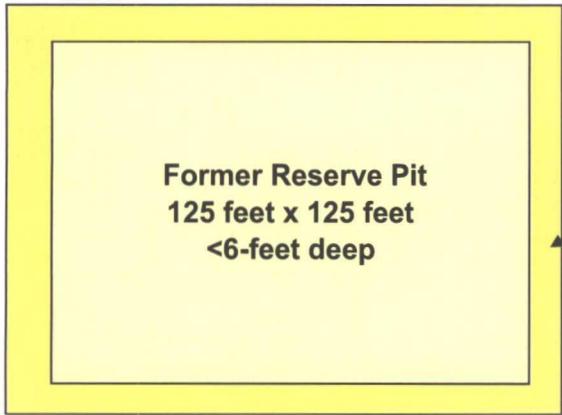
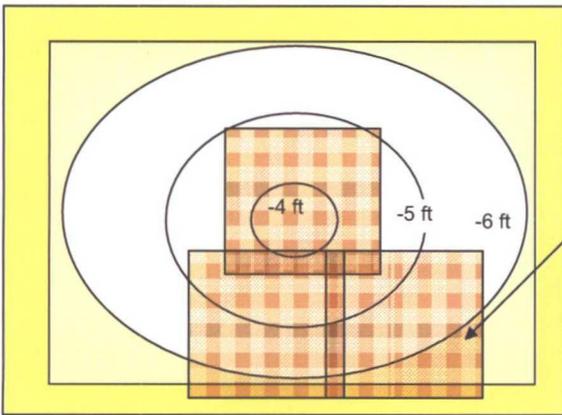
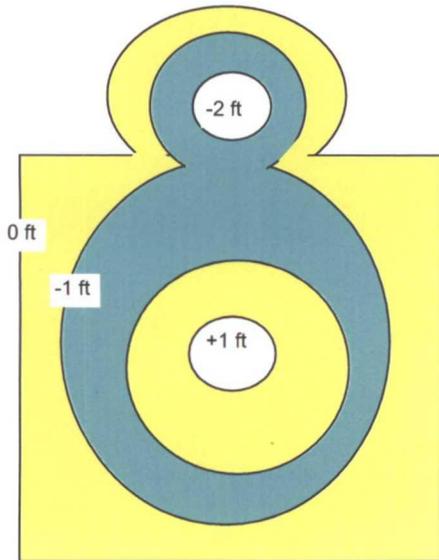
Plate 12

**Former Reserve Pit
125 feet x 125 feet
<6-feet deep**

Step 1

Excavate as required to create 3-foot clean zone around chloride impact

Step 2

Create sloping surface at bottom of excavation

Place 20-mil liner "shingles" over prepared surface

Shingles drain to un-impacted caliche

Step 3

Excavate ponding area(s)

1. Expand the existing drilling pit excavation as necessary to create a 3-foot wide area where subsurface impact of pit leakage does not exist (Plate 12, step 1).
2. Use the material from the pit expansion or deepen the excavation as necessary to create a mounded surface that slopes away from the center on the bottom of the excavation as suggested in Plate 12, step 2.
3. Over the mounded sloping surface, place "shingles" of recycled or new 20-mil, reinforced liner material that meet NMOCD specifications. The shingles are laid to shed any infiltrated water from the pit area to native soil and to prevent any upward migration of chloride into the root zone.
4. Backfill the excavation with clean material, beginning with caliche and/or sand and finishing the top of the backfill with about 6-inches of soil that is capable of supporting native vegetation.
