**JUNE 2010 GROUNDWATER  
MONITORING REPORT**

**CONOCOPHILLIPS COMPANY  
FLORA VISTA NO. 1  
FLORA VISTA, SAN JUAN COUNTY, NEW MEXICO**

OCD # 3R173

# JUNE 2010 GROUNDWATER MONITORING REPORT FLORA VISTA NO. 1, FLORA VISTA, NEW MEXICO

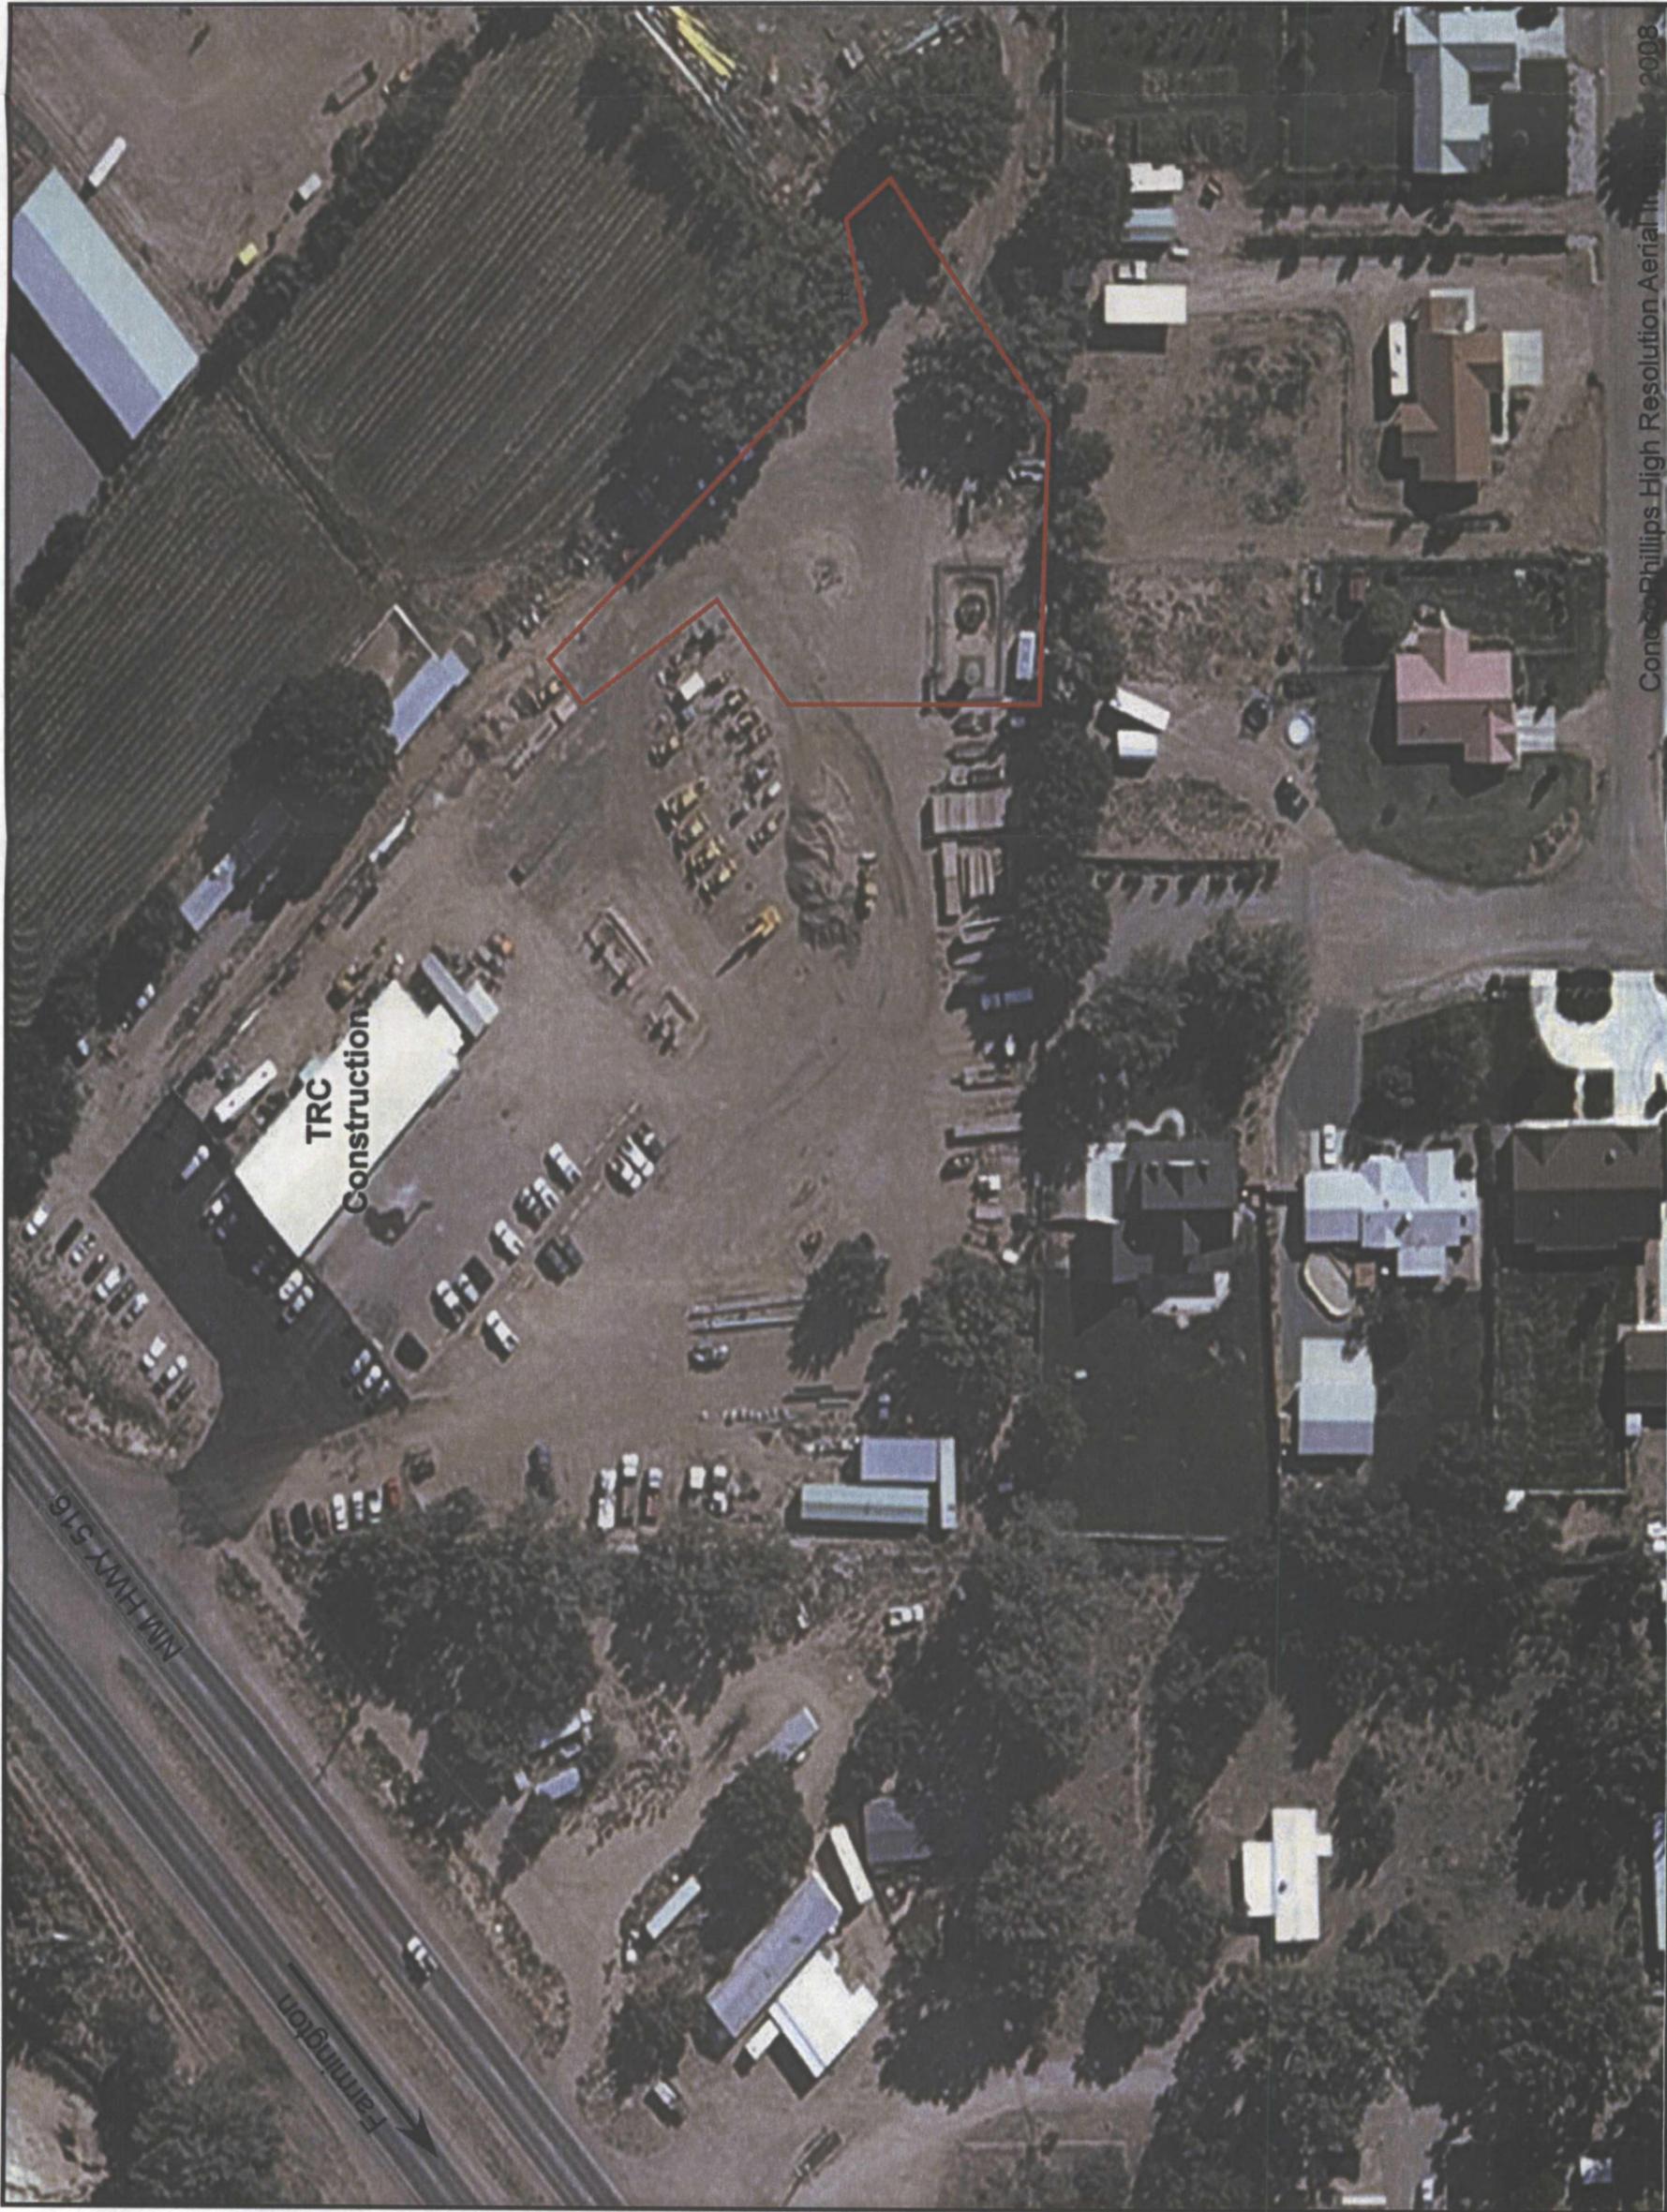
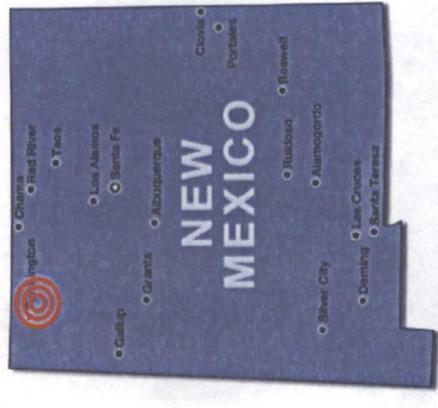
**FIGURE 1.**

Site Location Map  
 ConocoPhillips  
 Flora Vista No. 1  
 Flora Vista, NM

Approximate ConocoPhillips  
 Flora Vista No. 1 Site location

Latitude = 36°47'54.37" N  
 Longitude = 108°05'17.60" W

This report presents the results of the groundwater monitoring event conducted by Tetra Tech, Inc. (Tetra Tech) on June 10 and 11, 2010 at the ConocoPhillips Company, Flora Vista No. 1 site near Flora Vista, New Mexico (**Figure 1**). The site is located in on private property in Unit Letter F, Section 22, Township 30N, Range 12W, of San Juan County, New Mexico. The site consists of a gas production well and associated equipment and installations. A detailed site layout map is provided as **Figure 2**.
