Re: **Corrective Action Plan Report and Termination Request**  
Rice Operating Company – Hobbs SWD System  
**Hobbs G-9 Vent. T-19-S, R-38-E, Sec 9, UL G**  
NMOCD Case Number 1R428-73

## **Hobbs G-9 Vent**

### **Corrective Action Plan Report and Termination Request Rice Operating Company Hobbs G-9 Vent NMOCD Case Number 1R428-73**

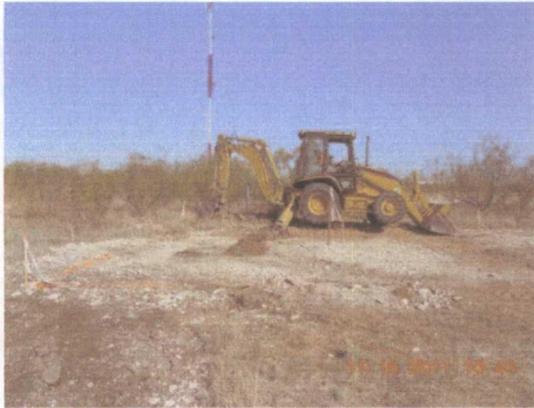
site prior to excavation, facing northwest

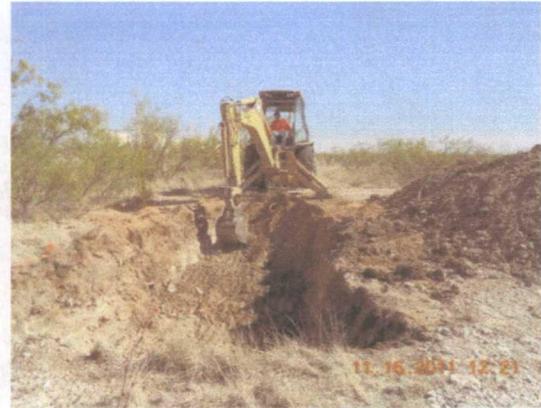
excavating the site, facing east

Beginning on November 16, 2011, ROC excavated soils from the affected area to a depth of 5 ft bgs across an area of 36 \* 31 ft. A six inch layer of clean blow sand was placed in the bottom of the excavation and a 36 \* 31 ft, 20 mil reinforced plastic liner was installed and properly seated. Six inches of clean blow sand were then carefully placed above the liner as padding. Additional blow sand was blended with remaining excavated soil for use as backfill. A composite, eight-point sample indicated a chloride concentration of 32 mg/kg and a PID reading of 64.3 ppm for this blended backfill, which was backfilled into the excavation up to approximately 6 inches of the ground surface. Clean blow sand was used to fill the remainder and this was graded to natural surface topography. 250 lbs of BioNhance was mixed into the upper backfilled material along with a blend of 5 lbs winter wheat and 8 lbs blue grama (custom mix). A total of 96 cubic yards of excavated soil material was hauled and disposed at Sundance

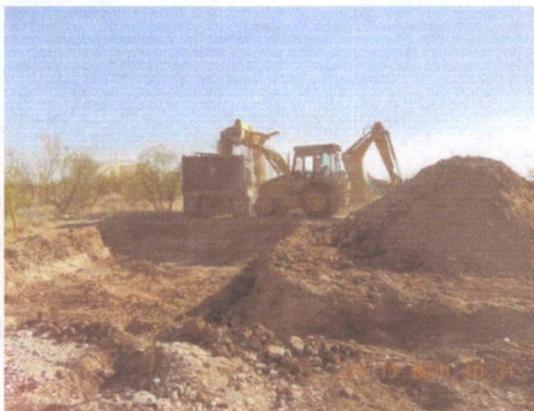
exporting excavated soil, facing east

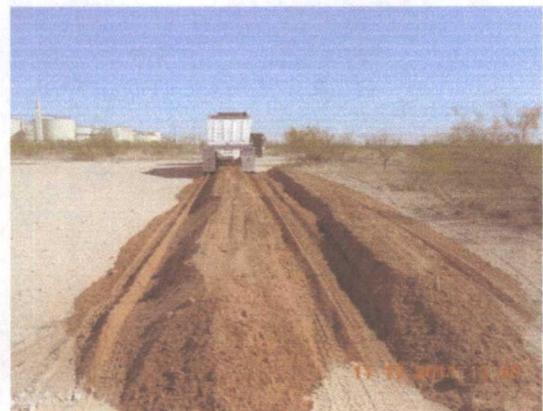
importing soil, facing east

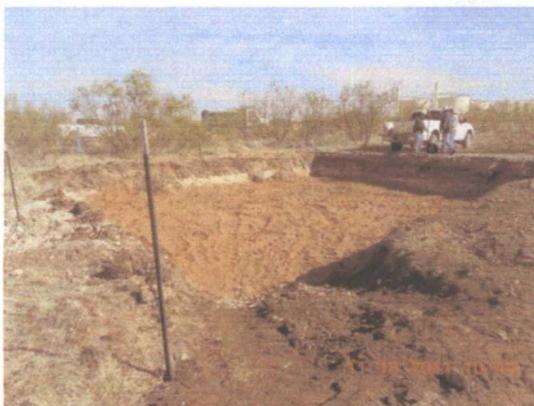
36x31x5-ft bgs excavation complete, with 6" blow sand pad, facing northeast

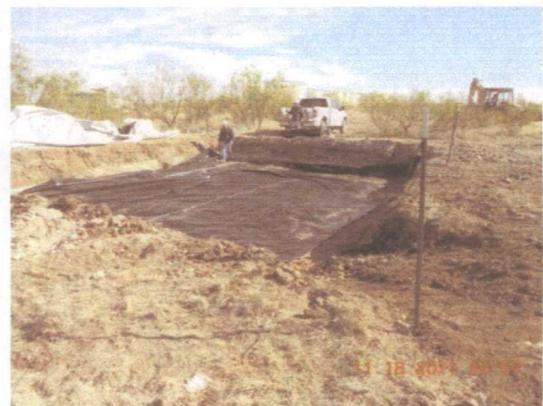
36x31-ft, 20-mil reinforced liner installed, facing northeast

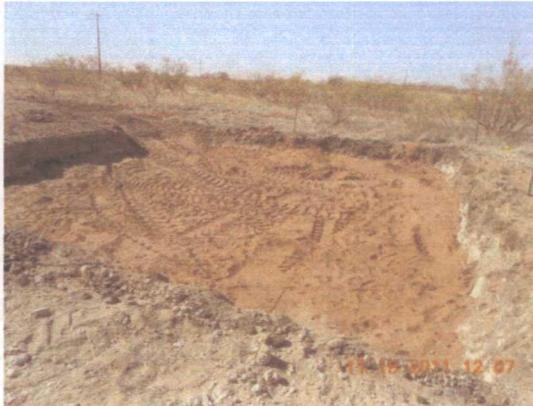
**6" blow sand pad above the reinforced liner,  
facing southwest**

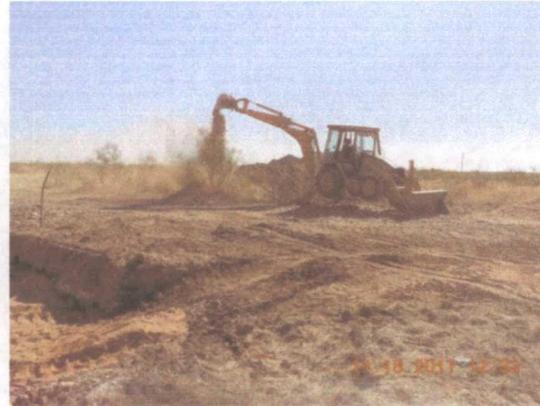
**blending excavated soil, facing southeast**

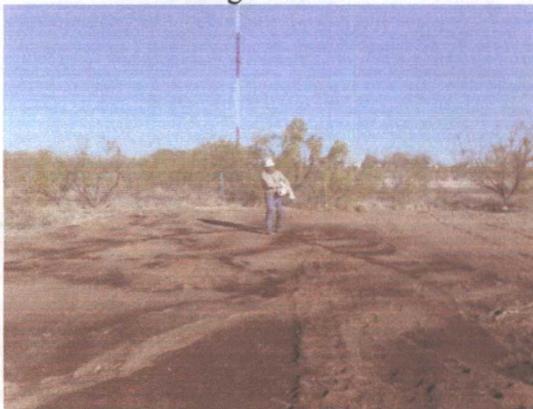
**adding BioNhance to the backfilled site,  
facing northwest 11/23/2011**

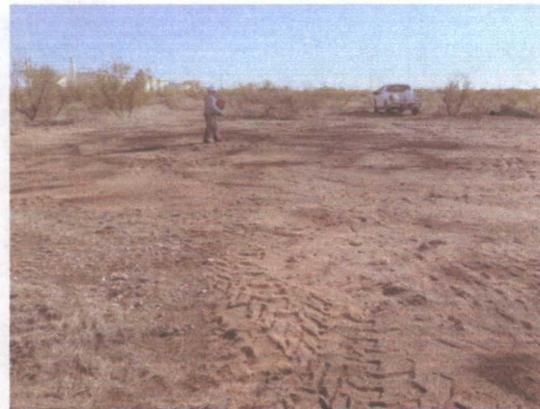
**seeding the backfilled site, facing east  
11/23/2011**

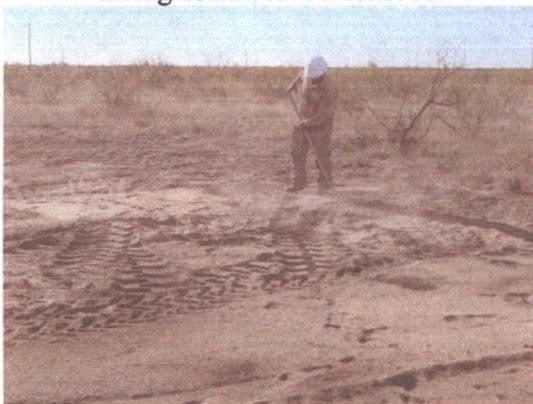
**raking in the seed and BioNhance, facing  
south 11/23/2011**

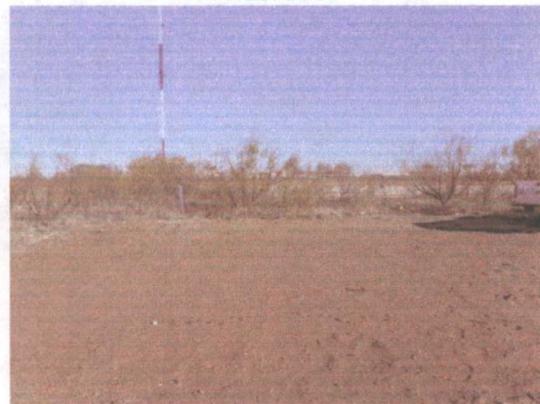
**site complete, facing northwest  
11/28/2011**
