1R - 427-320

**RE: Corrective Action Plan (CAP) Report and Termination Request  
Rice Operating Company – EME SWD System  
EME C-1 EOL (1R427-320): UL/C sec. 1 T20S R36E**

### **CAP Report of the Vadose Zone Remediation**

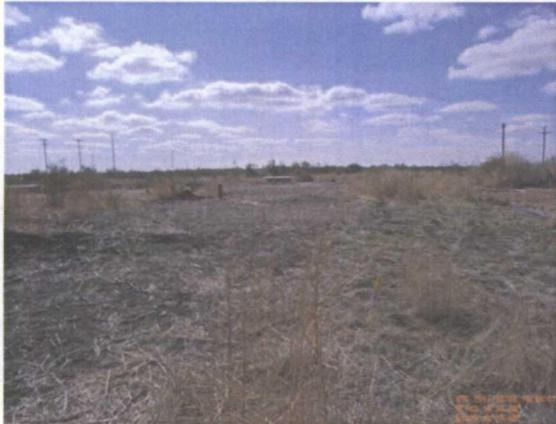
site prior to excavation, facing south  
10/28/2011

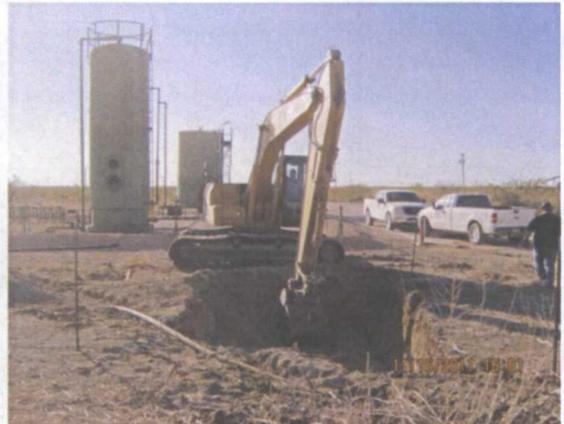
excavating site, facing west  
11/16/2011

Beginning November 16<sup>th</sup>, 2011, RECS personnel excavated the site to 51 ft x 44 ft to a depth of 5 ft bgs. A 20-mil reinforced poly liner was installed and properly seated at the base of the excavation. Excavated soil at this site was sandy; therefore, padding of the liner was not required. The excavated soils were blended on site to use as backfill. A composite sample of the blended soil was screened in the field for hydrocarbons and returned a result of 0.8 ppm. The sample was then taken to a commercial laboratory for analysis which returned a chloride value of 160 mg/kg. The excavation was backfilled

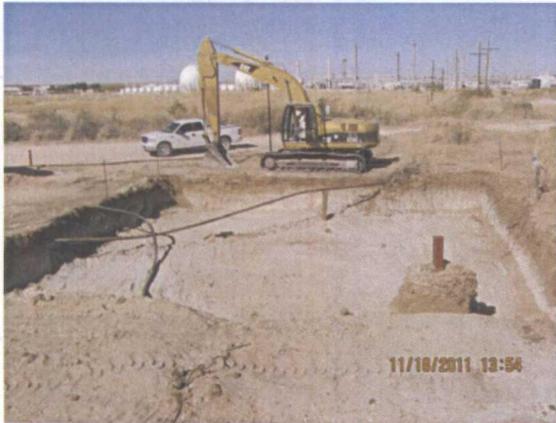
completed 51x44x5-ft excavation, facing north  
11/18/2011

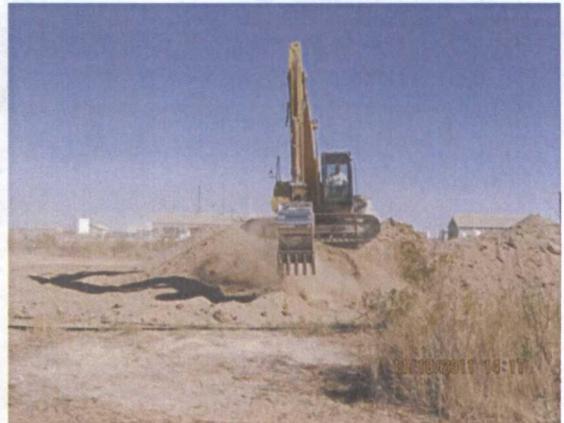
blending excavated soil, facing east  
11/18/2011

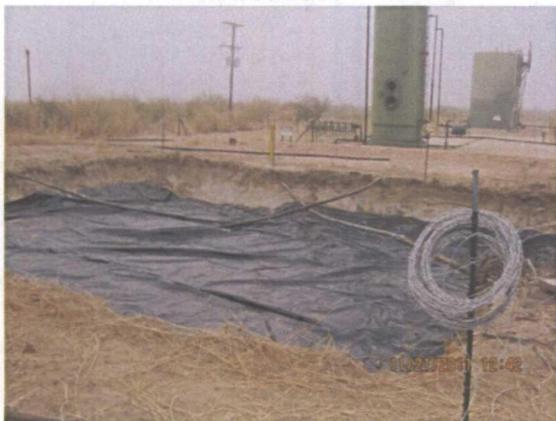
51x44-ft 20-mil, reinforced liner installed,  
facing west 11/21/2011

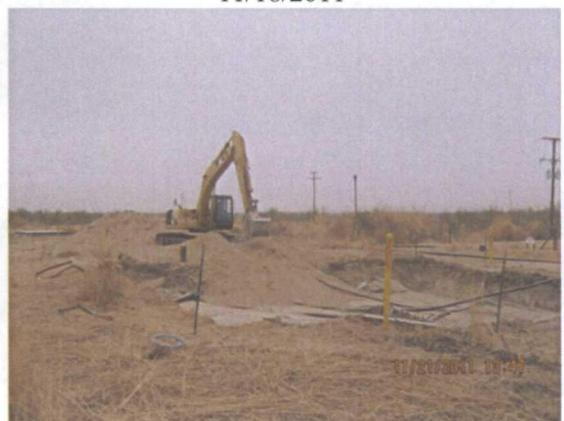
backfilling site with blended soil, facing south  
11/22/2011

with the blended soil and contoured to the surrounding landscape. Soil amendments were added to the soil and the site was seeded with a native vegetative mix. Silt net fencing was placed around the site to maintain seed integrity. Laboratory results, PID analysis, and photo documentation of these activities can be found in Appendix A.

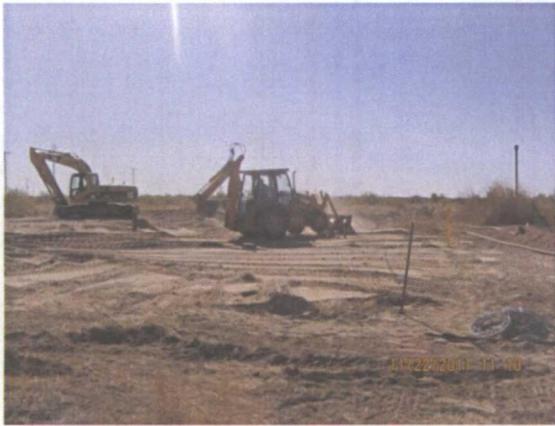
contouring the site to the surrounding area,  
facing south 11/22/2011

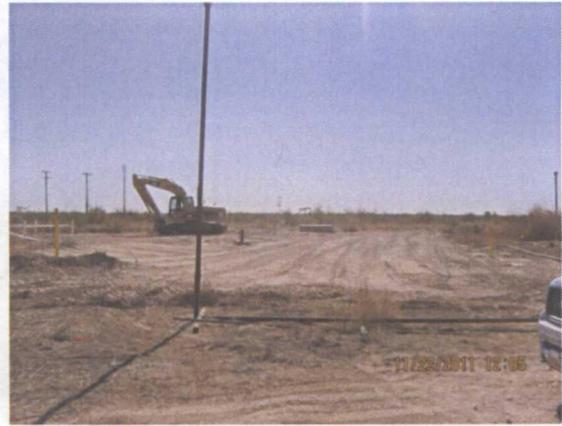
backfilled site, facing south  
11/22/2011

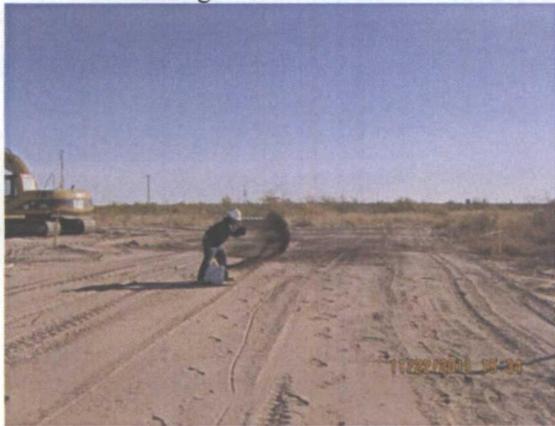
adding soil amendments, facing south  
11/22/2011

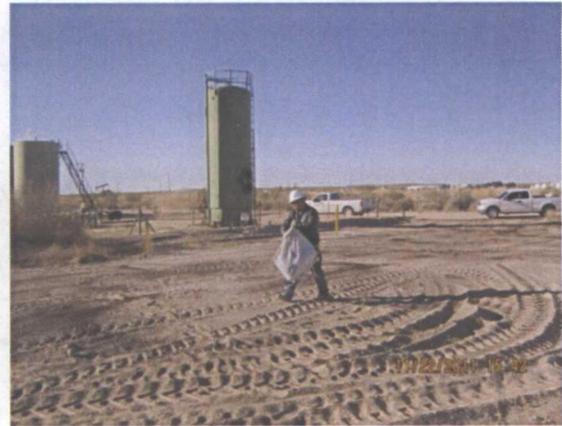
seeding the backfilled site, facing northwest  
11/22/2011

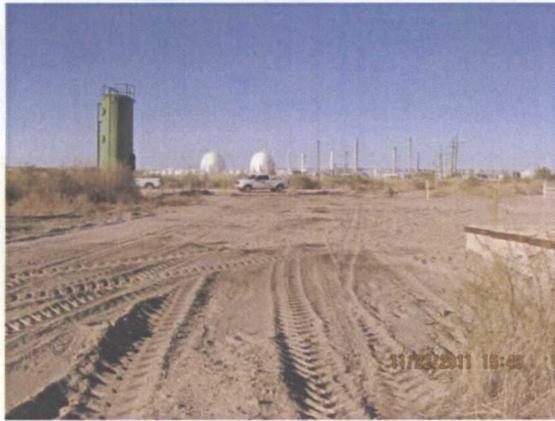
site complete, facing north  
11/22/2011

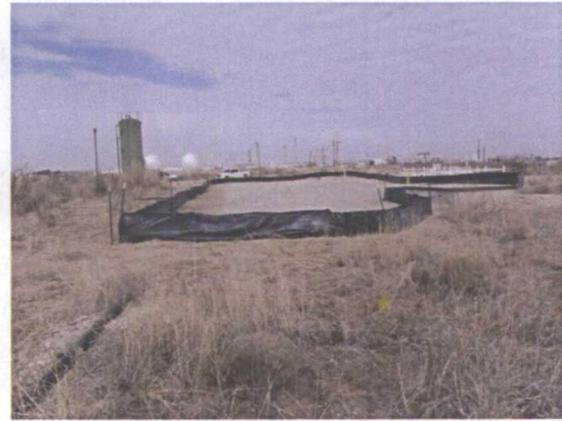
site complete with silt net fencing, facing south  
12/15/2011
