Rice Environmental Consulting & Safety

**RE: CAP Report and Termination Request
Rice Operating Company – EME SWD System
EME P-8-3 boot (1R427-231): UL/P sec. 8 T20S R37E**

EME P-8-3 Boot (1R427-231)
Unit P, Section 8, T-20-S, R-34-E

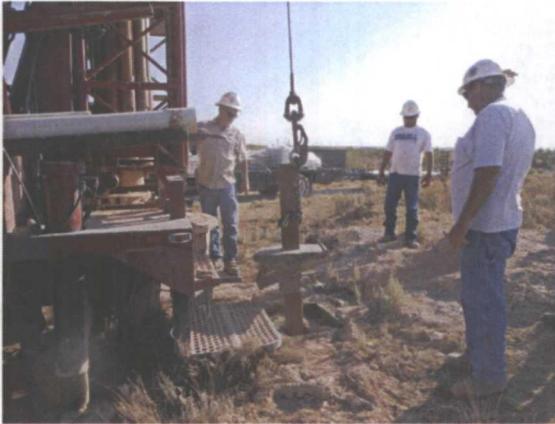
Pulling MW-1, facing northeast 9/1/11

the site. The Updated CAP was approved on August 25th, 2011. A request to leave up-gradient MW-2 in place was approved by NMOCD on August 31st, 2011. According to the NMOCD approved CAP, MW-1 was plugged and abandoned on August 25th, 2011, using a 1 – 3% bentonite/concrete slurry and a three foot concrete cap (Appendix A). On September 6th, 2011, RECS began excavating the site in preparation for liner installation (Appendix B). The site was excavated to 47 ft x 42 ft x 5 ft deep and 36 yards of excavated material were taken to an NMOCD approved facility for disposal. The remainder of the excavated soil was blended on site to use as backfill. A composite sample of the blended soil (8 pt blended backfill) was field tested with a PID meter for hydrocarbons which gave a reading of 4.2 ppm. The sample was then taken to a commercial laboratory for chloride analysis. The chloride laboratory reading for the blended backfill returned a result of 64 mg/kg.

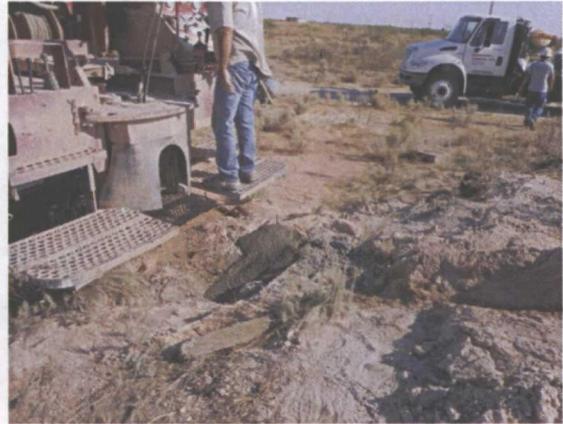
3 foot concrete cap installed, facing north 9/1/11

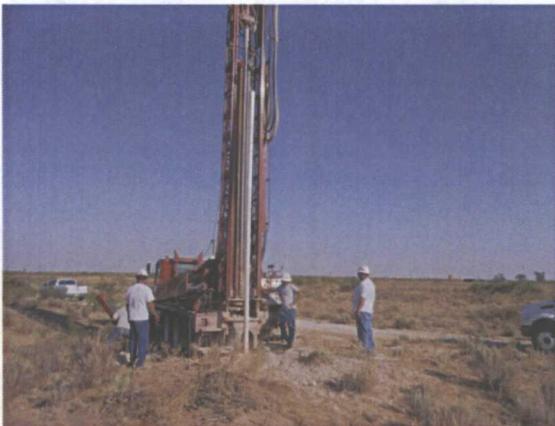
Pulling the casing, facing north 9/1/11

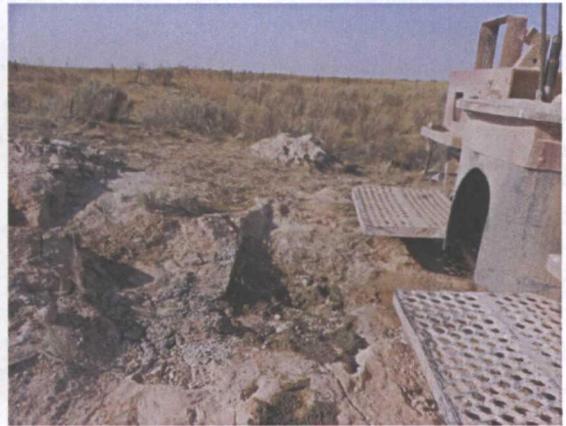
MW-1 plugged, facing south 9/1/11

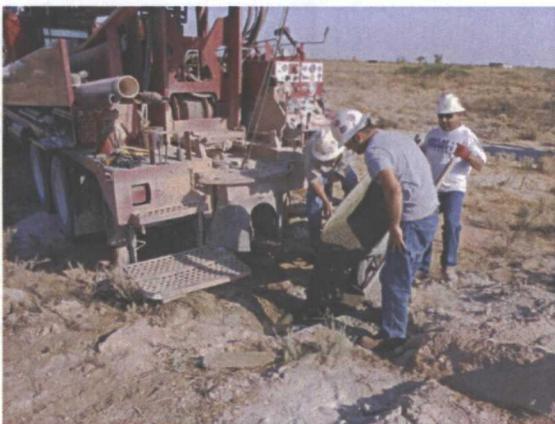
Plugging the bore with a 1- 3% bentonite/concrete slurry, facing north 9/1/11

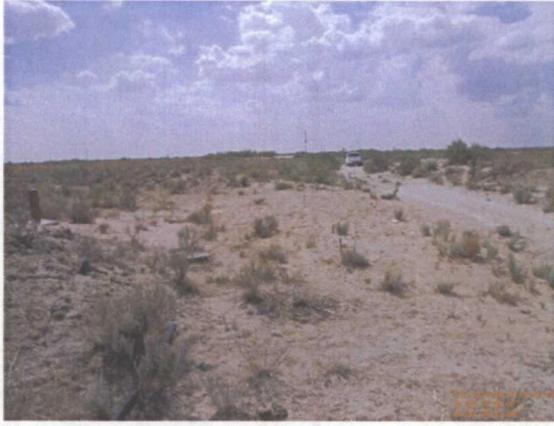
Site prior to excavation, facing west 8/15/11

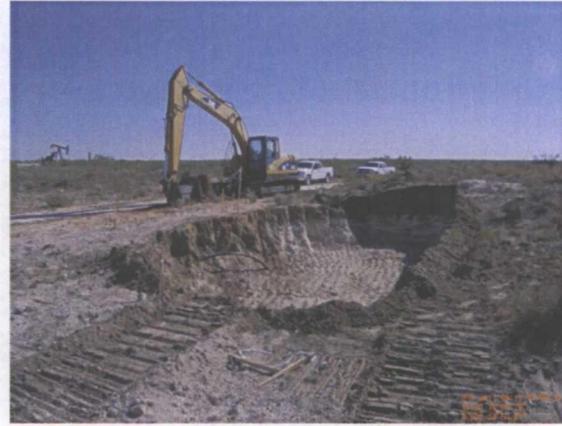
Excavating site, facing northeast 9/19/11

According to the additional information collected as part of the ICP Report, a Corrective Action Plan (CAP) was submitted to NMOCD in July 2011 and an Updated CAP was submitted August 16th, 2011. The Updated CAP proposed installing a 44x35-ft 20-mil, reinforce liner at 4-5 ft bgs. The soils placed above the liner would have a chloride reading no greater than 500 mg/kg and a field PID measurement below 100 ppm. Excavated soil would be evaluated for use as backfill, and any soil requiring disposal will be properly disposed of at a NMOCD approved facility. The site would then be seeded with native vegetation. The CAP also proposed plugging and abandoning MW-1 using a 1 – 3% bentonite/concrete slurry and the top three feet of the wells being capped with concrete. Since the site is located with the regionally impacted area, and the up-gradient monitor well has higher chloride and TDS readings than the source well, RECS determines that the P-8-3 site did not contribute to the degradation of the aquifer below

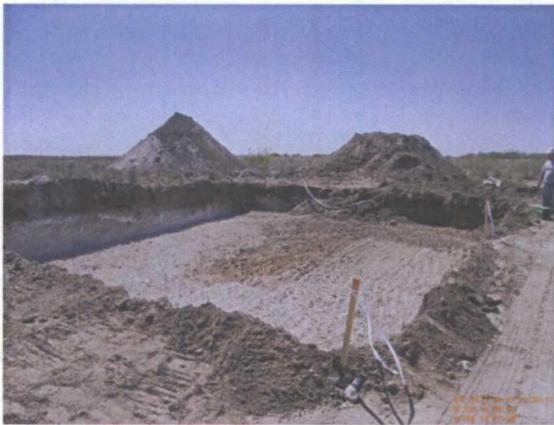
Completed excavation, facing west 9/19/11

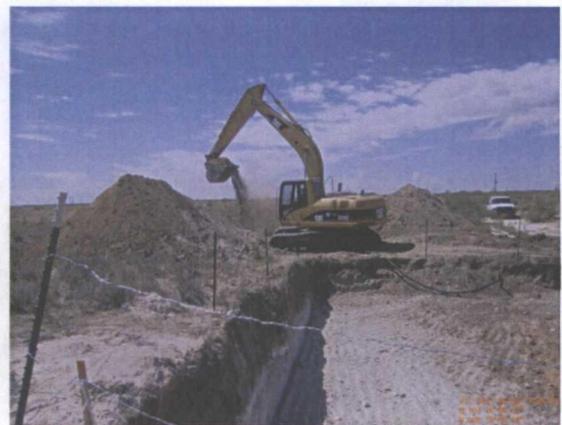
Blending backfill, facing west 9/20/11

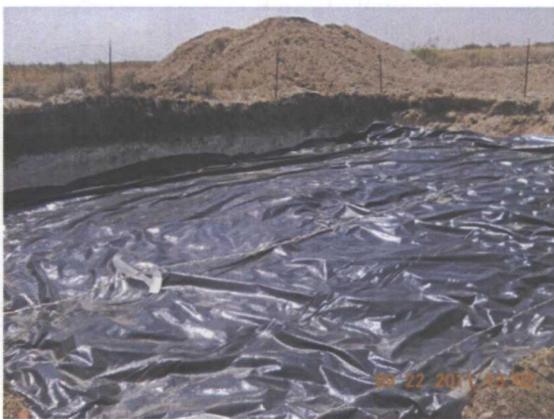
Plastic liner installed over pad, facing southwest 9/22/11

Imported soil was used to pad the liner. A six inch pad was placed below and above the liner to protect it from punctures. The imported sand was field tested with a PID meter for hydrocarbons and returned a result of 0.6 ppm. The sample was then taken to a commercial laboratory for analysis of chlorides. The chloride laboratory reading of the imported soil returned a result of non-detect. A 20-mil reinforced poly liner was installed and properly seated throughout the excavation on September 22nd, 2011. The excavation was then backfilled with the blended soil to a depth of six inches. Imported soil was used to complete the backfill of the excavation and to contour the site to the surrounding area. A total of 132 yards of sand was imported to pad the liner and to complete the backfill of the excavation.

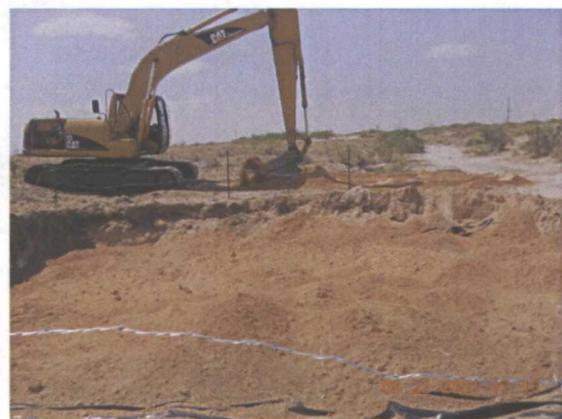
Installing pad above liner, facing south 9/22/11

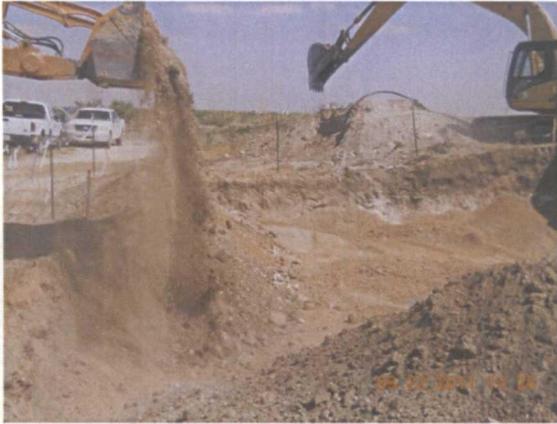
Backfilling with blended soil, facing southwest
9/22/11

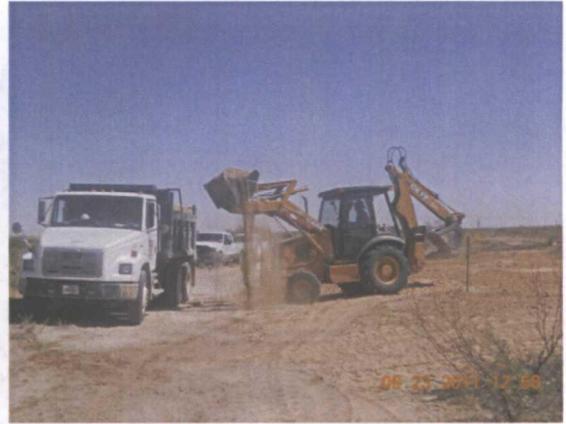
Exporting the spoil pile, facing east 9/23/11

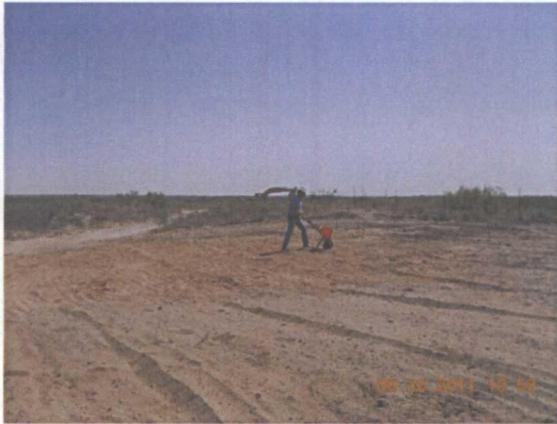
Seeding the site, facing east 9/26/11

On September 26th, 2011, the site was disked and soil amendments added. The site was seeded with a blend of native vegetation and is expected to return to normal vegetative capacity.

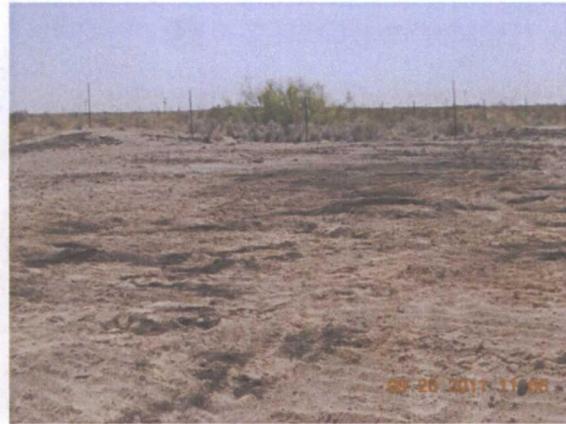
Soil amendments added, facing southeast 9/26/11

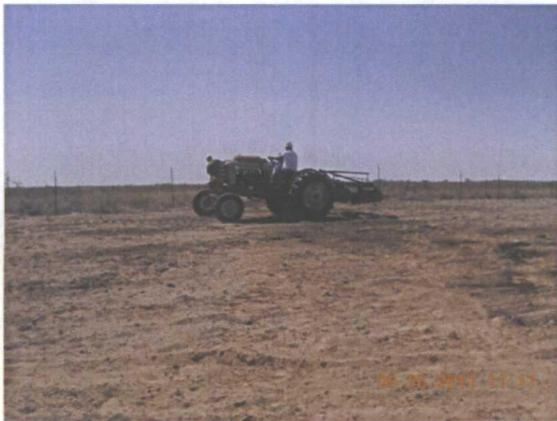
Disking the site, facing south 9/26/11

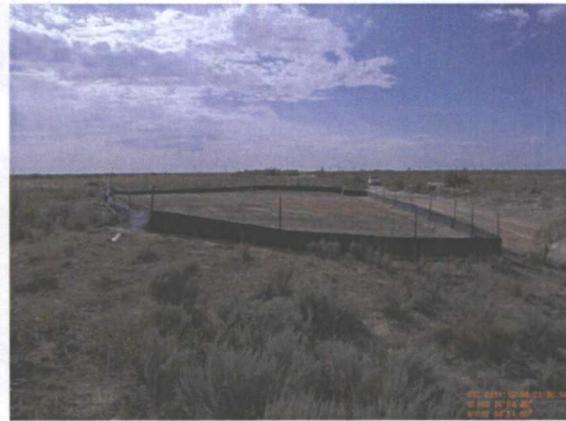
Site complete with silt fence, facing west 10/4/11
