WORKPLANS

**RE: Additional Groundwater Monitoring and Corrective Action Plan for
Groundwater
Rice Operating Company – Vacuum SWD System
Vacuum L-26 vent (1R425-66): UL/L sec. 26 T17S R35E**

- Figure 1 – Site Location Map
- Figure 2 – Monitor Well Installation Map
- Figure 3 – Monitor Well Sampling Map
- Appendix A – Monitor Well Installation Logs
- Appendix B – Monitor Well Sampling Laboratory Confirmation

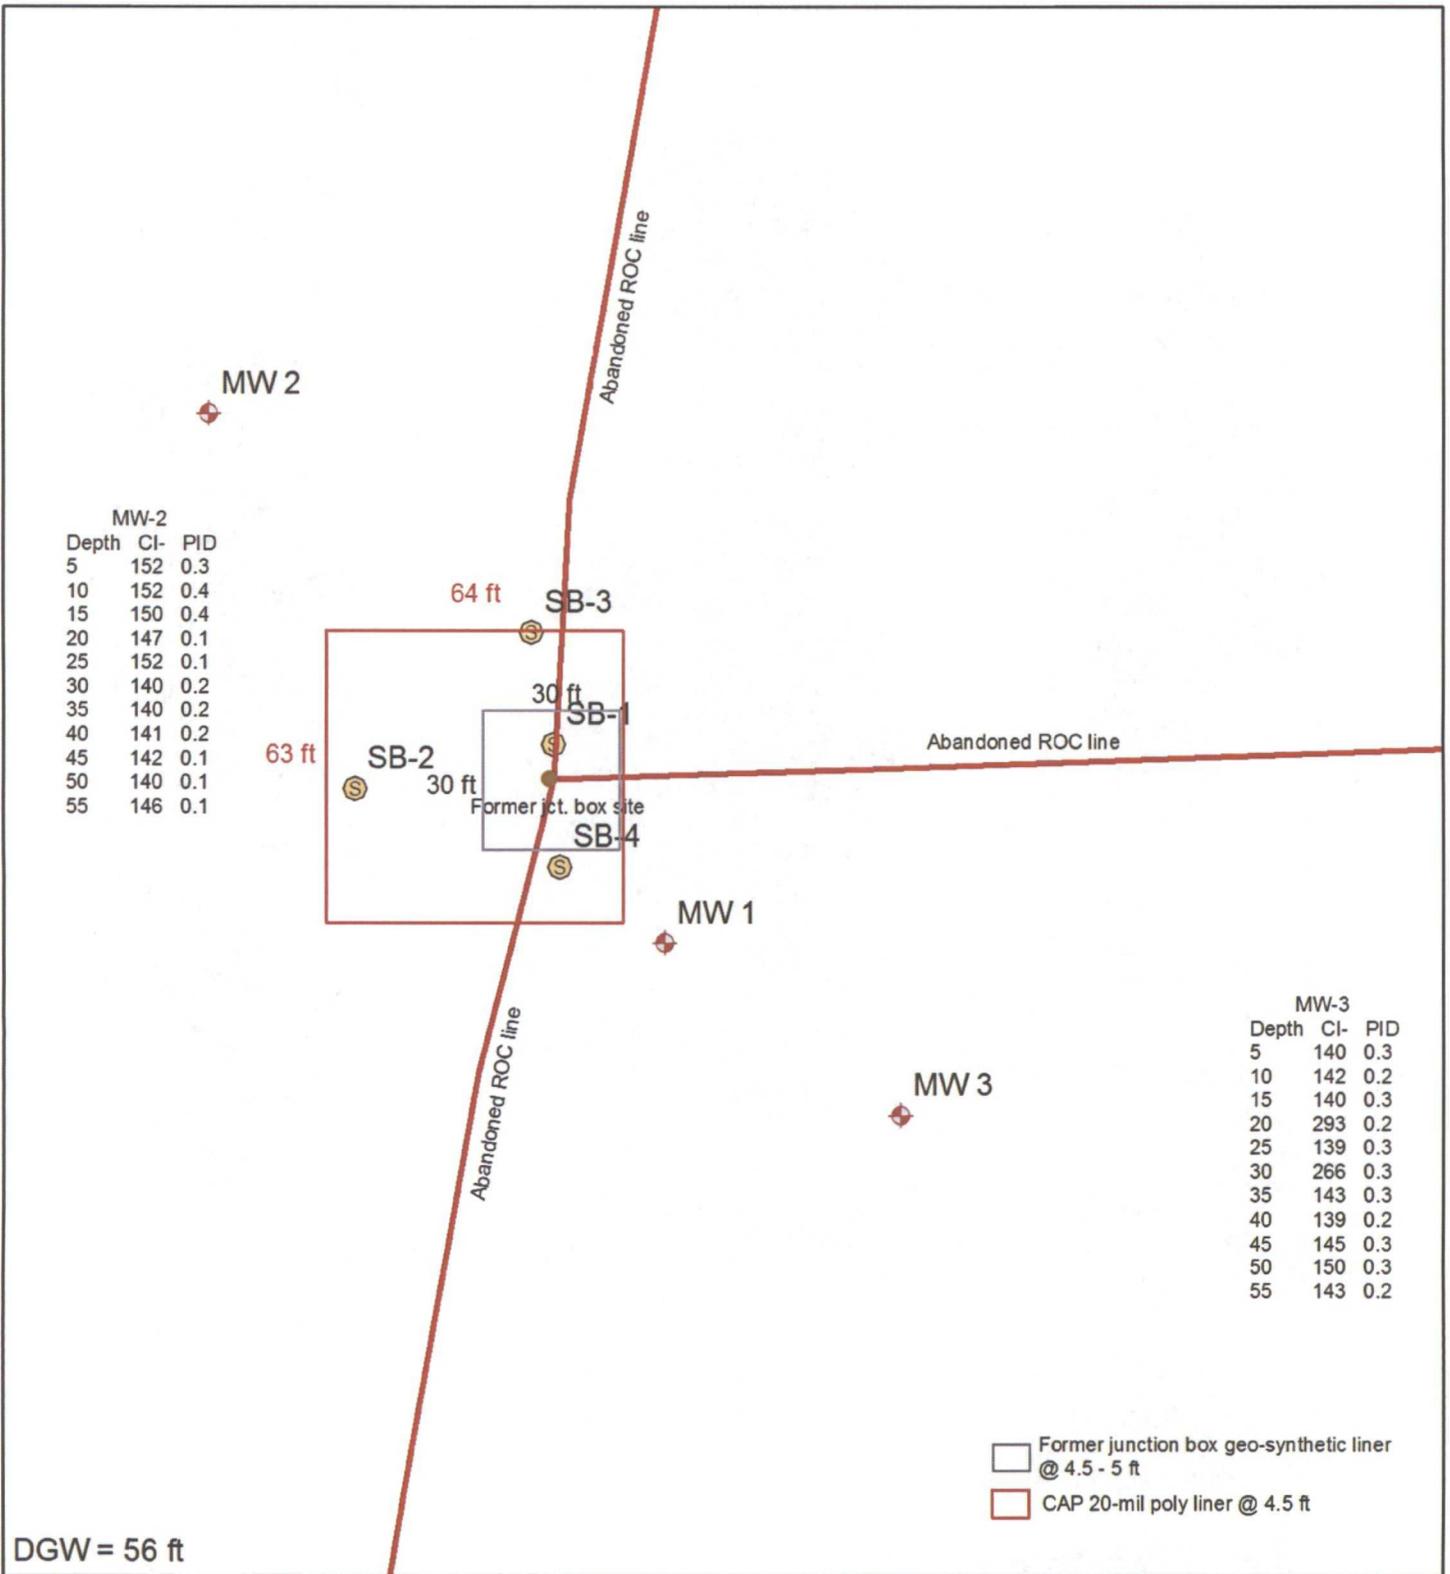
Figure 2

Monitor Well Installation

Two additional monitoring wells were installed at the site on April 11th, 2011 (Figure 2). Both wells were field tested for chlorides and hydrocarbons as they were advanced and showed clean soil throughout (Appendix A). All three wells have been sampled quarterly since their installation; the most recent sampling event occurring on December 2nd, 2011 (Figure 3). The source well, MW-1, had a chloride reading of 920 mg/kg, the up gradient

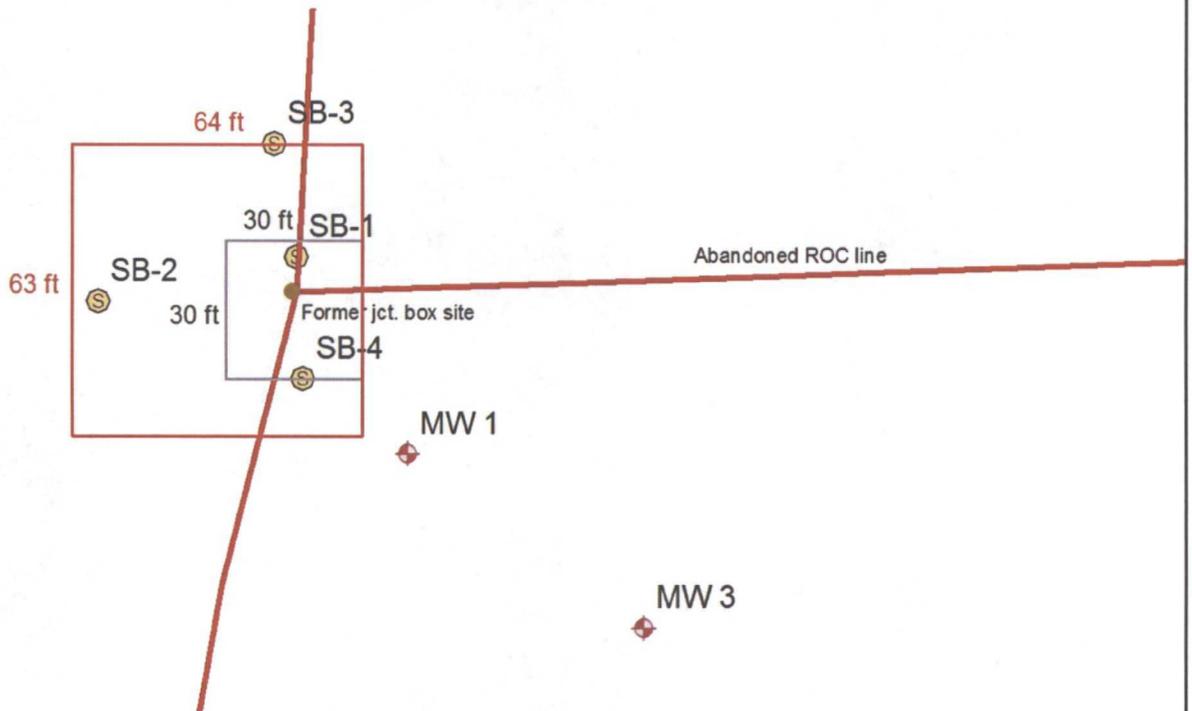
Figure 3

Monitor Well Sampling

MW	Depth to Water	Total Depth	Sample Date	Cl	TDS	Benzene	Toluene	Ethyl Benzene	Total Xylenes	Sulfate
				(mg/L)						
MW-1	56.53	72.54	11/22/2010	940	2120	<0.001	<0.001	<0.001	<0.003	79.6
	56.6	72.57	2/16/2011	960	2130	<0.001	<0.001	<0.001	<0.003	64
	56.7	72.57	6/4/2011	1040	2710	<0.001	<0.001	<0.001	<0.003	64.7
	56.79	72.57	8/31/2011	940	2440	<0.001	<0.001	<0.001	<0.003	67
	56.88	72.57	12/2/2011	920	2230	<0.001	<0.001	<0.001	<0.003	73.7

MW	Depth to Water	Total Depth	Sample Date	Cl	TDS	Benzene	Toluene	Ethyl Benzene	Total Xylenes	Sulfate
				(mg/L)						
MW-2	56.83	62.78	6/4/2011	32	457	<0.001	<0.001	<0.001	<0.003	37
	56.93	62.78	8/31/2011	32	374	<0.001	<0.001	<0.001	<0.003	33.5
	57.02	62.78	12/2/2011	36	405	<0.001	<0.001	<0.001	<0.003	40.8

MW	Depth to Water	Total Depth	Sample Date	Cl	TDS	Benzene	Toluene	Ethyl Benzene	Total Xylenes	Sulfate
				(mg/L)						
MW-3	56.14	68.92	6/4/2011	432	1210	<0.001	<0.001	<0.001	<0.003	69.1
	52.24	68.92	8/31/2011	416	1250	<0.001	<0.001	<0.001	<0.003	47.3
	56.34	68.92	12/2/2011	450	1330	<0.001	<0.001	<0.001	<0.003	56.8

DGW = 56 ft

- Former junction box geo-synthetic liner @ 4.5 to 5 ft
- CAP 20-mil poly liner @ 4.5 ft

well, MW-2, had a chloride reading of 36 mg/kg and the down gradient well, MW-3, had a chloride reading of 450 mg/kg (Appendix B).
