**RE: Further Investigation Report and Corrective Action Plan (CAP) for  
Soils  
Rice Operating Company – BD SWD System  
BD G-23 EOL (1R426-281): UL/G sec. 23 T22S R37E  
(formerly BD B-23 EOL)**

# Site Map

# Soil Bore and MW Installation and Proposed Liner

# BD G-23 EOL (1R426-281)

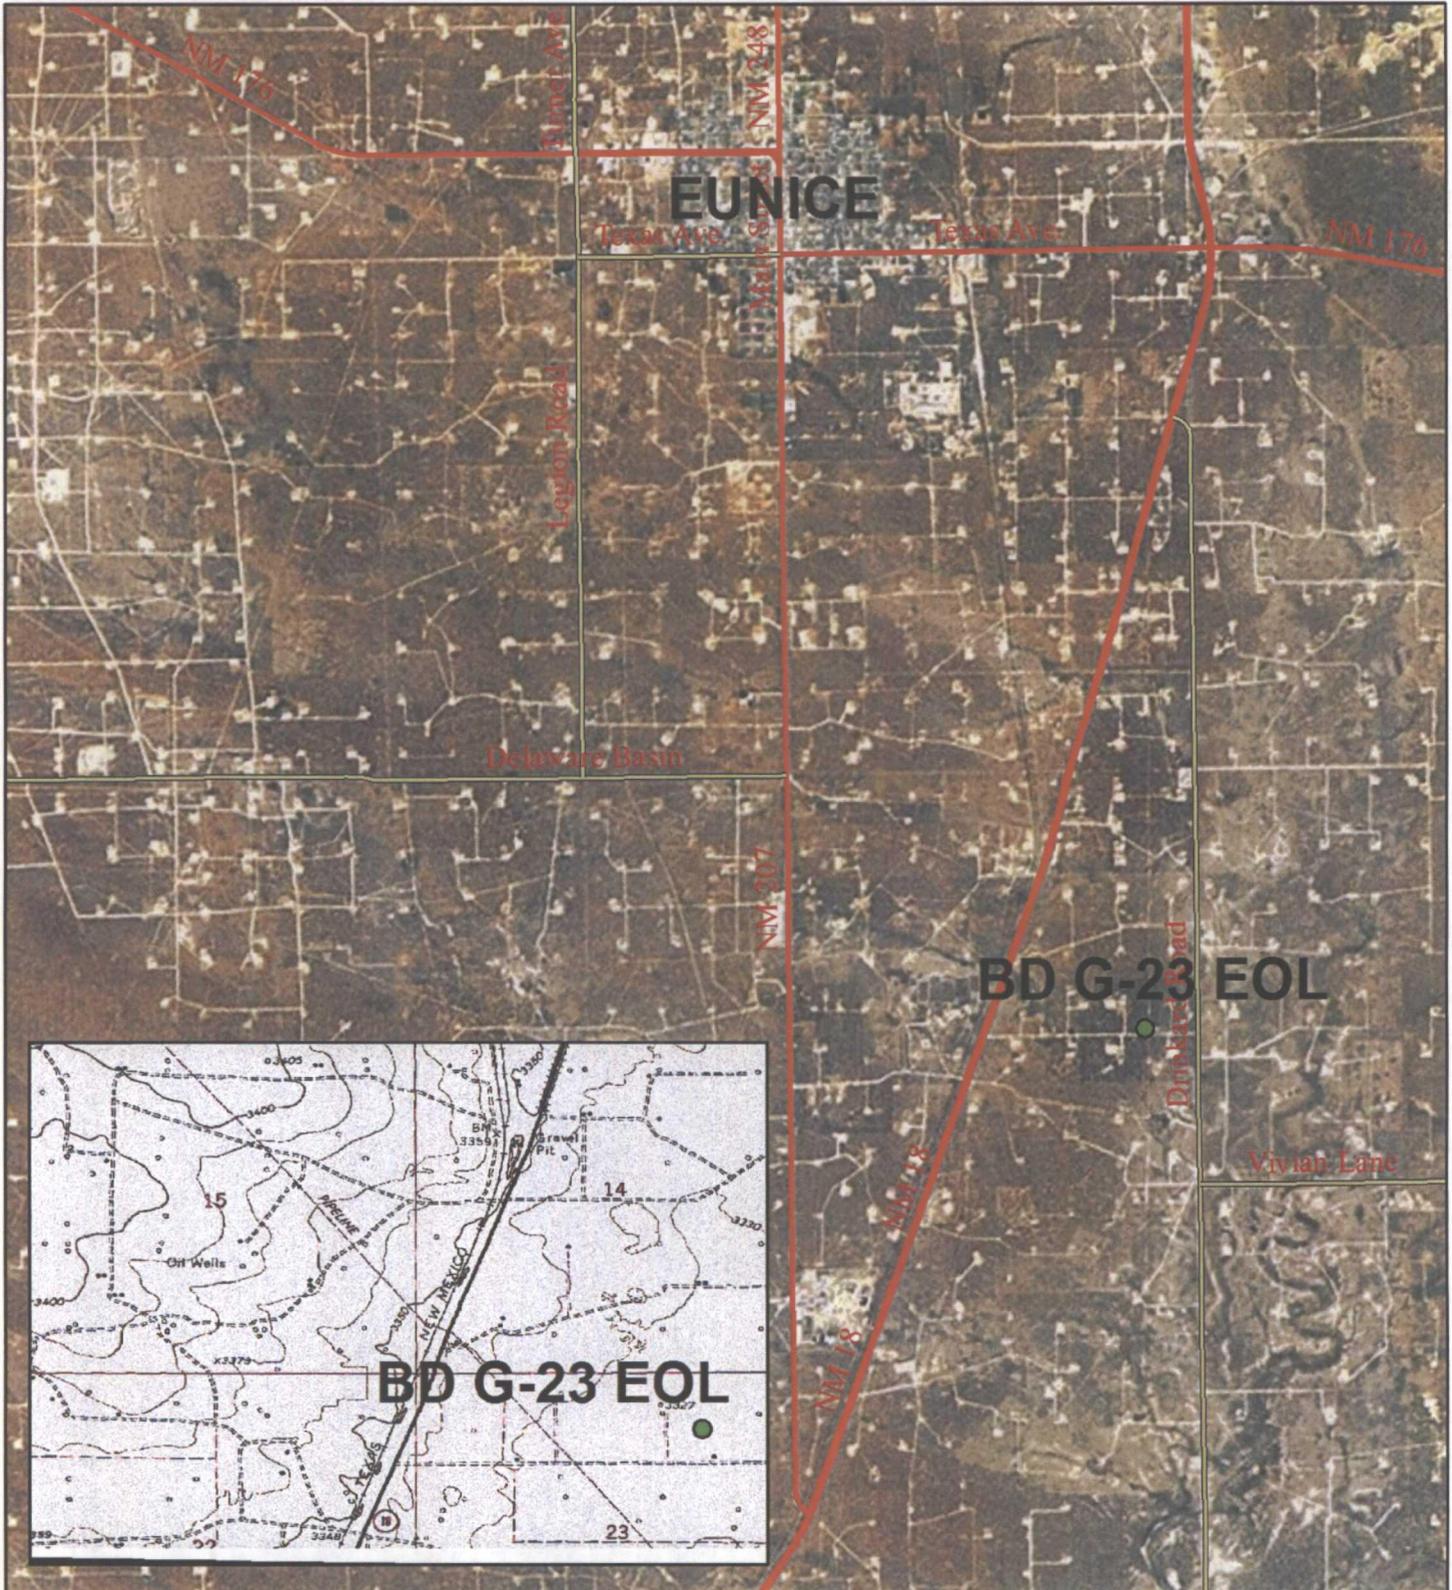
Figure 1

The site is located approximately 4 miles southeast of Eunice, New Mexico at UL/G sec. 23 T22S R37E as shown on the Site Location Map (Figure 1). Groundwater at this site is located at a depth of approximately 59 +/- feet.

**BD G-23 EOL**  
LEGALS: UL/G sec. 23  
T22S R37E  
NMOCD Case # : 1R426-281

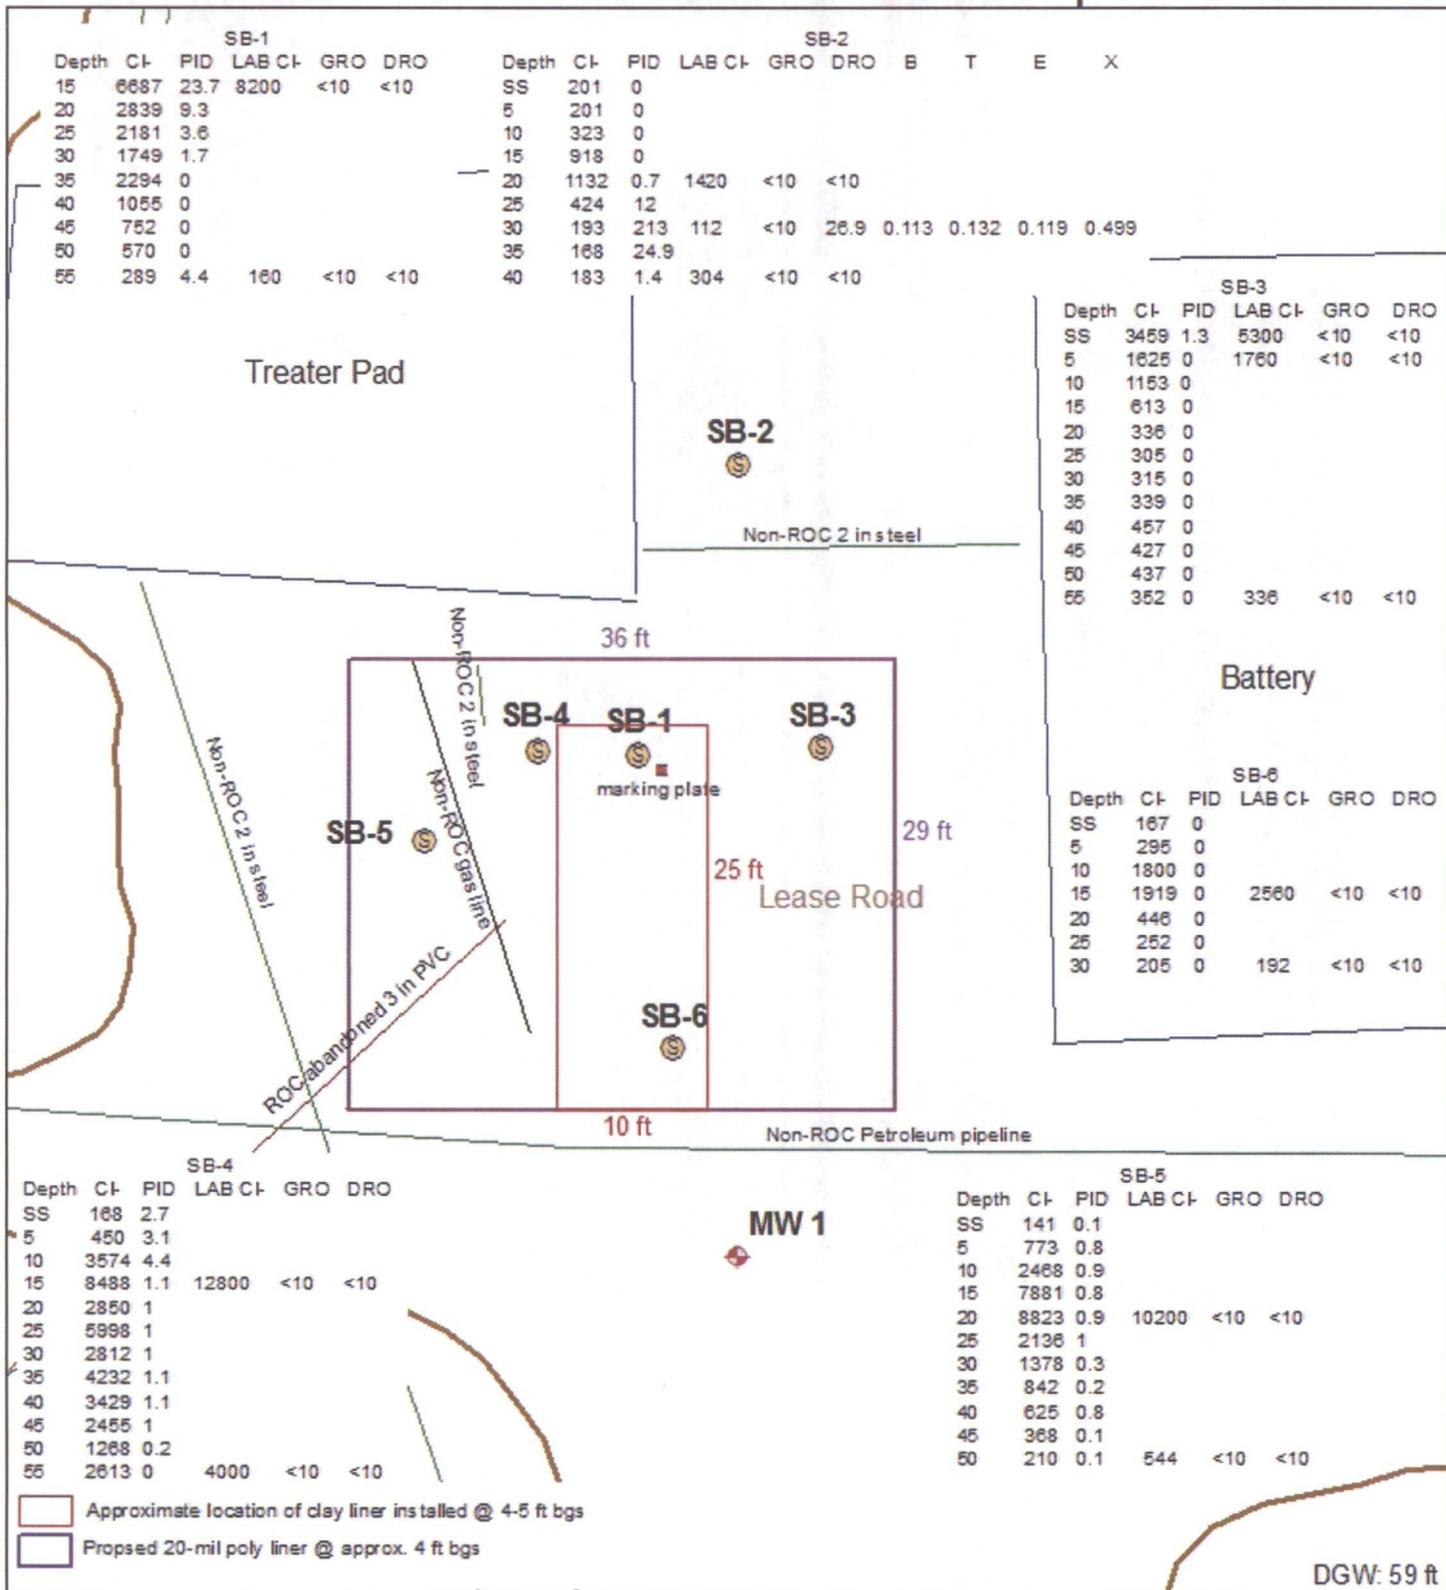
On January 31<sup>st</sup>, 2012, RECS personnel were on site to install a near-source monitor well (MW-1) (Figure 2). Samples were only taken for lithology as the well was being advanced (Appendix B). The well was then sampled on February 20<sup>th</sup>, 2012 and returned a chloride value of 860 mg/L, a TDS value of 1,970 mg/L and a BTEX value of

**BD G-23 EOL**  
 NMOCD Case # : 1R426-281  
 LEGALS: UL/G sec. 23  
 T22S R37E

ROC proposes to excavate the site to dimensions of 36 ft x 29 ft and properly seat a 20-mil, reinforced poly liner at approximately 4 ft bgs. The liner will cover the existing clay layer at 5-4 ft bgs measuring 10 ft x 25 ft. The soils placed above the liner will have a laboratory chloride reading no greater than 500 mg/kg and a field PID measurement below 100 ppm. Excavated soil will be evaluated for use as backfill and any soils requiring disposal will be properly disposed of at a NMOCD approved facility. The excavation will be capped with caliche since the site is located on an active battery lease pad (Appendix A) and seeding of the site will not be necessary.

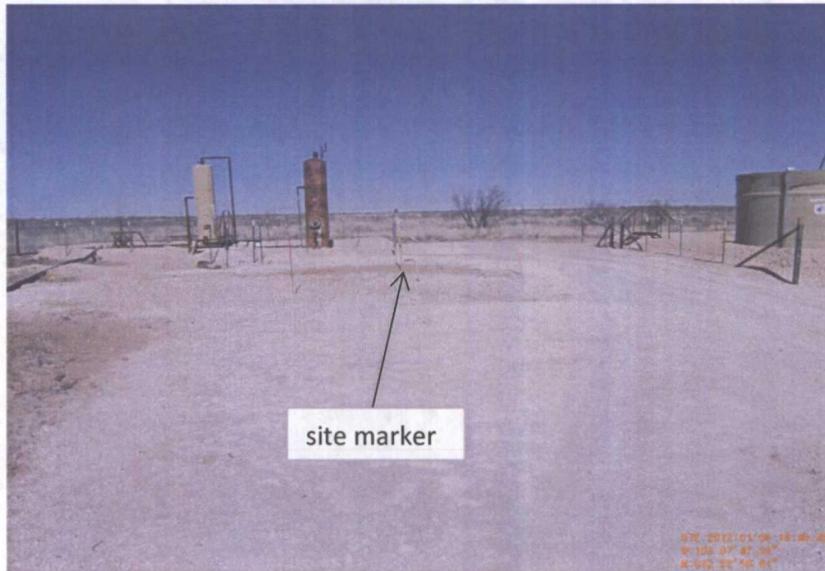
Site Photo

BD G-23 EOL in relation to the surrounding facility, facing northwest 1/6/2012
