From: Hansen, Edward J., EMNRD
Sent: Thursday, April 12, 2012 2:55 PM
To: Hack Conder
Cc: Leking, Geoffrey R, EMNRD; 'Katie Jones'; Laura Pena; 'Scott Curtis'
Subject: Remediation Plan (1R425-07) Termination- ROC Vacuum Jct A-31-1 Site

RE: Termination Request
Vacuum Jct. A-31-1 (1R425-07): UL/A, Sec. 31, T17S, R35E
RICE Operating Company – Vacuum SWD System

**RICE OPERATING COMPANY
JUNCTION BOX FINAL REPORT**

Vacuum jct. A-31-1

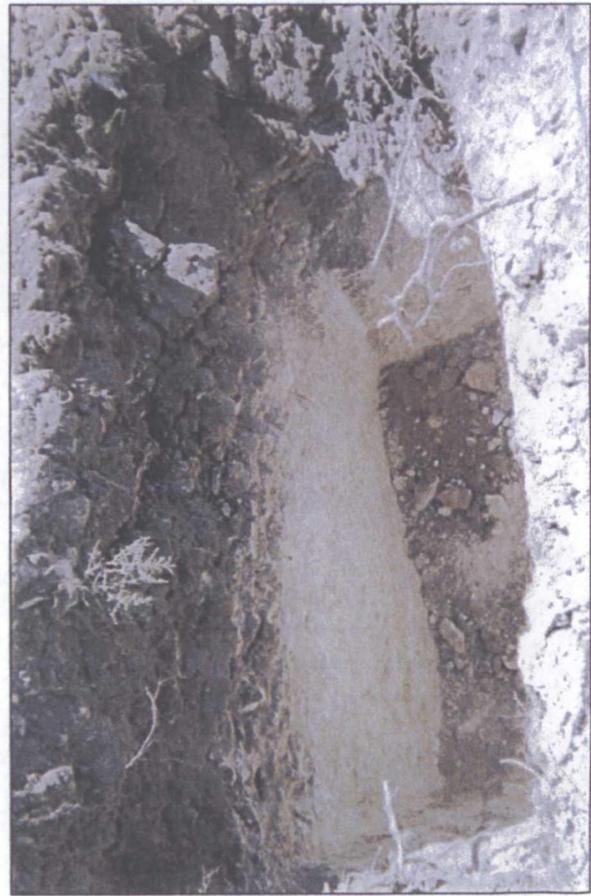
8/30/2005

delineation trench at former box site

part of the Vacuum SWD System Abandonment. After the box materials were removed, a delineation trench was made using a backhoe while soil samples were collected every ft of depth at 4-9 ft BGS. Chloride field tests were performed on these samples and yielded very low concentrations. PID screenings were also performed on the samples and these concentrations were also very low. The soil samples did not exhibit any physical indications of impact from the junction box operations. A grab sample at 9 ft BGS was analyzed at a laboratory for confirmation of the field tests. TPH was not present within the lab's detection limits (<10.0 ppm), meeting NMOCD guidelines. The excavated soil was blended on site and then backfilled into the trench. The disturbed surface was seeded with a blend of native vegetation and is expected to return to productive capacity at a normal rate.
