From: Hansen, Edward J., EMNRD
Sent: Monday, April 30, 2012 6:09 PM
To: Hack Conder (hconder@riceswd.com)
Cc: Leking, Geoffrey R, EMNRD; Katie Jones <kjones@riceswd.com> (kjones@riceswd.com);
Laura Pena (lpena@riceswd.com); Scott Curtis (scurtis@riceswd.com)
Subject: Remediation Plan (1R425-09) Termination - ROC Vacuum Vent B-5-1 Boot Site

RE: Termination Request
Vacuum vent B-5-1 boot (1R425-09): UL/B, Sec. 5, T18S, R35E
RICE Operating Company – Vacuum SWD System

**RICE OPERATING COMPANY
JUNCTION BOX FINAL REPORT**

Vacuum B-5-1 boot vent

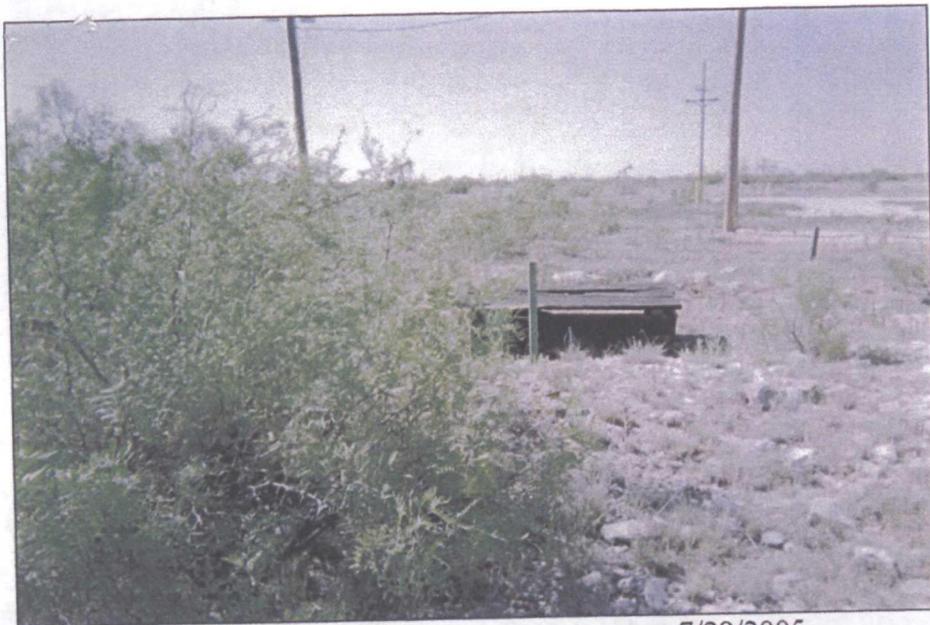
undisturbed junction box

7/28/2005

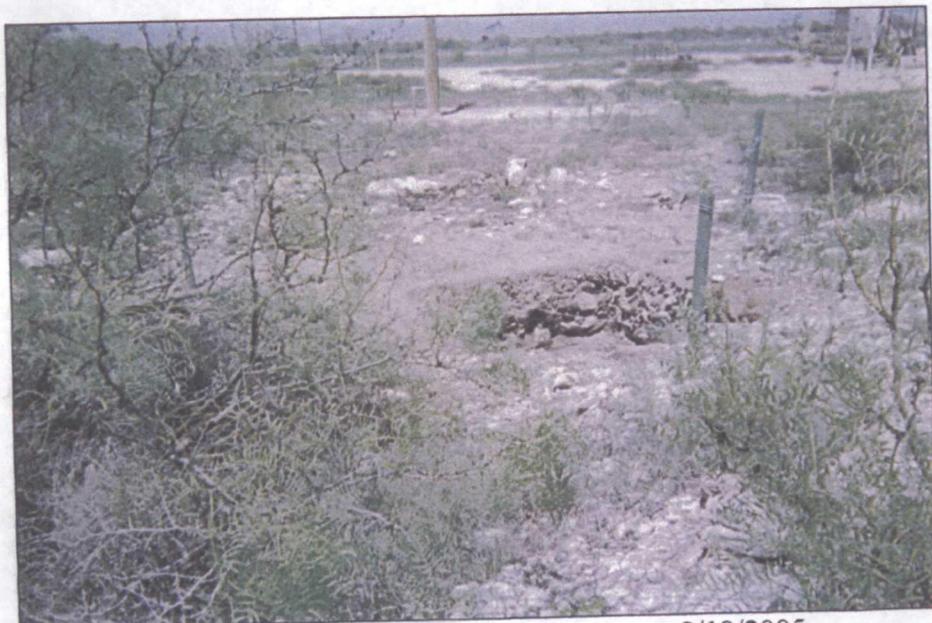
junction box removed

8/18/2005

This junction box contained a vent and a boot and was addressed as part of the Vacuum SWD System abandonment. After the box was removed, a delineation trench was made at the junction with a backhoe. Soil samples were collected every ft of depth from 3 to 8 ft BGS. Chloride field tests were conducted on every sample and concentrations were <100 ppm for all samples. Laboratory analysis of the 8 ft grab sample yielded 46.9 ppm chloride, similar to background level. There were no physical indicators of hydrocarbon impact in the soil samples and all PID screenings performed on the samples were 0.0 ppm. Lab analysis confirmed that NOMCD TPH guidelines were met. The excavated soil was blended on site and then backfilled into the trench. The disturbed surface was seeded with a blend of native vegetation on 12/2/2005 and is expected to return to productive capacity at a normal rate.

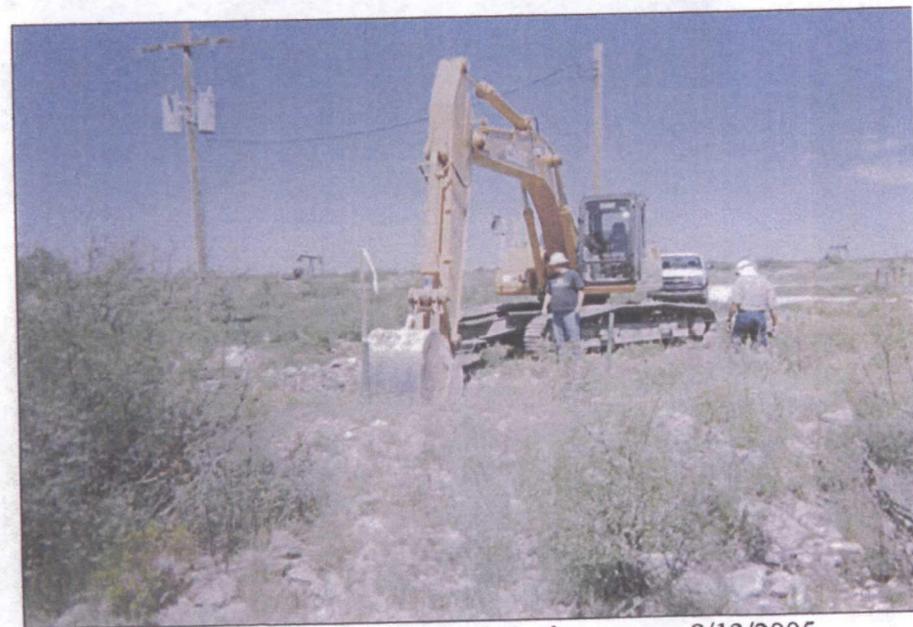
delineation trench at former box site

9/13/2005

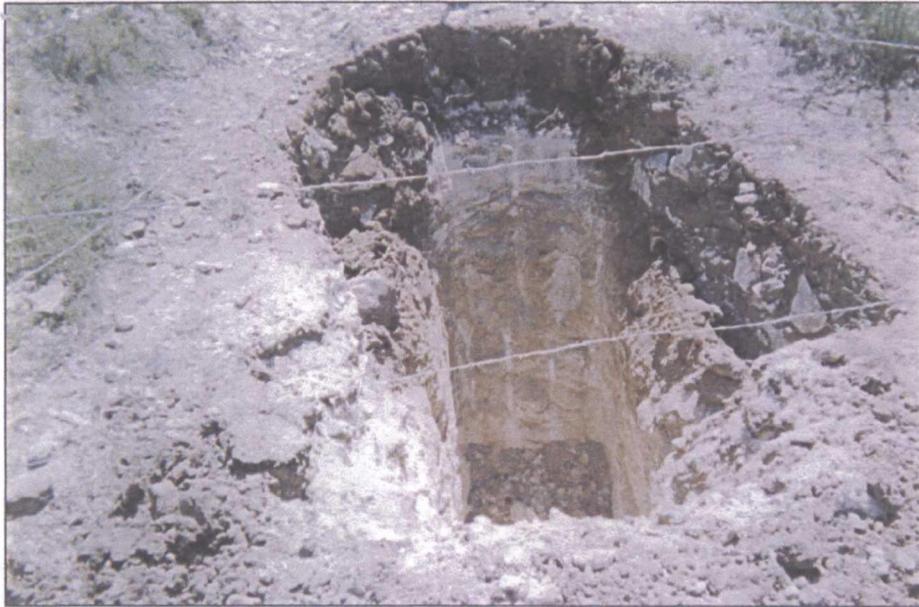
8-ft-deep delineation trench

9/13/2005

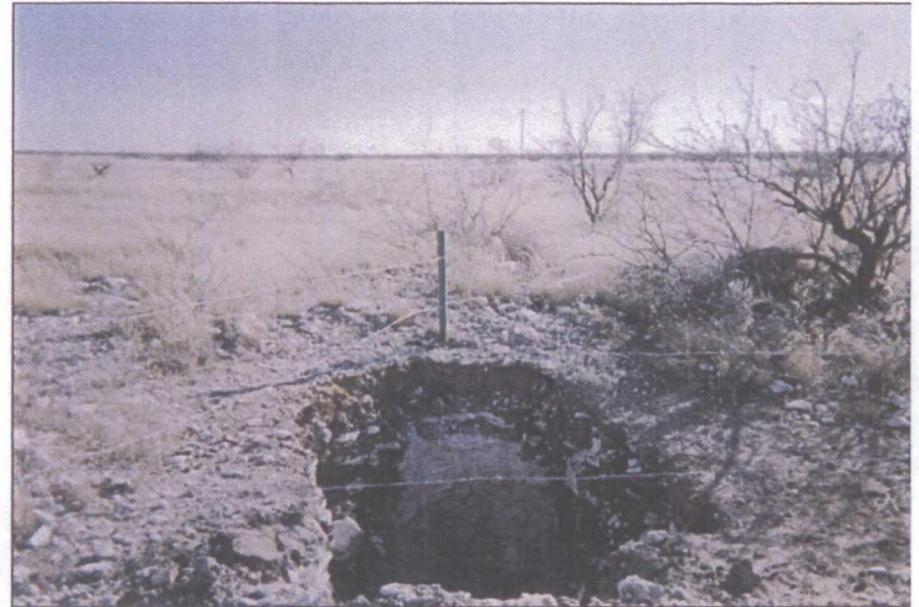
8-ft-deep delineation trench

9/13/2005

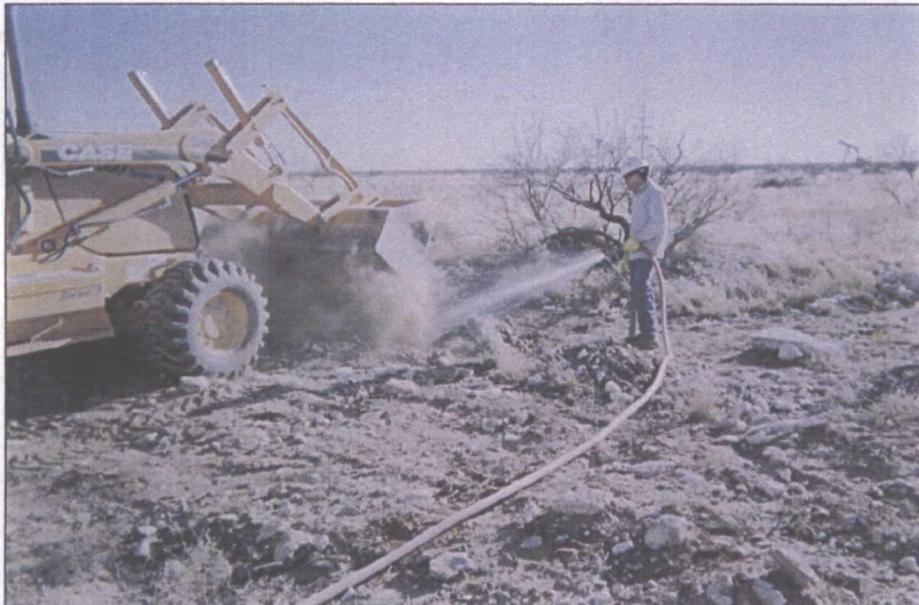
backfilling and compacting trench

12/2/2005

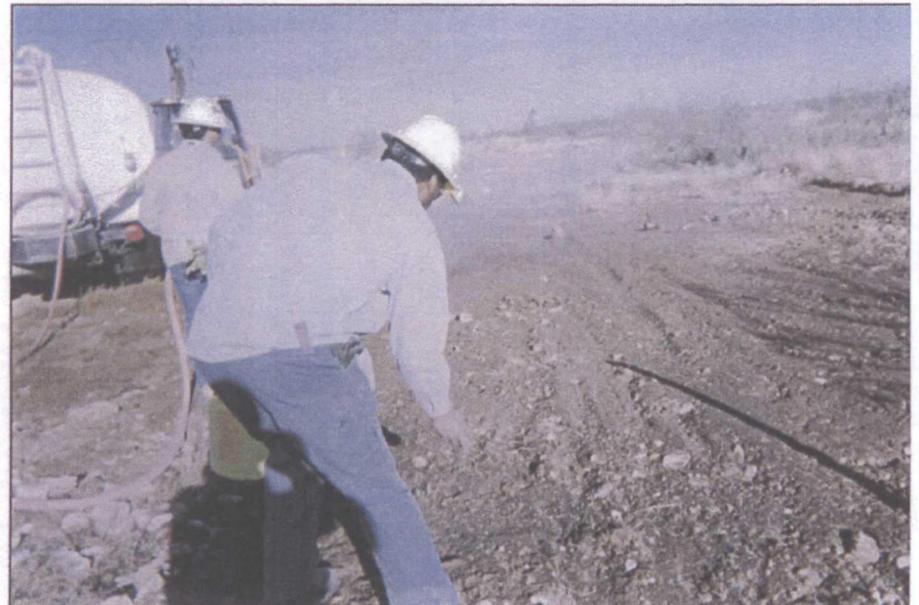
seeding and watering backfilled site

12/2/2005
