WORKPLANS

April 17th, 2012

**RE: Report of Further Investigation and Corrective Action Plan (CAP)
Rice Operating Company – EME SWD System
EME H-7 EOL (1R427-351): UL/H sec. 7 T20S R37E
(formerly EME I-7 EOL)**

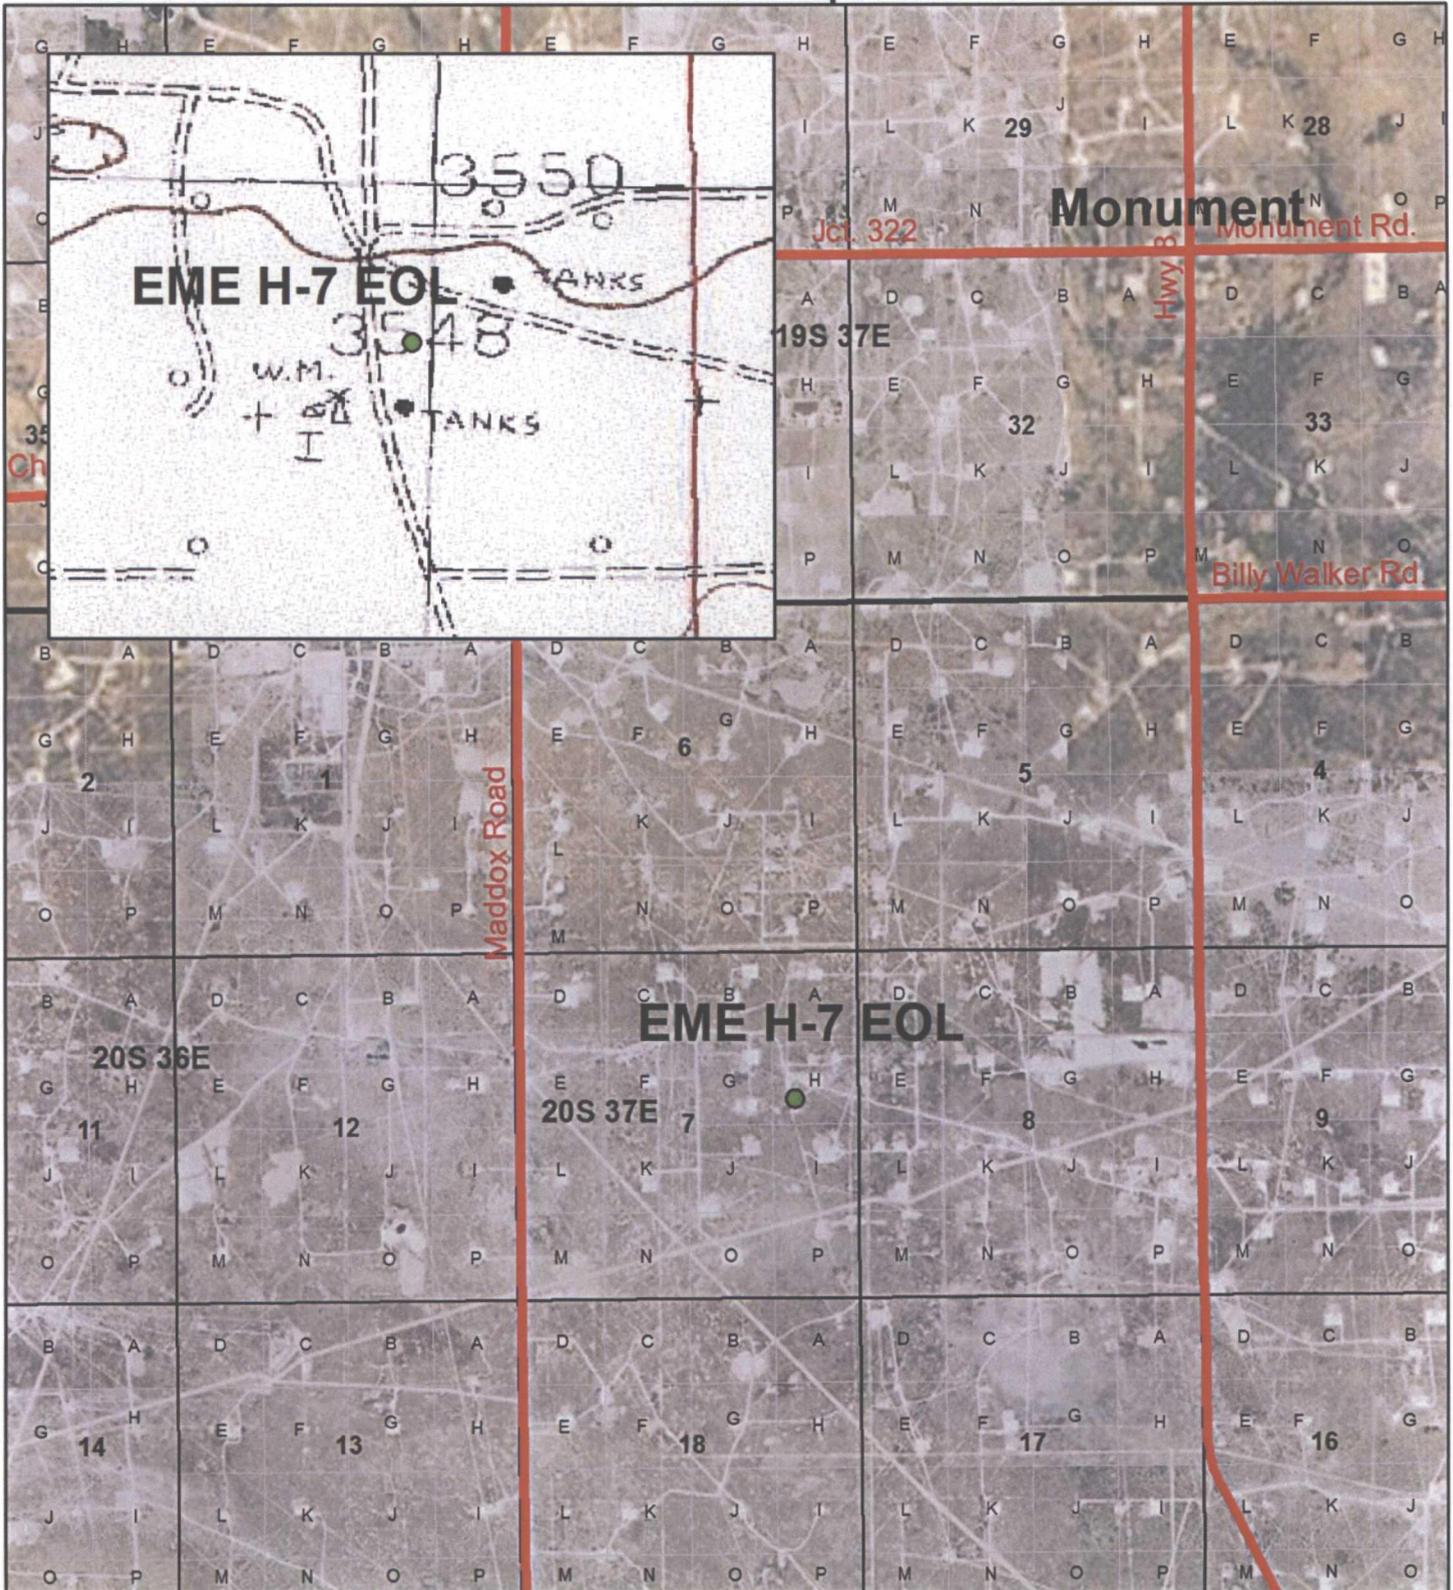
The site is located approximately 2.5 miles south-west of Monument, New Mexico at UL/H sec. 7 T20S R37E as shown on the Site Location Map (Figure 1). Monitor well sampling at the site shows groundwater to be located at 29 ft bgs.

Site Map

Figure 1 – Site Map

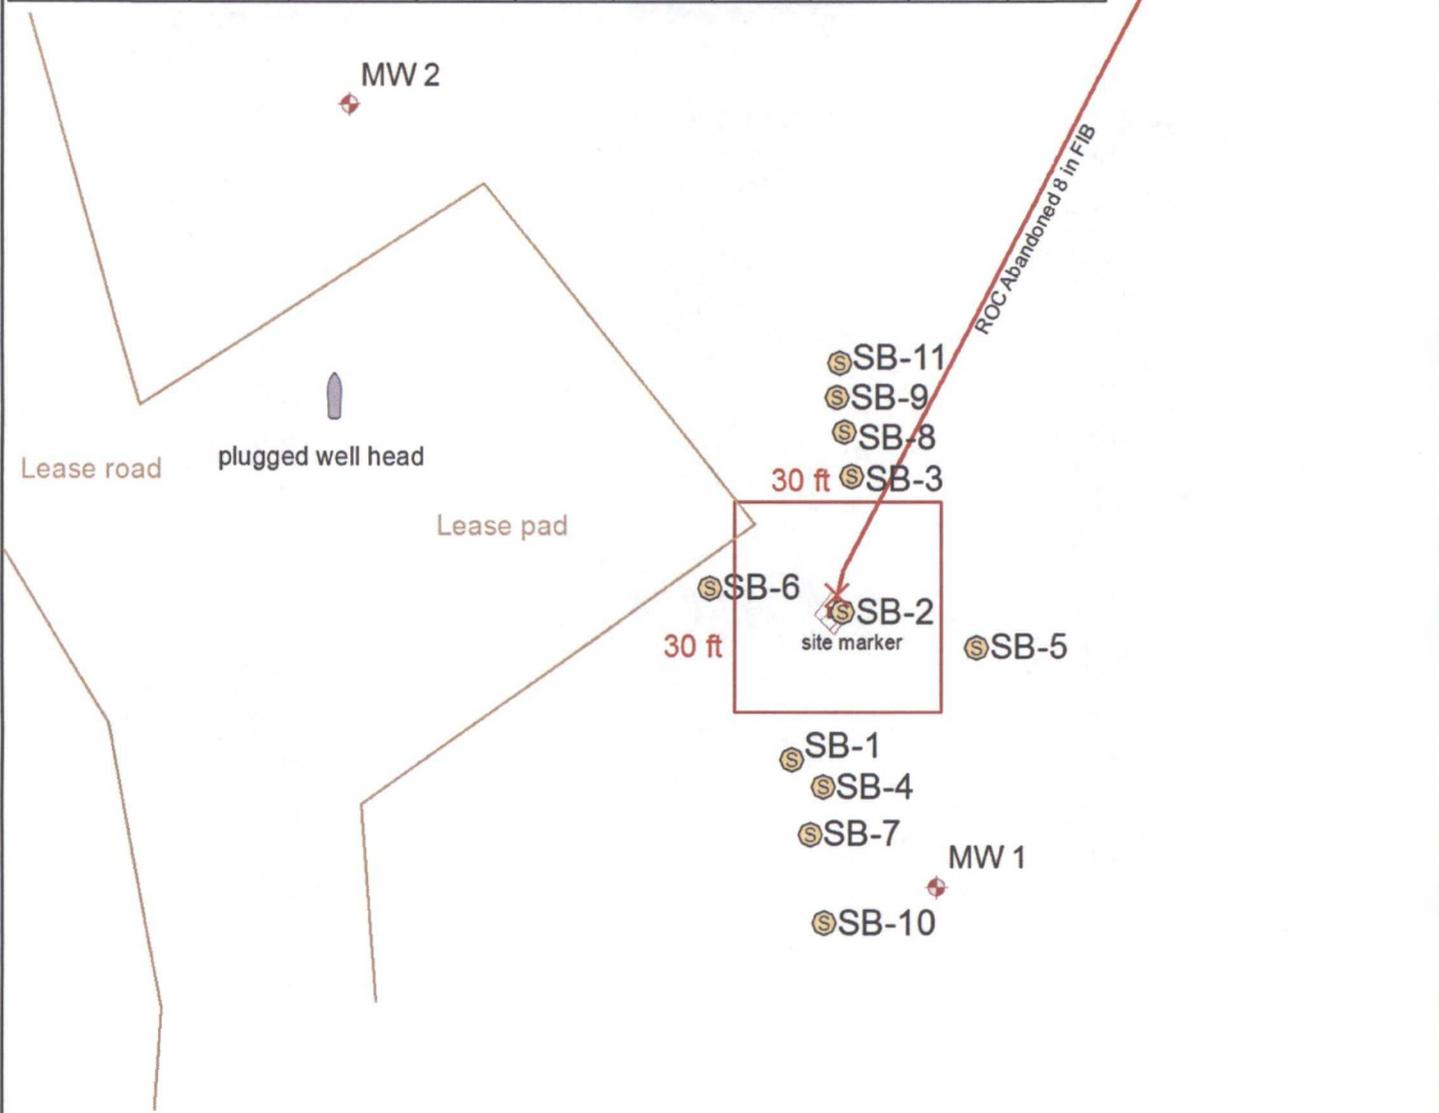
The monitor wells have been sampled quarterly since their installation (Figure 2). The site is located within a regionally impacted groundwater area (Figure 3). During the last sampling event that occurred on February 10th, 2012, MW-2, the up gradient monitor well, showed a chloride concentration of 1,900 mg/L. The near source monitor well, MW-1, showed a chloride concentration of 2,300 mg/L (Appendix A). Although the groundwater coming onto the site is already impacted from chlorides, it is evident that the site also contributed to the degradation of groundwater.

Monitor Well Sampling Data

Current Clay Layer @ 12'
 DGW = 29 ft

Figure 2 – Monitor Well Sampling Data

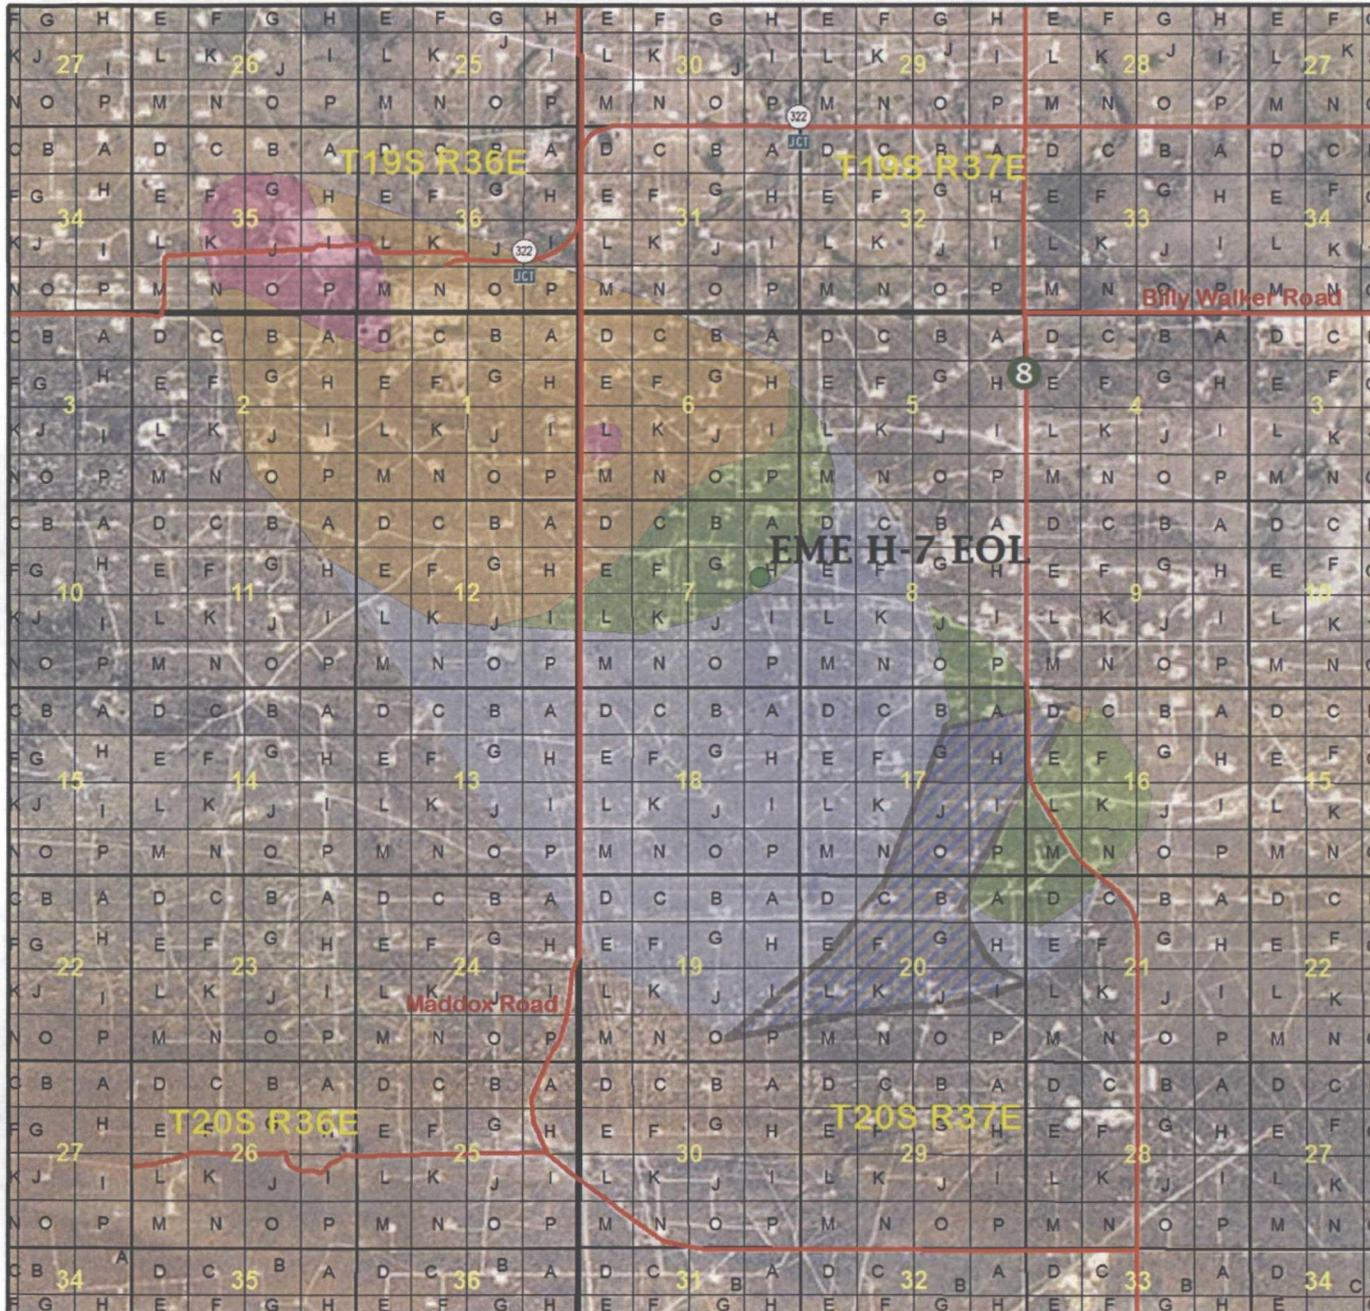
EME Groundwater Contamination

- Cl- concentration > 10,000
- 10,000 > Cl- concentration > 5,000
- 5,000 > Cl- concentration > 2,000
- 2,000 > Cl- concentration > 700
- Hypothetical Cl- contamination area

This map was prepared for Rice Operating Company. This map represents the known chloride impact concentrations in the groundwater as of 2011. As conditions change and/or new monitor wells are added, the contamination plume will undergo permutations that will be reflected in future maps. Rice Operating Company does not assume any responsibility for the use of this information by others.

Figure 3 – EME Groundwater Contamination

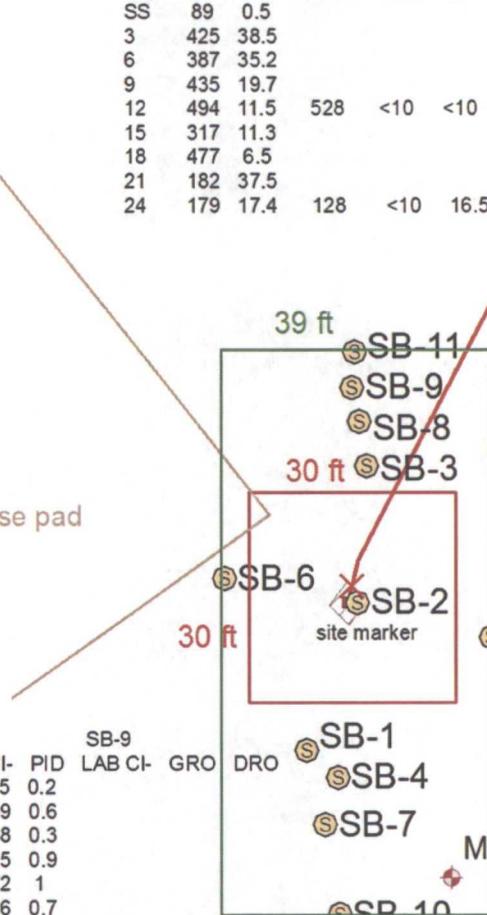
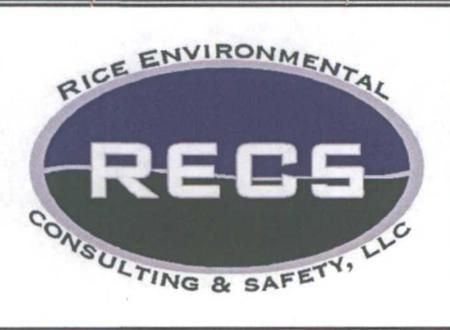
ROC proposes to excavate the site to the dimensions of 81 ft x 39 ft and properly seat a 20-mil reinforced poly liner at approximately 4-5 ft bgs (Figure 4). The liner will cover the existing clay layer installed at 12 ft bgs measuring 30 ft x 30 ft. The soils placed above the liner will have a laboratory chloride reading no greater than 500 mg/kg and a field PID reading below 100 ppm. Excavated soil will be evaluated for use as backfill and any soils requiring disposal will be properly disposed of at a NMOCD approved facility. Upon completion of backfilling, the site will be seeded with a native vegetative mix and soil amendments will be added as needed. Vegetation above the liner will also provide a natural infiltration barrier for the site since plants capture water through their roots thereby reducing the volume of water moving through the vadose zone to groundwater.

Proposed Liner

Proposed 20-mil reinforced liner @ 4-5'
 Current Clay Layer @ 12'
 DGW = 29 ft

As part of the Investigation and Characterization Plan approved by NMOCD on July 21st, 2011, seven soil bores (SB-2 through SB-8) were advanced at the site to a depth of 24 ft. The soil bores were sampled every three feet and the samples were field tested for chlorides and screened in the field with a photo-ionization detector for hydrocarbons. Representative samples from each bore were taken to a commercial laboratory for analysis of chlorides and hydrocarbons. Chloride readings ranged from a high of 1,060 mg/kg at 21 ft bgs in SB-8 to a low of 128 mg/kg at 24 ft bgs in SB-5. GRO readings at all depths in all bores were non-detect. DRO readings were also non-detect in all samples, except for at 24 ft bgs in SB-8 where the DRO reading was 11.9 mg/kg (Figure 4).

To fully delineate the vadose zone, SB-9 through SB-11 were advanced at the site on November 8th, 2011 (Figure 4). The soil bores were sampled every three feet as they were advanced and were field tested for chlorides and hydrocarbons. Representative samples from each bore were taken to a commercial laboratory for confirmation of field numbers (Appendix B). In SB-9, the chloride value at 18 ft bgs was 800 mg/kg which decreased to 768 mg/kg at 24 ft bgs. In SB-10, the chloride value at 21 ft bgs was 688 mg/kg which decreased to 416 mg/kg at 24 ft bgs. In SB-11, the chloride value at 18 ft bgs was 848 mg/kg and the chloride value at 24 ft bgs was 1,140 mg/kg. The GRO and DRO values were non-detect in all three bores at all depths.

Figure 4 – Proposed Liner

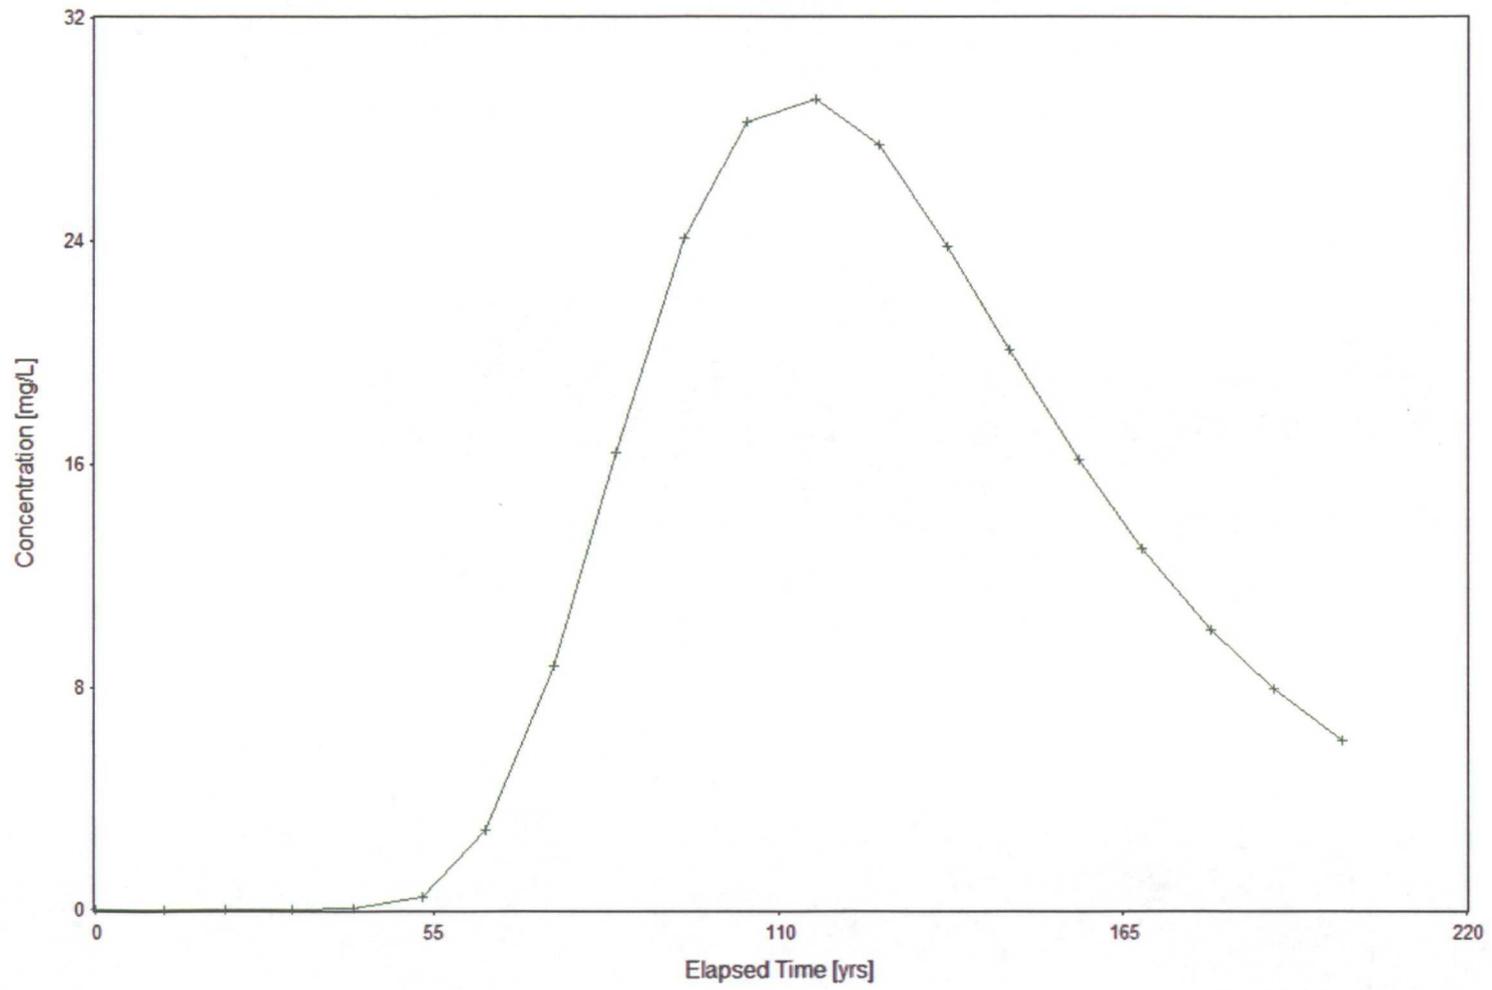
To determine if the residual chlorides in the vadose zone pose a threat to groundwater quality, ROC ran the U.S. Environmental Protection Agency Exposure Assessment Multimedia Model (MULTIMED Version 1.5, 2005). Data inputs and model outputs are included in Appendix C. With the proposed infiltration barrier measuring 81 ft x 39 ft, the model output concludes that the peak concentration of chlorides in groundwater contributed by the vadose zone soils would be approximately 28.6 mg/L in 116 years. Since the estimated increase in chloride concentrations in groundwater from residual chloride migration is below the WQCC standard of 250 mg/L, no further action will be warranted for the vadose zone of this site.
- Estimated chloride mass in the groundwater**

Chloride Concentration At The Receptor Well
EME H-7 EOL
