**RE: Termination Request
for the Rice Operating Company's
Vacuum K-35 Vent Site
Unit Letter K, Section 35, T17S, R35E, NMPM, Lea County, New Mexico
Remediation Plan (1R425-32) Termination**

RE: Termination Request
Vacuum K-35 vent (1R425-32): UL/K, Sec. 35, T17S, R35E
RICE Operating Company – Vacuum SWD System

**RICE OPERATING COMPANY
JUNCTION BOX FINAL REPORT**

Vacuum K-35 vent

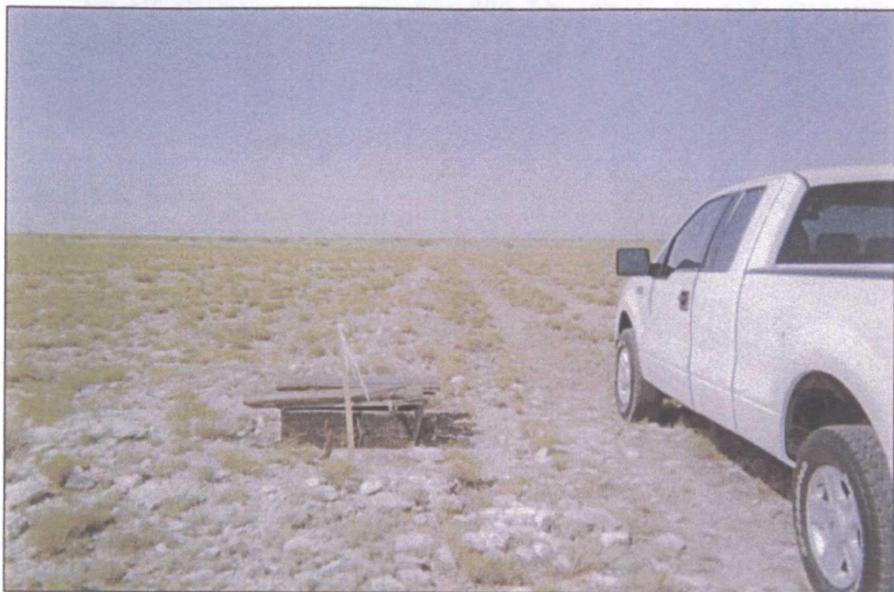
junction box prior to excavation

7/11/2005

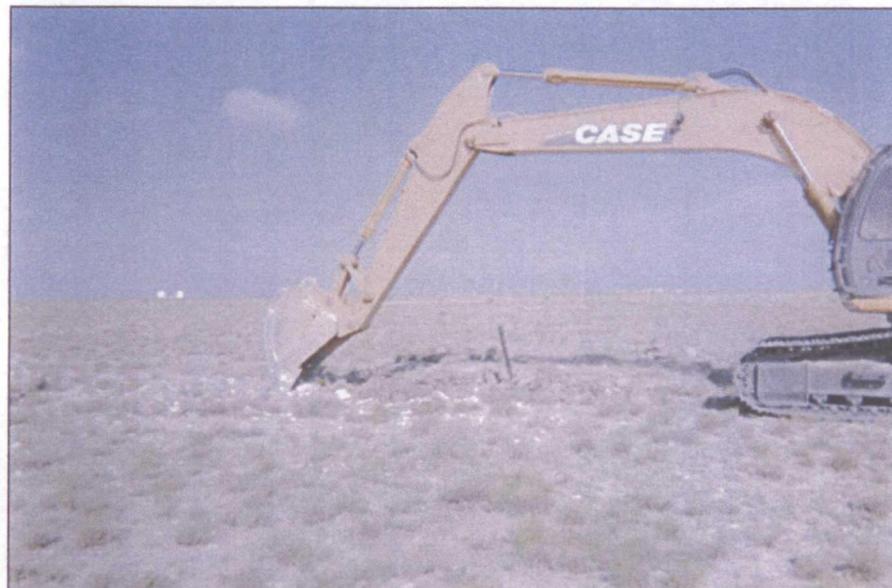
beginning delineation trench at former jct. site

8/12/2005

as part of the Vacuum SWD System Abandonment. After the box was removed, the site was delineated using a backhoe to collect soil samples at regular intervals to a depth of 7 ft. Chloride field tests and PID readings were conducted on all of the samples. Concentrations of both constituents were very low. A sample from the bottom of the trench was analyzed by a laboratory for confirmation of field tests. The excavated soil was blended on site and then backfilled into the trench and contoured to the surrounding terrain. The disturbed surface was seeded with a blend of native vegetation on 2/22/2006 and is expected to return to productive capacity at a normal rate.

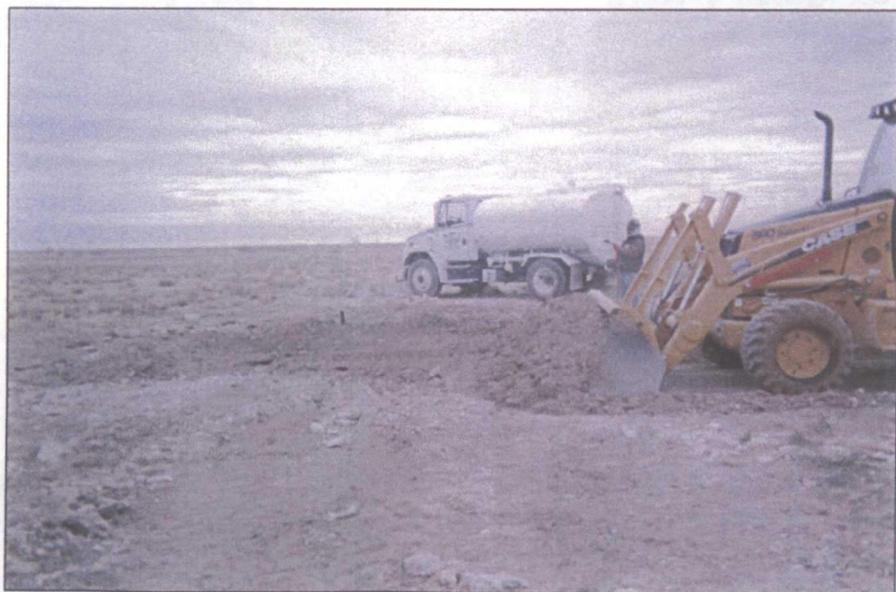
spreading imported topsoil on backfilled site

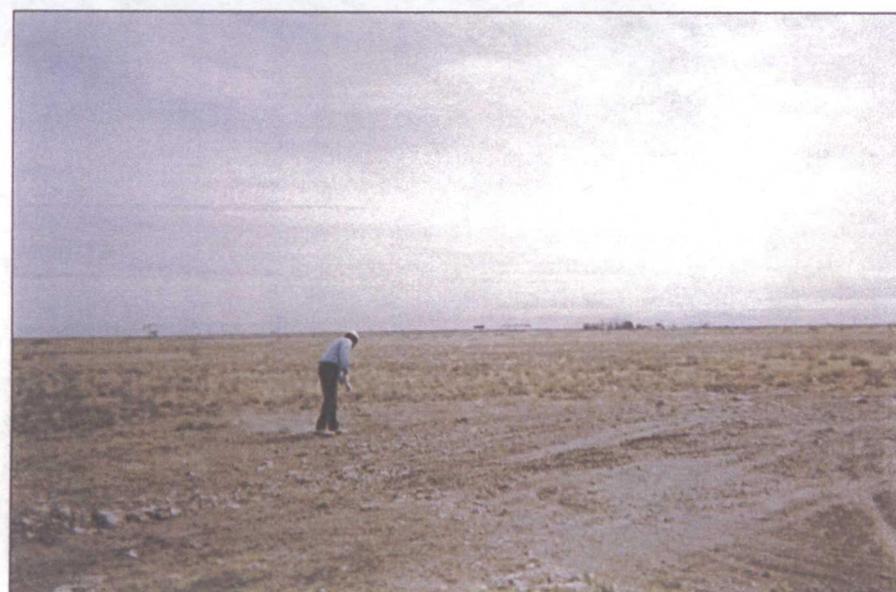
raking seed

2/22/2006
