RE: Termination Request  
Vacuum Southwestern "VC" EOL (1R425-19): UL/L, Sec. 36, T17S, R35E  
RICE Operating Company – Vacuum SWD System

RICE OPERATING COMPANY  
JUNCTION BOX FINAL REPORT

# Vacuum Southwestern VC EOL

Unit 'L', Sec. 36, T17S, R35E

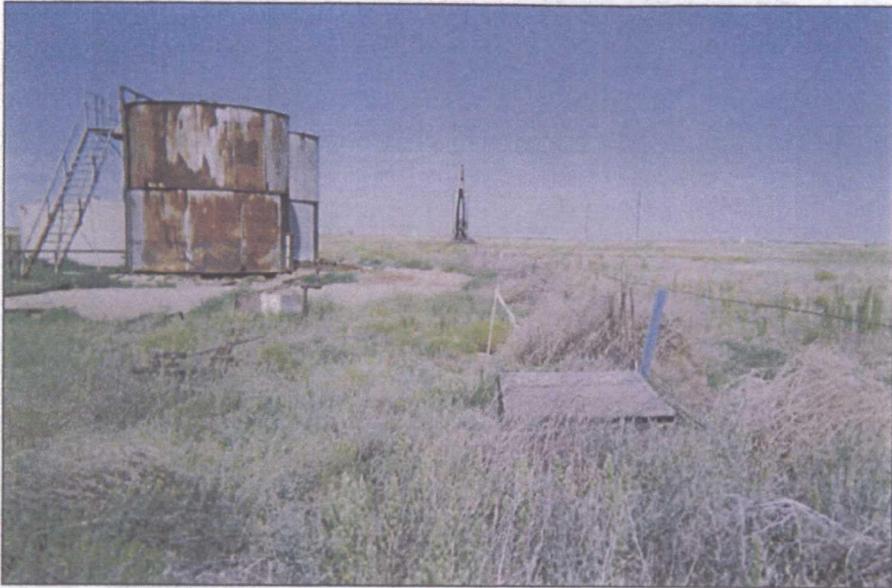
6/30/2005

undisturbed junction box

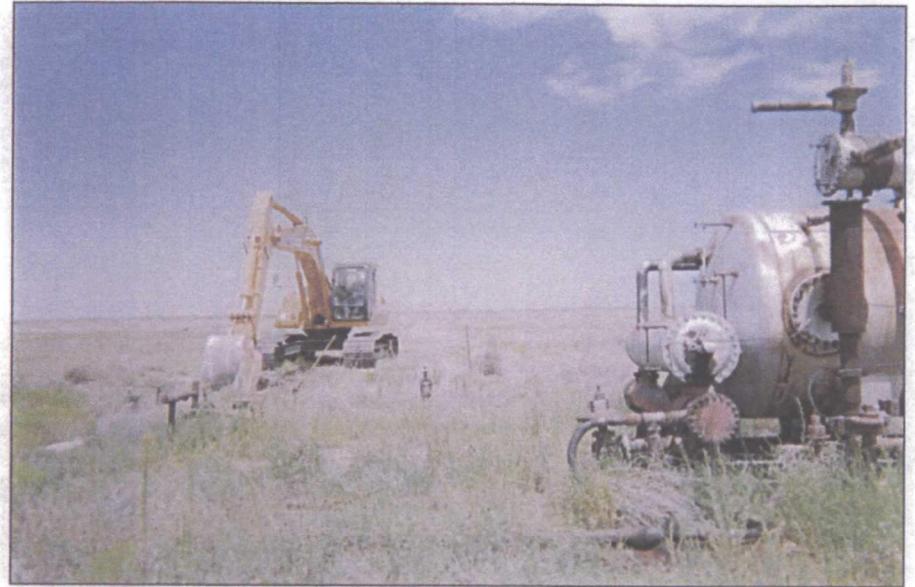
8/11/2005

delineation trench at former junction box site

General Description of Remedial Action: This end-of-line (EOL) junction box was abandoned with the Vacuum SWD System abandonment. After NORM decontamination, the box lumber was removed and a delineation trench was made at the former junction site using a backhoe. Chloride field tests and PID screenings were performed on soil samples collected from the trench every vertical foot of depth to 12 ft BGS. Chloride concentrations exhibited a conclusive trend of decline with depth and all PID levels were well below 100 ppm. Laboratory analysis on the 12-ft sample yielded TPH concentrations below detection limits (<10 mg/kg), meeting NMOCD guidelines. The trench was backfilled with the excavated soil and leveled to the surrounding surface. The disturbed surface was seeded with a blend of native vegetation and is expected to return to productive capacity at a normal rate.

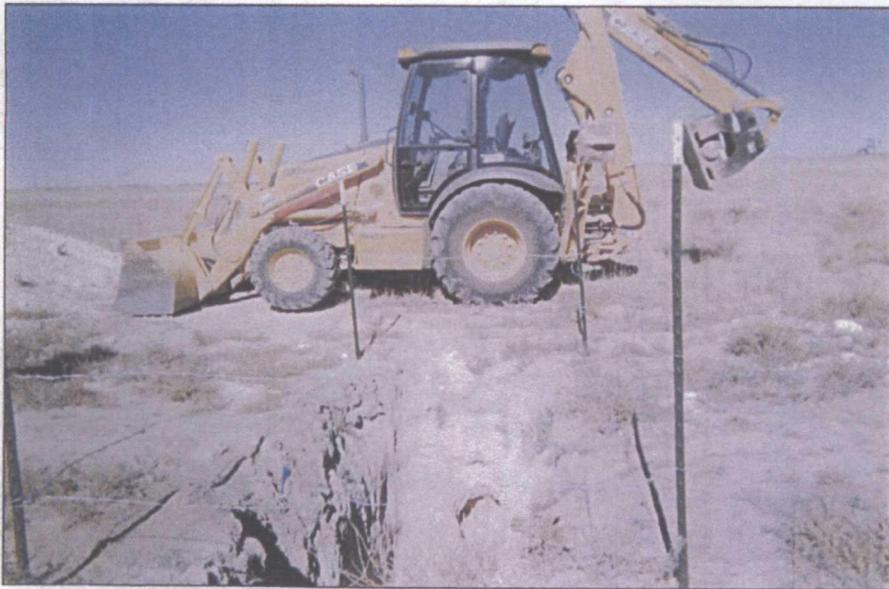
11/21/2005

backfilling delineation trench

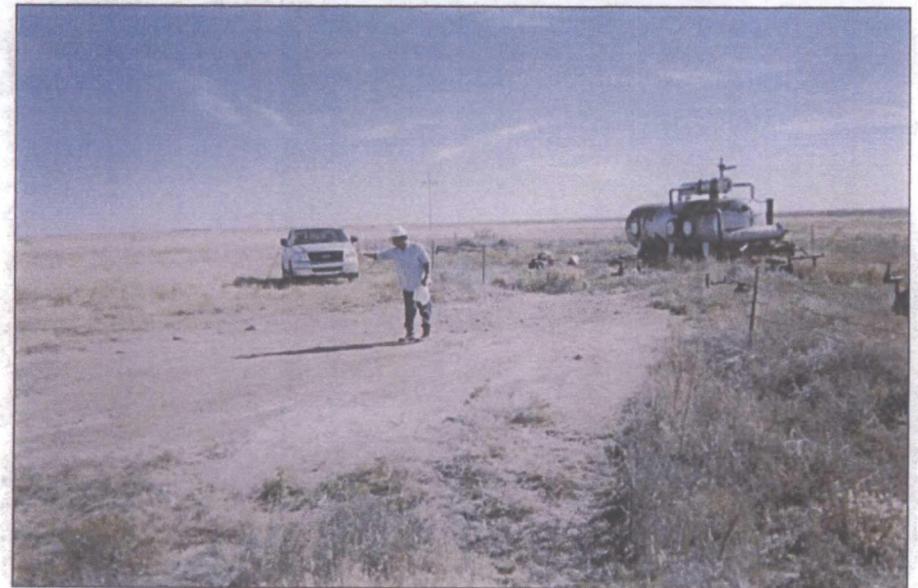
11/23/2005

seeding disturbed surface after backfill

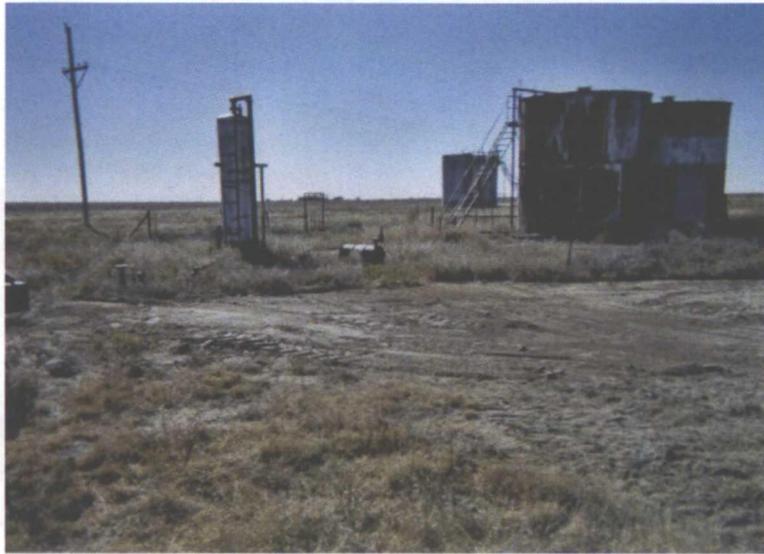
11/23/2005

Facing south

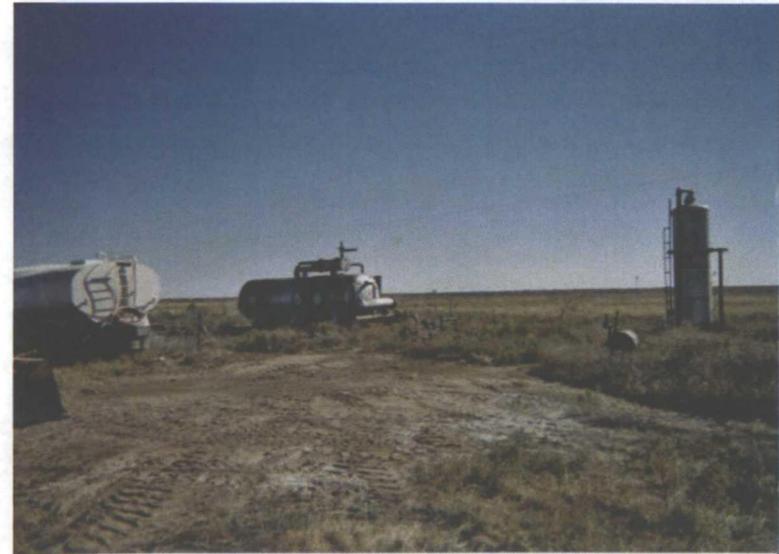
11/23/2005

Facing east

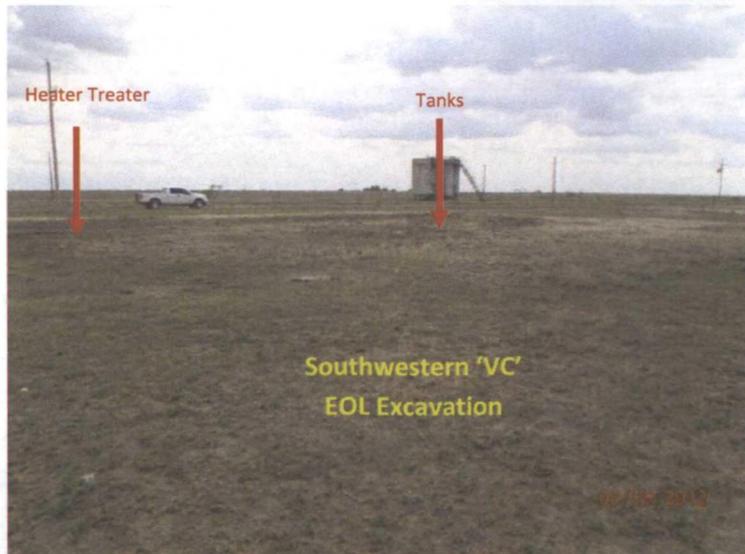
5/9/2012

The excavated area does have vegetation; however, please note that the tanks present in the 2005 photos have been removed. Those areas do not exhibit signs of vegetation (locations are marked on the current photographs).

Facing south

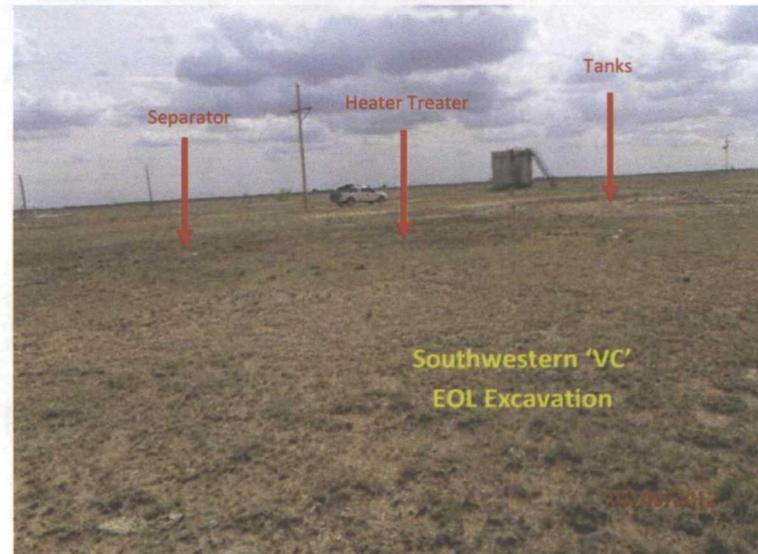
5/9/2012

Facing south
