**RE: Termination Request  
for the Rice Operating Company's  
Vacuum Phillips B-1578 EOL Site  
Unit Letter C, Section 30, T17S, R35E, NMPM, Lea County, New Mexico  
Remediation Plan (1R425-40) Termination**

RE: Termination Request  
Vacuum Phillips B-1578 EOL (1R425-40): UL/C, Sec. 30, T17S, R35E  
RICE Operating Company – Vacuum SWD System

**RICE OPERATING COMPANY  
JUNCTION BOX FINAL REPORT**

# Vacuum B-1578 EOL

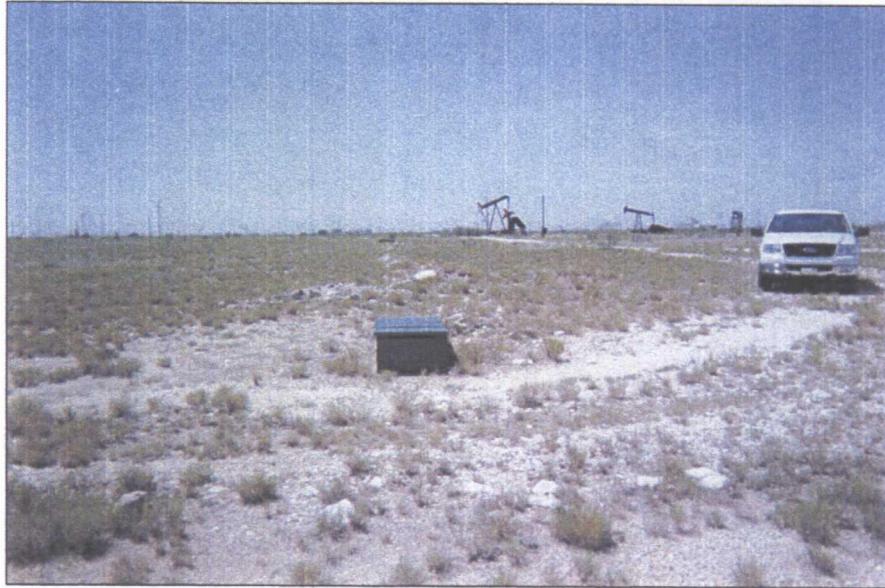
undisturbed junction box

7/11/2005

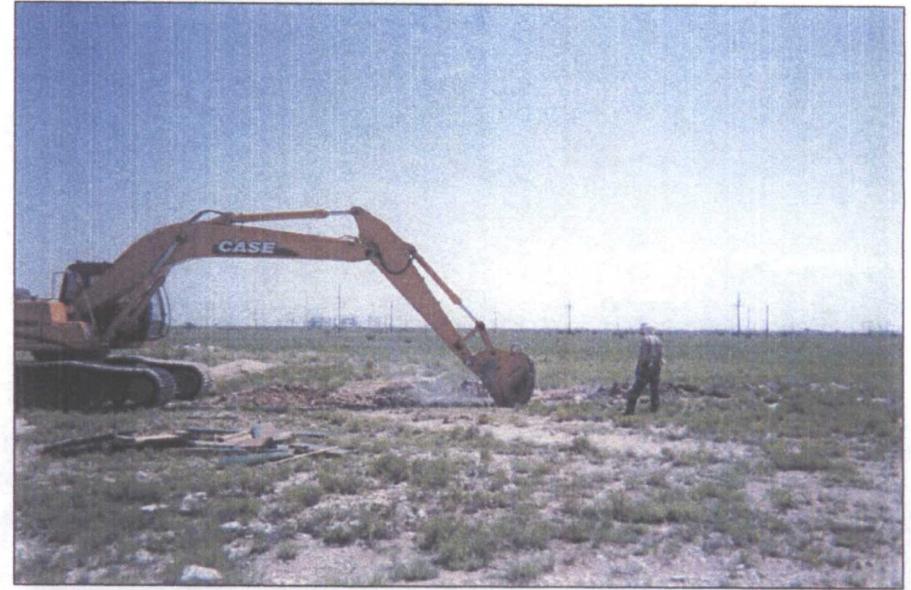
beginning delineation with trackhoe

9/1/2005

This junction box site was addressed as part of the Vacuum SWD System abandonment. After the box was removed, a backhoe was used to collect soil samples at regular intervals producing a 35 x 35 x 12-ft-deep excavation. Chloride field tests were conducted on each sample; concentrations declined with depth and breadth. Organic vapors were also measured using a PID and these concentrations were low. Composite samples were collected from the final excavation for laboratory confirmation of field results. TPH concentrations met NMOCD guidelines. The excavated soil was blended on site and returned to the excavation. Clean soil was imported to complete the backfill and contour to the surrounding surface. The disturbed area was seeded with a blend of native vegetation and is expected to return to productive capacity at a normal rate.

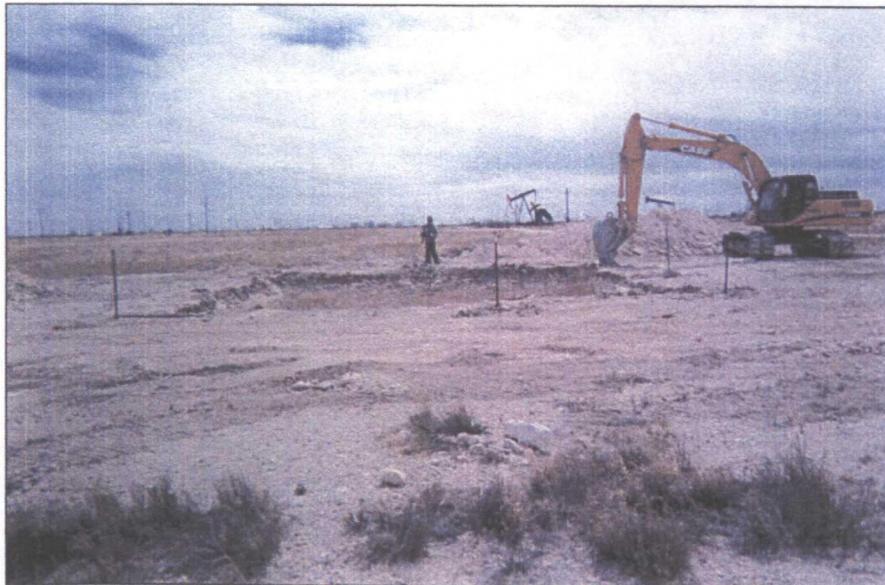
final 35 x 35 x 12-ft-deep excavation

3/9/2006

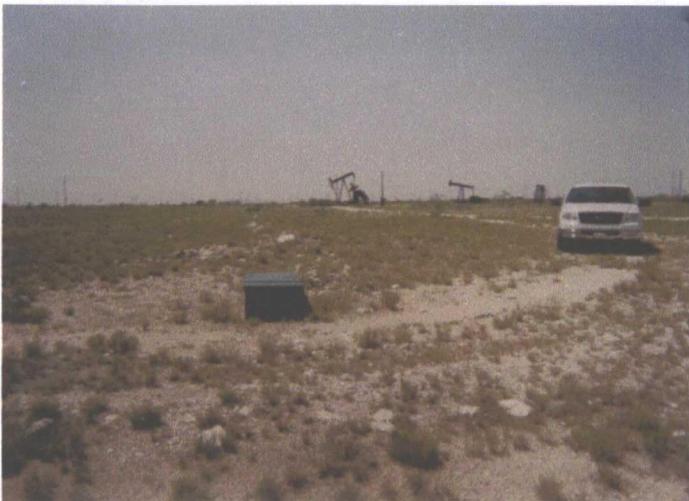
Facing east

7/11/2005

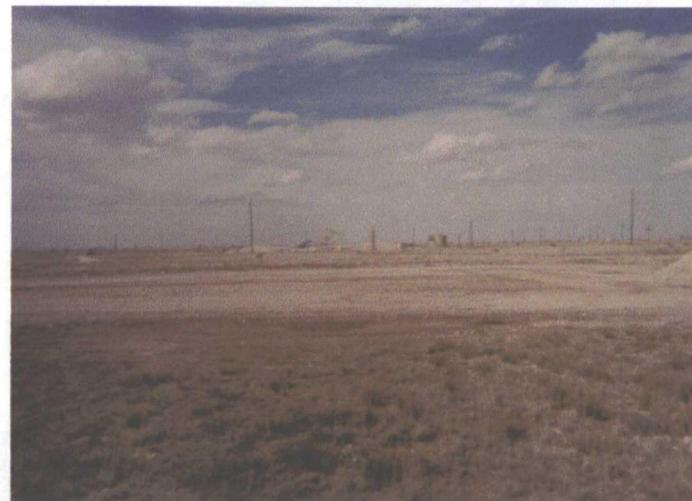
Facing west

7/11/2005
