EME C-5 EOL

DISCLOSURE

Unit C, Section 5, T21S, R36E

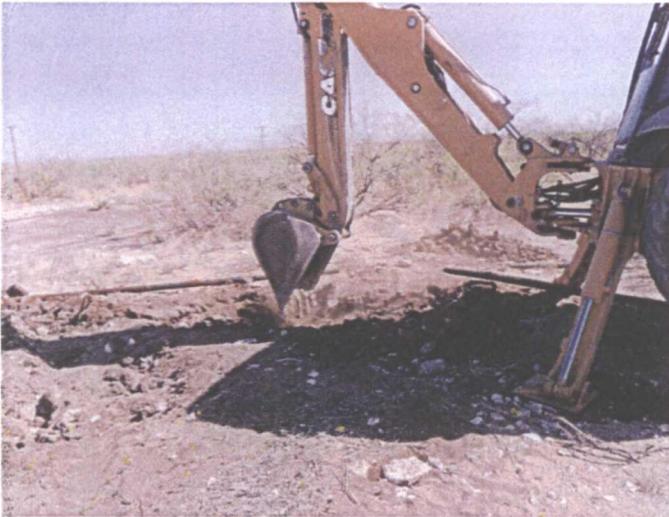
Excavating the former junction box, facing east
10.21.11

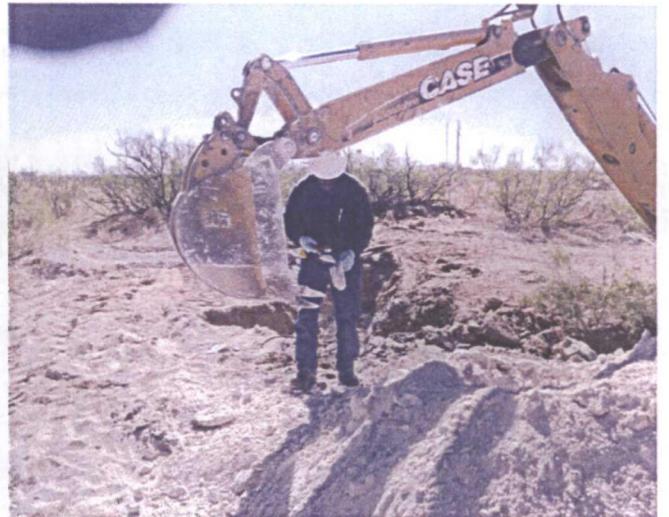
Collecting a soil sample, facing south
11.3.11

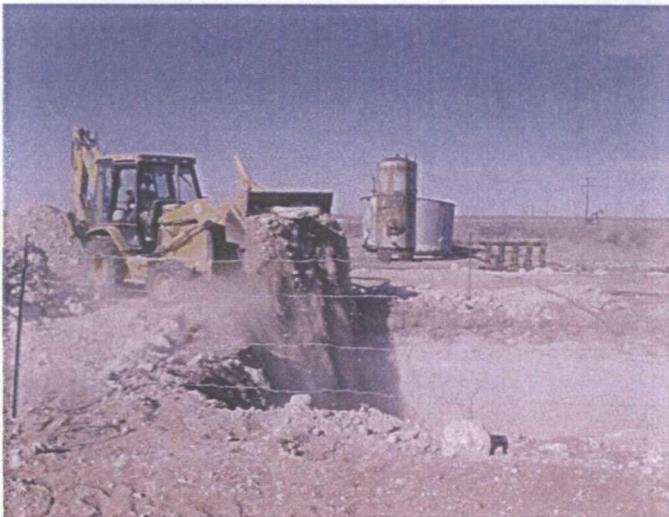
Backfilling excavation, facing north
12.16.11

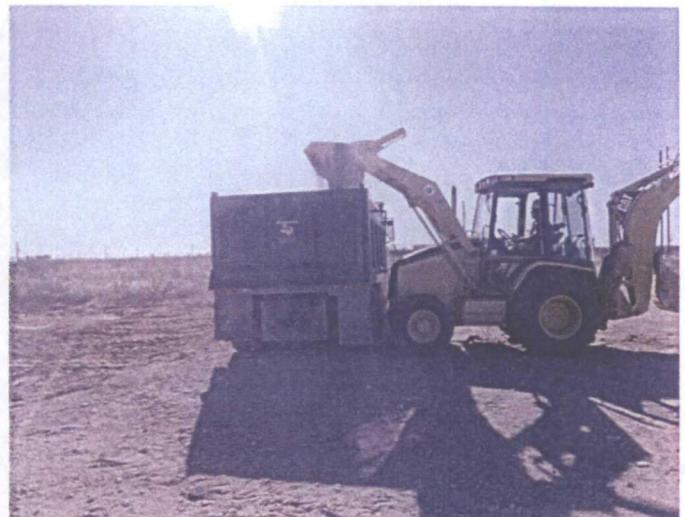
Exporting spoil pile, facing south
12.21.11

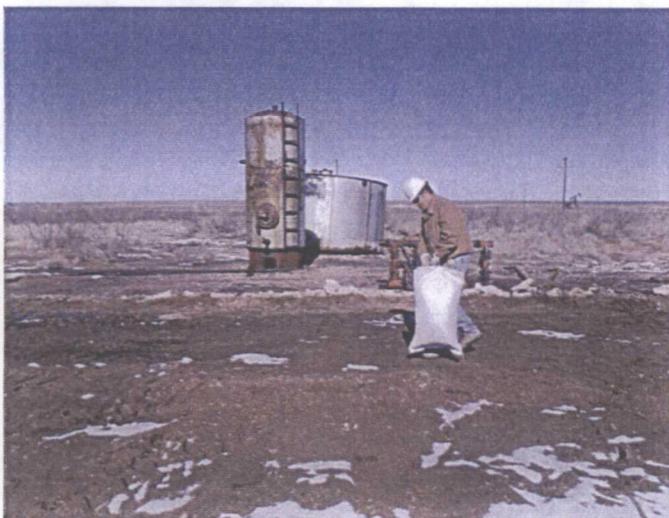
Seeding site, facing north
12.28.11

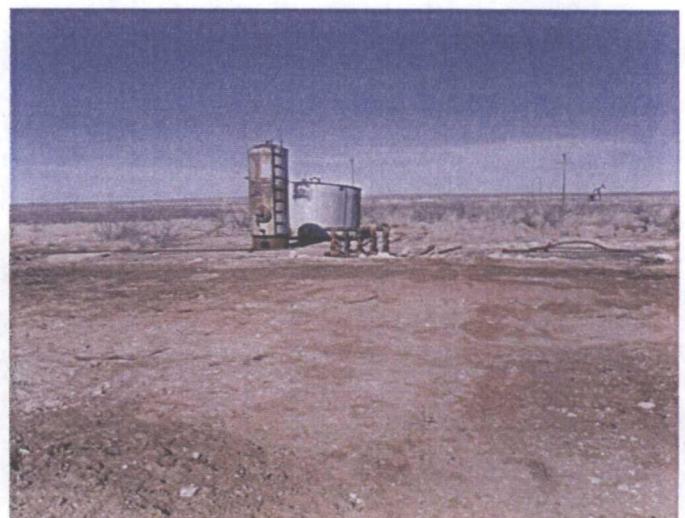
Site complete, facing north
12.30.11

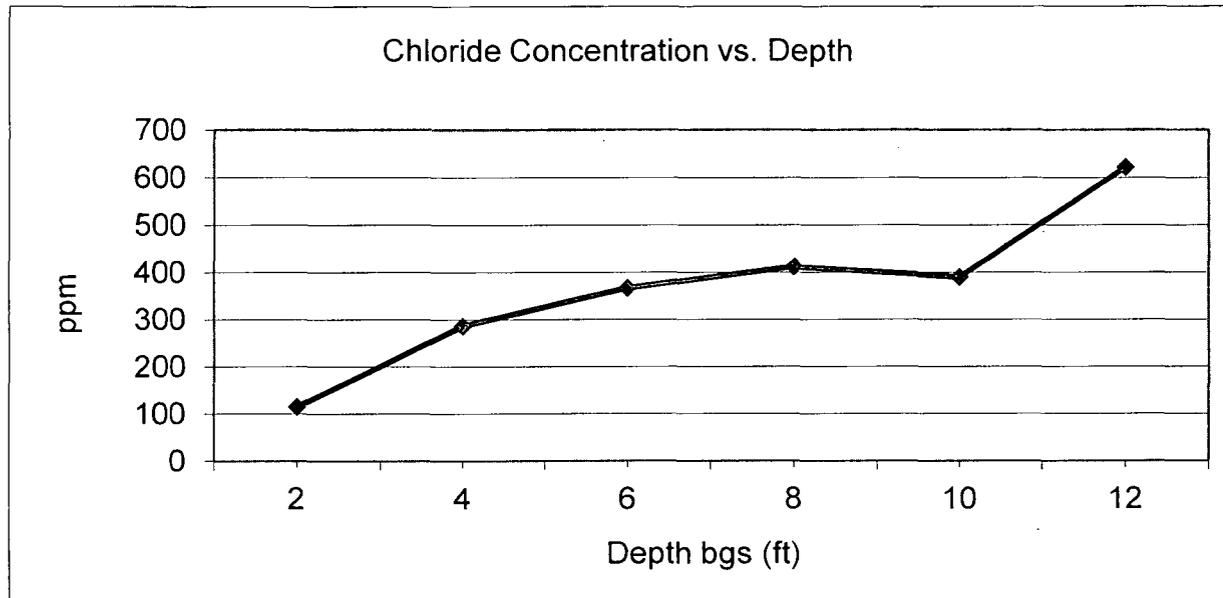
Backhoe samples at 15 ft East of the junction (source)

Depth bgs. (ft)	[Cl ⁻] ppm
2	115
4	286
6	367
8	412
10	390
12	622

Groundwater = 162 ft
