EME Jct. G-14

**RICE OPERATING COMPANY
JUNCTION BOX DISCLOSURE* REPORT**

Unit G, Section 14, T20S, R36E

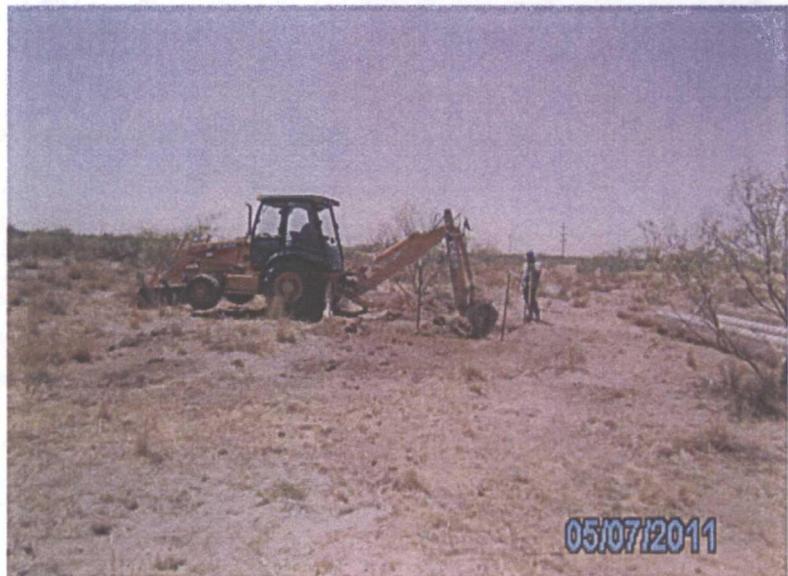
5.7.11

Excavating the site, facing west

General Description of Remedial Action: This junction was eliminated during the pipeline replacement/upgrade program. After the former junction box was removed, an investigation was conducted using a backhoe to collect soil samples at regular intervals creating a 30X30X12-ft. deep excavation. Chloride field test performed on each sample yielded concentrations similar to that of the background sample. Organic vapors were measured using a PID, which yielded elevated concentrations. Representative samples were collected from the bottom of the excavation and excavation walls. The samples were sent to a commercial laboratory for analysis of chloride, TPH, and BTEX. All excavated soil was properly disposed of at a NMOCD approved facility. Clean imported soil was used to backfill the excavation to a depth of 5 ft. BGS. On 7/26/2011, a 20-mil reinforced plastic liner was installed at 5 ft. BGS and the excavation was backfilled with clean imported soil to ground surface and contoured to the surrounding area. On 11/3/2011, the site was seeded with a blend of native vegetation and is expected to return to a productive capacity at a normal rate. NMOCD was notified of potential groundwater impact on 3/13/2012.

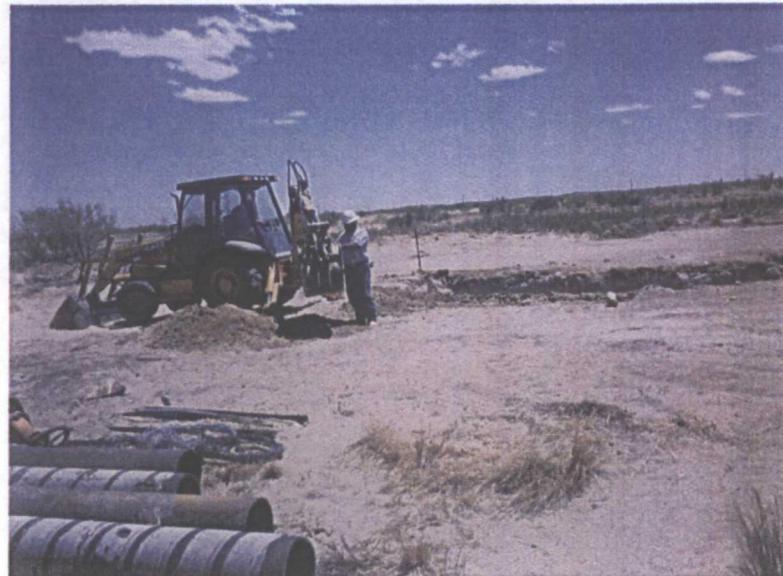
5.19.11

Collecting sample, facing southeast

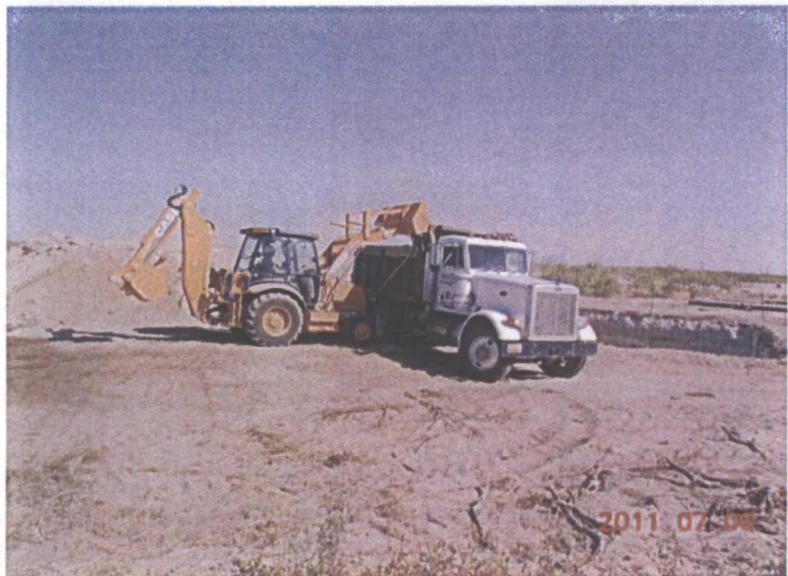
7.6.11

Exporting soil, facing northwest

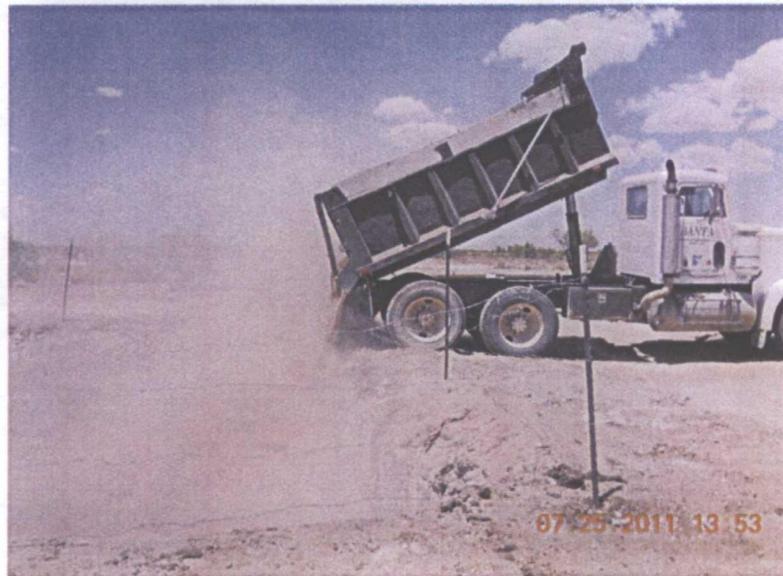
7.25.11

Importing soil, facing north

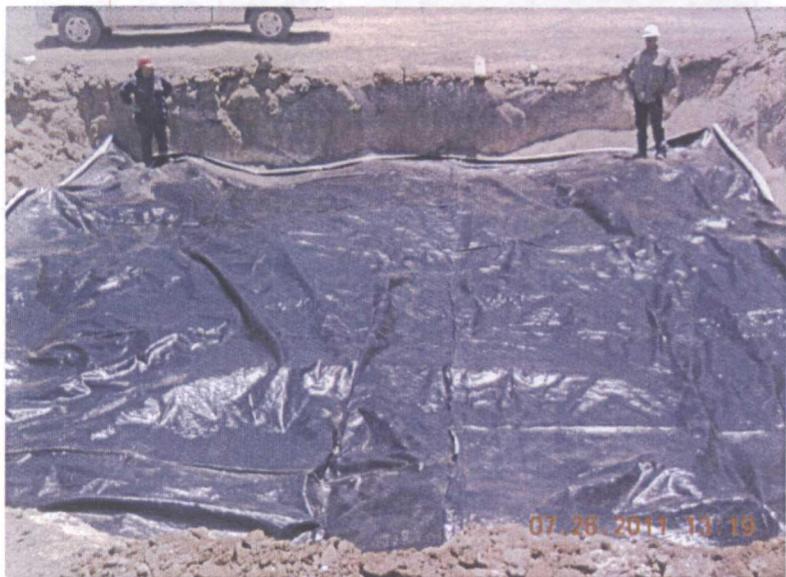
Installing 30 x 30 20-mil reinforced liner at 5-ft. BGS, facing south 7.26.11

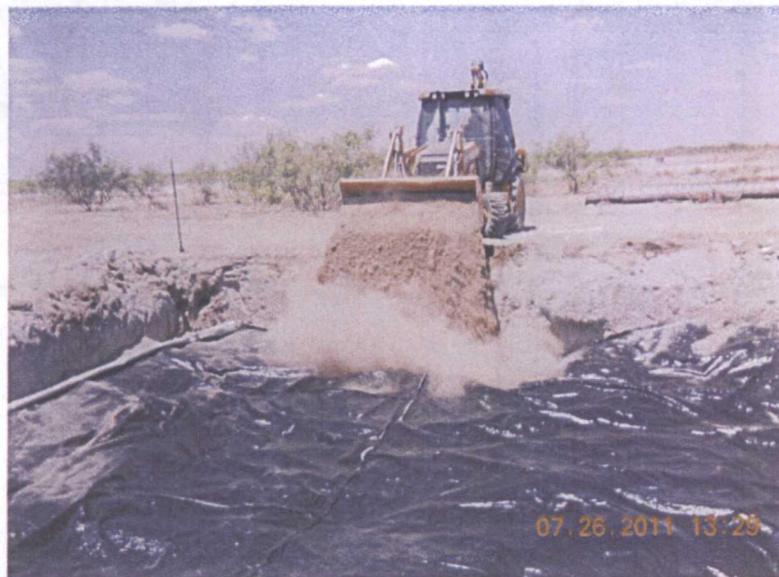
Backfilling site with imported soil, facing north 7.26.11

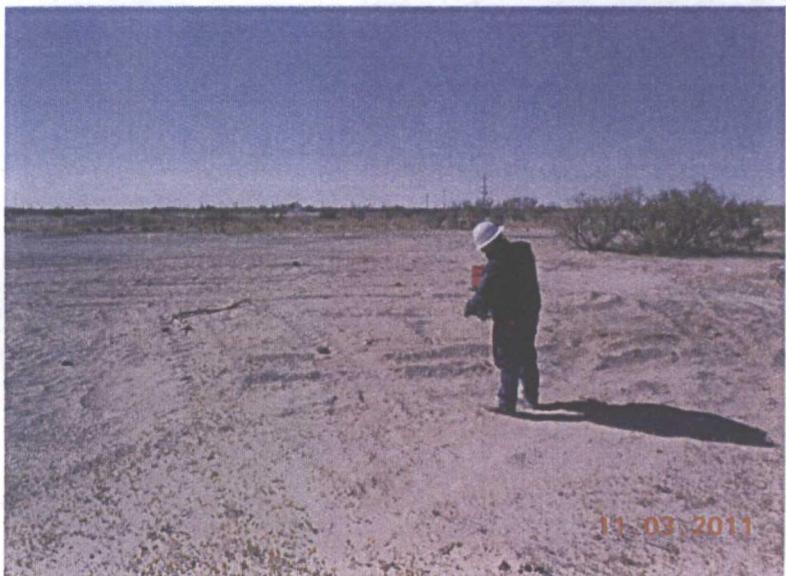
Seeding site, facing west 11.3.11
