RE: Termination Request  
EME C-10 EOL: UL/C, Sec. 10, T20S, R36E  
RICE Operating Company – Eunice Monument Eumont SWD System

**RICE OPERATING COMPANY  
JUNCTION BOX FINAL REPORT**

# EME C-10 EOL

Unit C, Section 10, T20S, R36E

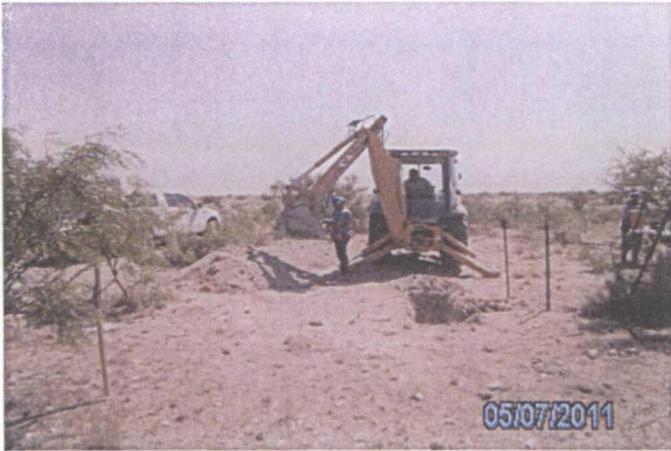
Excavating the former junction box site, facing east  
5.7.11

**General Description of Remedial Action:** This junction and line were eliminated during the pipeline replacement/upgrade program. After the former junction box was removed, an investigation was conducted using a backhoe to collect soil samples at regular intervals creating a 10X10X12-ft. deep excavation. Chloride field test performed on each sample yielded concentrations similar to that of the background sample. Organic vapors were measured using a PID, which yielded some elevated concentration. The excavated soil was blended on site and representative samples were collected from the blended backfill, the bottom of the excavation, and the excavation walls. The representative samples were sent to a commercial laboratory for analysis of chloride, TPH, and BTEX which yielded low concentrations of each. The excavation was backfilled using the blended backfill to ground surface and contoured to the surrounding area. On 7/8/2011, the site was seeded with a blend of native vegetation and is expected to return to a productive capacity at a normal rate.

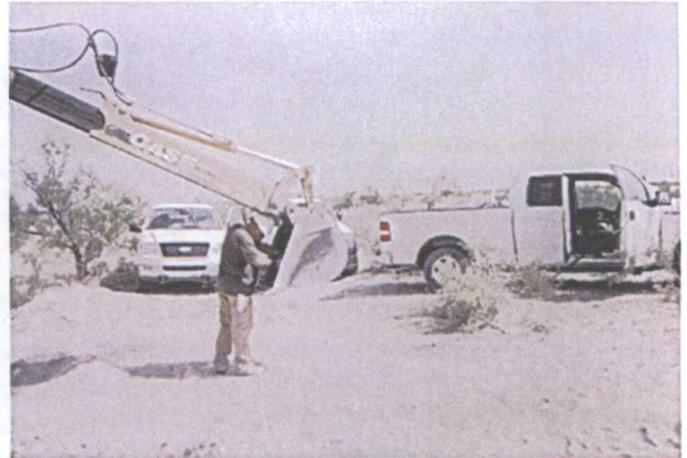
Collecting sample, facing north  
6.1.11

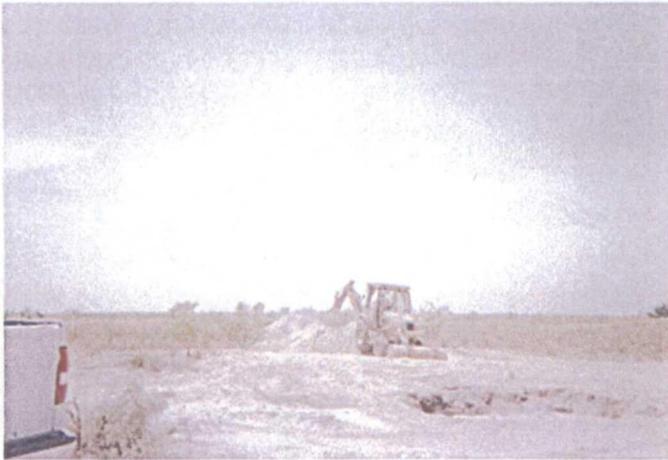
Blending backfill, facing south  
6.28.11

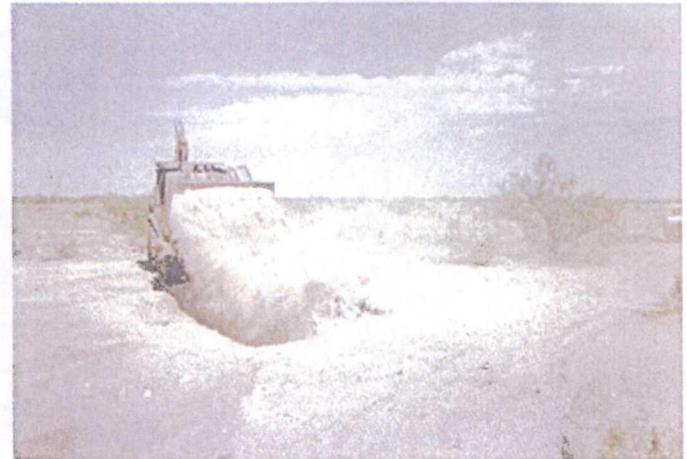
Backfilling, facing northwest  
6.28.11

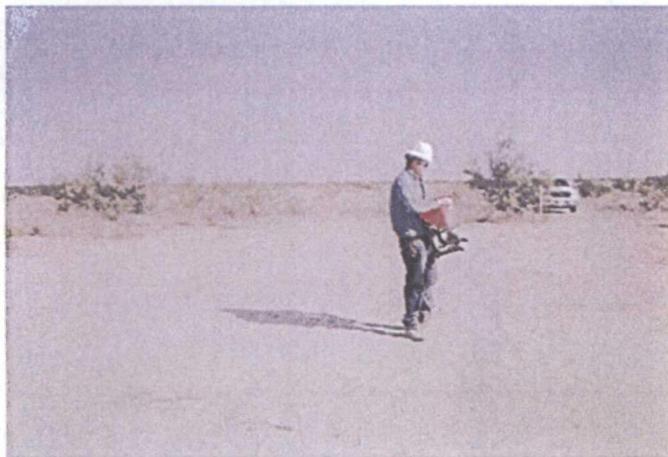
Seeding site, facing north  
7.8.11

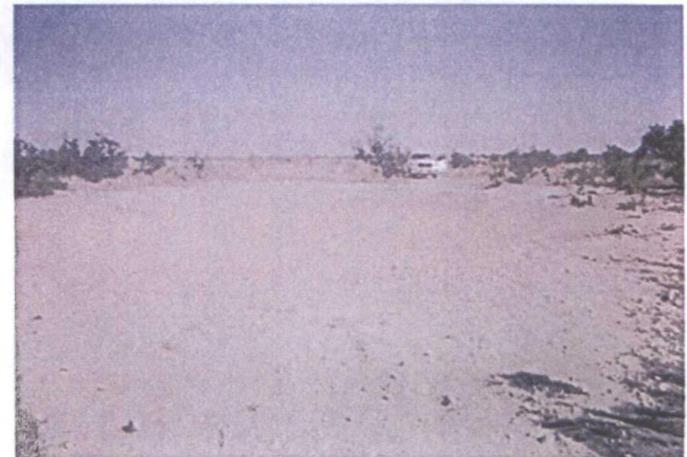
Site completed, facing north  
7.8.11

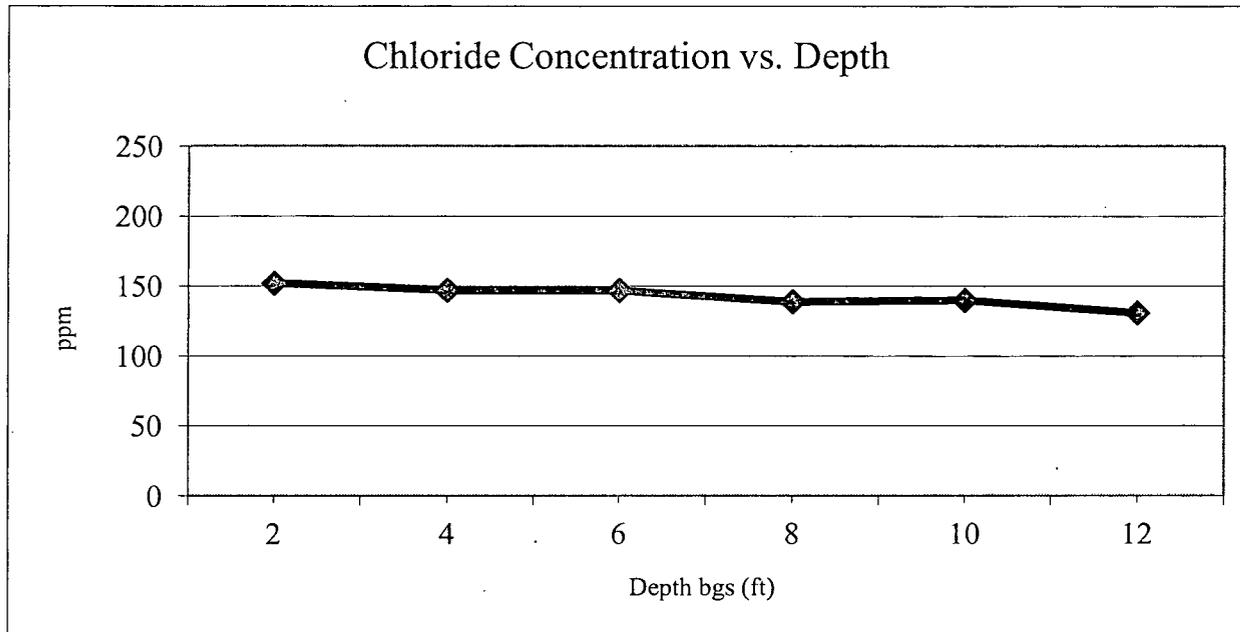
# EME C-10 EOL

*Backhoe samples 5' east of source*

Depth bgs (ft)	[Cl <sup>-</sup> ] ppm
2	152
4	147
6	147
8	139
10	140
12	131

Groundwater = 35 ft

CHLORIDE FIELD TESTS		
LOCATION	DEPTH	mg/kg
4-wall comp.	N/A	56
bottom comp.	12'	111
blended	N/A	83
background	6"	82
vertical delineation trench 5' east of source	2'	152
	4'	147
	6'	147
	8'	139
	10'	140
	12'	131
