CLOSURE

RE: Termination Request
EME E-23 EOL: UL/E, Sec. 23, T19S, R36E
RICE Operating Company – Eunice Monument Eumont SWD System

EME E-23 EOL

Unit E, Section 23, T19S, R36E

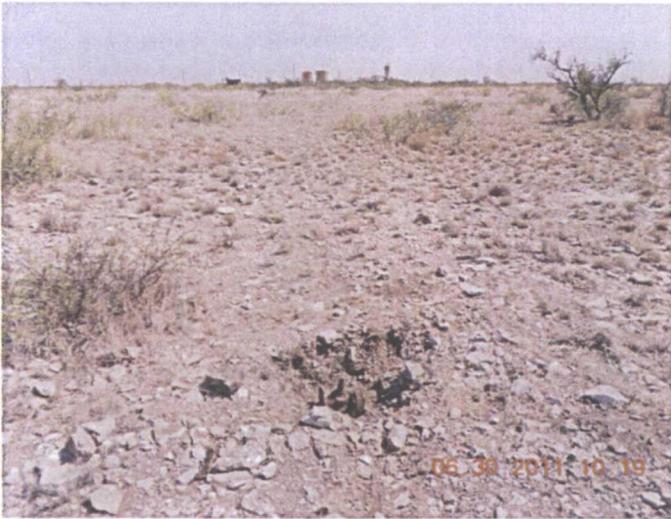
Site prior to excavating, facing north 6.30.11

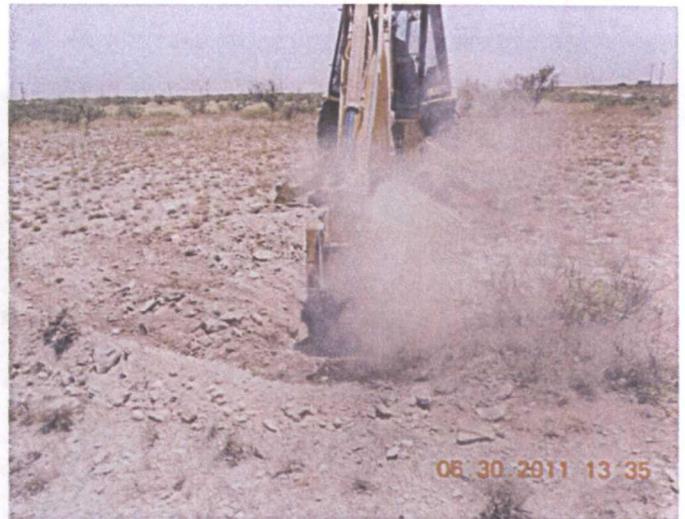
Digging source, facing south 6.30.11

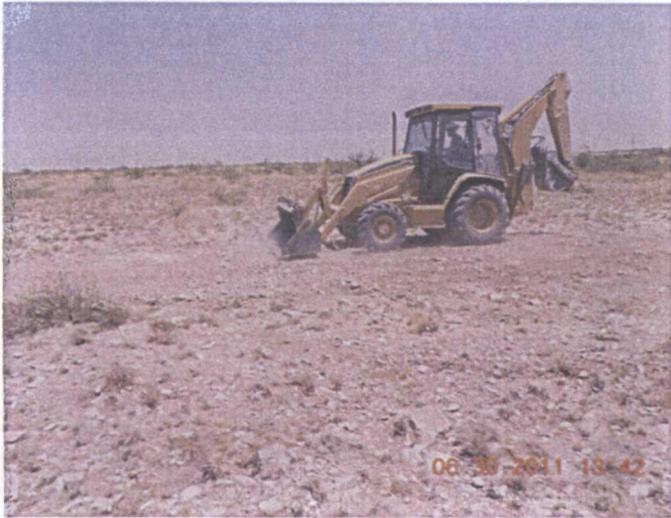
Backfilling site, facing east 6.30.11

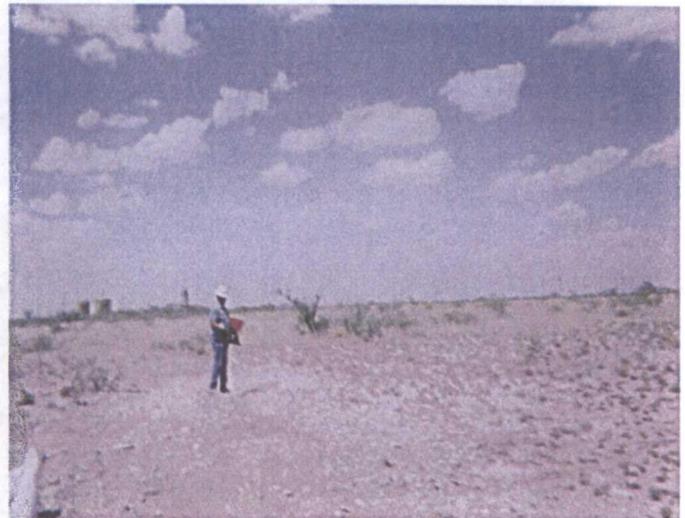
Seeding site, facing north 7.28.11

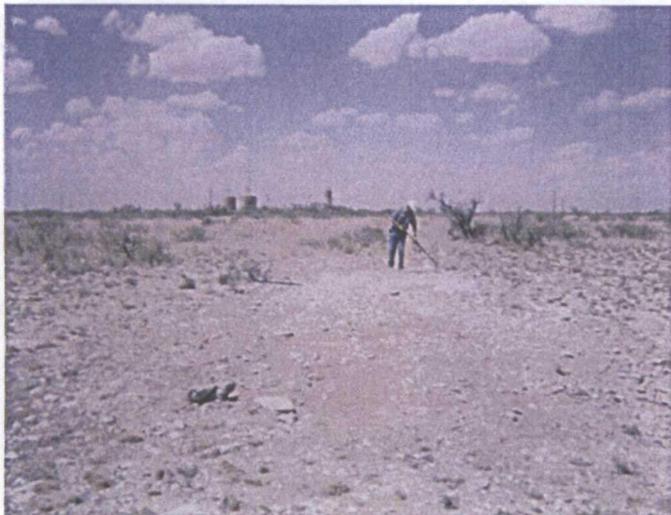
Raking in seed, facing north 7.28.11

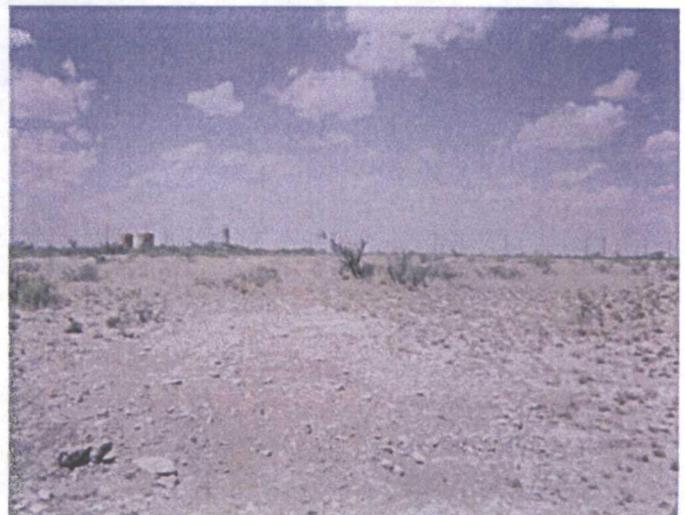
Site completed, facing north 7.28.11

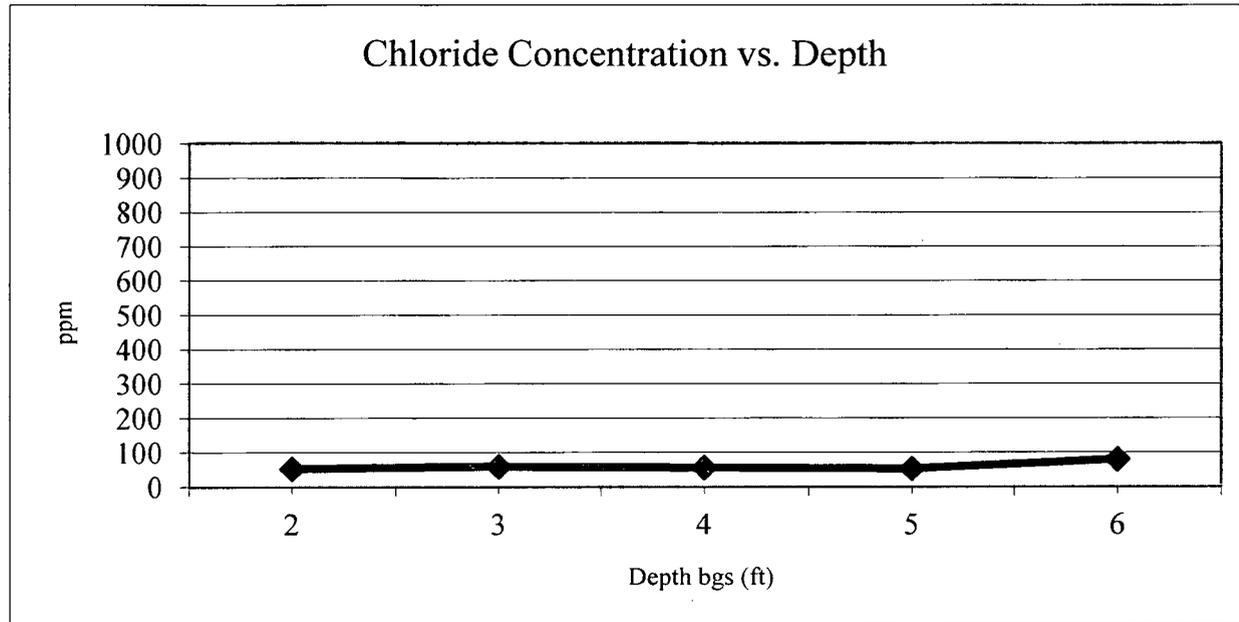
Backhoe samples at junction (source)

Depth bgs (ft)	[Cl ⁻] ppm
2	53
3	59
4	56
5	53
6	80

Groundwater = 57 ft
