EME F-23 EOL
2011

CLOSURE

RE: Termination Request
EME F-23 EOL: UL/F, Sec. 23, T19S, R36E
RICE Operating Company – Eunice Monument Eumont SWD System

**RICE OPERATING COMPANY
JUNCTION BOX FINAL REPORT**

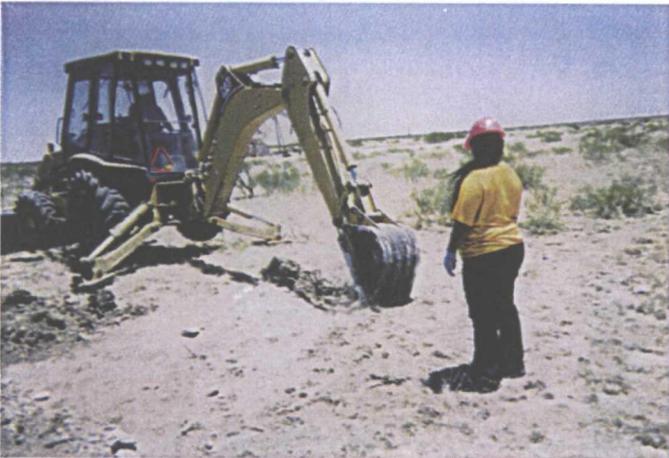
6.29.11

Excavating site, facing east

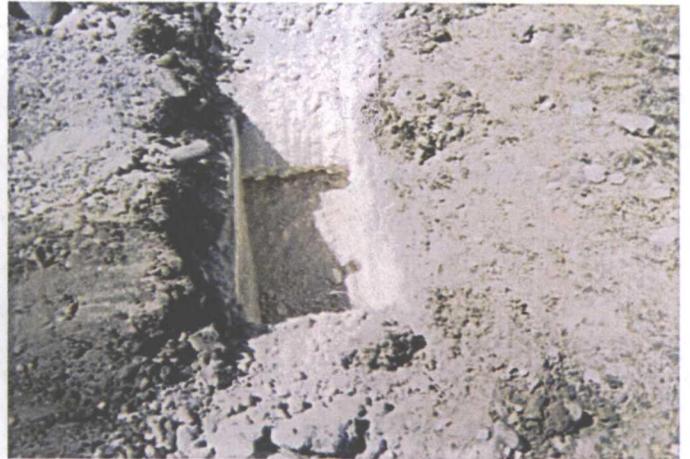
6.29.11

Digging source

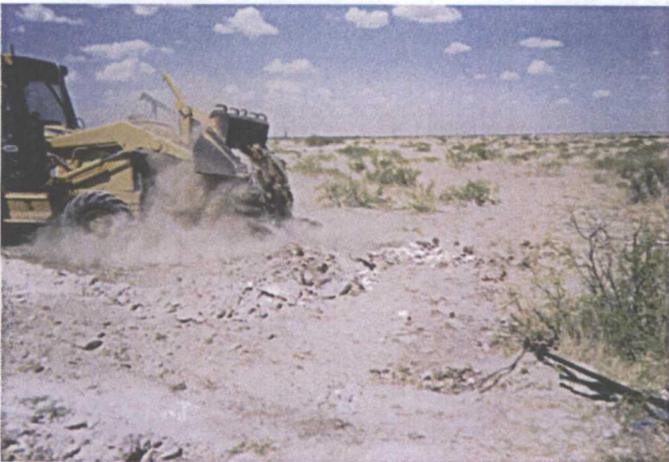
6.29.11

Backfilling site, facing north

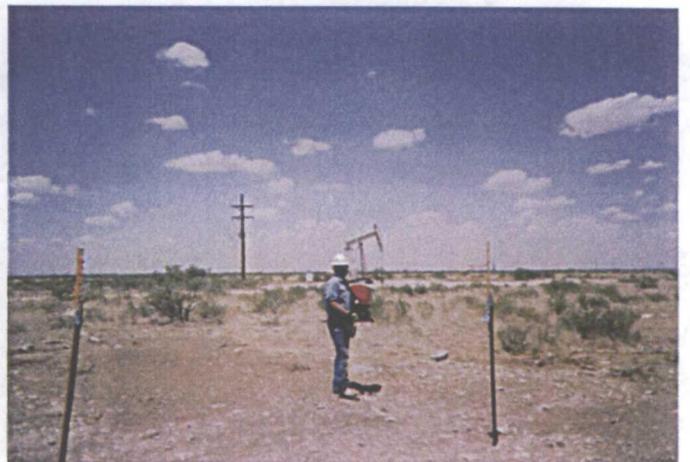
7.28.11

Seeding site, facing north

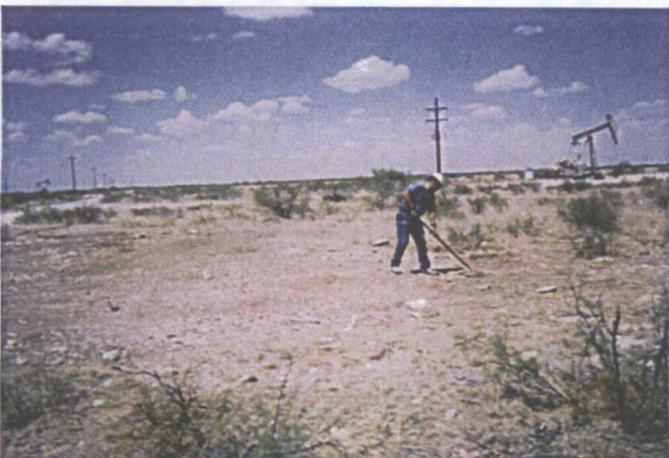
7.28.11

Raking in seed, facing north

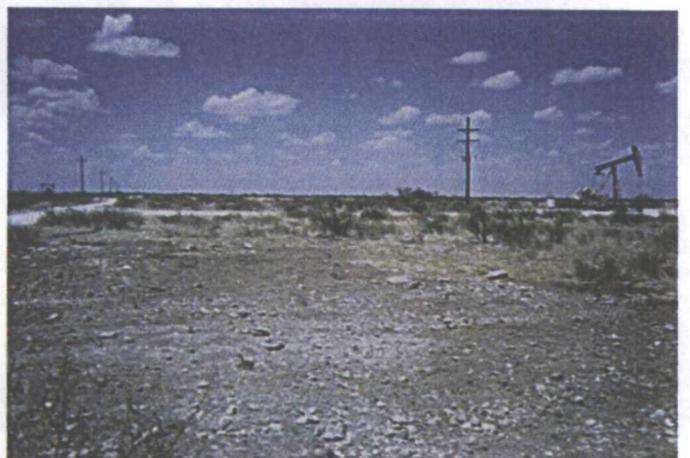
7.28.11

Site completed, facing north
