RE: Termination Request
EME H-36 EOL: UL/H, Sec. 36, T19S, R36E
RICE Operating Company – Eunice Monument Eumont SWD System

**RICE OPERATING COMPANY
JUNCTION BOX FINAL REPORT**

EME H-36 EOL

Unit H, Section 36, T19S, R36E

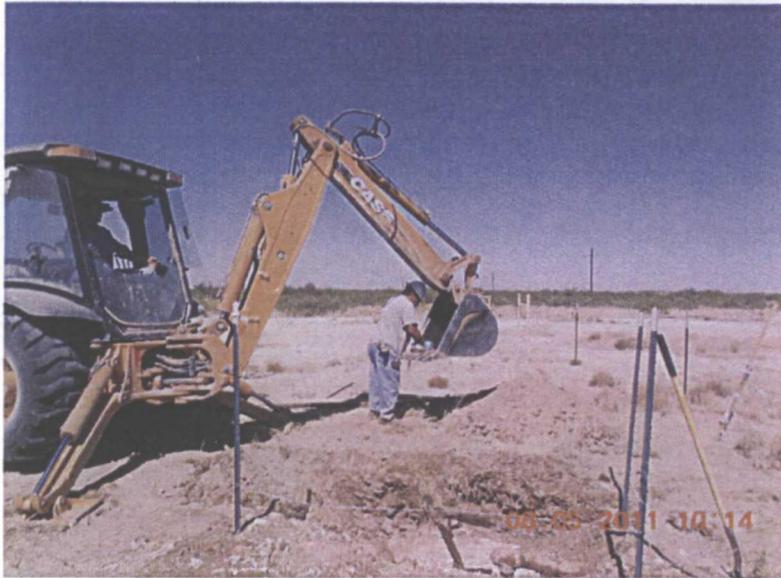
8.5.11

Collecting sample, facing west

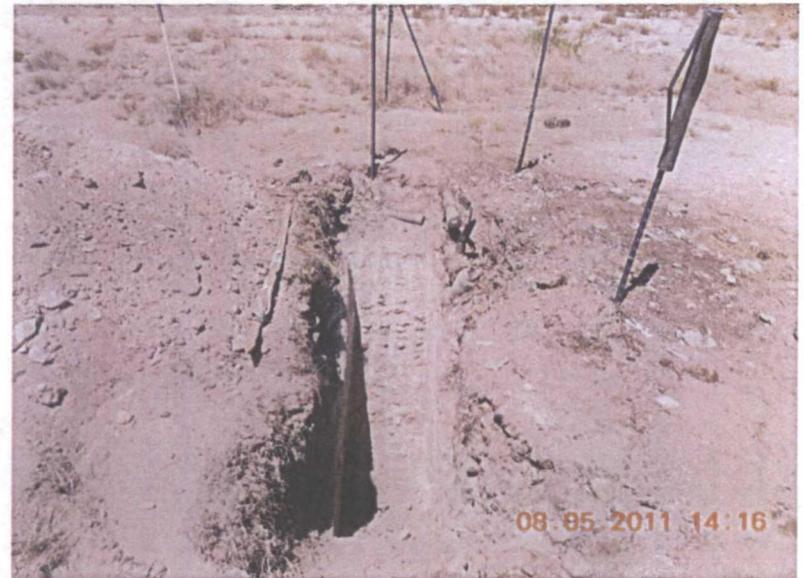
8.5.11

Final excavating, facing west

General Description of Remedial Action: This junction and line were eliminated during the pipeline replacement/upgrade program. After the former junction box was removed, an investigation was conducted using a backhoe to collect soil samples at regular intervals creating a 7X3X6-ft. deep excavation. Chloride field tests performed on each sample yielded concentrations similar to that of the background sample. Organic vapors were measured using a PID, which yielded low concentrations. The deepest sample, 6 ft. BGS, was sent to a commercial laboratory for analysis of chloride and TPH, which confirmed low concentrations of each. The excavation was backfilled with excavated soil to ground surface and contoured to the surrounding area. On 8/9/2011, the site was seeded with a blend of native vegetation and is expected to return to a productive capacity at a normal rate.

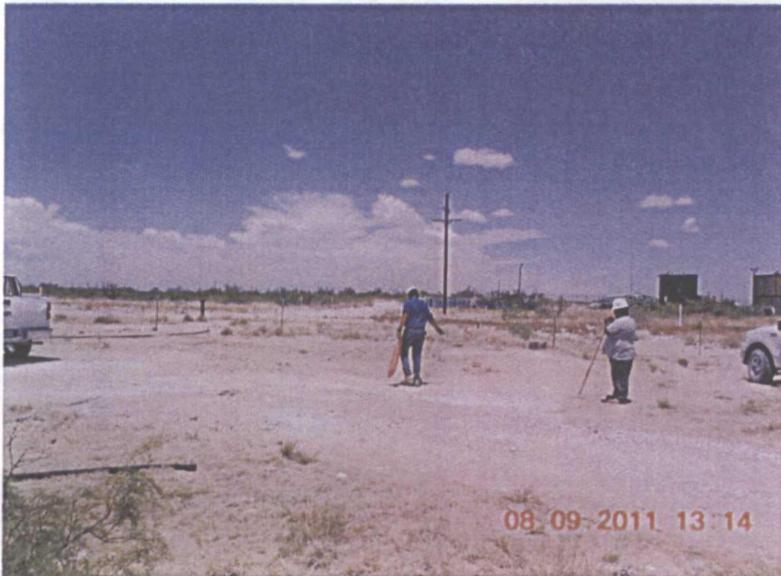
8.9.11

Spreading seed, facing north

Custom seed mix <input checked="" type="checkbox"/>	Prescribed mix <input type="checkbox"/>	Seed mix name: Dooms Mix	Seeding date: 8/9/2011
Broadcast <input checked="" type="checkbox"/>			
Method: By Hand			
Soil conditions during seeding: Dry <input checked="" type="checkbox"/> Damp <input type="checkbox"/> Wet <input type="checkbox"/>			
Photos attached <input type="checkbox"/>	Observations:		
Number of photos:

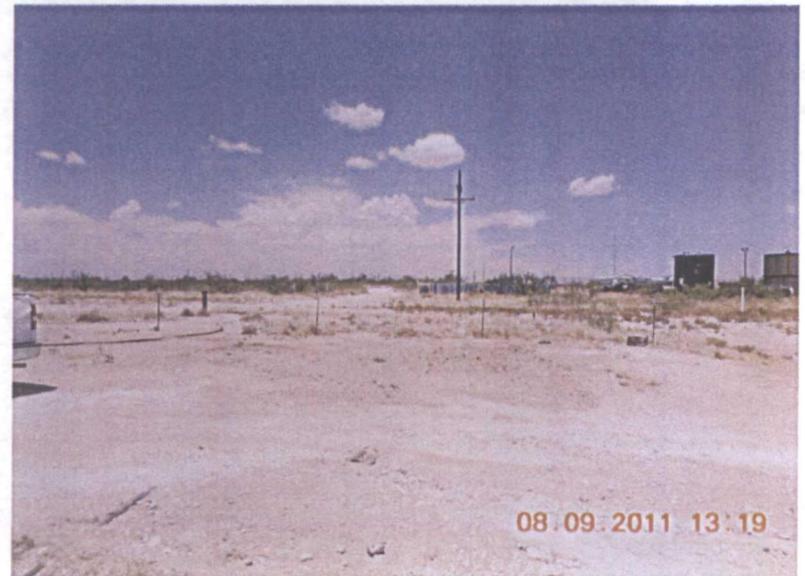
8.9.11

Site complete, facing north
