RE: Termination Request
EME I-19 EOL: UL/I, Sec. 19, T19S, R37E
RICE Operating Company – Eunice Monument Eumont SWD System

**RICE OPERATING COMPANY
JUNCTION BOX FINAL REPORT**

EME I-19 EOL

Unit I, Section 19, T19S, R37E

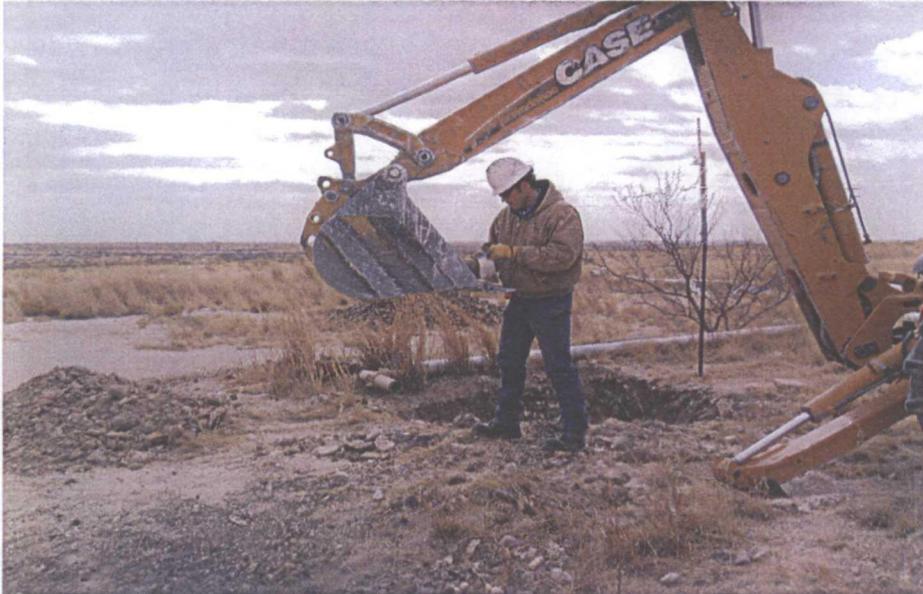
4/26/2011

Collecting sample, facing east

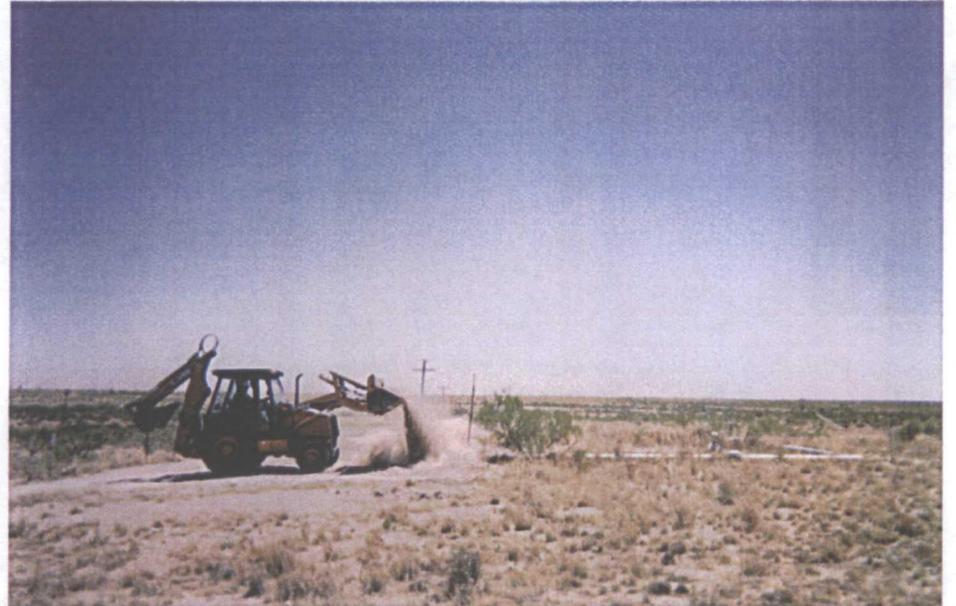
5/12/2011

Backfilling with clean imported soil, facing east

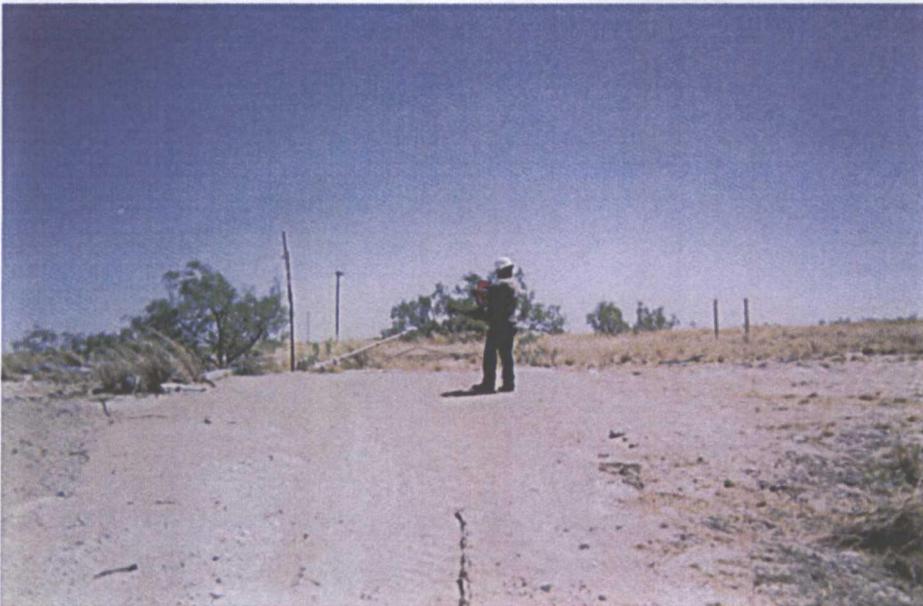
5/12/2011

Seeding location, facing south

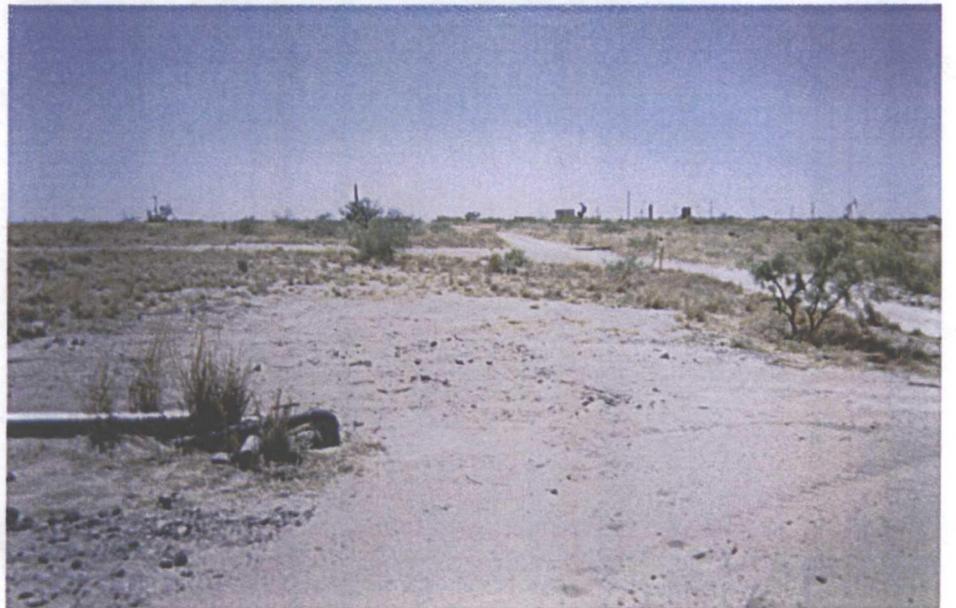
5/12/2011

Site complete, facing west

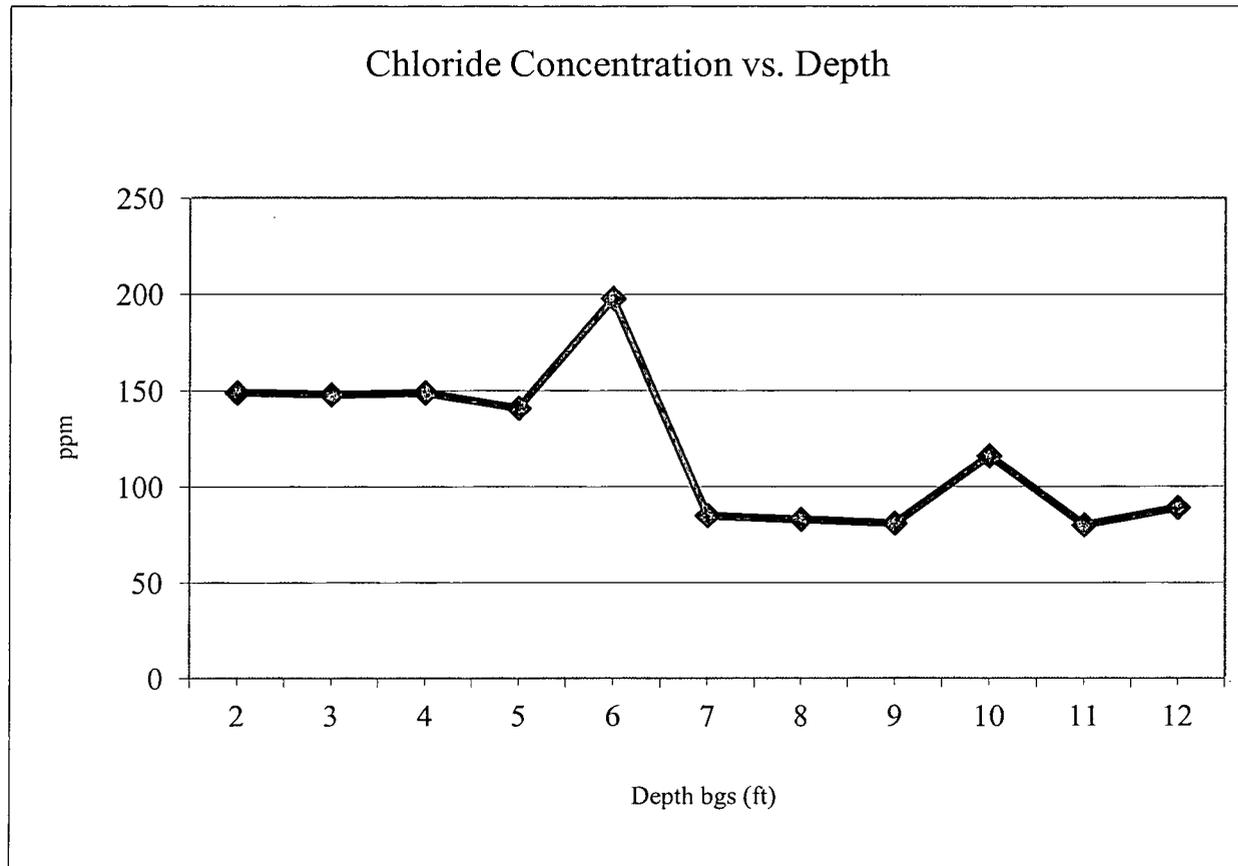
Backhoe samples at junction (source)

Depth bgs (ft)	[Cl] ppm
2	149
3	148
4	149
5	141
6	198
7	85
8	83
9	81
10	116
11	80
12	89

Groundwater = 40 ft
