EME Jct. F-23
2011

CLOSURE

RE: Termination Request
EME Jct. F-23: UL/F, Sec. 23, T19S, R36E
RICE Operating Company – Eunice Monument Eumont SWD System

**RICE OPERATING COMPANY
JUNCTION BOX FINAL REPORT**

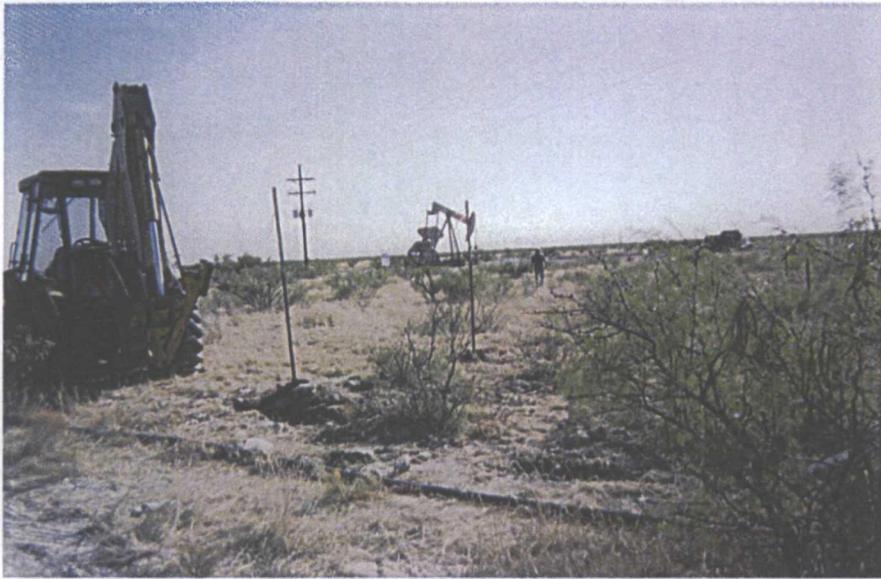
6.29.11

Site prior to excavation, facing north

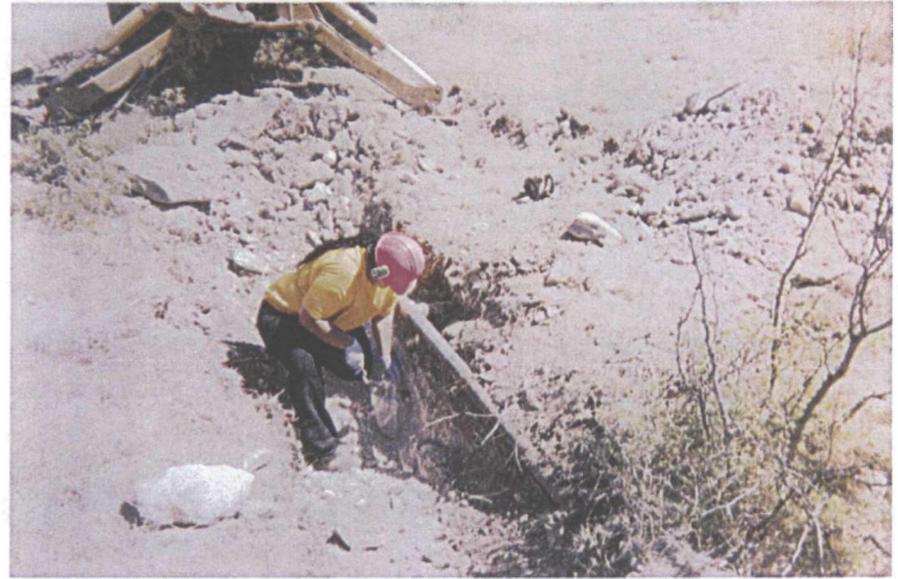
6.29.11

Collecting sample, facing north

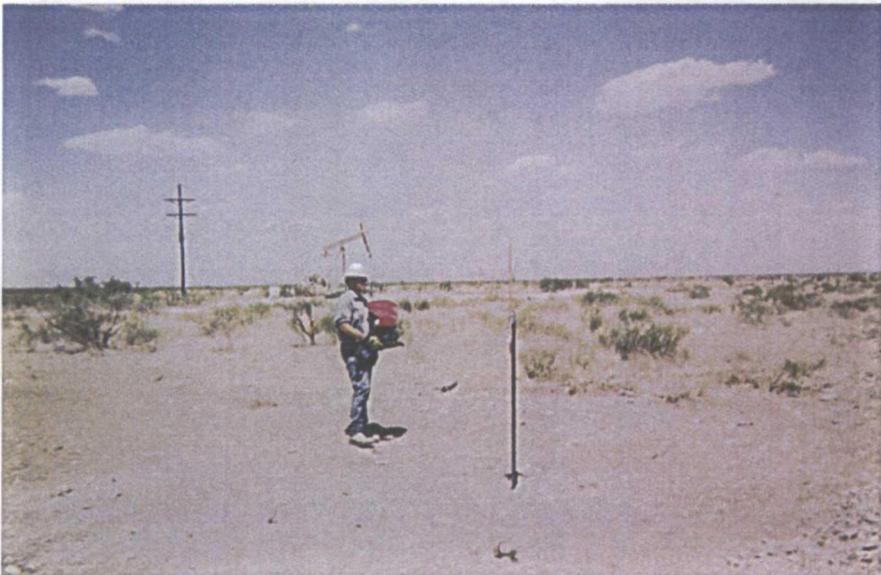
7.28.11

Seeding site, facing north

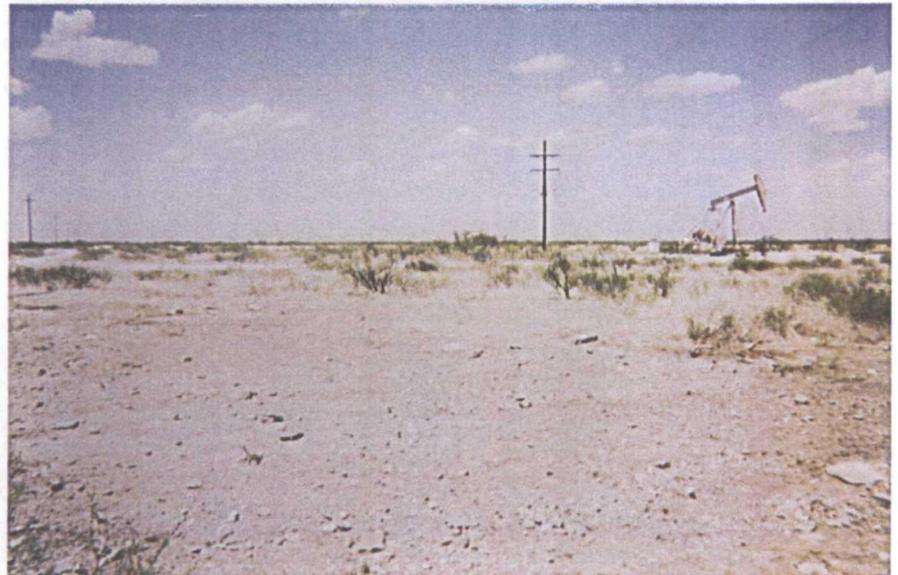
7.28.11

Site completed, facing north

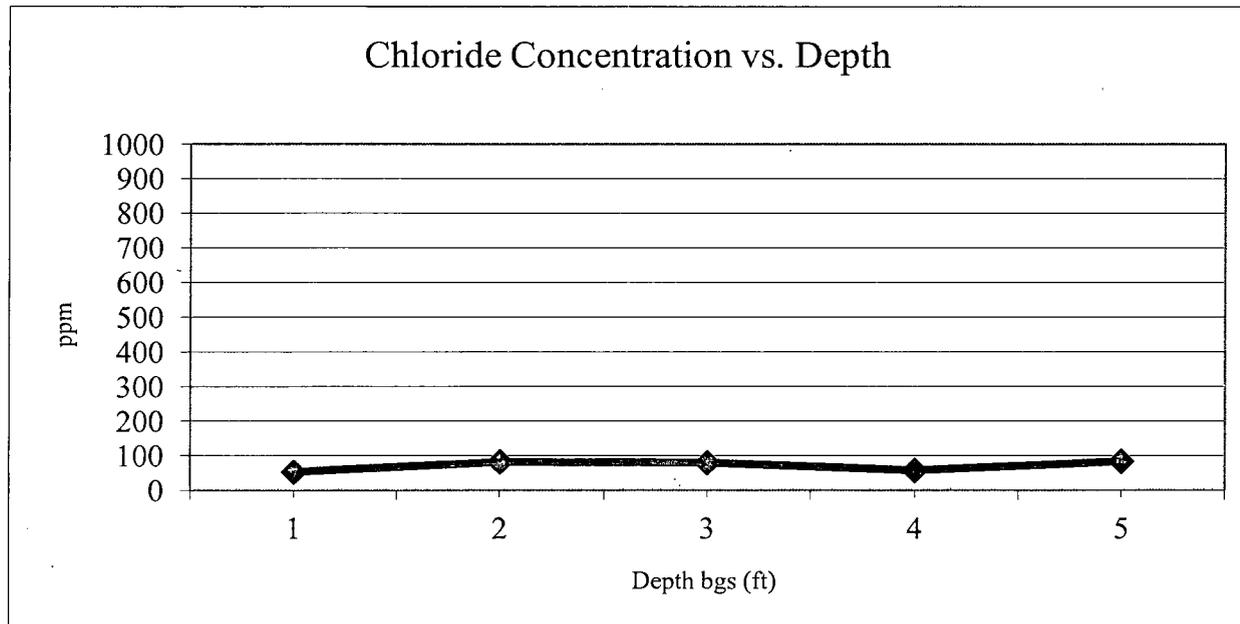
EME Jct. F-23

Backhoe samples at junction (source)

Depth bgs (ft)	[Cl] ppm
1	53
2	82
3	80
4	58
5	84

Groundwater = 57 ft
