RE: Termination Request  
EME Jct. G-4: UL/G, Sec. 4, T20S, R36E  
RICE Operating Company – Eunice Monument Eumont SWD System

**RICE OPERATING COMPANY  
JUNCTION BOX FINAL REPORT**

# EME Jct. G-4

Unit G, Section 4, T20S, R36E

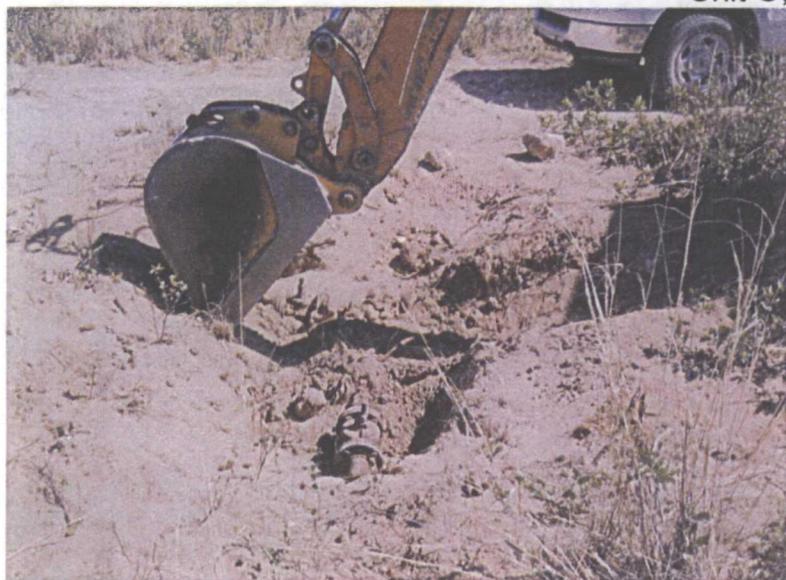
5.26.11

Excavating site, facing north

**General Description of Remedial Action:** This junction was eliminated during the pipeline replacement/upgrade program. After the former junction box was removed, an investigation was conducted using a backhoe to collect soil samples at regular intervals creating a 2X5X7-ft. deep excavation. Chloride field tests performed on each sample yielded concentrations similar to that of the background sample. Organic vapors were measured using a PID, which yielded low concentrations. The deepest sample, 7 ft. BGS, was sent to a commercial laboratory for analysis of chloride and TPH, which confirmed low concentrations of each. The excavation was backfilled with excavated soil to ground surface and contoured to the surrounding area. On 12/16/2011, the site was seeded with a blend of native vegetation and is expected to return to a productive capacity at a normal rate.

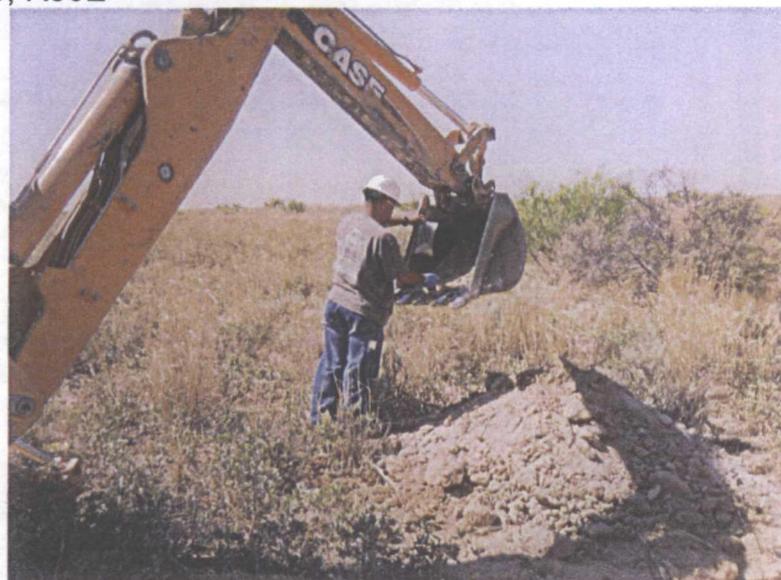
5.26.11

Collecting sample, facing south

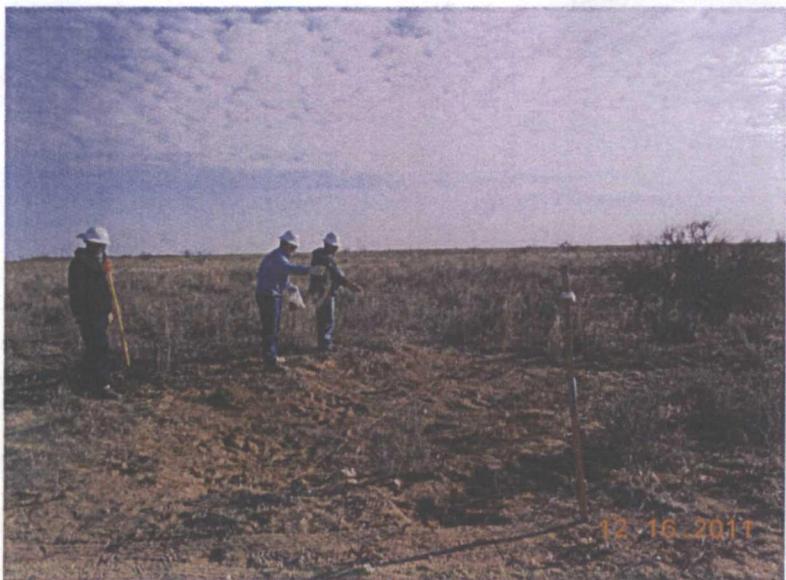
12.16.11

Spreading seed, facing east

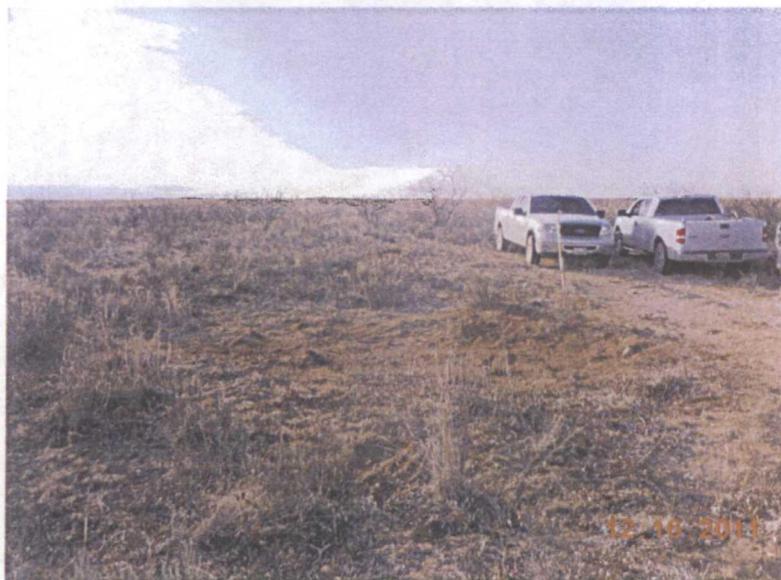
12.16.11

Site complete, facing west

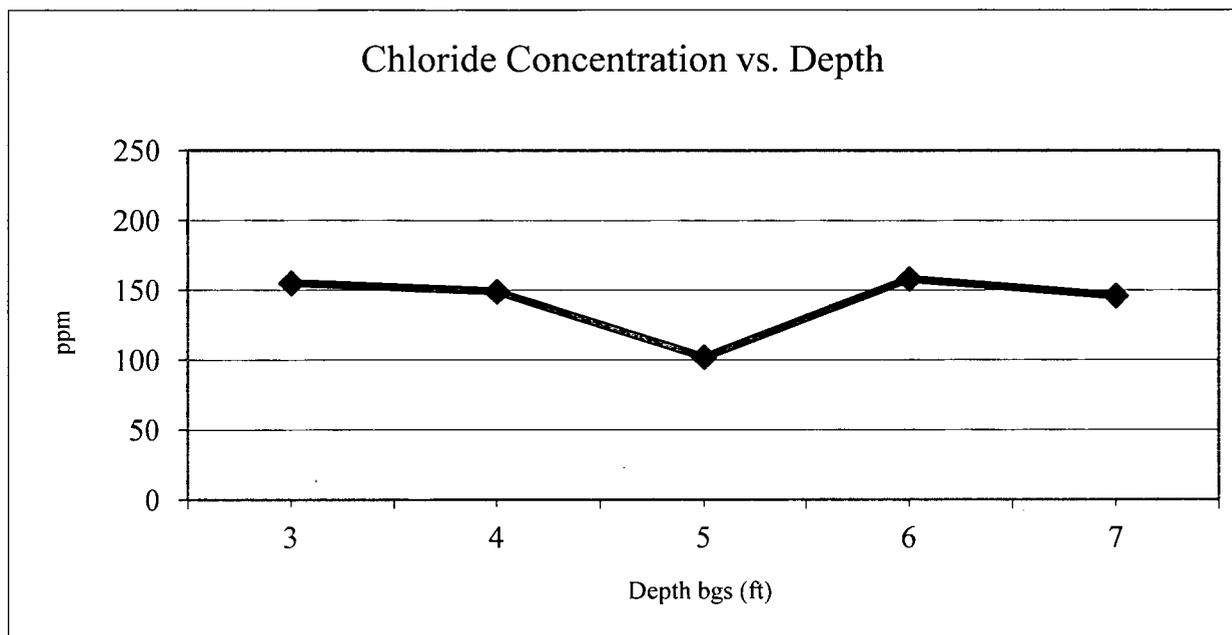
*Backhoe samples at junction (source)*

Depth bgs (ft)	[Cl <sup>-</sup> ] ppm
3	155
4	149
5	102
6	158
7	146

Groundwater = 40 ft
