RE: Termination Request  
EME Jct. J-25-2: UL/J, Sec. 25, T19S, R36E  
RICE Operating Company – Eunice Monument Eumont SWD System

# EME Jct. J-25-2

Unit J, Section 25, T19S, R36E

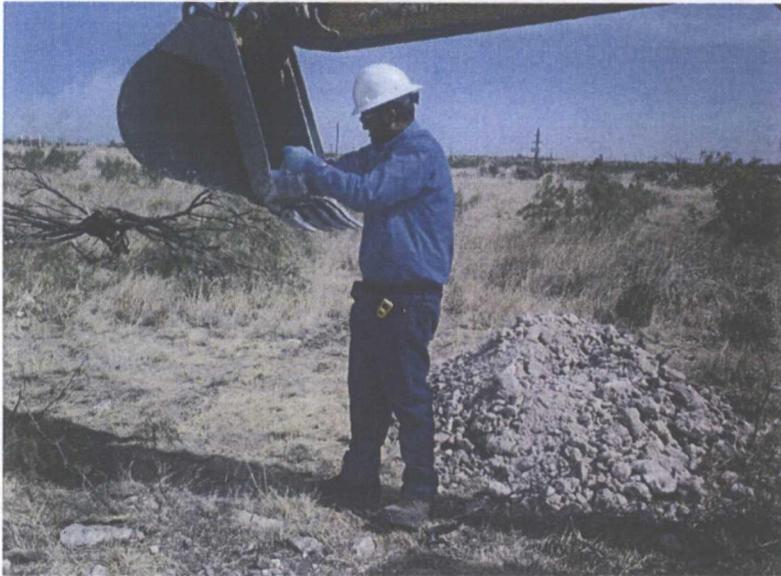
4.25.11

Collecting sample, facing west

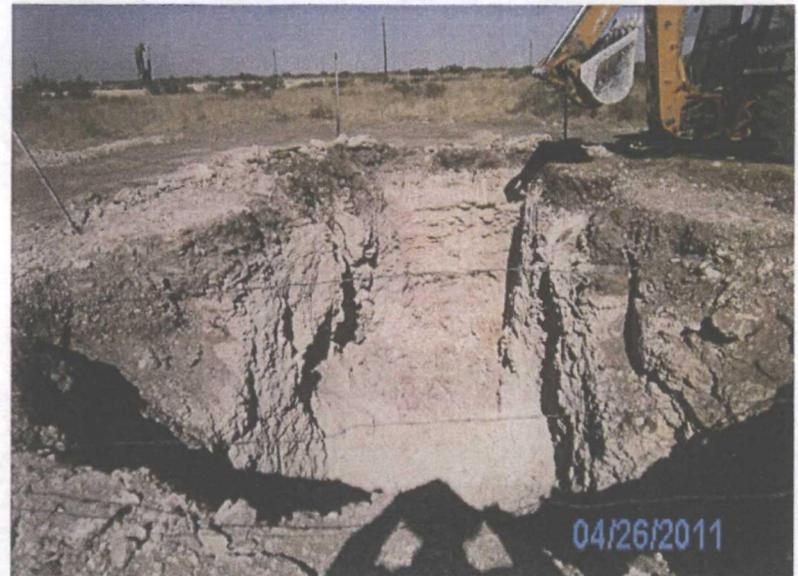
4.26.11

Final excavation, facing west

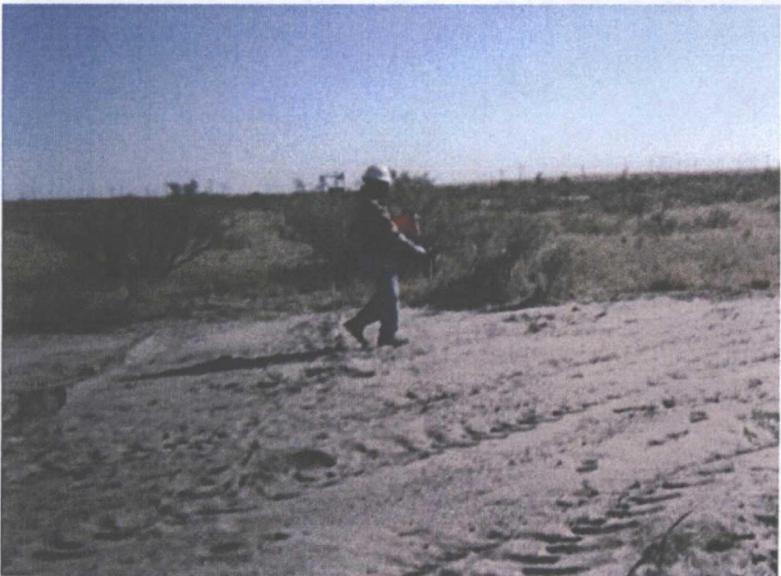
5.13.11

Spreading seed, facing north

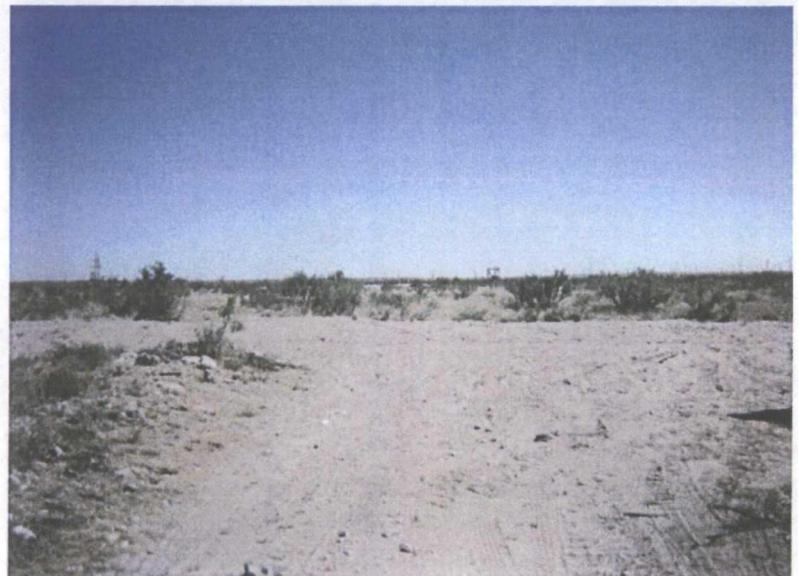
5.13.11

Site complete, facing north

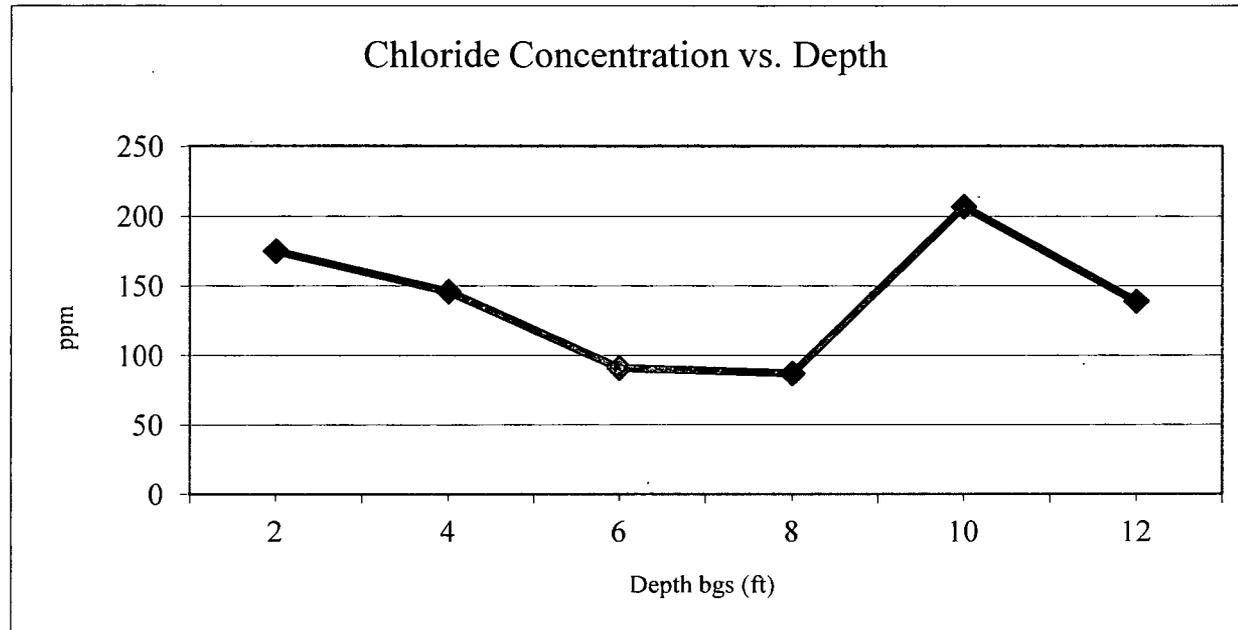
*Backhoe samples 5' north of source*

Depth bgs (ft)	[Cl <sup>-</sup> ] ppm
2	175
4	146
6	91
8	87
10	207
12	139

Groundwater = 25 ft
