EME Jct. P-22
2011

CLOSURE

RE: Termination Request
EME Jct. P-22: UL/P, Sec. 22, T19S, R36E
RICE Operating Company – Eunice Monument Eumont SWD System

**RICE OPERATING COMPANY
JUNCTION BOX FINAL REPORT**

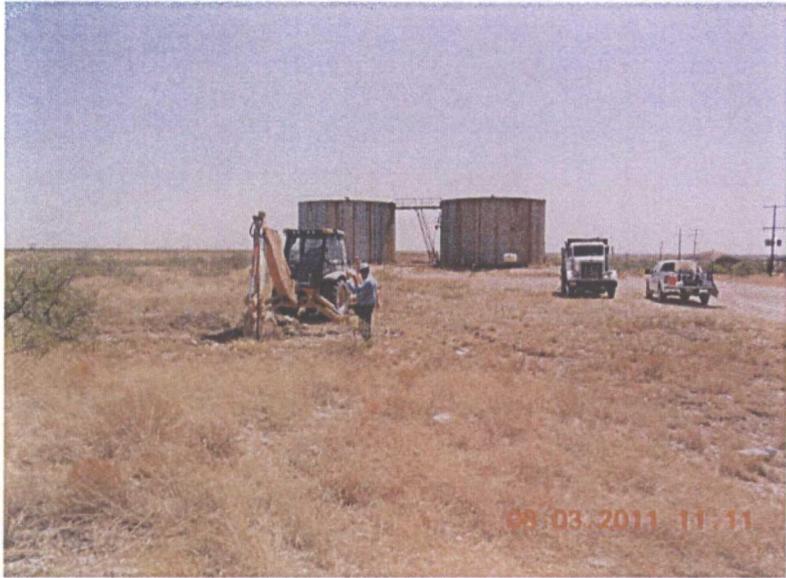
8.3.11

Digging source vertical, facing east

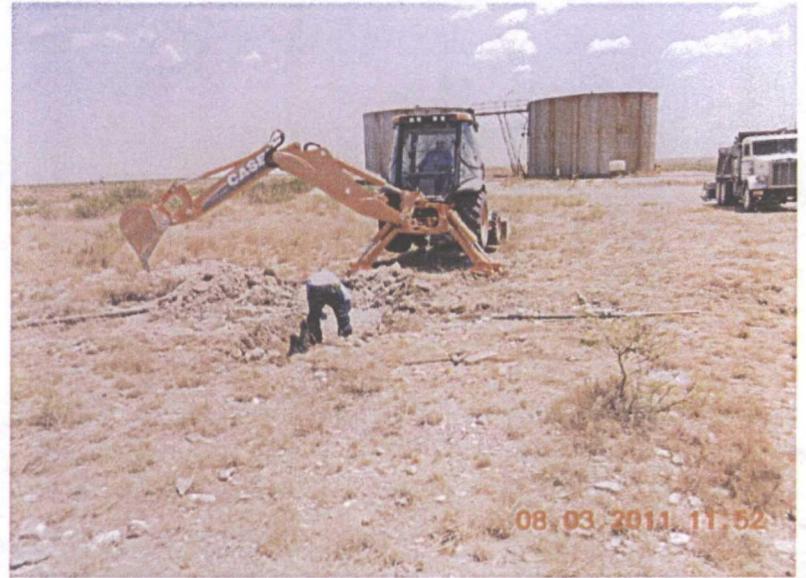
8.3.11

Collecting sample, facing east

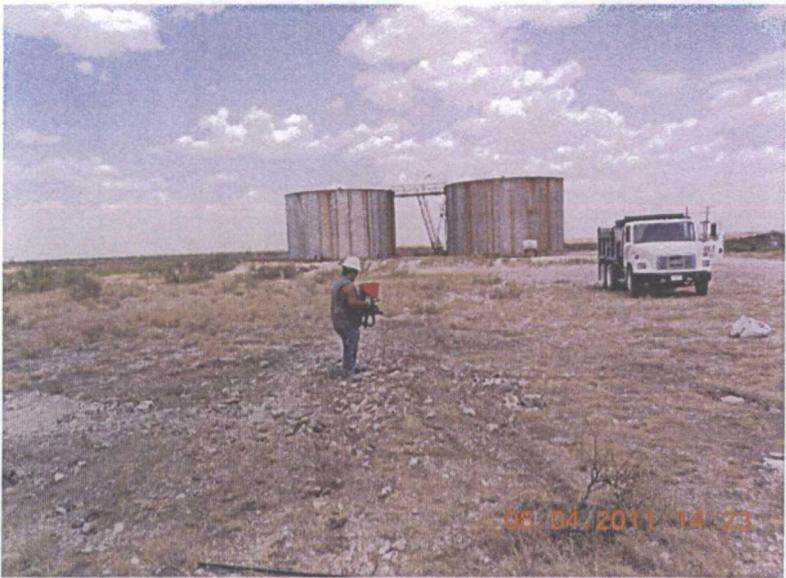
8.4.11

Spreading seed, facing east

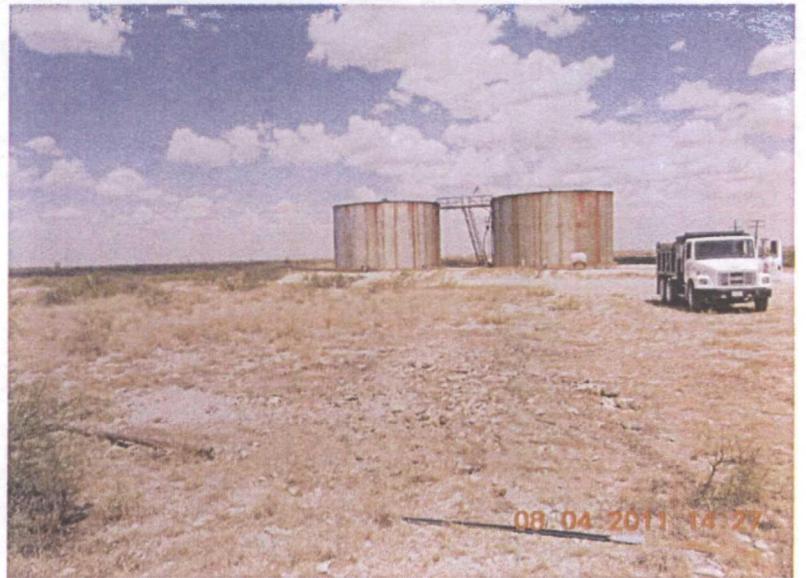
8.4.11

Site complete, facing east

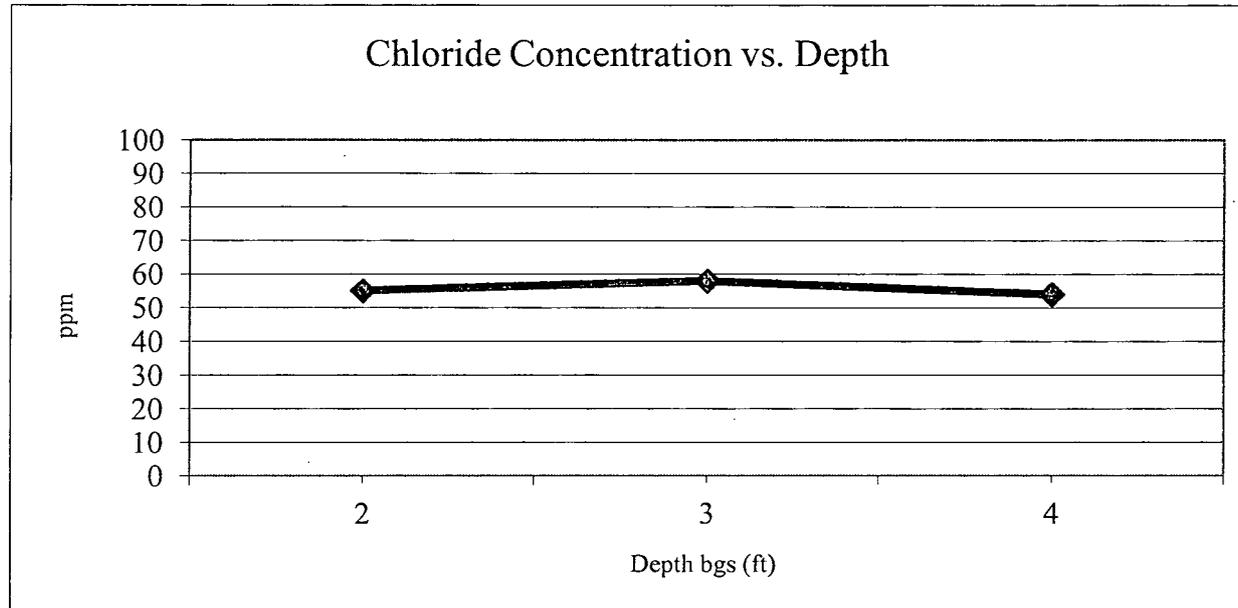
CHLORIDE CONCENTRATION CURVE

Backhoe samples at junction (source)

Groundwater = 49 ft
