EME K-10-1 Jct.
2011

CLOSURE

RE: Termination Request
EME K-10-1 Jct.: UL/K, Sec. 10, T20S, R36E
RICE Operating Company – Eunice Monument Eumont SWD System

**RICE OPERATING COMPANY
JUNCTION BOX FINAL REPORT**

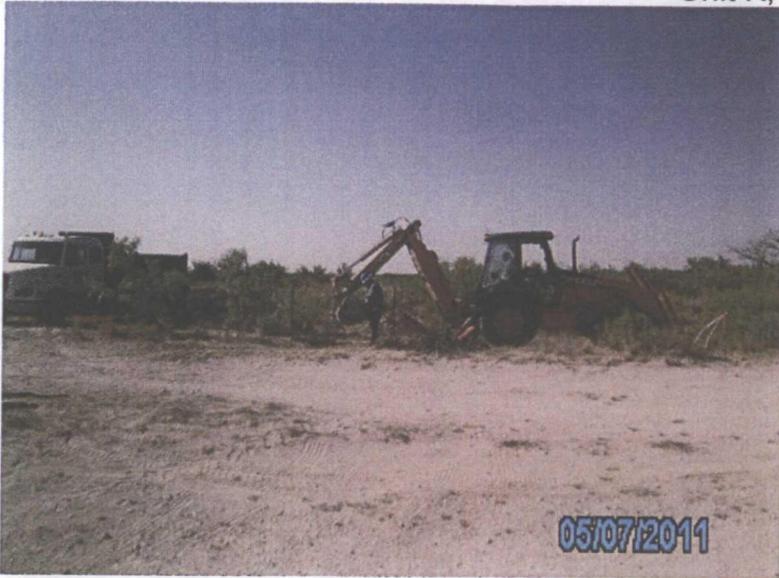
Collecting sample, facing south

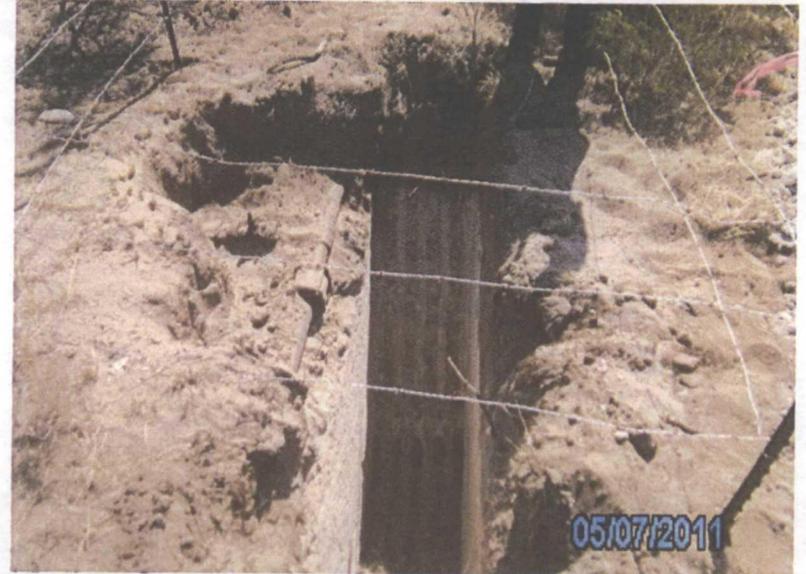
Excavation, facing east

General Description of Remedial Action: This junction was eliminated during the pipeline replacement/upgrade program. After the former junction box was removed, an investigation was conducted using a backhoe to collect soil samples at regular intervals creating a 3X7X7-ft. deep excavation. Chloride field tests performed on each sample yielded concentrations similar to that of the background sample. Organic vapors were measured using a PID, which yielded low concentrations. The deepest sample, 7 ft. BGS, was sent to a commercial laboratory for analysis of chloride and TPH, which confirmed low concentrations of each. The excavation was backfilled with excavated soil to ground surface and contoured to the surrounding area. On 5/27/11, the site was seeded with a blend of native vegetation and is expected to return to a productive capacity at a normal rate.

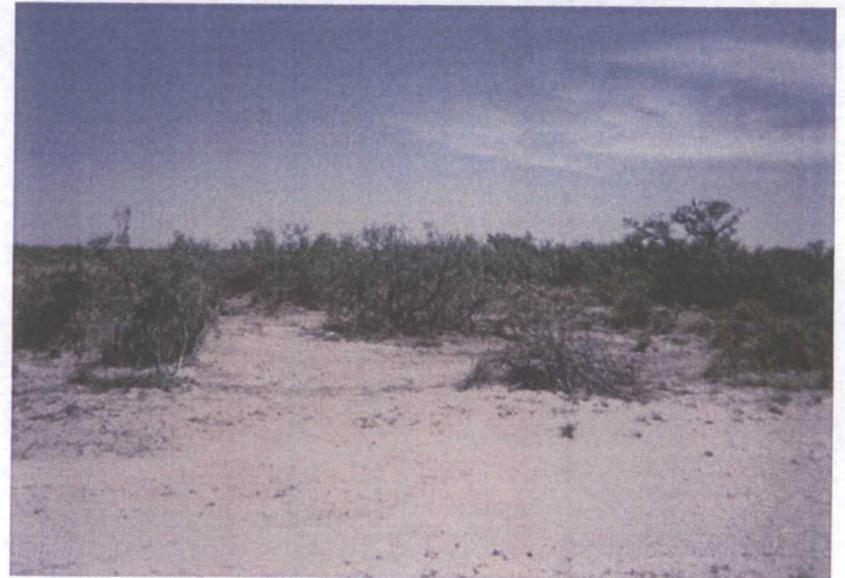
Site complete, facing south
