**CLOSURE**

RE: Termination Request  
EME L-5 EOL: UL/L, Sec. 5, T21S, R36E  
RICE Operating Company – Eunice Monument Eumont SWD System

**RICE OPERATING COMPANY  
JUNCTION BOX FINAL REPORT**

# EME L-5 EOL

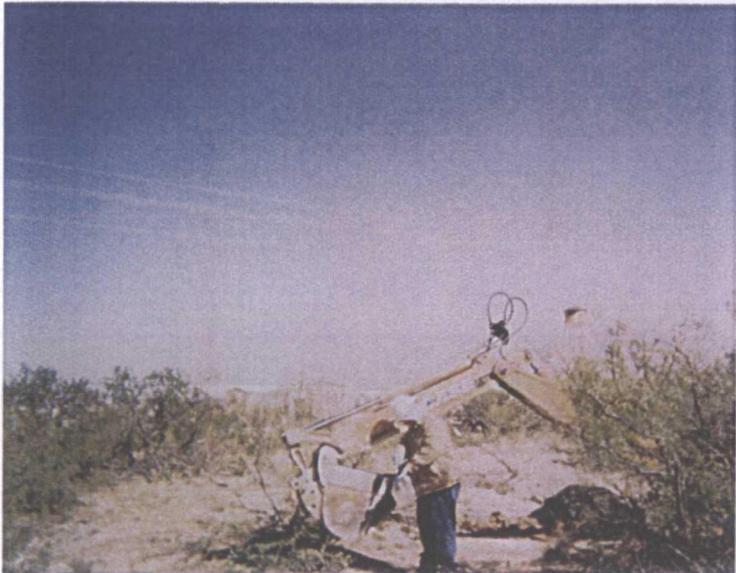
Collecting sample, facing east

11.2.11

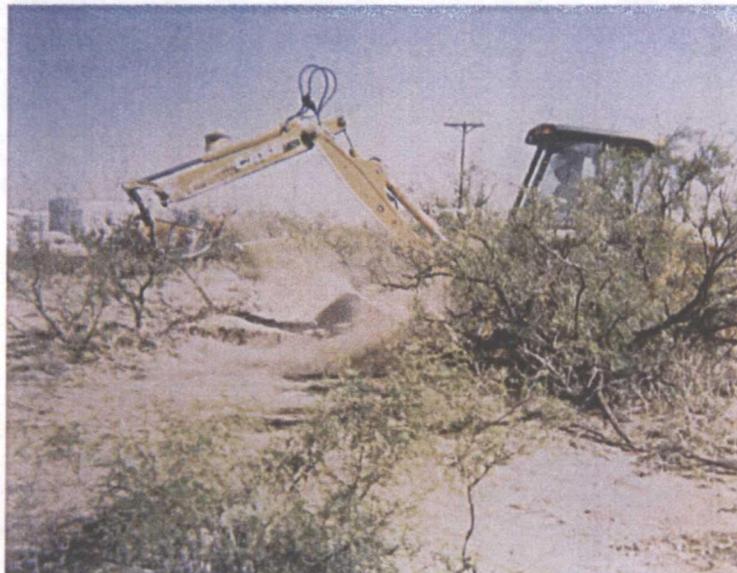
Backfilling site, facing east

11.2.11

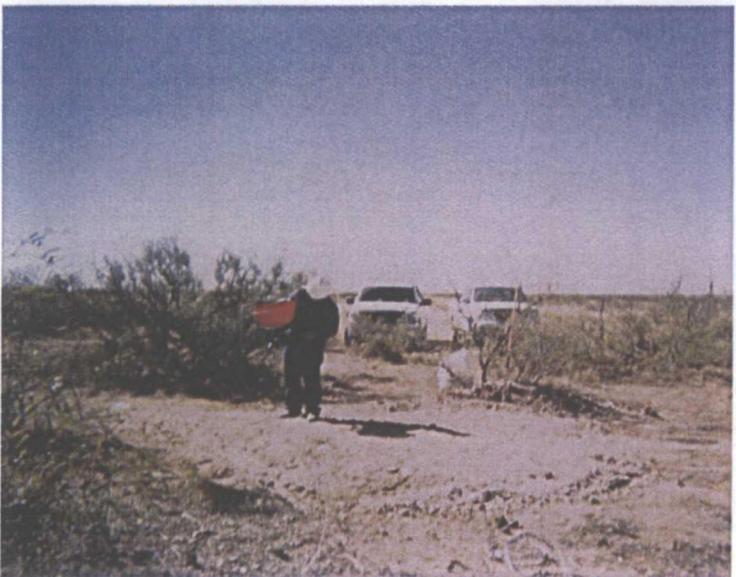
Spreading seed, facing west

11.3.11

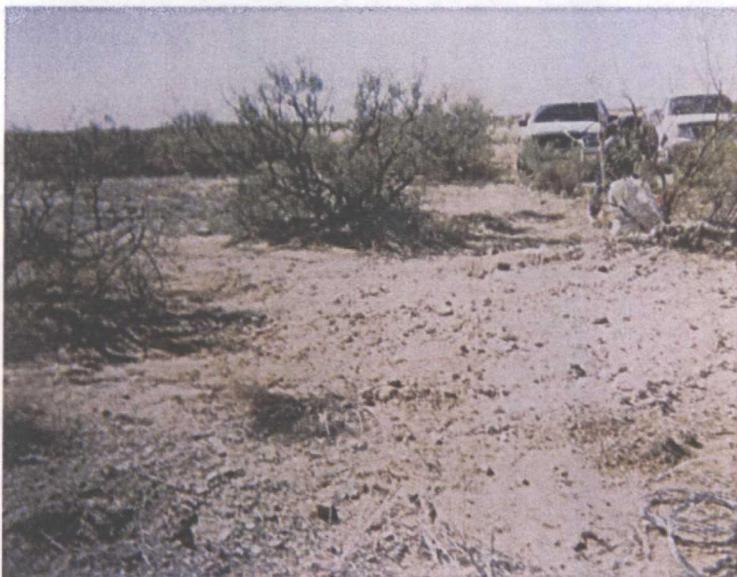
Site complete, facing north

11.3.11

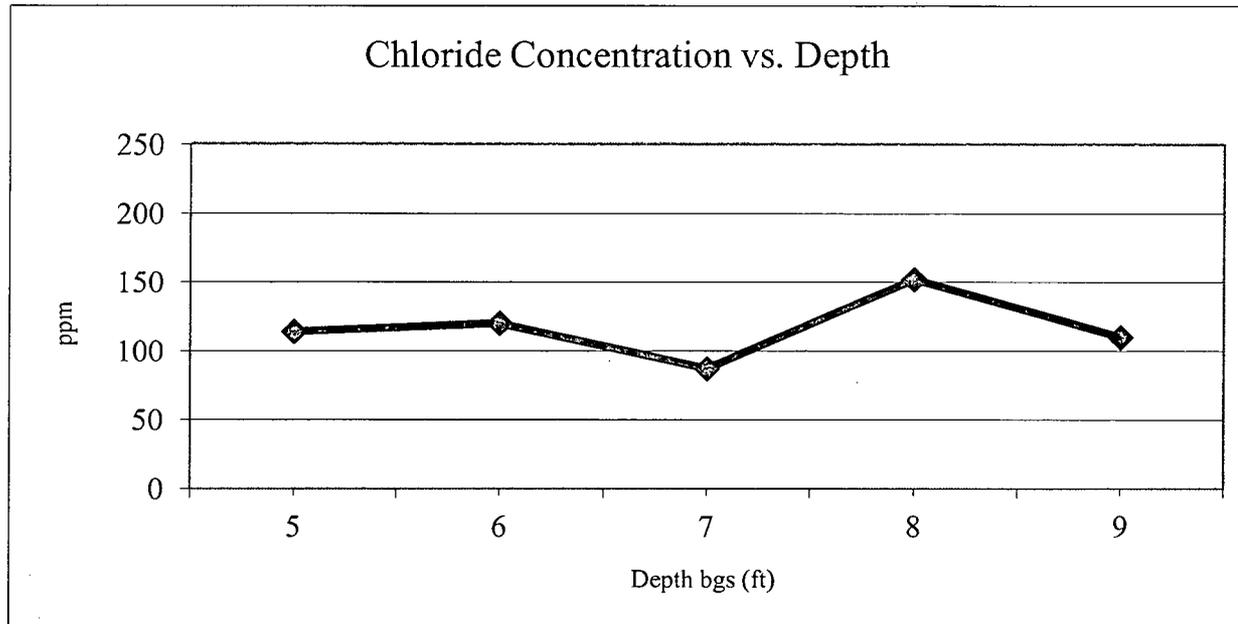
# EME L-5 EOL

Backhoe samples at junction (source)

Depth bgs (ft)	[Cl] ppm
5	114
6	120
7	87
8	152
9	110

Groundwater = 162 ft
